Tornado - July 19th, 2019 Preliminary Summary

Summary of Carter County Tornadoes

July 19, 2019

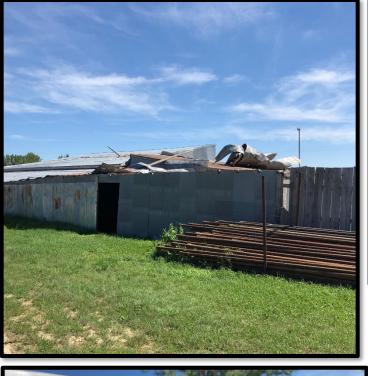
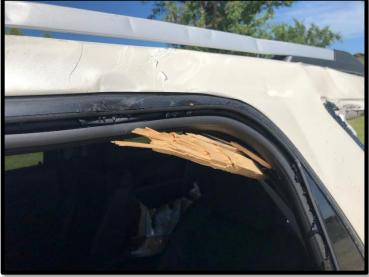
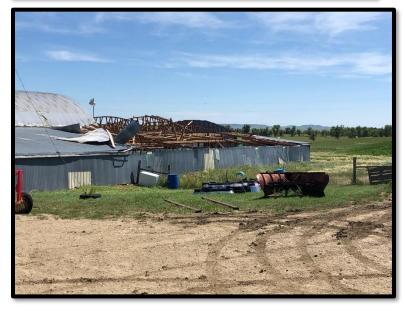
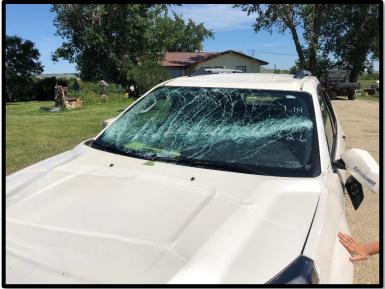
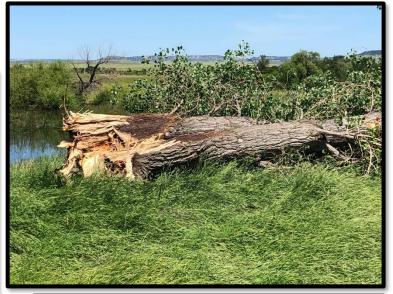
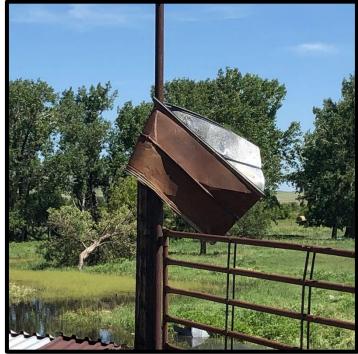
There was considerable damage to buildings on a local ranch. A shop building had 2 doors blown in and roof damage. Two other sheds had significant roof damage. Several metal rooftops were torn off and peeled back. A small garage was destroyed with a vehicle displaced inside, turned and moved by a couple feet. Several trees were snapped (approximately 1 foot diameter), with other smaller trees blown over or uprooted.
