# National Weather Service Storm Survey of Bremer County Wind Damage June 23, 2010

## Survey Results:

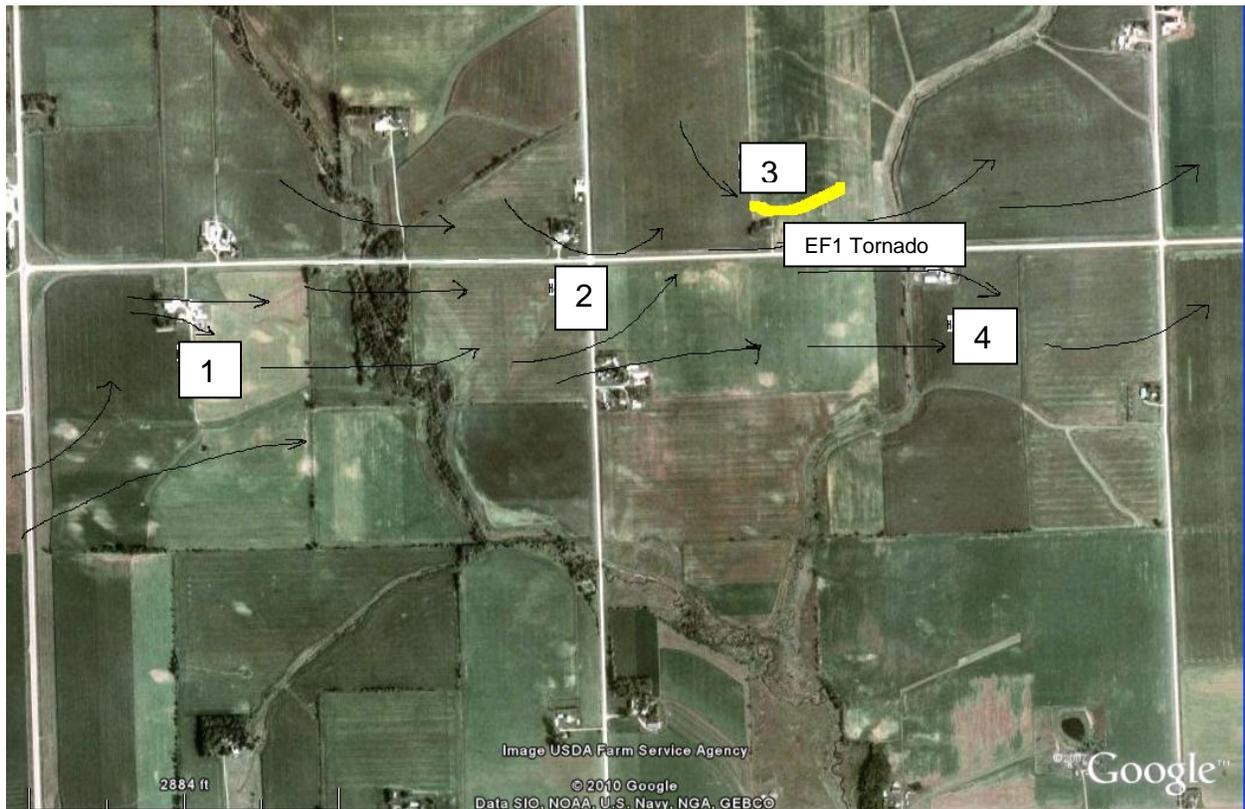
**This Google Map image shows the area of significant damage in Bremer County west of Tripoli. The black arrows show the straight-line wind flow which were based on the orientation of the debris and how the corn was bent. The yellow line is the path length of a brief Enhanced Fujita (EF) scale tornado.**

Most of the data suggested that the wind damage was caused by severe straight-line winds which blew generally from the west southwest.

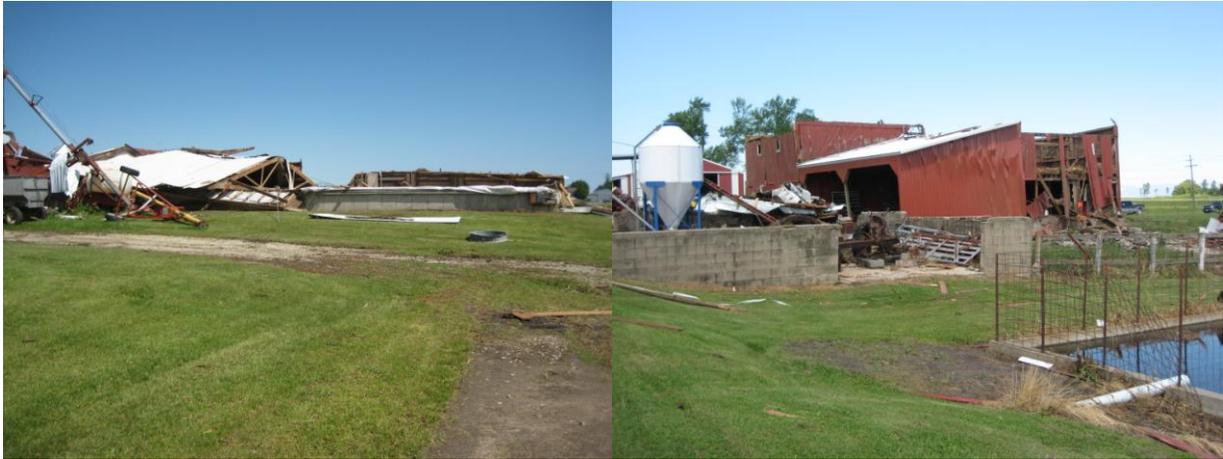
### Point 1:

Point one was a farm with a home and several barns and outbuildings. Two barns were destroyed and there was significant damage to another outbuilding, several large trees and the home. Wind speed estimates based on the damage ranged from 75 mph to 95 mph at this farm.

**Barn damage to barns and outbuildings at Point 1 which was caused by straight-line winds of between 85 and 90 mph**

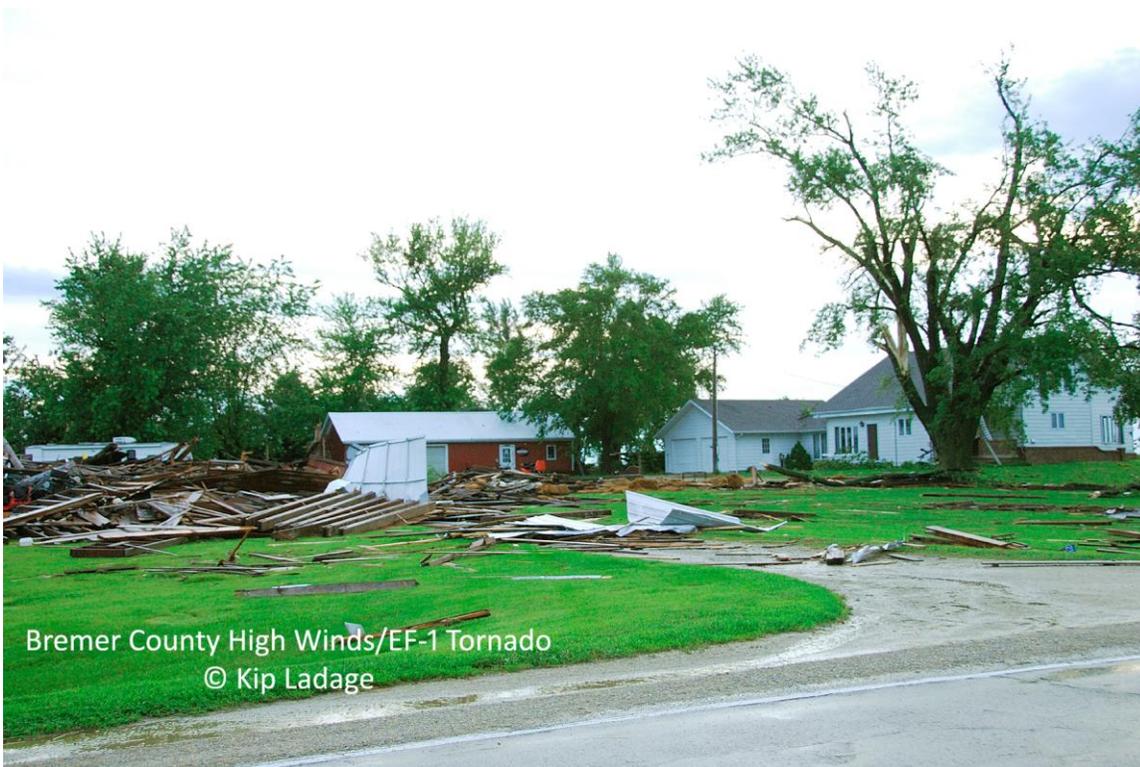
**Point 2:**

The severe straight-line winds continued east from Point 1 to Point 2. Several trees were topped along the creek between Points 1 and 2. Power poles were bent southeast of Point 2. Point 2 was a farm with a home and several barns and outbuildings. A large barn and a corncrib were destroyed and the home suffered significant damage. Wind speeds were estimated at 90 to 100 mph which destroyed the barn.

**Destroyed barn at Point 2. Picture is courtesy of Kip Ladage.**

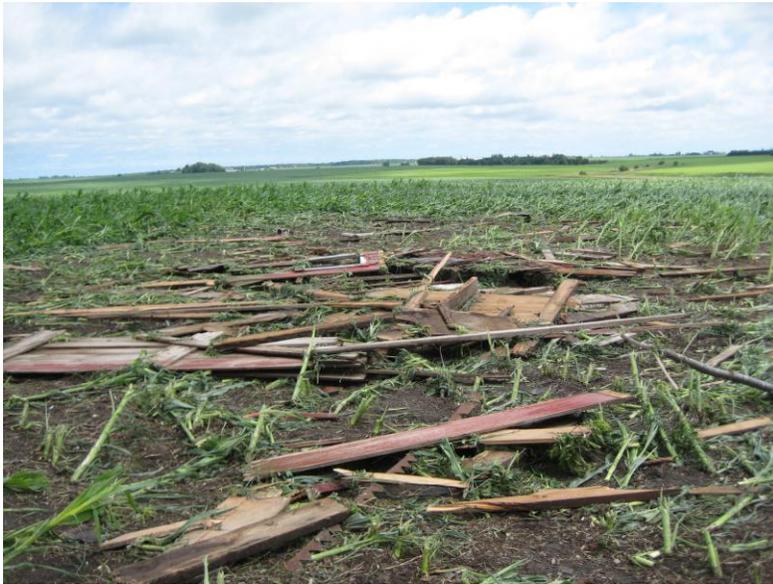
### Point 3:

Point 3 was an abandoned farm on the north side of the Highway 93. An old barn and grain bin were destroyed. There was strong evidence of convergence just north of the barn location. Sections of the barn were north and northwest of its location suggesting a southeast wind component. In addition, there was evidence of convergence in the corn and a short tornado track was noted in the corn field northeast of this location for a few hundred yards. The brief EF1 tornado occurred with wind speeds of 90 to 100 mph.

**Debris pointing northwest from Point 3**

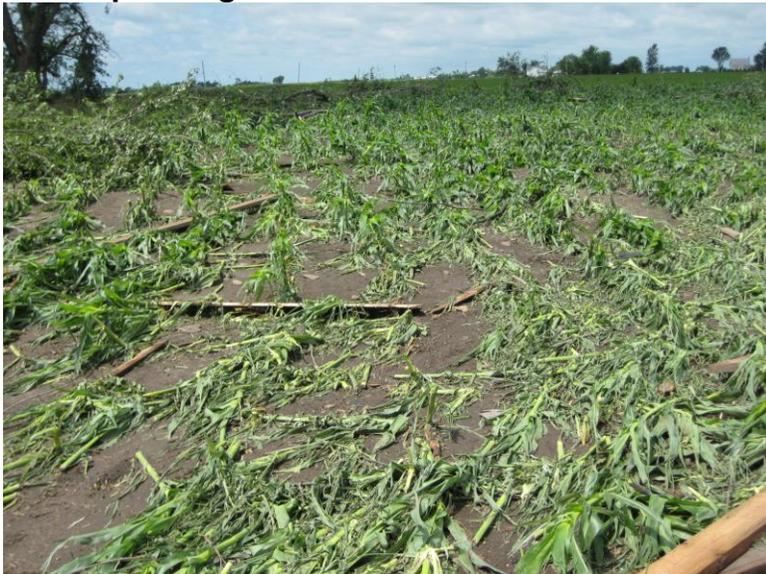
**Corn field where a brief EF1 tornado occurred**
