National Weather Service Des Moines

June 12, 2013 Tornado Event Summary

Updated on February 23, 2014

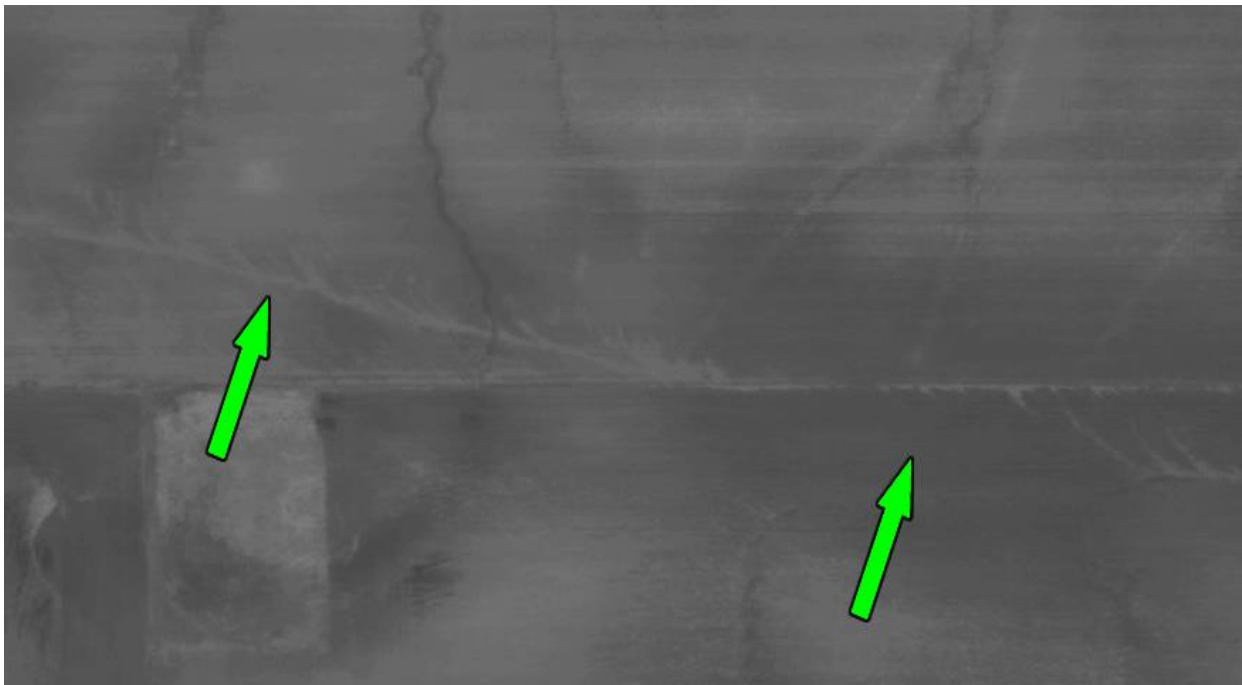
High resolution black and white satellite imagery of cyclonic swirls associated with the tornado as it travelled through a farm field NW of Belmond (green arrows).

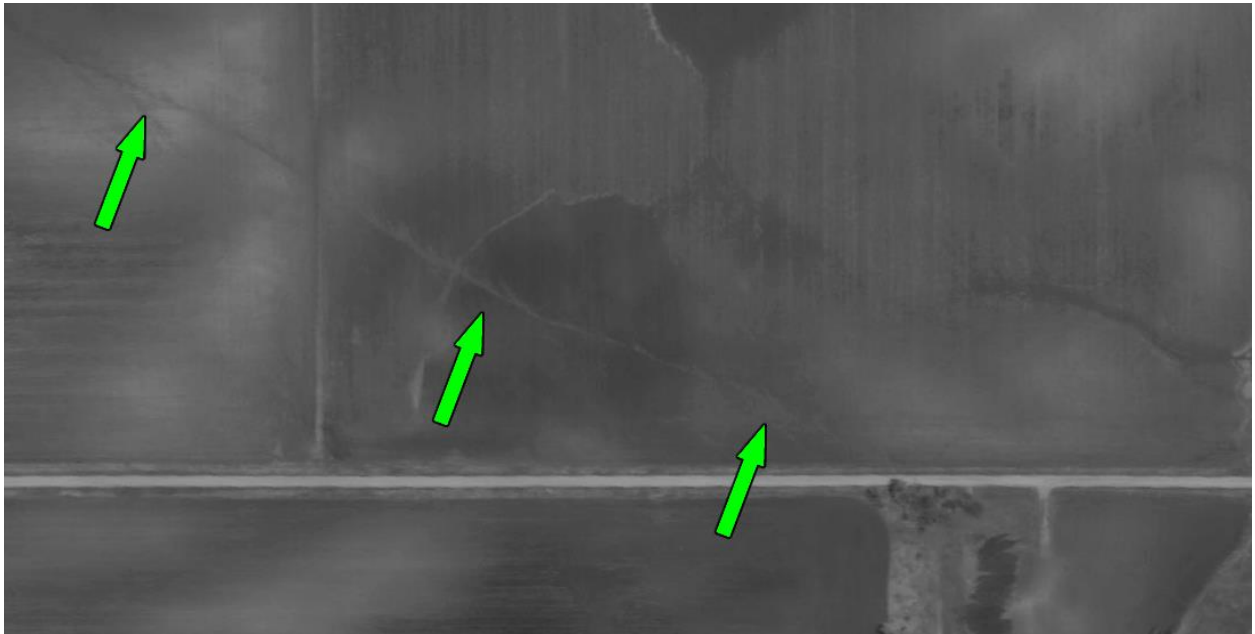
High resolution black and white satellite imagery of cyclonic swirls associated with the tornado as it travelled through a farm field SE of Belmond (green arrows). The trees in the photo above are at the bottom right of this image.
