PRELIMINARY HURRICANE IKE DAMAGE ASSESSMENT VICINITY MILE MARKER 74 (MM – 74)

Matt Parke, OPL
National Weather Service Forecast Office, Key West

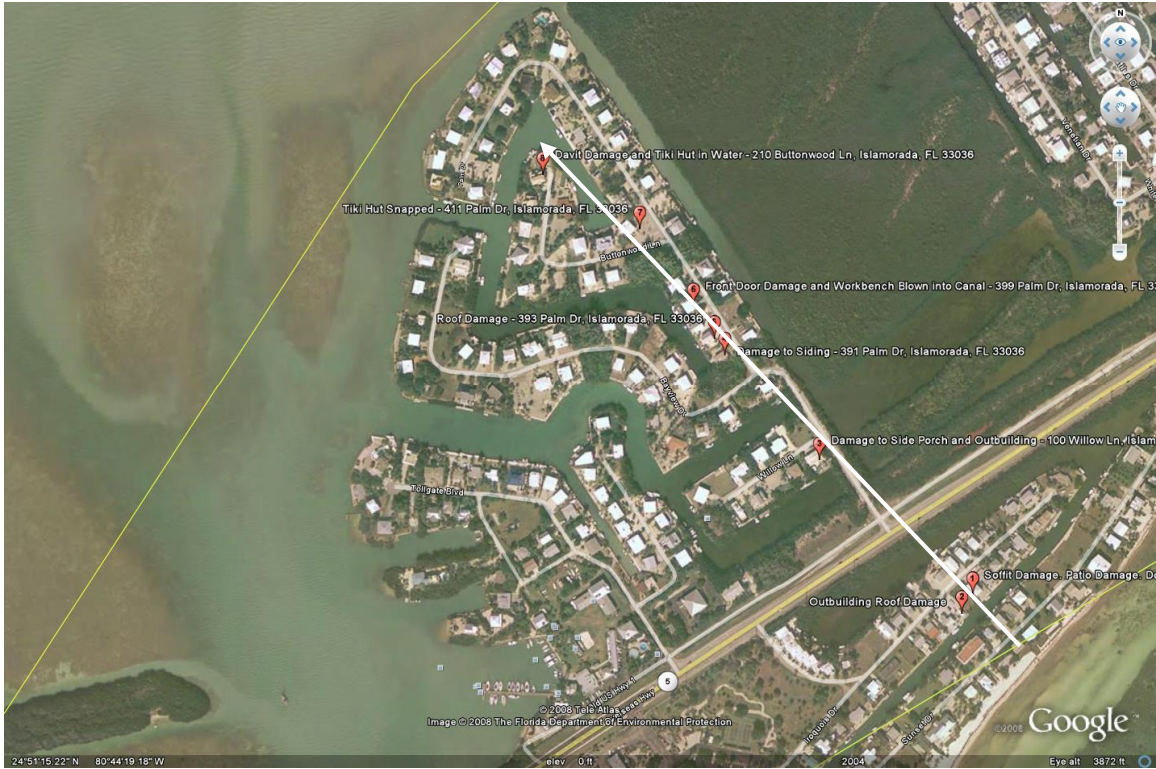
Figure 2. Damage track from lower right to upper center. Arrow indicates direction of motion. Balloons indicate areas of damage discussed in this assessment.

The damage path of Ike was on a track that trended from the southeast to the northwest. This would be indicated in Figure 2 from the lower right portion to the upper center portion of the image. The track of the tornadic event came across from the Atlantic side in the vicinity of Iroquois Drive and moved northwest towards Buttonwood Lane causing damage about 100 yards wide. The red pushpins in Figure 2 indicate damaged homes along the path. Photographs included in the remainder of this report correspond to damage at individual homes.

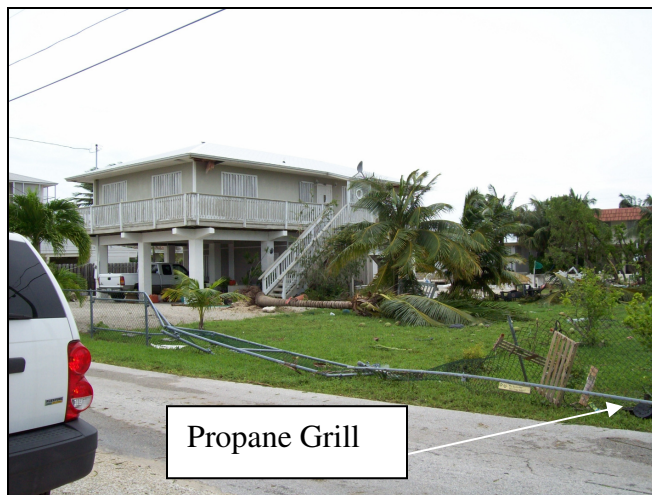
Figure 3. 153 Iroquois Dr.

The tornadic event came ashore around 4:00 am along the southern coast of Lower Matecumbe Key. The view in Figure 3 is looking approximately east. On the other side of the distant trees are the nearshore Atlantic waters. Note in the above figure that there is damage to the soffit of the house. However, the metal roof is undamaged. Note also that several palm trees have been blown over, the fence is blown down, and the considerable amount of debris strewn into the sideyard. Some of the debris was rather heavy (a weight bench with weights, and a propane grill) was moved well out into the sideyard from the back porch (See Figures 3 and 4). The owner of the house at 153 Iroquois Drive stated that the event occurred near 4:00 am. The owner stated that they were asleep in the Master Bedroom at the time and that it sounded as if a “bomb” had gone off. Not shown are the pictures which show one of the upstairs patio doors had exploded as the storm shutter was ripped off, presumably by the propane grill which was out on the upstairs back porch. Also not shown is the bowed out and fractured back bedroom closet mirror doors.

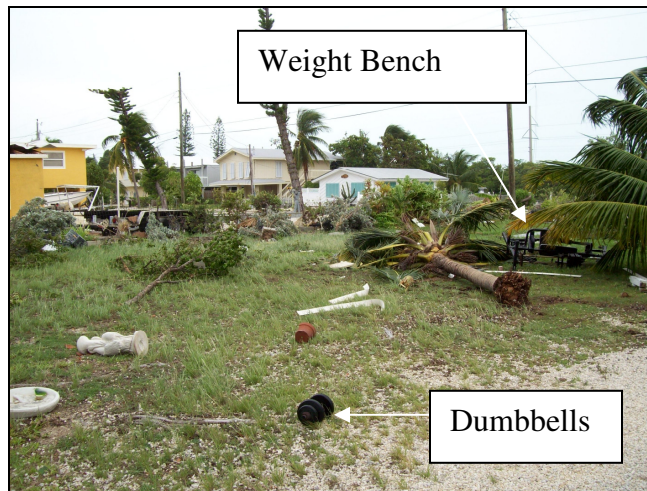
Figure 4. View looking approximately northwest from 153 Iroquois Dr

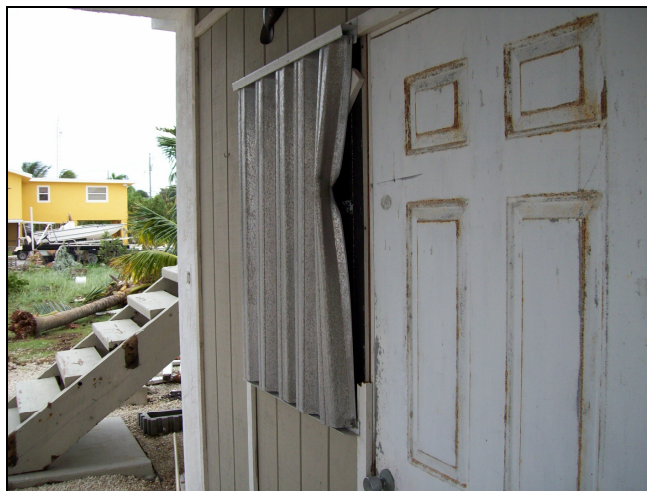
Figure 5. Damage to back porch of 153 Iroquois Dr.

This view is looking approximately south from the back porch of 153 Iroquois Dr. Note the damage to the storage door and the metal storm shutter. According to the homeowner, the weight bench which was flung into the sideyard was located on the back porch. It is hypothesized that the bench was lifted and flung up towards the door and storm shutter causing the breaking of the door frame and denting the storm shutter. There is a piece of the door frame embedded between the storm shutter and the exterior window it is protecting. When looking approximately southwest from the upstairs screened-in porch at 153 Iroquois Dr (Figure 5), moderate roof damage is apparent in the neighbor's house adjacent to the sideyard with the roof peeling back from approximately a west to east fashion. Further note that the main house (yellow) appears to be unaffected by the event. The house is about 100 yards away.

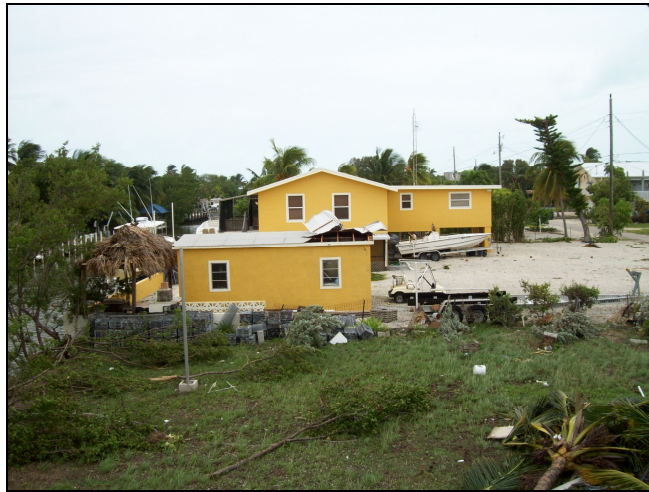
Figure 6. House to southwest of 153 Iroquois Dr.

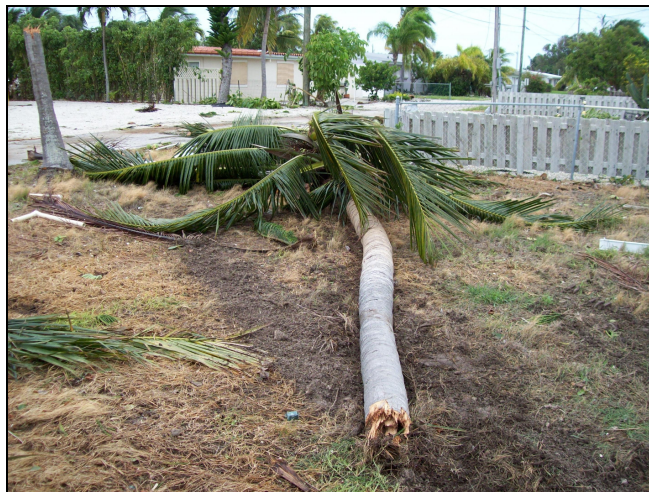
Figure 7. Snapped palm tree across road to northwest of 153 Iroquois Dr.

Across Iroquois Dr. and to the northwest of 153 Iroquois, a palm tree was snapped about 1/3 of the way up from the surface. The stump can be seen in the upper left of the photo. The trunk and palm fronds are oriented in approximately a north south direction.

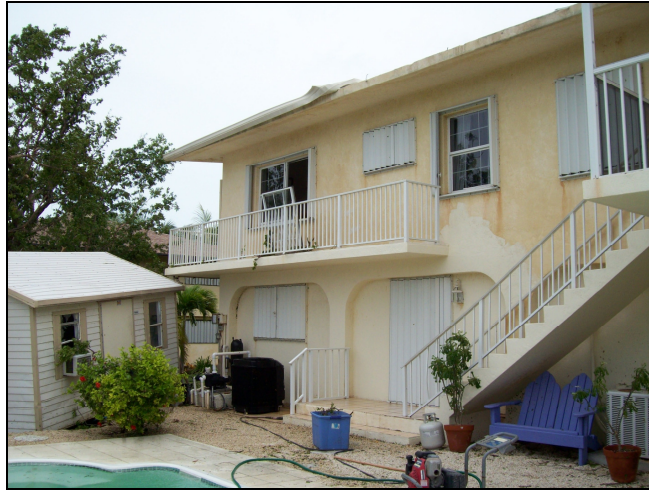
Figure 8. Backyard view of house at 100 Willow Lane.

The event came across the back and sideyards of the 100 Willow Lane house. Note the damage to the gutter system, the outbuilding which has been transported from its original location to the left in the picture (See also Figure 11) and the popped out upper bedroom window. The owner was not at home during the event, but stated that the window's storm shutter was not closed at the time. This house suffered damage to the back and side screened-in porch. Figure 9 shows this with the view looking from the southeast to the northwest. The front of the house (on Willow Lane) is in the background and Palm Drive is to the right of the photo. The front of the house (Figure 10) shows damage to the gutter system.

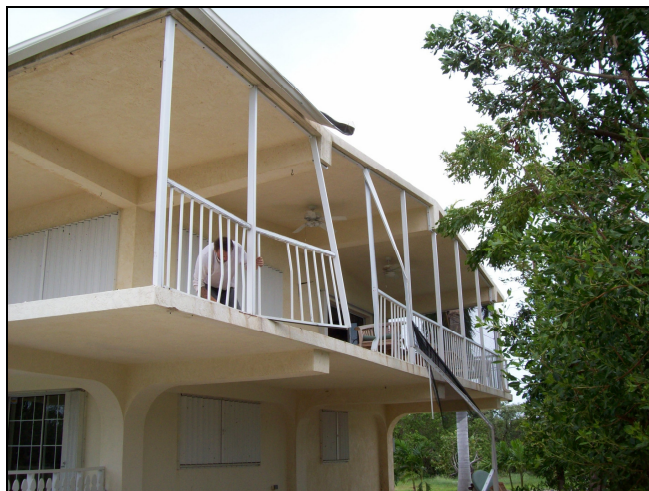
Figure 9. Porch Damage at house at 100 Willow Lane.

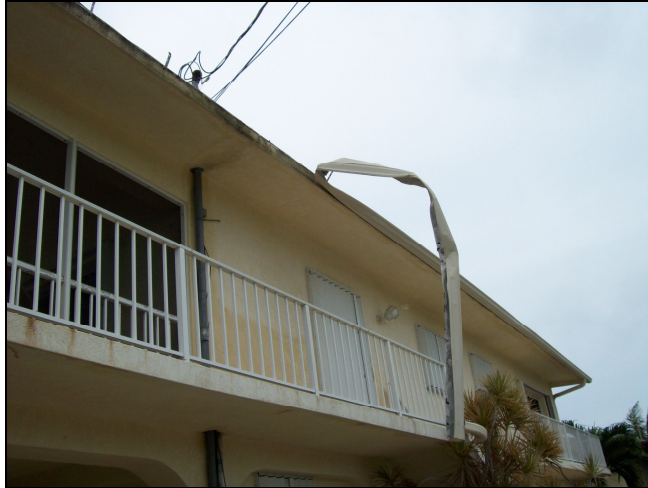
Figure 10. Front view of house at 100 Willow Lane.

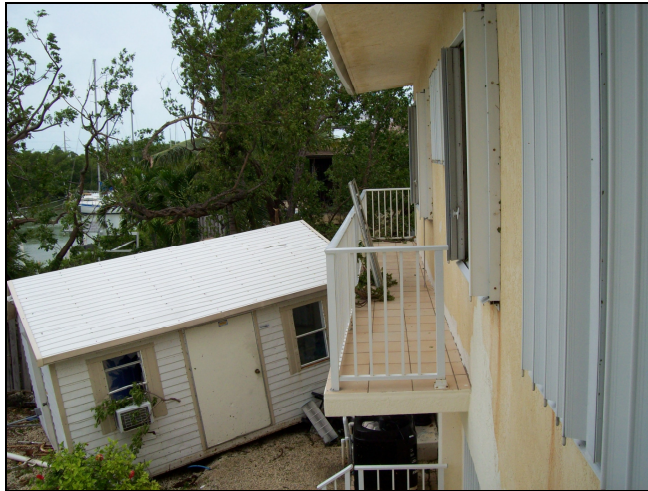
Figure 11. Backyard of house at 100 Willow Lane.

Note also in Figure 11 the snapped trees in the background when looking approximately south. Photos not included in this report are of a few trees in the front yard bent to the northwest, as well as a photo indicating the apparent continuation of the track across Willow Lane to the northwest. Witnesses at 100 Willow Lane told me that there was further damage down Palm Drive to the northwest, so I proceeded along Palm Drive to investigate.

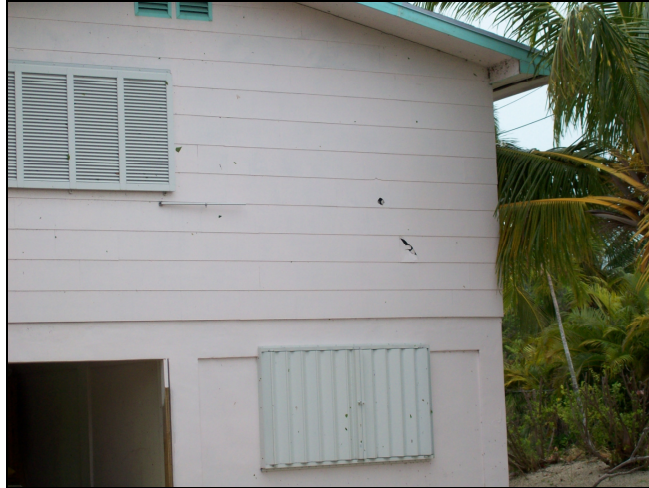
Figure 12. House on Palm Dr with siding damage.

This house (Figure 12) is the first in a linear series of 4 houses on the right side of Palm Drive about midway into the development known as Safety Harbor (see Figure 2). This view would be looking approximately south from Palm Drive. Note in the photo several penetrations of the siding by some type of wind-borne projectiles.

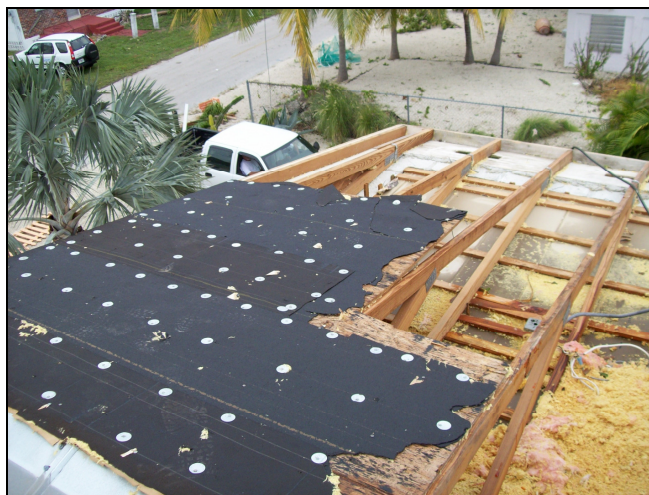
The next house in the series, 393 Palm Drive, had extensive roof damage (Figures 14 through 16). This house had a metal roof whose eastern side was torn away in the event. Note that large chunks of the metal roof were removed and that no apparent damage was done to the part of the roof to the west of the roofline (Figure 15). Note also the lack of damage to the air conditioning ducting and rafter structure. The roof's rafters were well tied together with storm strapping. It is also interesting to note that numerous roofing nails were left in the rafters, their nailheads extending above the bare rafters. The damage to the roof also included damage to the dining room ceiling. Figure 16 shows an inward bowed and cracked ceiling. It is unknown how this occurred unless part of the roof above came down and impacted the ceiling briefly before being carried away.

Figure 13. Roof damage at house at 393 Palm Dr. View is looking east southeast.

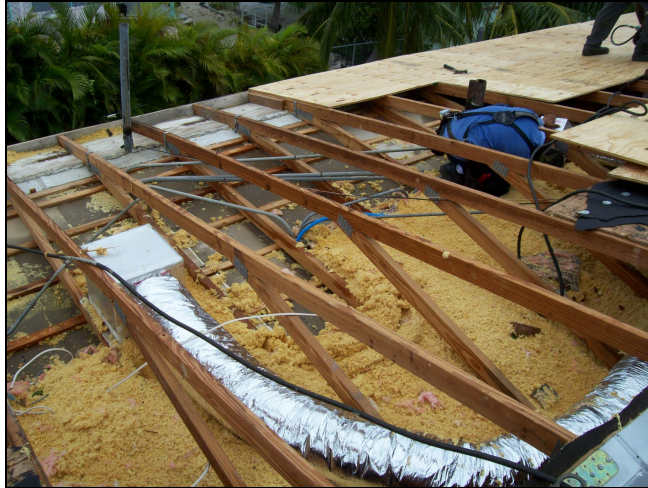
Figure 14. Roof damage at house on Palm Dr.

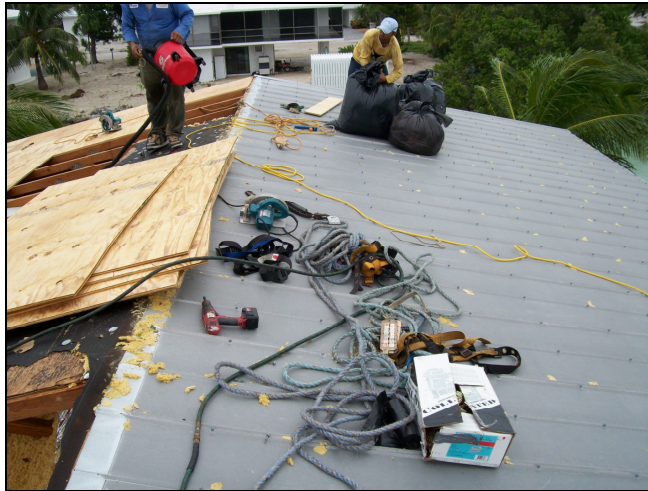
Figure 15. Roof damage to house on Palm Dr. View is looking approximately south.

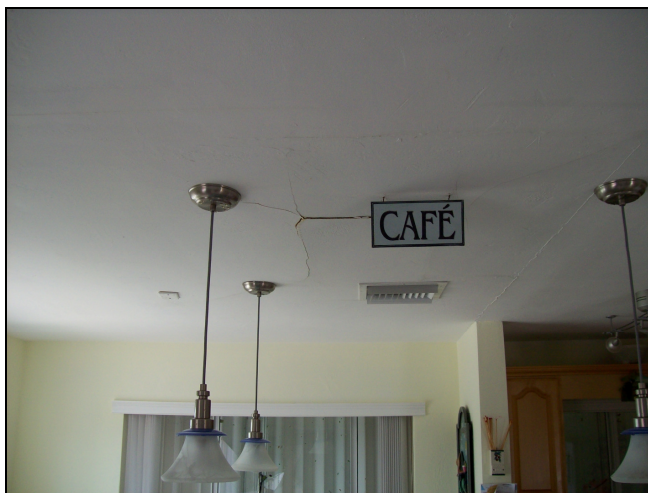
Figure 16. Dining room ceiling of house at 393 Palm Drive whose roof was damaged. Note the window in the background through which a tree limb came through. This view is looking approximately southeast.

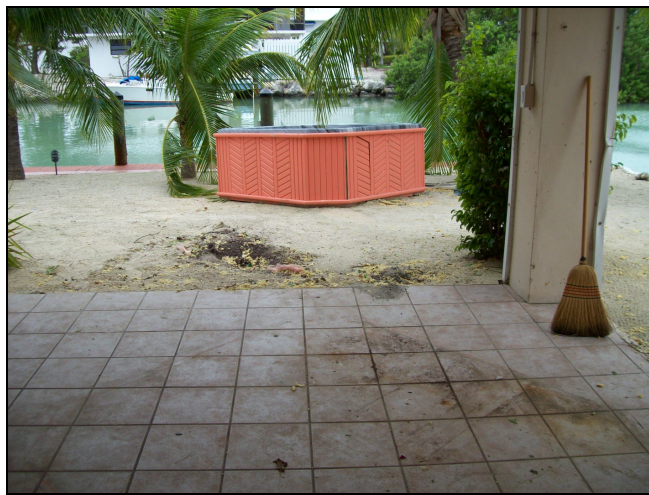
Underneath the house at 393 Palm Drive, the wind swept through the downstairs patio and moved the hot tub from underneath the structure out to the backyard, a distance of approximately 15 feet. Witnesses at the scene said the occurrence of the event was around 4:00 am. It is interesting to note that one of the occupants of the house was in the front room with the family dog, attempting to calm the animal down when the event happened. A tree limb came through the 2nd story window, transited across the dining room into the living room, and hit the adjacent couch, narrowly missing the individual trying to comfort the dog. It is also interesting to note that just before the limb came through the window, the dog broke free of its master, and quickly scampered to the back bedroom and under the bed. The window through which the limb came through was not shuttered at the time.

Figure 17. Hot tub blown out from underneath house at 393 Palm Drive.

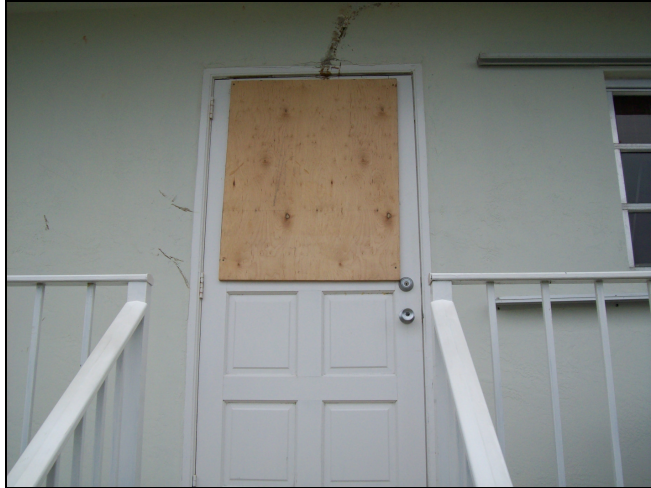
A witness at 393 Palm Drive told me to check out damage 2 doors down. The witness said that apparently some of the roof from 393 Palm had hit the front door of the house at 399 Palm Drive. Upon driving down to that address, I noted damage to the front door which was on the east side of the house (Figure 18). The homeowner stated that a piece of roofing was blown into his front door shattering the top portion of the door which was made of wood. A closer photo of the door (Figure 19) indicated damage to the wooden door frame as well as damage to the concrete wall above the door. The owner stated that the event occurred between 3:45 am and 4:00 am. When looking back toward the east southeast, it was noted that a house stood between the residence which had lost its roof (393 Palm Drive) and the residence at 399 Palm Drive. The house in between apparently had not been damaged (Figure 20). The distance traveled by the roof debris was approximately 175 feet.

Figure 18. Home at 399 Palm Drive with front door damage. Door faces east.

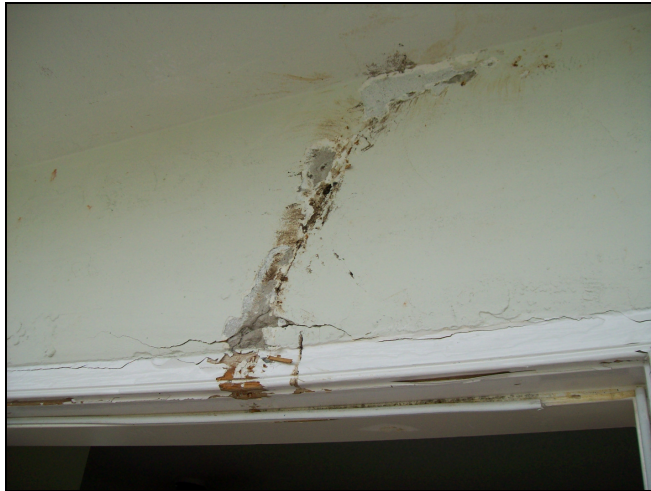
Figure 19. Close up view of damage above door in Fig. 18.

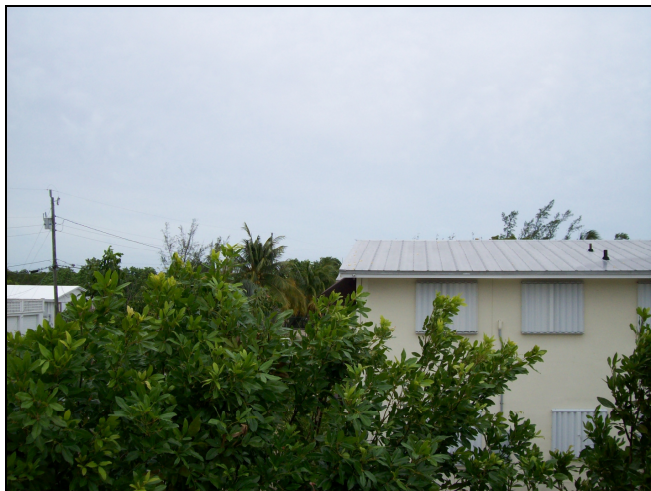
Figure 20. Looking back to east southeast from home at 399 Palm Drive with door damage.

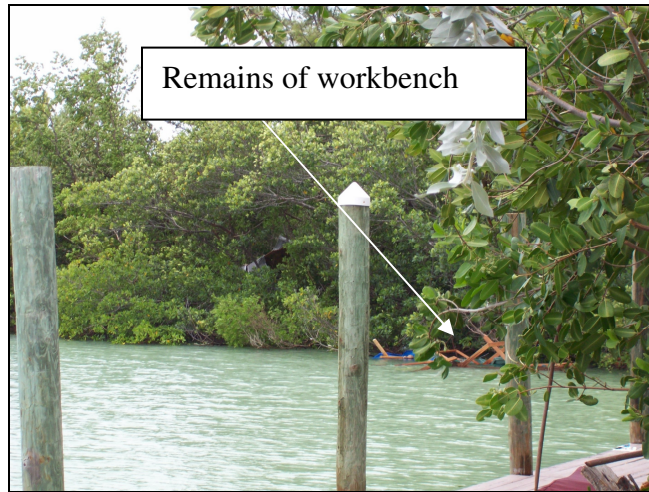
Other apparent damage noted at 399 Palm Drive was the removal of a workbench from underneath the eastern side of the house. The workbench, according to the homeowner, was 6 feet by 8 feet and had been built around a Sears brand table saw. The bench was blown out into the adjacent canal mangroves northwest of the home (Figure 21). This distance was estimated to be about 100 feet. The homeowner stated that the table saw was retrieved out of the backyard canal using a grappling hook – minus the electric motor, which was not recovered (Figure 22).

Figure 21. Workbench in the mangroves.

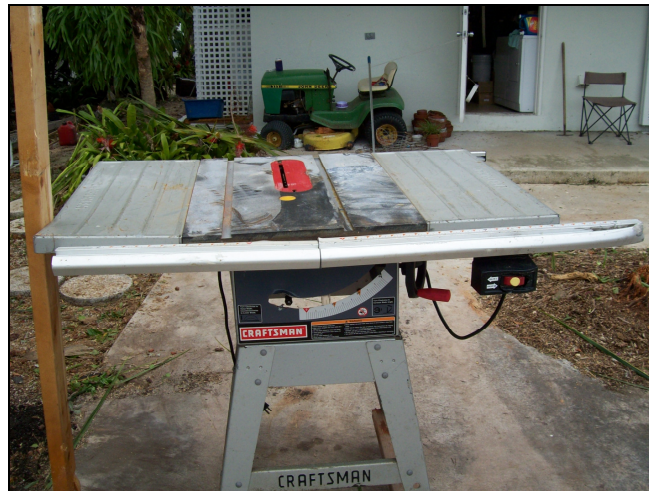
Figure 22. Recently retrieved table saw from canal.

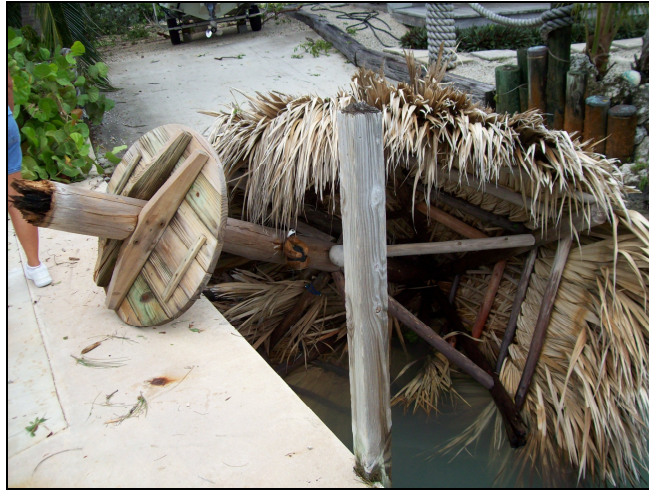
Figure 23. Tiki hut snapped and blown into adjacent boat ramp.

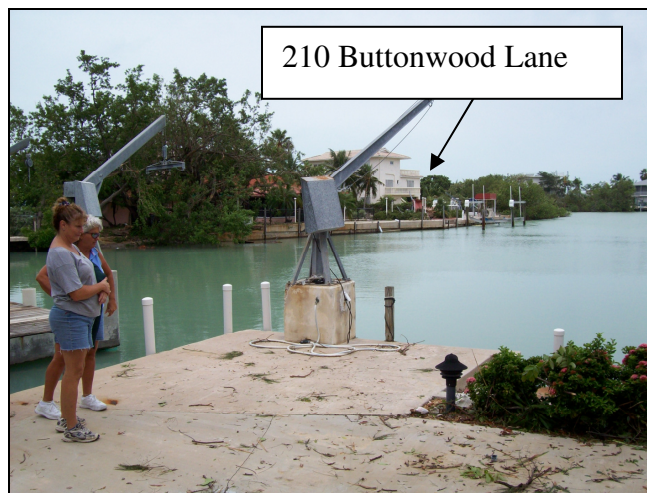
Figure 24. View looking northwest from house at 411 Palm Drive.

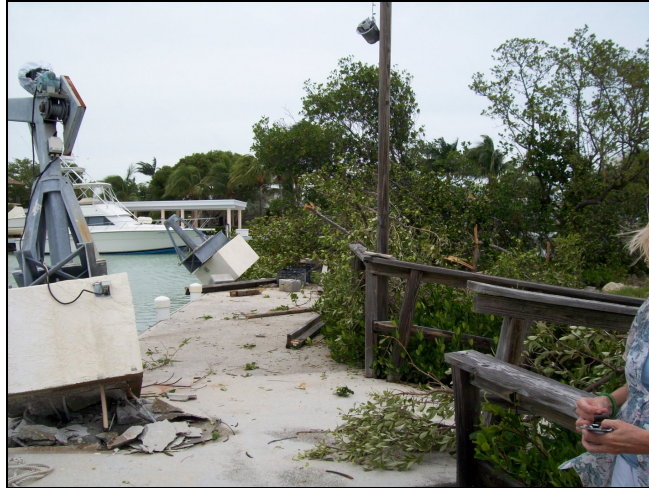
At 210 Buttonwood Lane, severe davit damage had occurred along the seawall which faces northwest. The homeowner speculated that a Tiki hut in the backyard had been ripped up from its location and was flung in a generally south to north direction across a fence, into the rightmost davit (when facing northwest) and then into the canal adjacent to their property (Figures 25 and 26).

Figure 25. View looking north northeast from backyard of 210 Buttonwood Lane. Note apparent travel of tiki hut would have been from right to left and just beyond electric pole in center of photo. Rightmost davit in background.

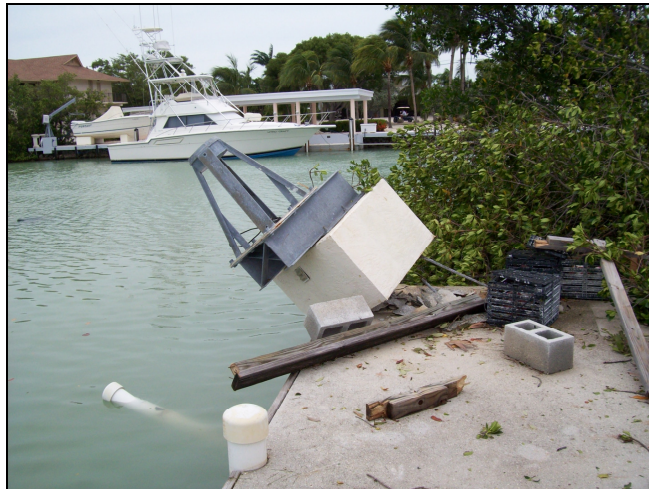
Figure 26. Close up view of rightmost davit at home at 210 Buttonwood Lane. Note top rail of fence on seawall as well as cinder blocks blown from right side of picture. Also note broken seawall bumper in canal.

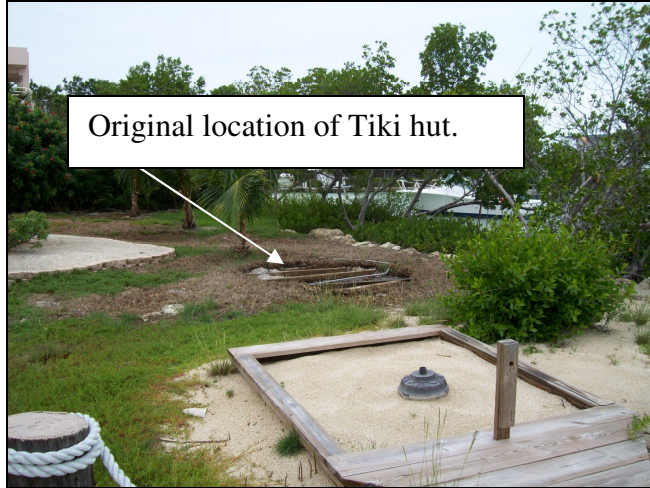
As previously mentioned, the Tiki hut was located in the backyard approximately south of the seawall (Figure 27). According to the homeowner, the hut had electrical power run out to it in electrical conduit. The hut was apparently lifted whole severing the electrical power and tossed a distance of approximately 75 feet to the north damaging shrubbery, the fence bordering the seawall, and the rightmost davit before ending up in the canal (Figures 28 and 29). It is speculated that once the Tiki hut impacted and severely damaged the rightmost davit the weight of the attached motorboat in conjunction with the wind served to pull up the leftmost davit (Figure 26). The owners were not at this home during the event. However, a witness from the other side of the canal said that the event happened around 4:00 am and that power was lost near that time and then a huge rush of wind (he specifically said it did not sound like a freight train) which lasted for about 10 seconds.

Figure 27. Original location of Tiki Hut at 210 Buttonwood Lane backyard. View from boarded walkway just off of seawall. Rightmost davit would be over left shoulder.

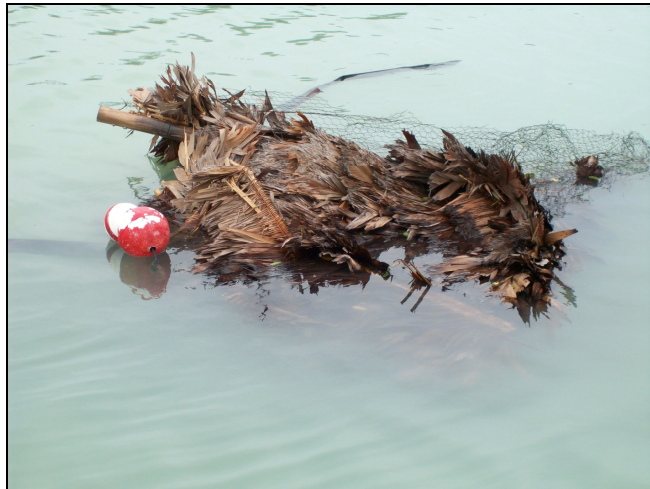
Figure 28. Remains of Tiki hut in canal at 210 Buttonwood Lane.

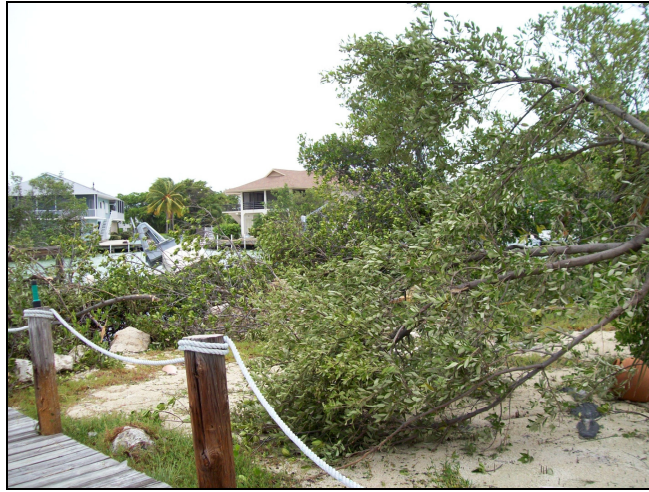
Figure 29. Apparent track path of Tiki hut across backyard of 210 Buttonwood Lane. View looking north-northeast.

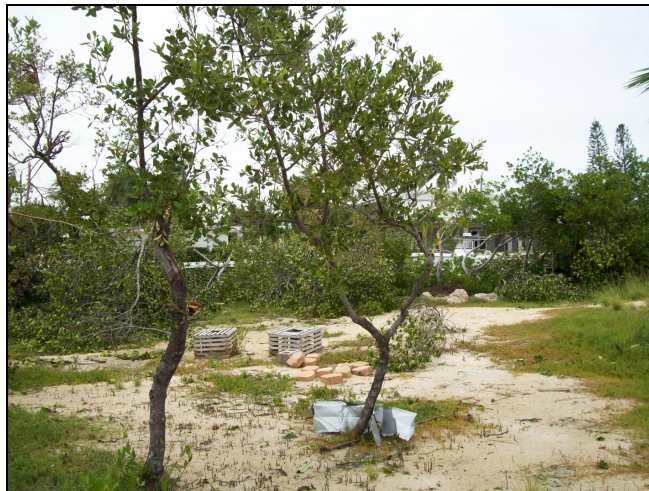
Figure 30. View looking east southeast from 210 Buttonwood Drive backyard.

In looking from the backyard back towards the southeast, a damage path could be discerned with snapped tree limbs and debris in the yard. It is interesting to note the piece of metal abutting the small tree in the foreground and wonder where it was blown from.
