# Severe Weather Outbreak April 19<sup>th</sup>, 2011

#### **Overview**

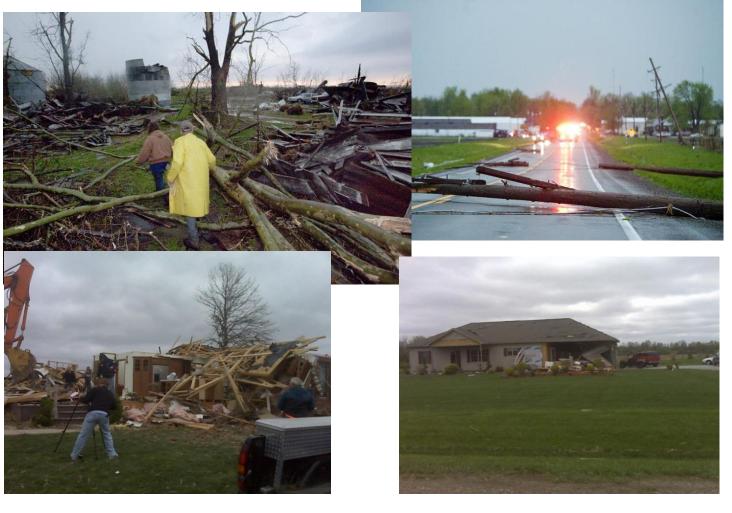
#### Girard, Illinois EF3 Tornado (Macoupin IL)

The path of this tornado was a very curved one as it initially tornado touched down about 2.5 miles west of Girard, Illinois, on Emerson Airline Road at 5:58 pm. It caused extensive damage to a couple of houses in this location. It then travelled to the northeast crossing Henry Road, north of the intersection with Emerson Airline Road, and damaging 3 farmsteads. One home was destroyed and another home sustained moderate damage, trapping the residents in the basement until they could be rescued. Also, several barns were destroyed in this area. The tornado began to travel on a more easterly course, damaging or destroying several farmsteads on Neff Road. Numerous outbuildings were destroyed in this area and one house was destroyed. As it approached Pleasant Hill Road approximately 1.2 miles northwest of Girard, it caused major damage to a brick home and destroyed all of the outbuildings. The tornado continued to travel to the east, destroying a farm about a mile north of town on Illinois Route 4. Several cows were killed in this location. Then the tornado began to curve back to the southeast, crossing Prose Road about half a mile south of the intersection with Substation Road. In this location it caused extensive damage to a brick home with most of the exterior walls destroyed but with the interior wall structure intact. This damage was rated EF3. The tornado continued to the southeast. It caused moderate roof damage to a house on Kimes Road near intersection with Adams Road. The tornado then lifted and dissipated at 6:05 pm on Adams Road after hitting one last farmstead and causing minor damage. Several farms sustained damage along the path of the tornado with many of the houses that were damaged rated EF2 with large portions of the roofs badly damaged. Numerous outbuildings were either destroyed or sustained major damage along this track as well. Also, about 20 power poles were blown down along Illinois Route 4 just north of town. The average path width of the tornado was 150 yards with a maximum width of 200 yards. The highest rating of the damage was EF3 and with peak wind speeds of 150 mph. Two miles west of Girard, two people heading for the basement to seek shelter from the tornado, sustained minor cuts and bruises. Because the path of the tornado was curved the actual total path length of the tornado was 5.1 miles.

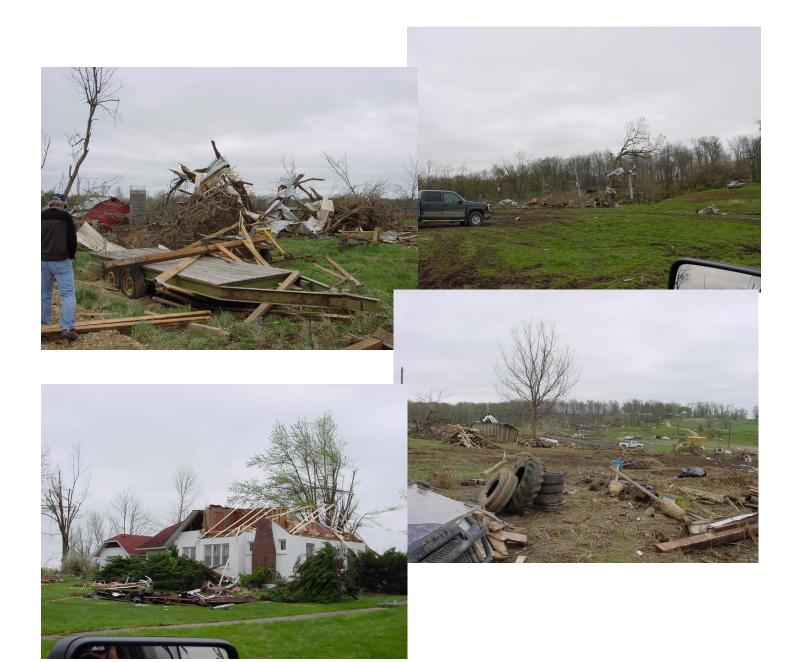
## Bowling Green (Pike County, MO) EF1 Tornado

A tornado touched down about 6 miles southwest of Bowling Green, near the intersection of County Roads 147 and 148, producing minor tree damage. The tornado then moved northeast, damaging a barn south of County Road 482 and then producing extensive tree damage just north of the intersection of County Roads 482 and 481. The tornado continued northeast, striking a farm on Highway Y. A barn was destroyed at this location, and produced extensive damage to the roof and the second story of a home.

The tornado then veered a bit to the east and produced its greatest damage to a farmstead about 2.4 miles southwest of Bowling Green and 1.5 miles west of Highway 161. The home at this location suffered extensive damage, while several outbuildings and implements were totally destroyed. Although the tornado lifted shortly after striking the farm, debris was strewn over one-half mile to the east of the farm, with insulation from the farmstead blown across Highway 161.

The total length of the tornado was about 4.1 miles, with a maximum damage width of 100 to 150 yards. Maximum damage rated at the second farmstead was high end EF1, with winds of 100 to 110 mph.

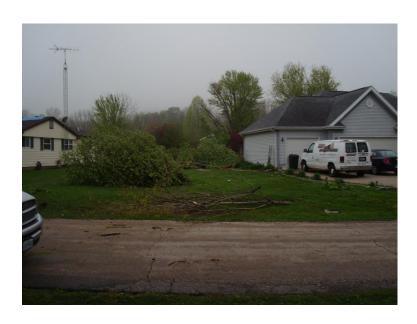
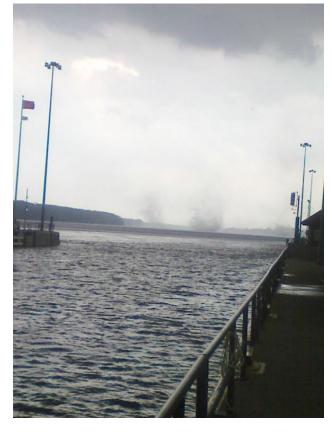
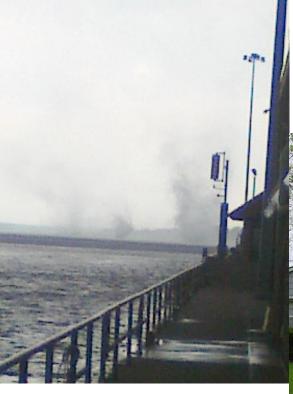
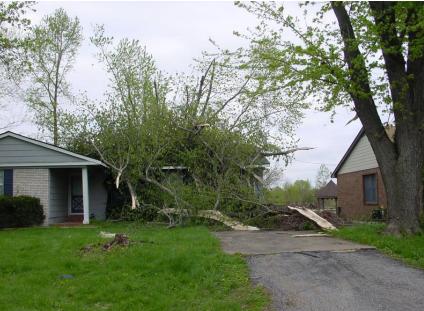
#### Clarksville (Pike County, MO) EFO Tornado

The tornado touched down in the south side of Clarksville, damaging trees, removing shingles from several homes, and damaging fencing and several carports in the area. Several windows on the east side of the Catholic Church were also broken. Witnesses report that after the tornado exited Clarksville the funnel began to cross the Mississippi River, but dissipated before crossing into Calhoun County, Illinois. Total length of this tornado was 0.4 miles, with a maximum width of about 50 yards. The damage in this area was rated EFO, with winds of 70 to 75 mph.

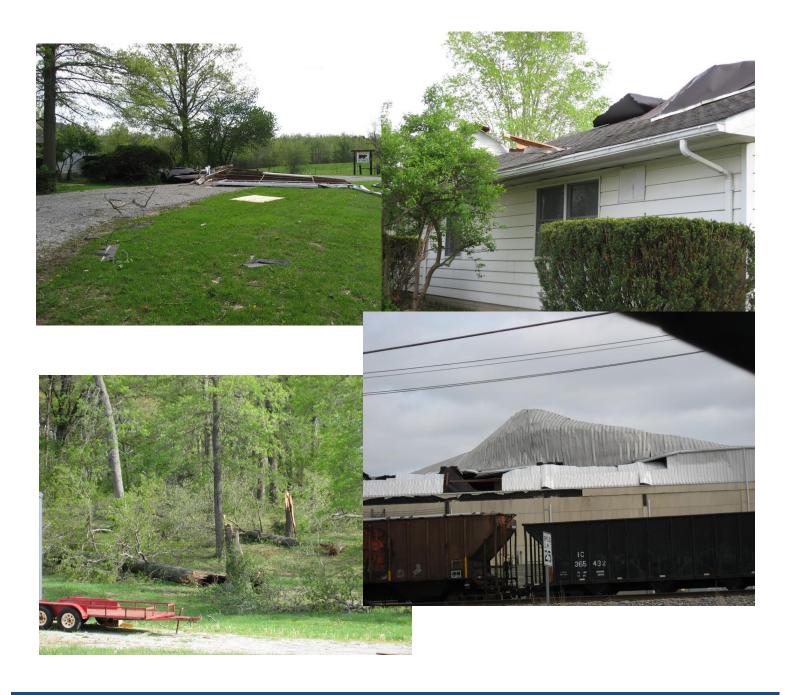
#### Centralia to Salem (Marion County, IL) Wind Damage and EF1 Tornado

One tornado touched down in southwest Marion County Illinois on Tuesday April 19th. The tornado touched down approximately 1 mile east of the Centralia Municipal Airport, west of Moonglow Road and south of IL 161. Several large healthy trees were uprooted in this area and a convergent pattern was found. A house on the southwest corner of Moonglow and IL 161 sustained EF1 damage when the roof of an attached workshop or garage on the south side of the house was uplifted and thrown to the northwest. At least one 2x4 was driven into the roof on the north side of the house. A house on the southeast corner of Moonglow and IL 161 sustained minor roof damage. A trampoline on the south side of this house was blown back to the northwest and was found on the north side of IL 161. Debris was scattered into a field on the northwest corner of Moonglow and IL 161. A small outbuilding on the northeast corner of Moonglow and IL 161 sustained damage on the east facing side. A new pole barn located east of Moonglow and south of Firewood Lane collapsed.

The total length of this tornado was about 0.4 miles with a maximum width of 50 to 75 yards. Maximum damage was rated EF1 with winds of 95 mph. The vast majority of the damage sustained in the city of Centralia was due to straight line winds that were at least 75 mph.

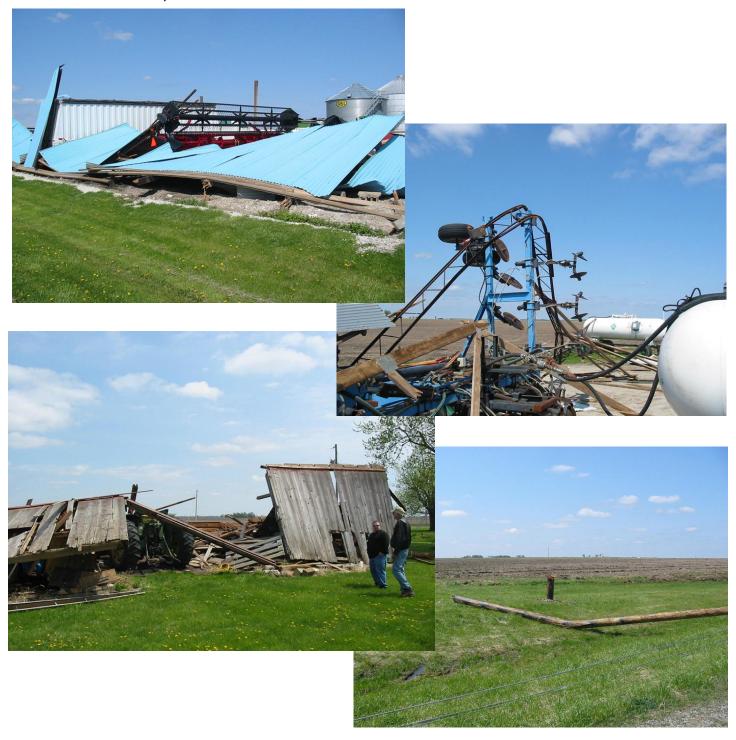
## Farmersville EF2 Tornado (Montgomery County, Illinois)

The tornado began around 608 pm, one third of a mile northwest of the intersection of Studebaker Avenue and West Frontage Road, or around one and a quarter miles north of Farmersville. The tornado moved east snapping 3 power poles along the frontage road just to the west of Interstate 55. A grain bin originally located just to the west of I-55 was rolled across the interstate and deposited in a tree line a quarter mile to the east of the interstate. A number of trees were also snapped or uprooted in the vicinity of the grain bin. The tornado moved slightly south of due east damaging or destroying two machine sheds along County Road 400E. Debris was scattered well to the east and the tornado appeared to lift near County Road 600E.

The maximum damage from this tornado was rated EF-2. The path length was around 3.2 miles with a maximum width of 150 yards.
