# **Severe Weather Event** April 30<sup>th</sup>, 2010

#### **Overview**

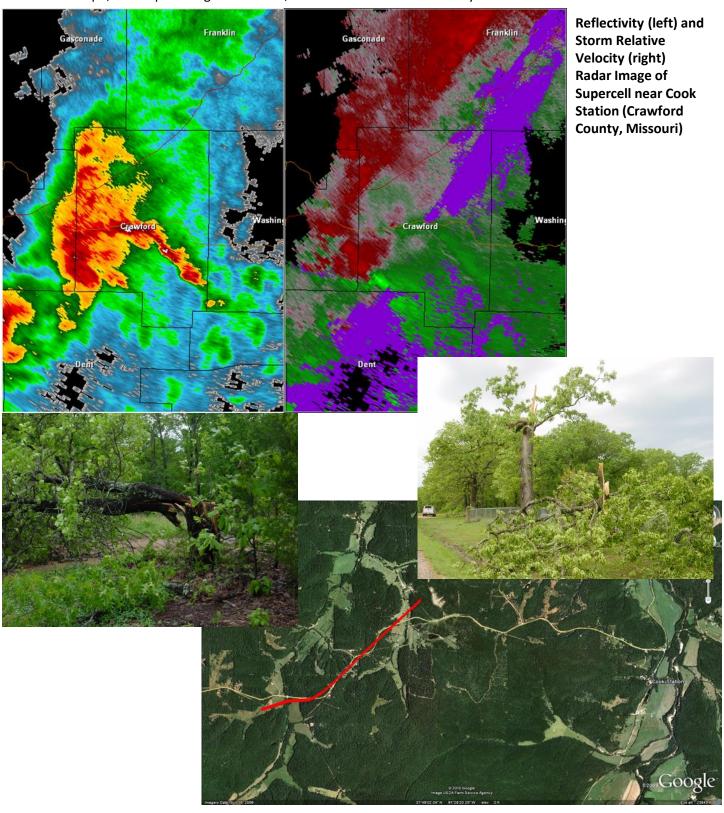
## **Crawford County, Mo Tornado**

A tornado touched down 5 miles west of Cook Station at 6:50 PM CDT. The tornado paralleled/crossed Route YY several times and lifted 3.5 miles west-northwest of Cook Station at 6:53 PM CDT. Damage was observed at the Carr Cemetery and The Big Game Ranch. Damage consisted of snapped and uprooted trees and downed branches. The worst damage was at the Carr Cemetery where a number of large healthy oak trees were snapped just above the base of the trunk. The tornado was rated an EF1 on the Enhanced Fujita Scale with maximum wind speeds of 90 to 95 mph, a total path length of 2 miles, and a maximum width of 100 yards.

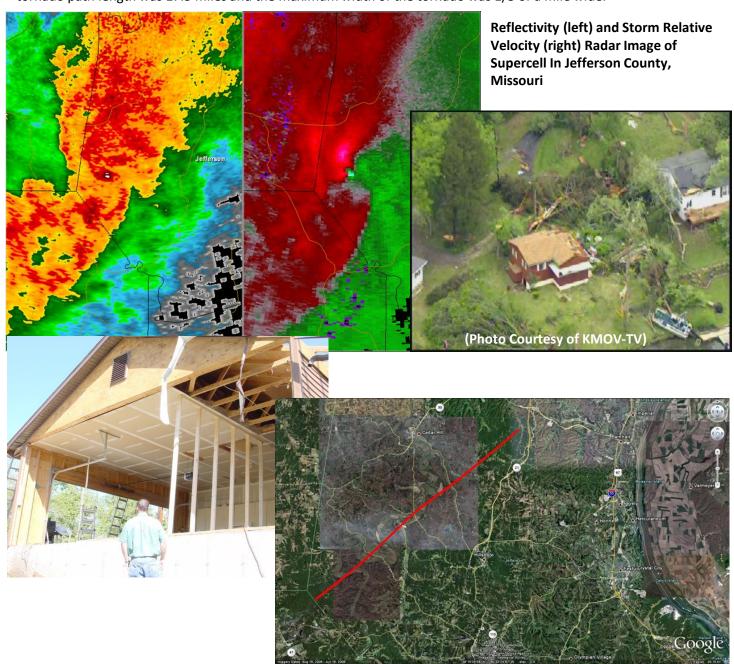
## **Jefferson County, Mo Tornado**

The tornado snapped and uprooted numerous trees and downed numerous tree limbs along the entire path. There were several areas of more substantial damage. On Brook Hollow Lane, three miles north-northwest of Fletcher, a home was damaged with part of the roof removed and a wall of the garage destroyed. Also on Brook Hollow Lane a manufactured home sustained roof, siding, and window damage.

Another area of damage was along Highway B just north of the Big River. An outbuilding of the Morse Mill Baptist Church had the overhead doors caved in, which caused the roof to be removed and parts of the exterior walls to fail.

The last area of significant damage was at Lake Tishomingo, especially along the north shore. Several of the homes suffered damage to roofs and porches. Also a number of homes were damaged when trees fell on them.

The tornado was rated an EF1 on the Enhanced Fujita Scale, with maximum wind speeds of 100 MPH. The tornado path length was 17.5 miles and the maximum width of the tornado was 1/3 of a mile wide.

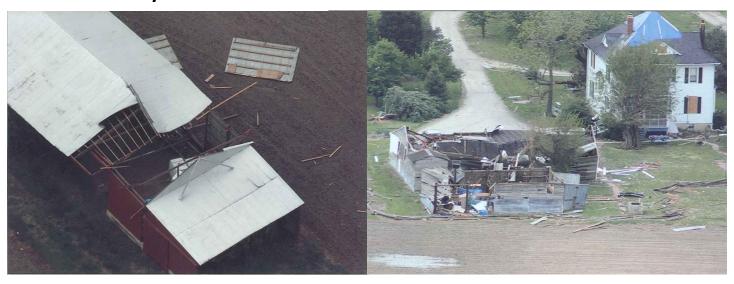
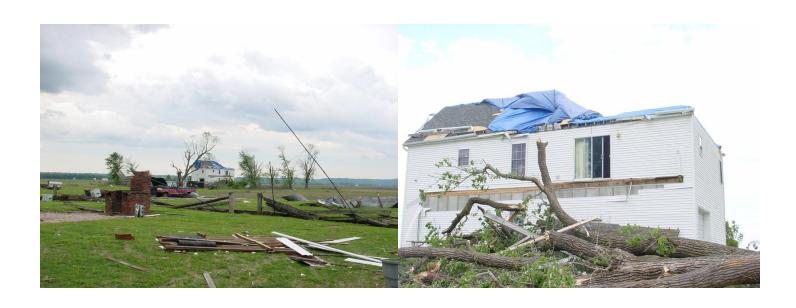
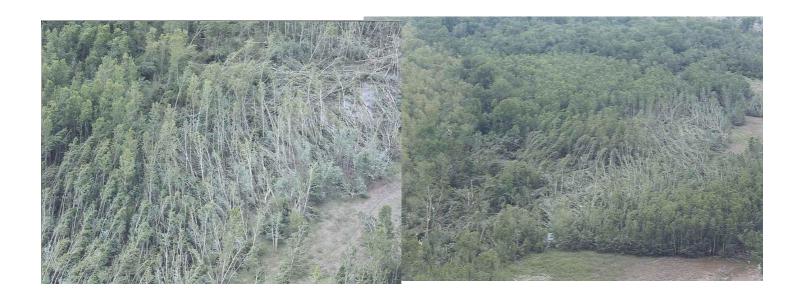
# **Monroe County Continued**

The greatest degree of damage occurred on 200 E just south of the intersection of 200 E and Merrimac Road. The roof of a two story home was approximately 80 percent removed. A second roof to a porch was totally removed and blown to the north-northeast. Window and siding damage was also observed. Several trees and large limbs at the back of this home were severely damaged and helped to show a large convergent damage pattern. Two other homes west of the first home sustained varying degrees of damage. Roof, window, and siding damage was common at these two locations. Several other trees near these homes laid to the east further supporting the convergence damage pattern.

A large hanger at Jacobs Field, northeast of the home damage, sustained varying degrees of damage. Large sections of a hanger/s metal roof were blown 1/4 to 1/2 mile to the north-northeast. The tornado continued to damage small to medium size machine sheds and caused minor damage to a few homes along its path. The damage intensity of the tornado was rated EF2 on the enhanced Fujita Scale with maximum wind speeds of 115 to 120 mph.

A second tornado in Monroe County briefly touched down on Deer Hill Road approximately 1.5 miles southwest of the intersection Deer Hill Road and County Road HH. A few large trees and several large tree limbs were downed by the tornado. One home in the path of this tornado sustained shingle damage. The damage path length of this tornado was 250 yards long, while the damage width was 40 to 50 yards wide. The damage was rated EFO on the Enhanced Fujita Scale. The initial tornado touchdown was approximately 8:57 p.m. CDT.
