Tornado and Hail Event

October 18th, 2004

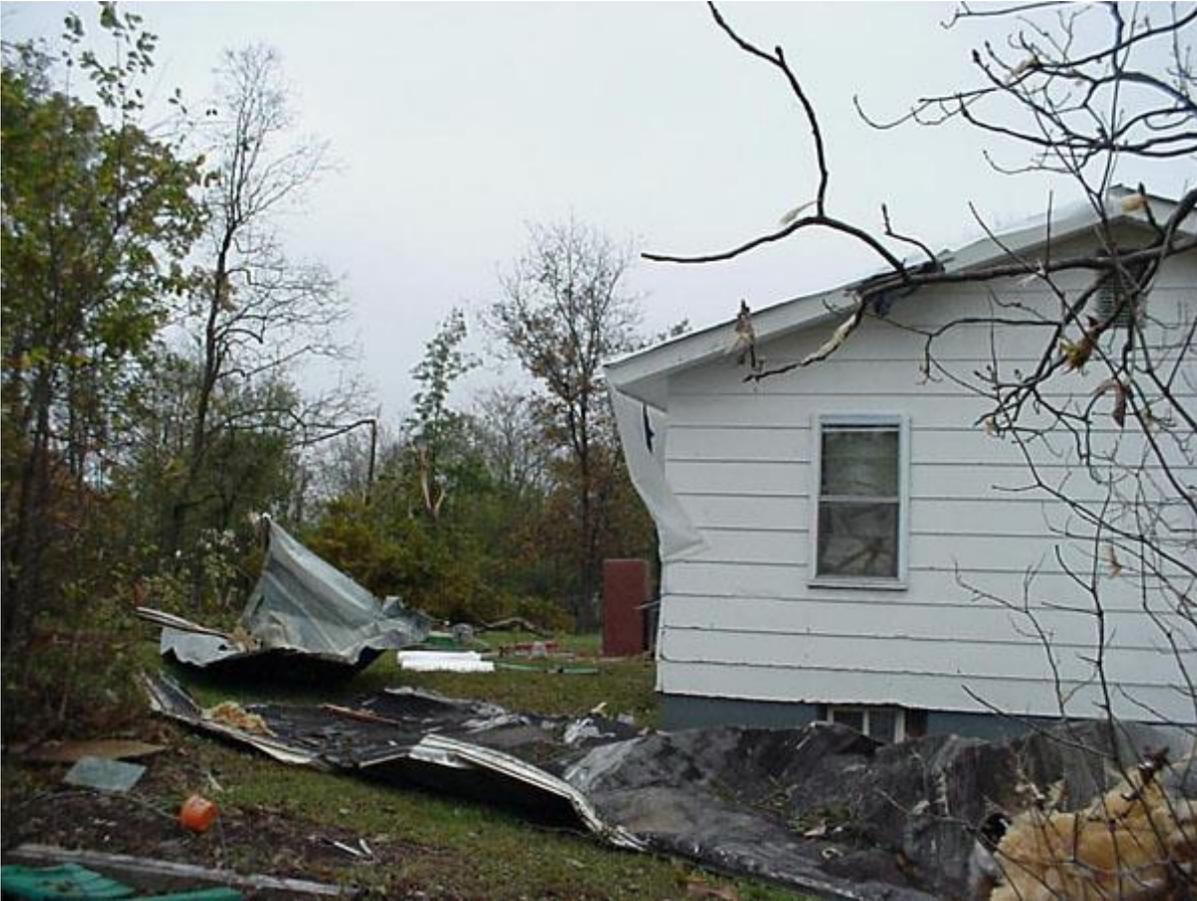
Another view of the home damage along the east side of East State Highway caused by the second of five tornadoes.

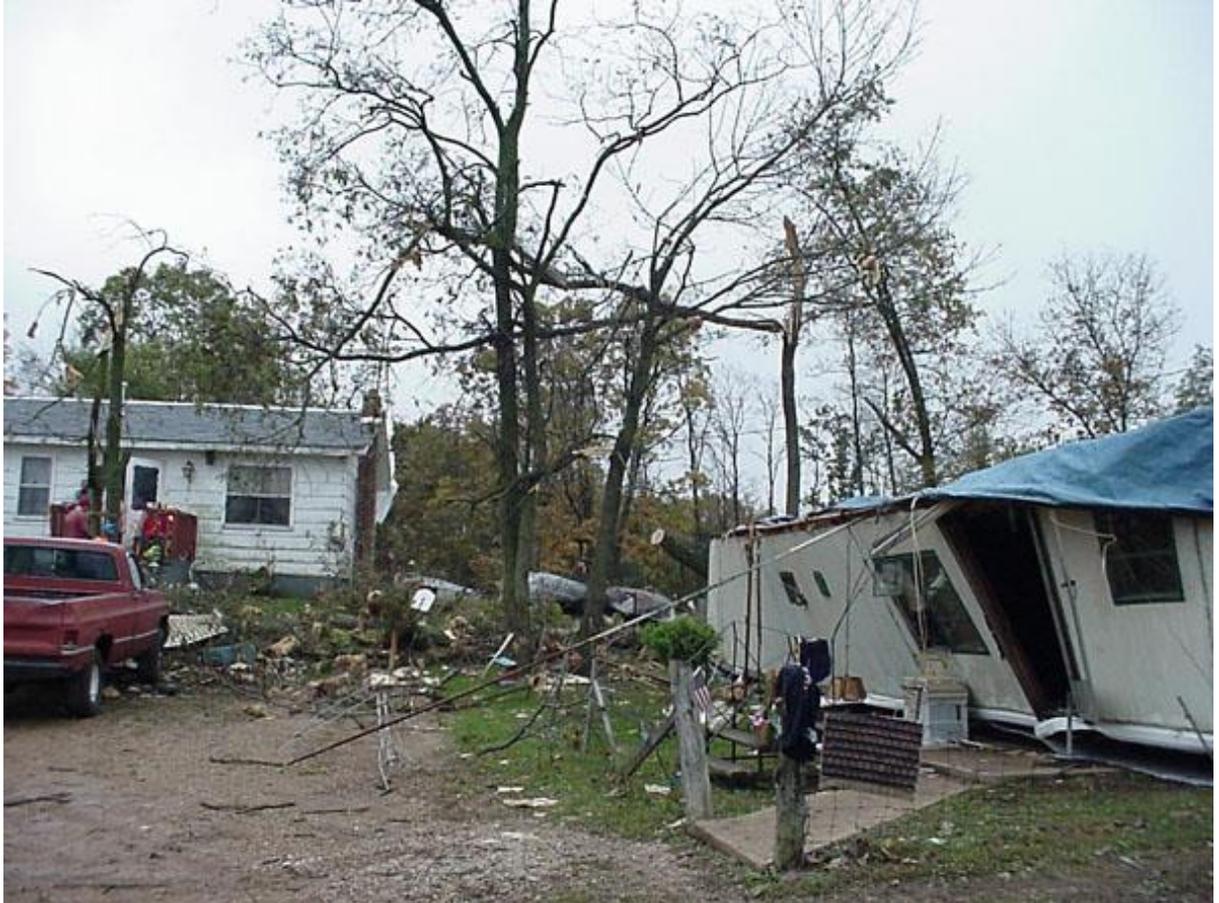
Damage to a house trailer, and home along the east side of East State Highway (one mile northeast of Potosi Missouri) from the second of five tornadoes. Viewing southeast.

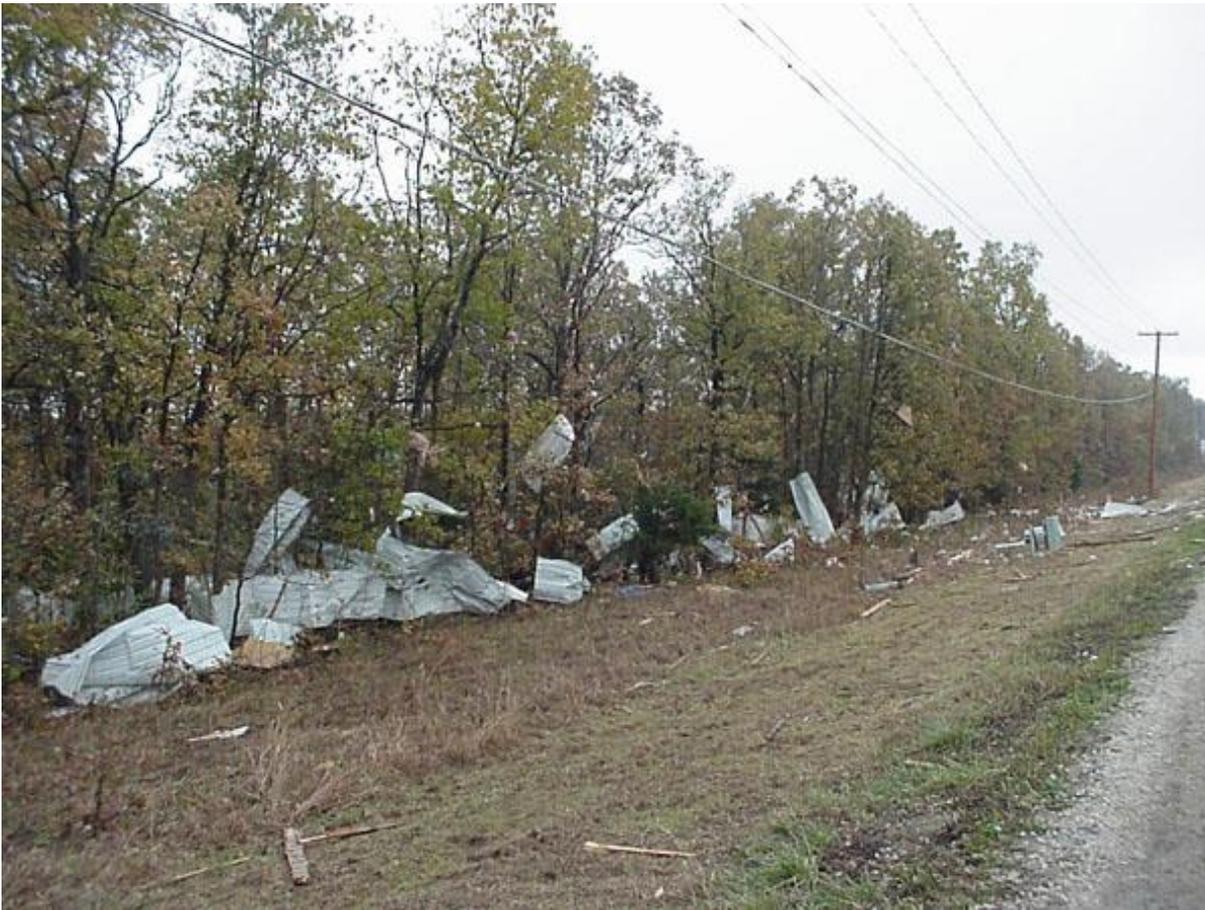
Debris from the buildings along the east side of Highway 21. Viewing south.

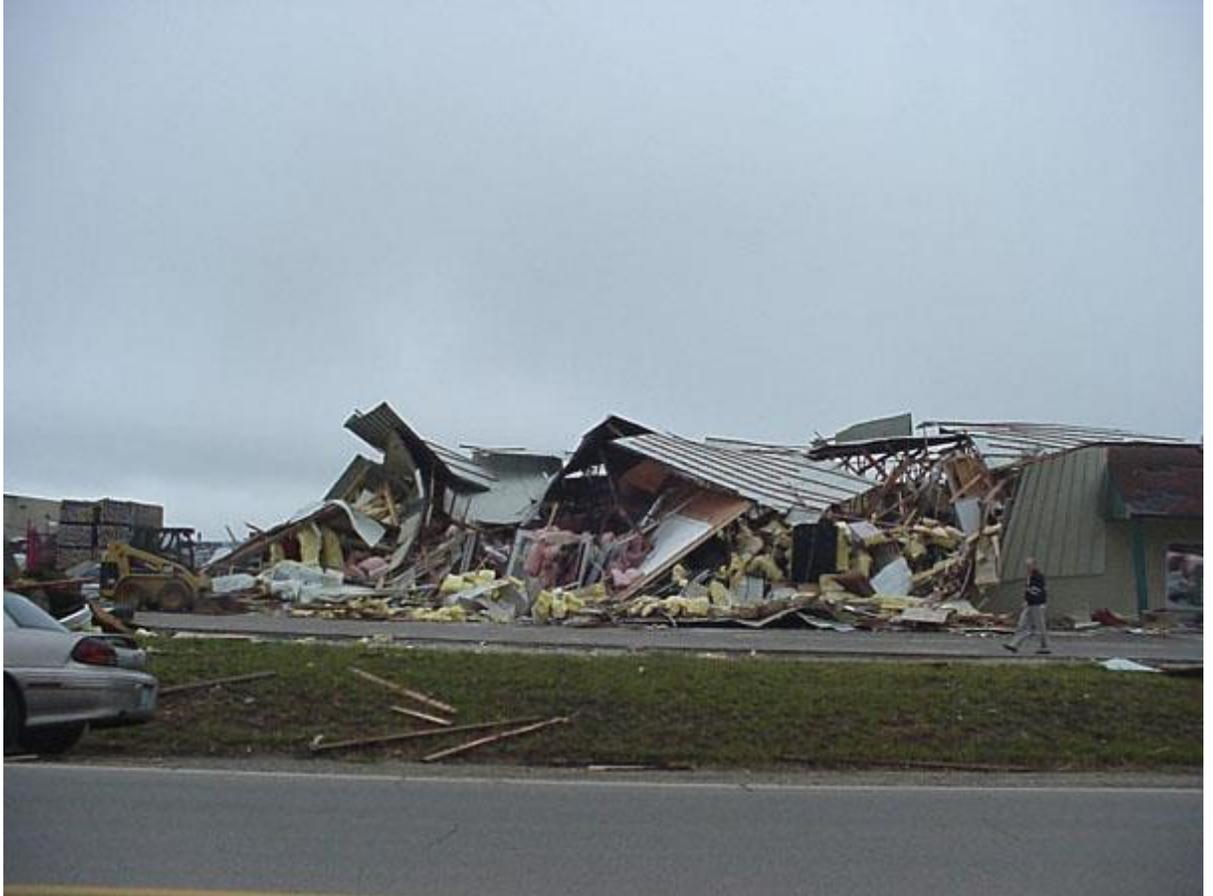
Total view of the first building. Viewing west. The tornado approached the lumberyard from the west.

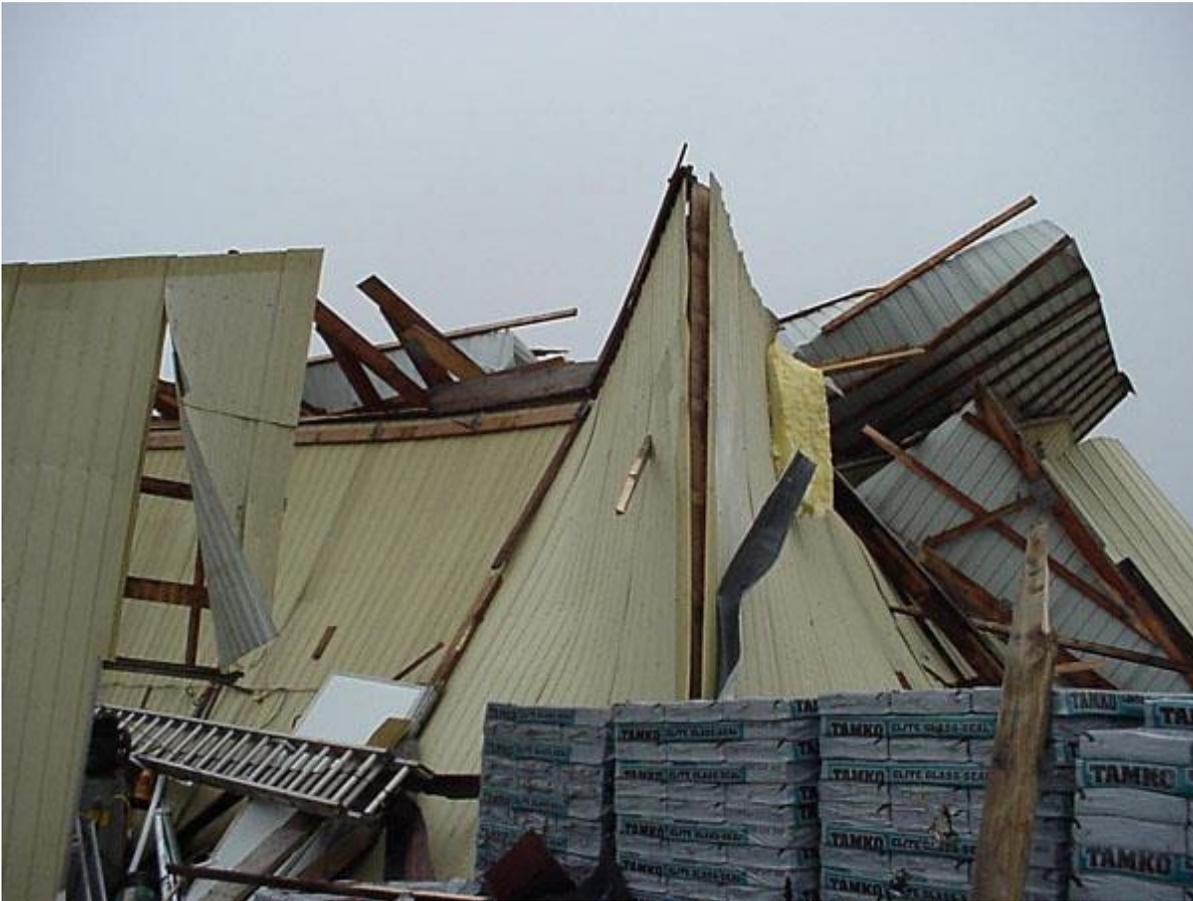
Example of missiles embedded within the sheet metal associated with the first building.

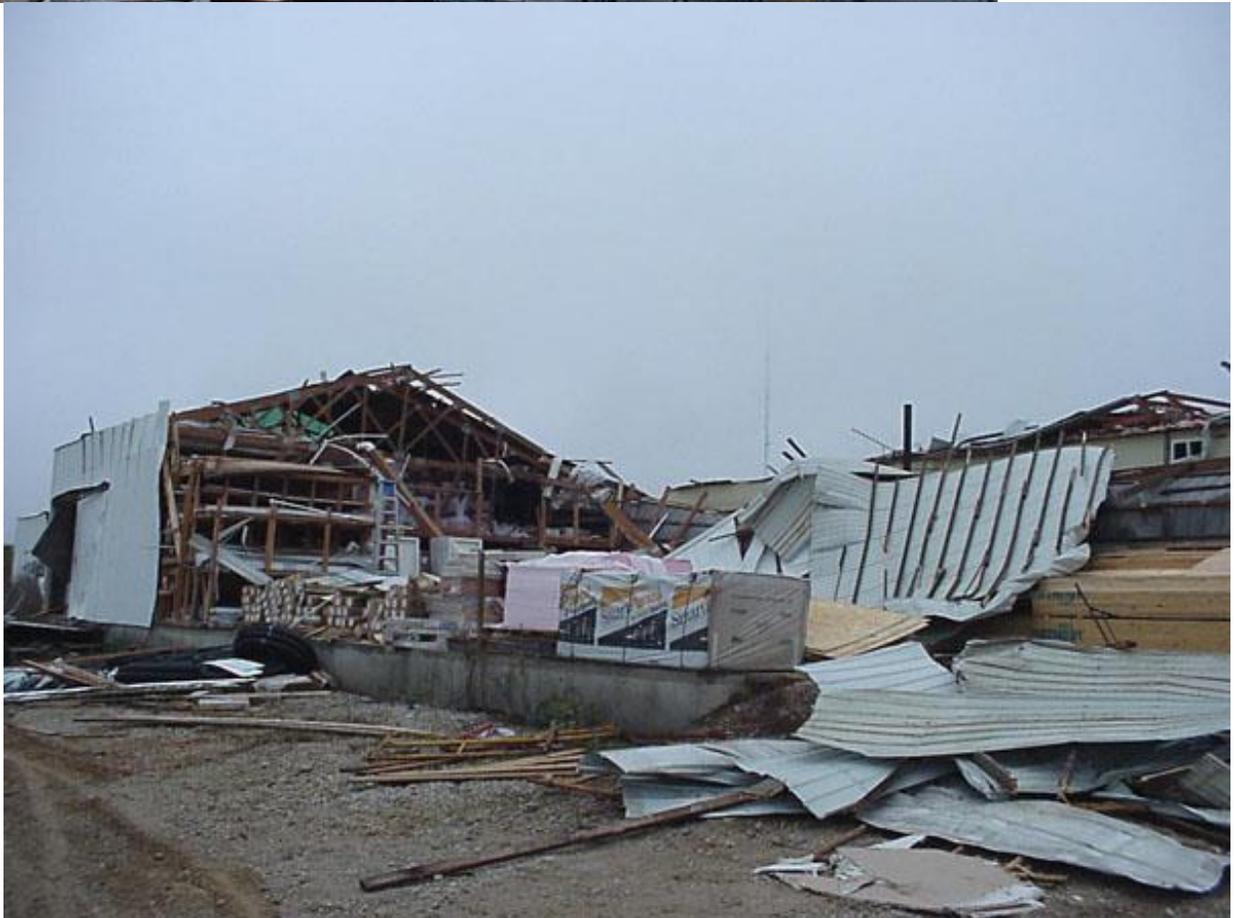
Damage to a third building near the western part of the lumberyard. Part of this building was totally destroyed. Viewing north-northeast.

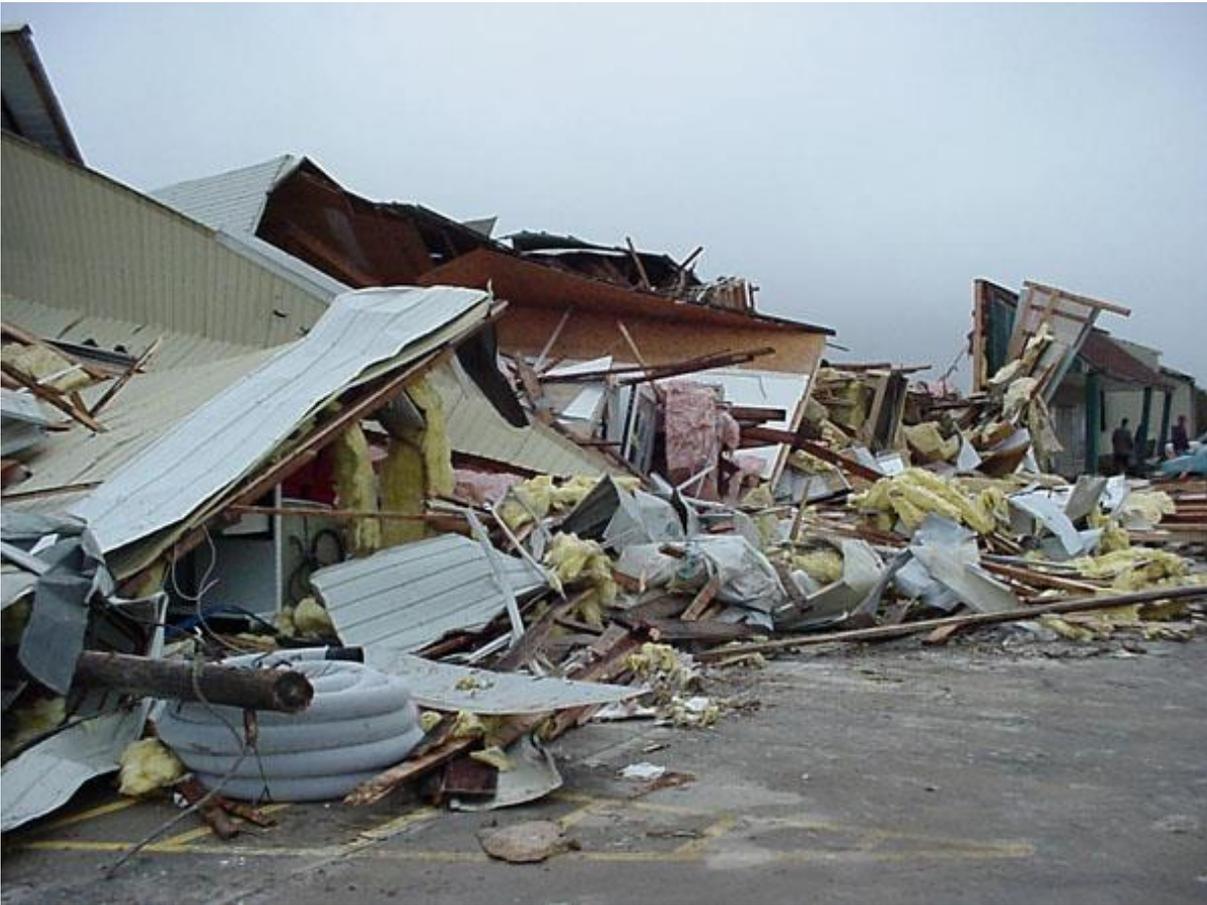
A series of 5 weak tornadoes formed quickly and moved across parts of central Washington County Missouri. The first tornado occurred about 4:08 PM CDT and damaged the Potosi lumberyard about 0.5 mile northeast of Potosi along highway 21. Three buildings were severely damaged by the tornado. Seven people were injured. One was kept overnight at a local hospital while the other six were treated and released. The overall damage path was about 0.2 mile long and 80 yards wide. The tornado was rated F1.

Damage to the first and largest of three buildings at the Potosi Lumberyard from the first of five tornadoes. This area of damage occurred approximately 1/2 mile north-northeast of Potosi. Damage intensity was rated high-end of F1. Viewing north-northeast.

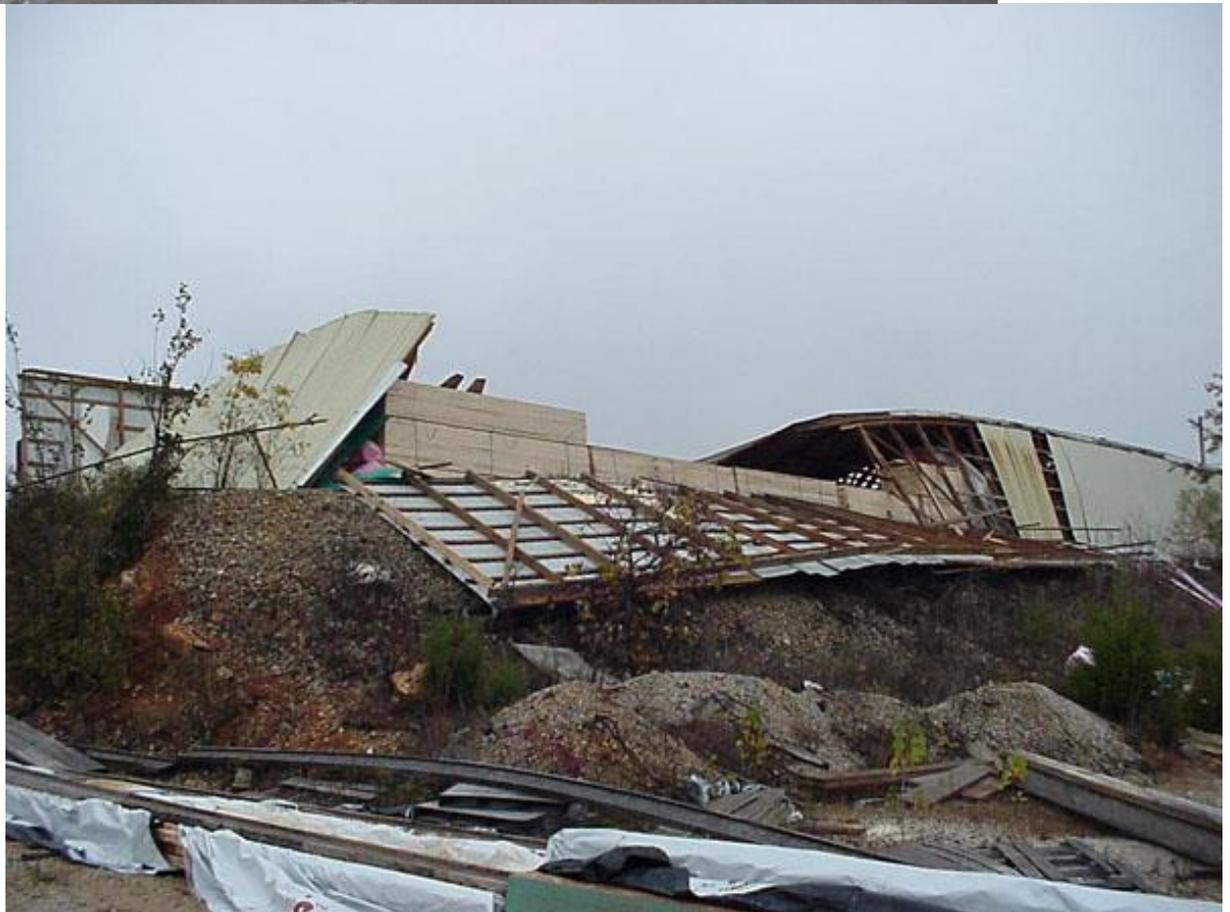
Damage to a second building near the southern part of the lumberyard. The western part of this building which housed plywood sustained the greatest degree of damage. The tornado was moving from left to right. Viewing northeast.

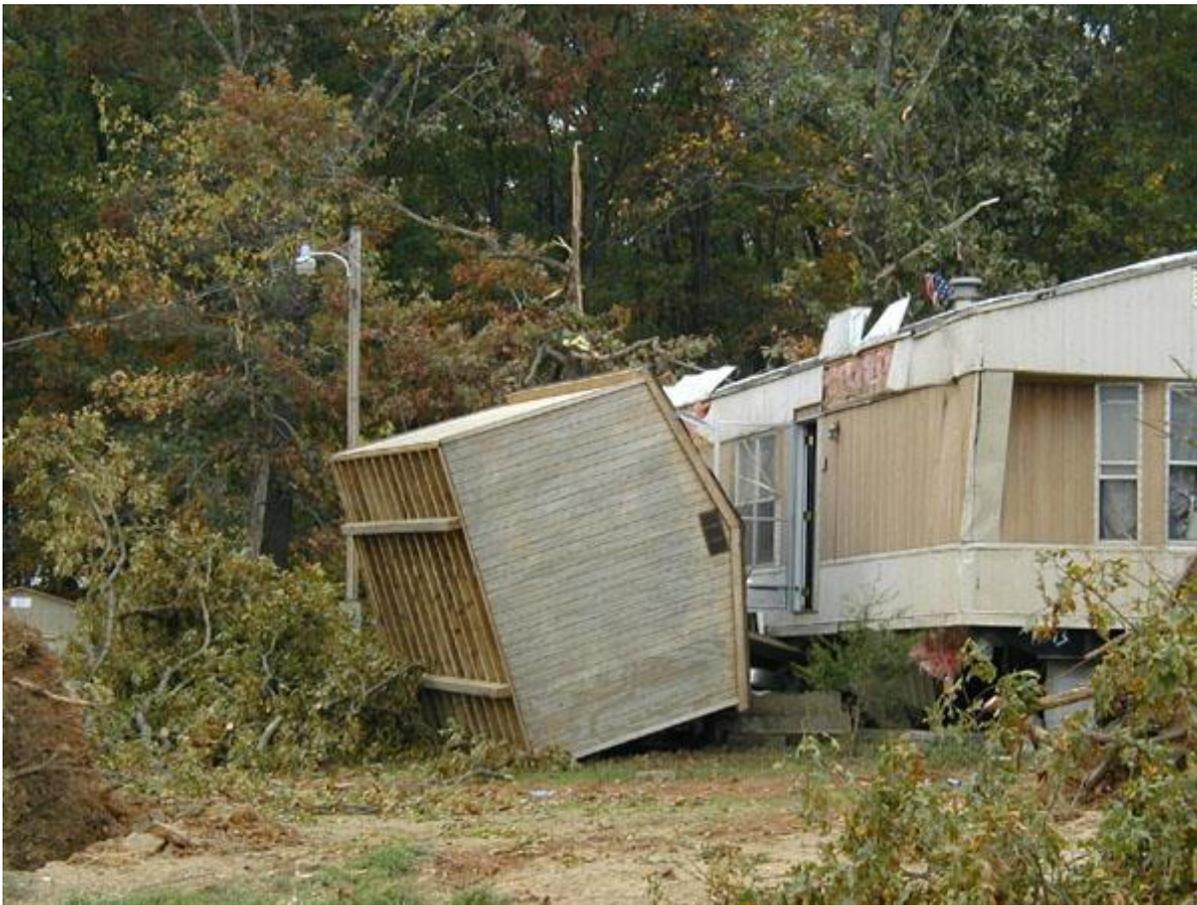
Close-up of unanchored shed rolled into a mobile home and some snapped trees in the Country Star Mobile Home Community.

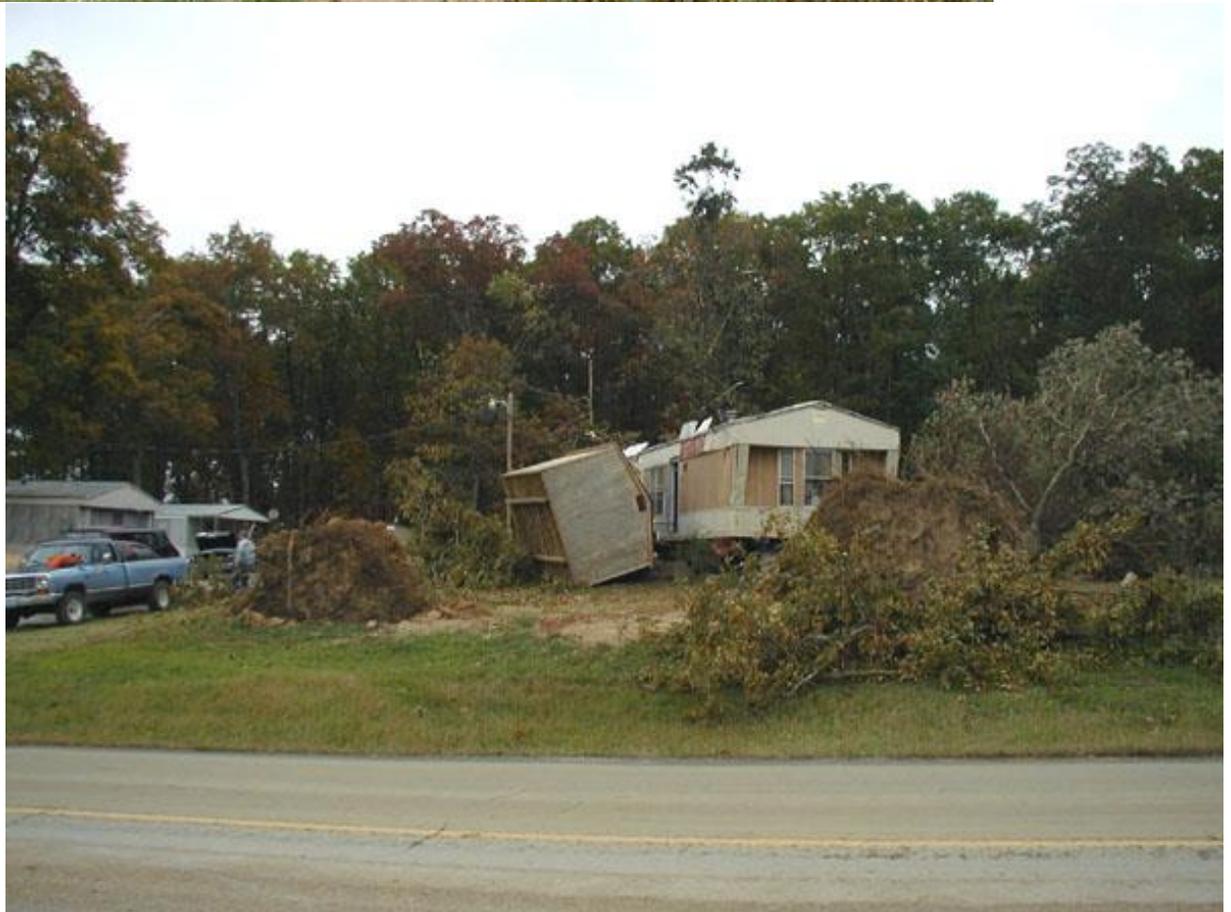
Damage to a mobile home and trees uprooted in the Country Star Mobile Home Community along State Road H, northwest of Fredericktown .

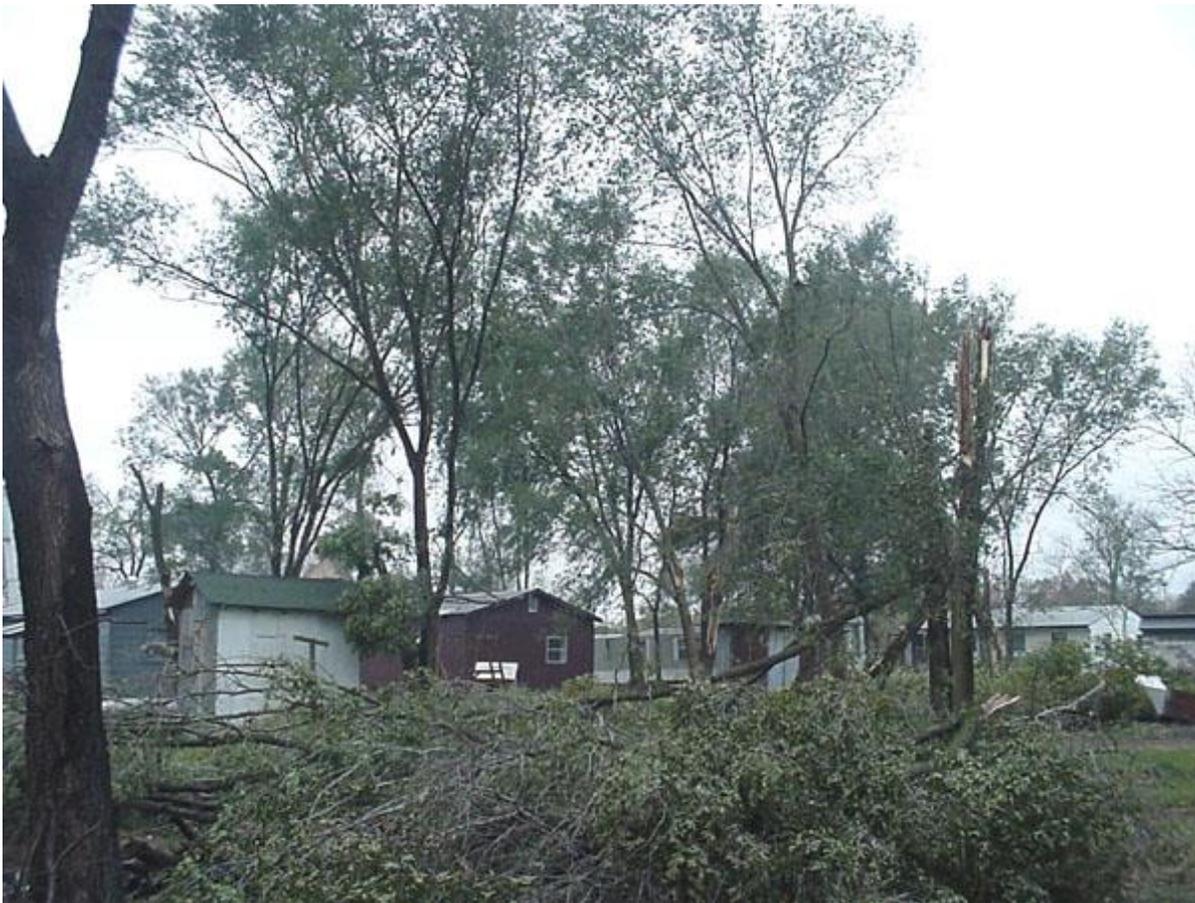
Windows were blown out while numerous large limbs and trees were down by the fourth tornado. Several witnesses reported two tornadoes in the Mineral Point area. The fourth tornado crossed the central part of the town while the fifth tornado caused damage to house trailers and trees along the far east side of town.

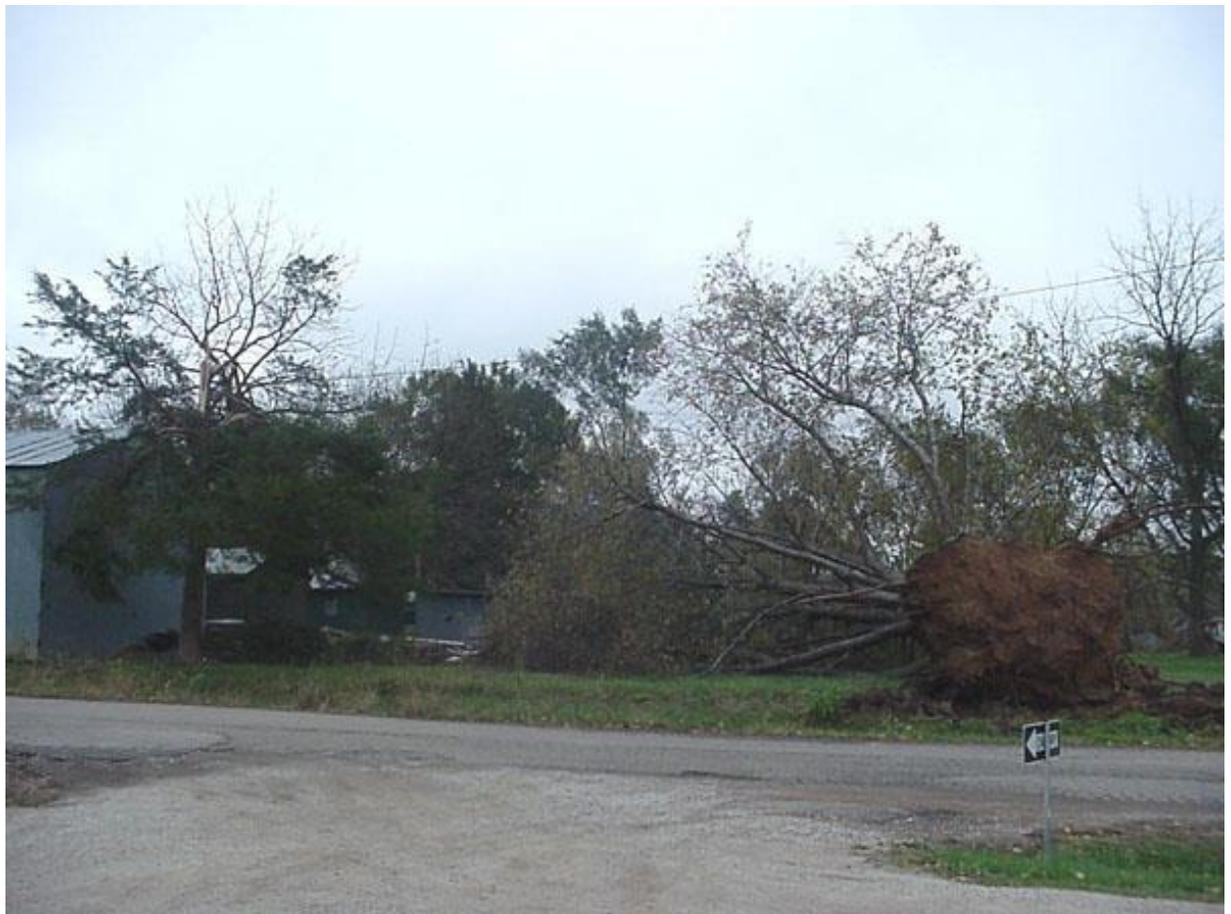
Damage caused by the fourth of five tornadoes along the southwest side of Mineral Point. One pine tree was snapped while a second large tree was uprooted. The tornadoes were moving north-northeast along the forward side of the larger mesovortex. Viewing northeast.

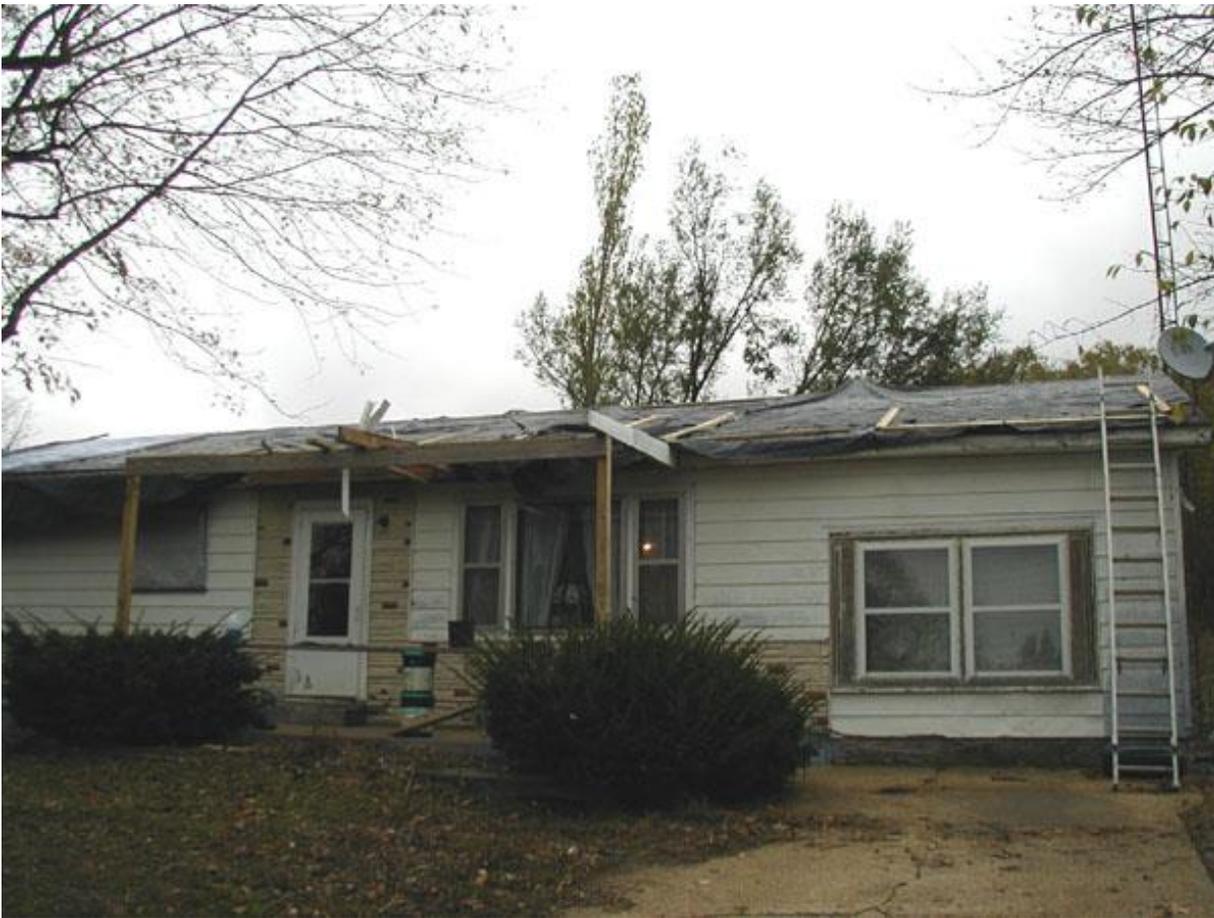
Roof and front porch damage to the small home near the intersection of County Roads 257 and 261. A portion of the front porch was thrown around 125 yards into the woods to the east of the house.

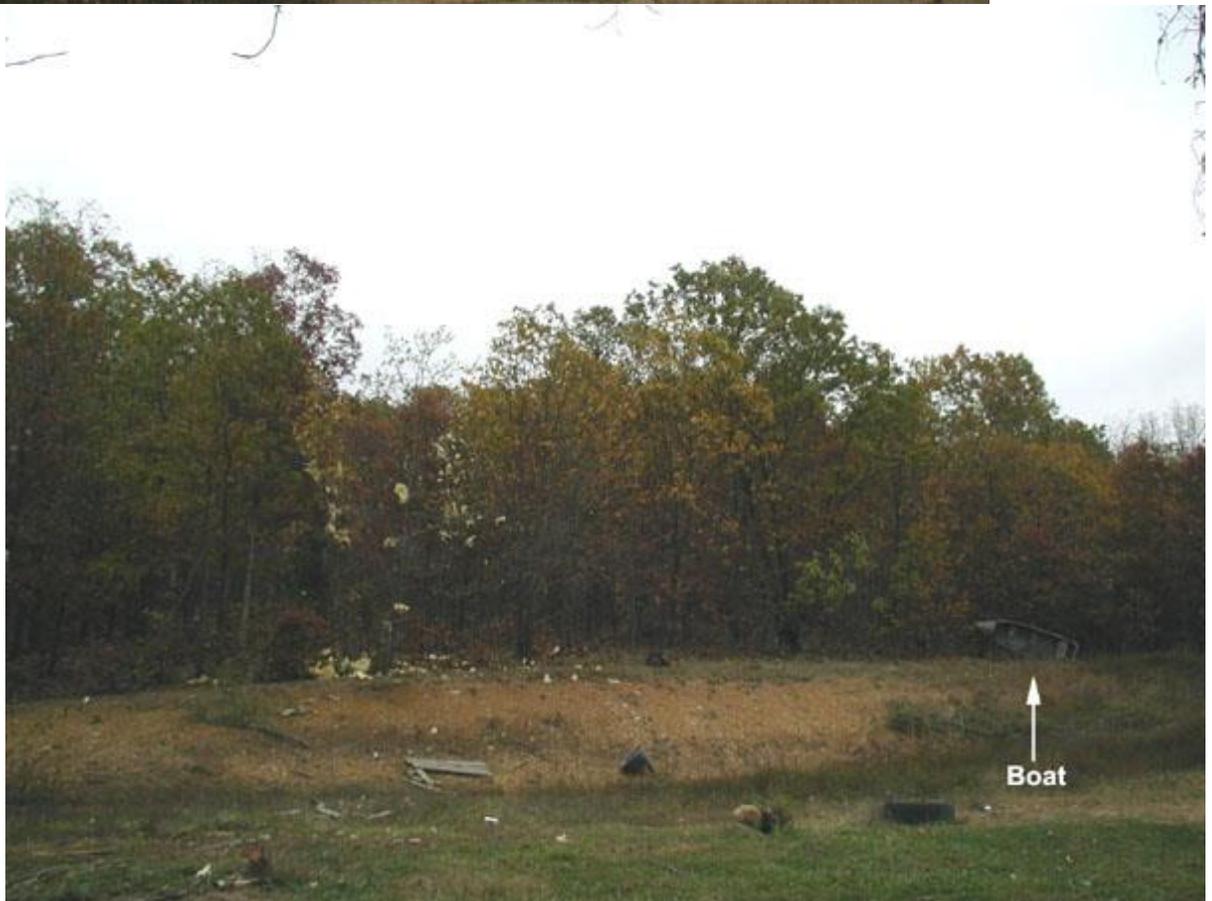
East looking view from the rear of the small home near the intersection of County Roads 257 and 261. Note small boat which was hurled around 100 yards into the woods from a pond next to the home.

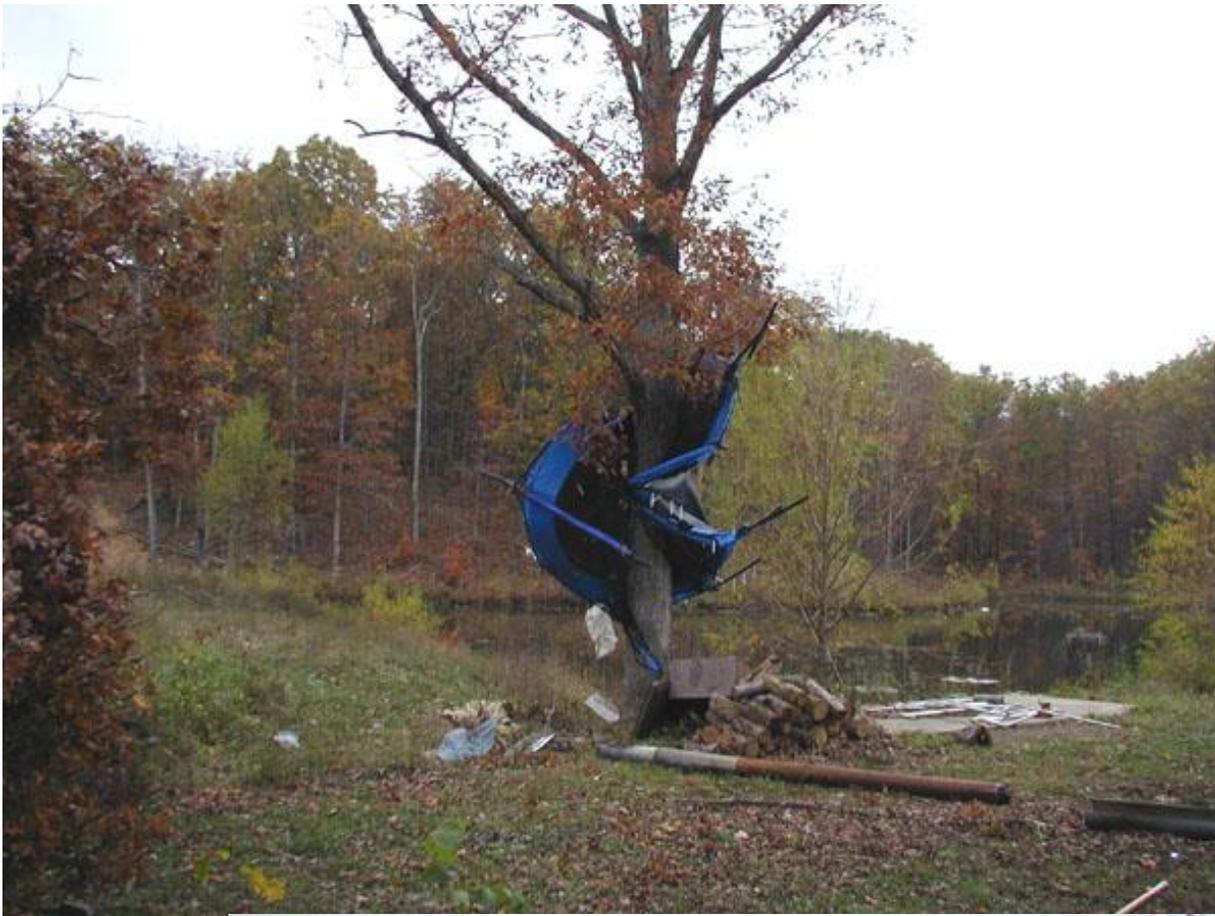
Trampoline thrown northward and wrapped around a tree from the rear of a small home near the intersection of County Roads 257 and 261.

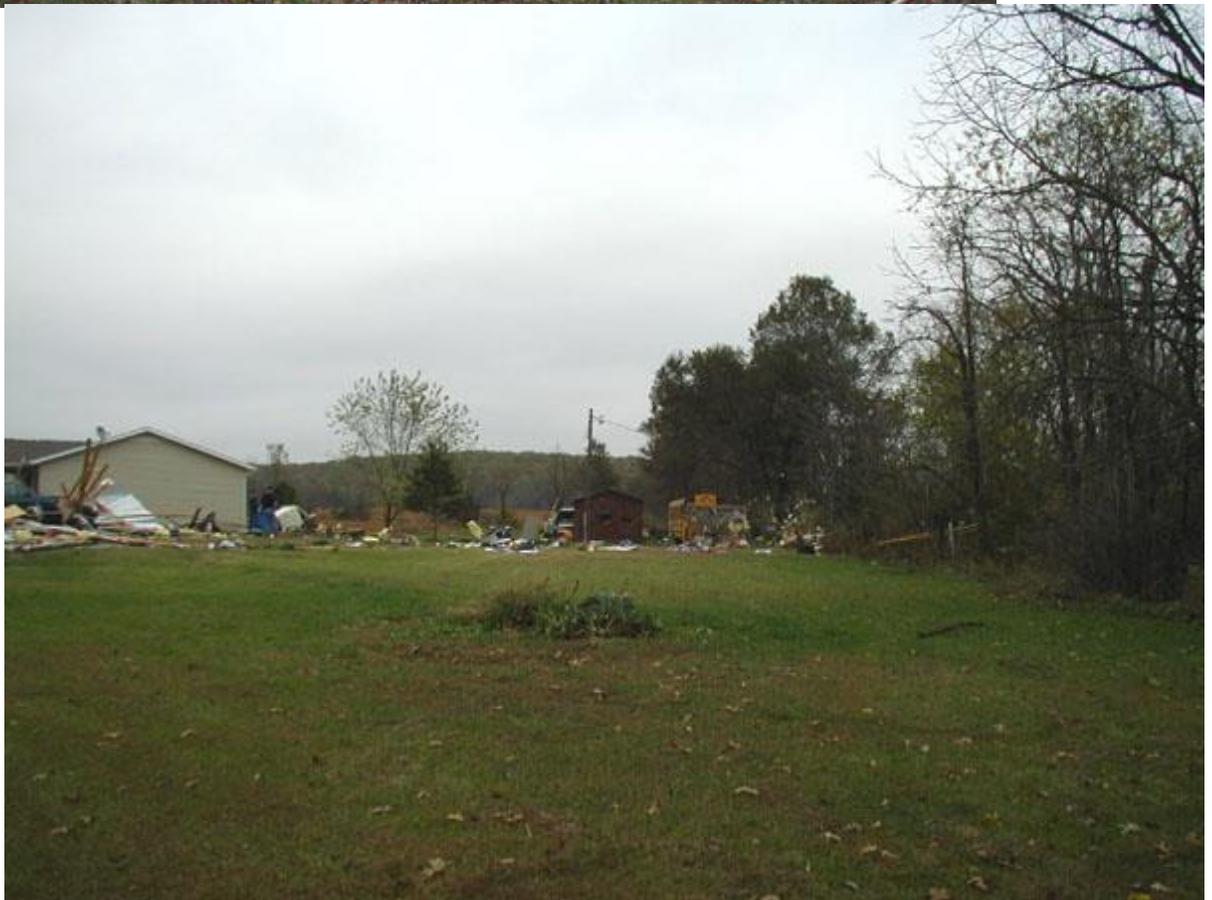
North facing view of the destroyed garage and debris field along the east side of County Road 219 northeast of Fredericktown. Note the single story home which is just north of the garage was completely untouched by the tornado.

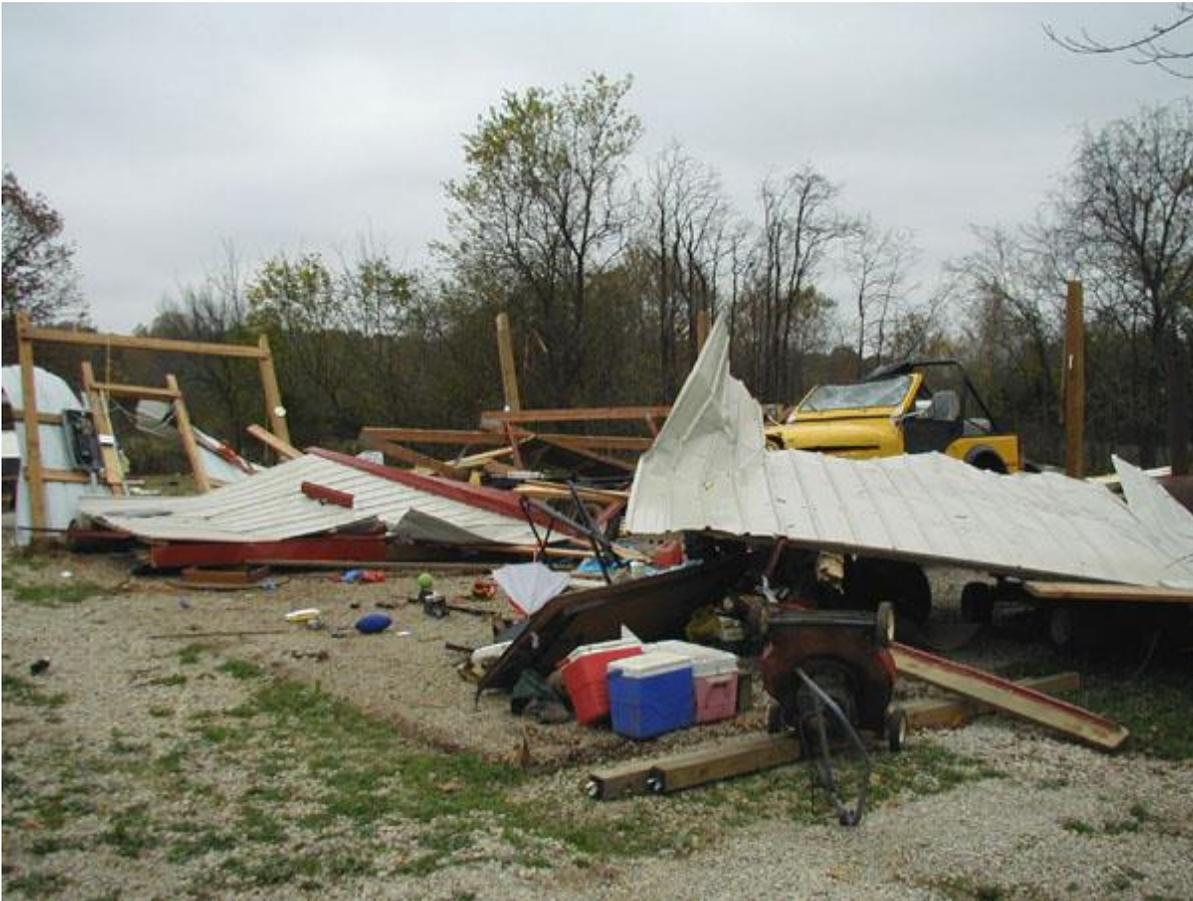
Destroyed minimally-anchored and unattached garage along east side of County Road 219 northeast of Fredericktown. Strewn debris from the garage is shown in the previous picture.

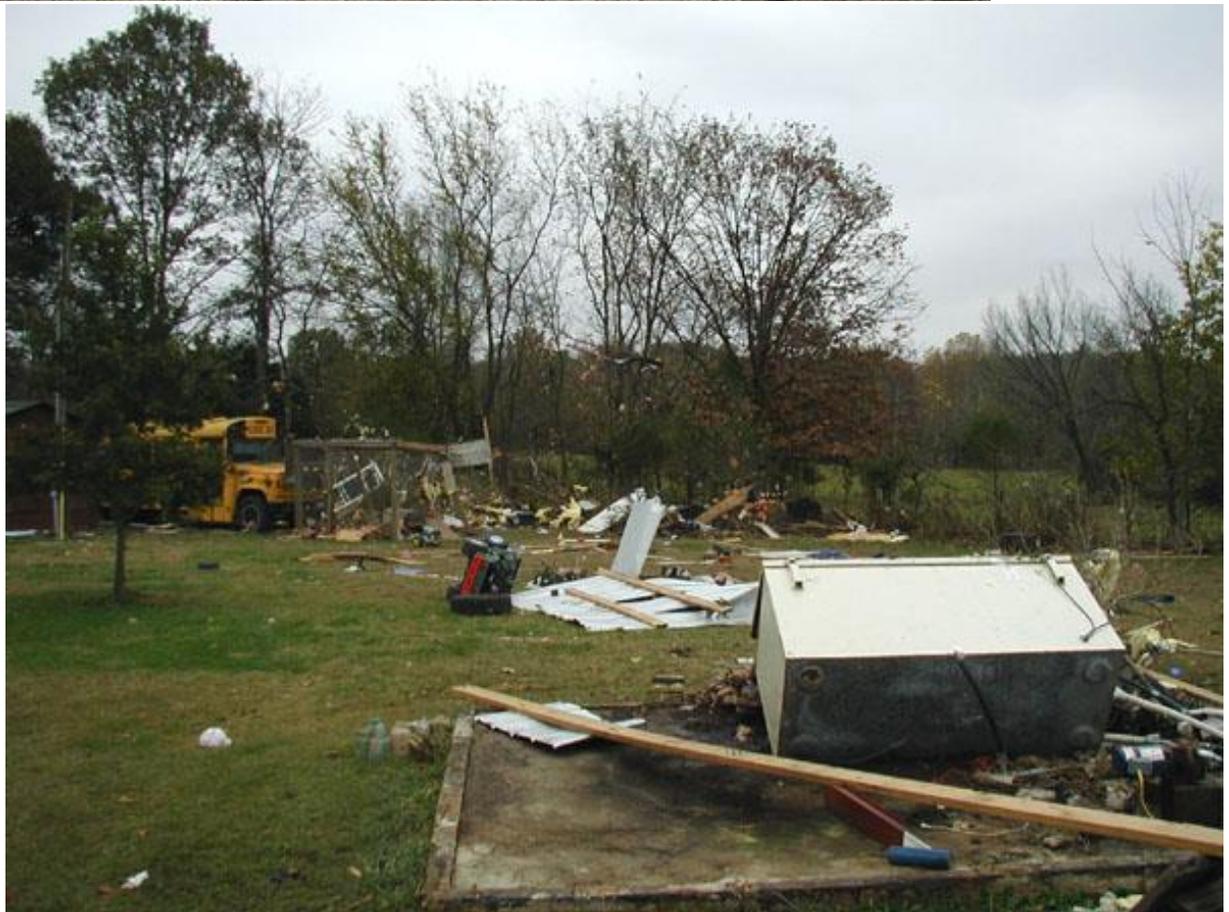
Looking east, remnants of a destroyed detached garage strewn along the path of the tornado. Location is along east side of County Road 219 northeast of Fredericktown.

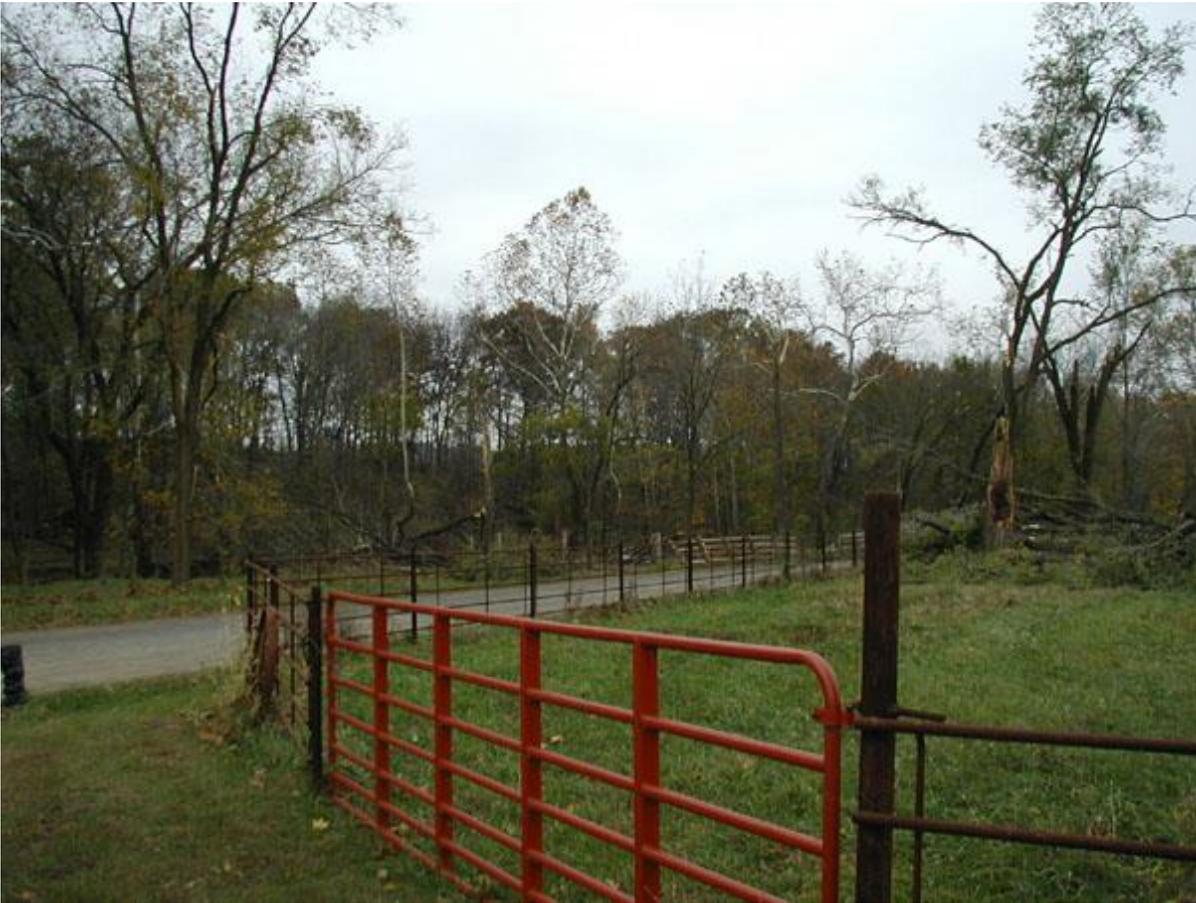
More tree damage along County Road 217 northeast of Fredericktown.

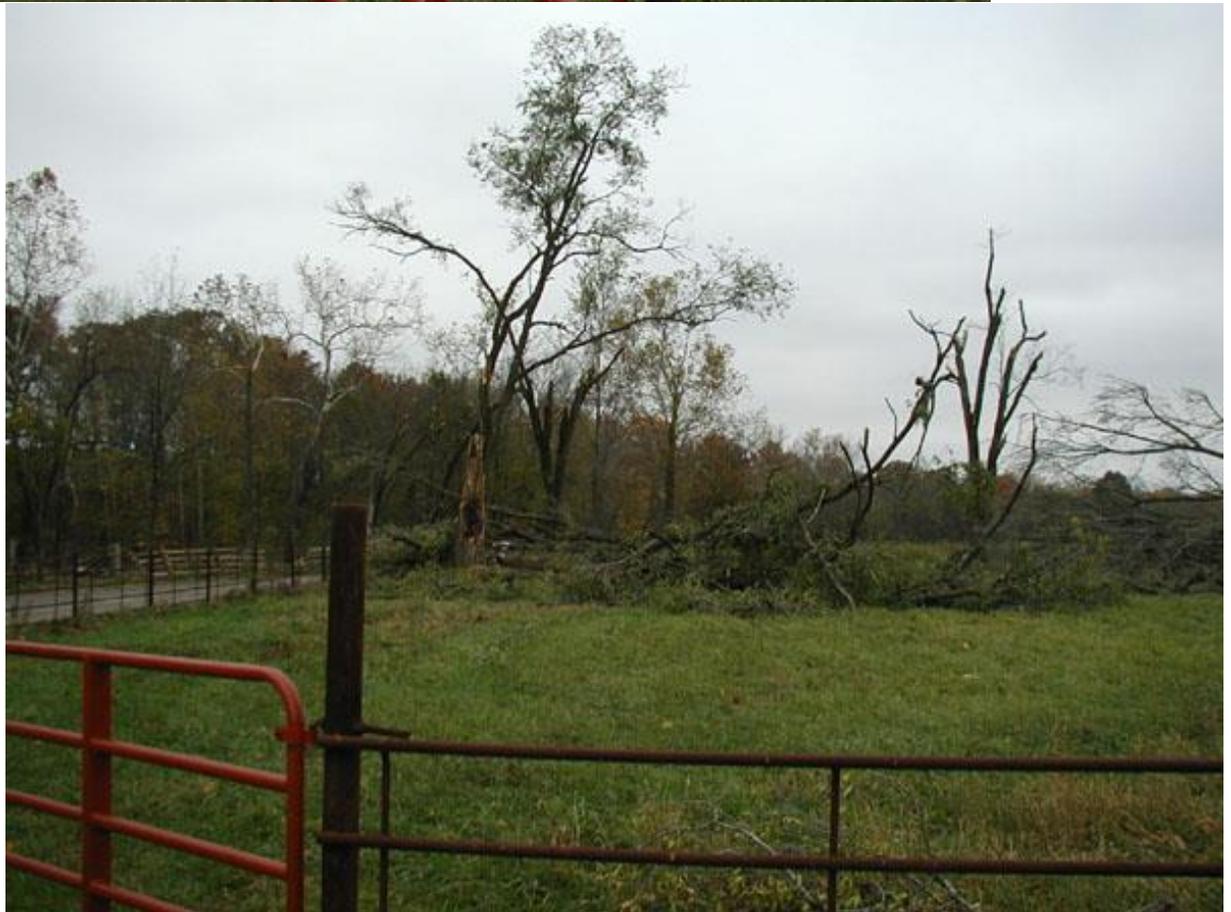
Tree damage near County Road 217 northeast of Fredericktown.
