Tornado and Hail Event

October 18th, 2004

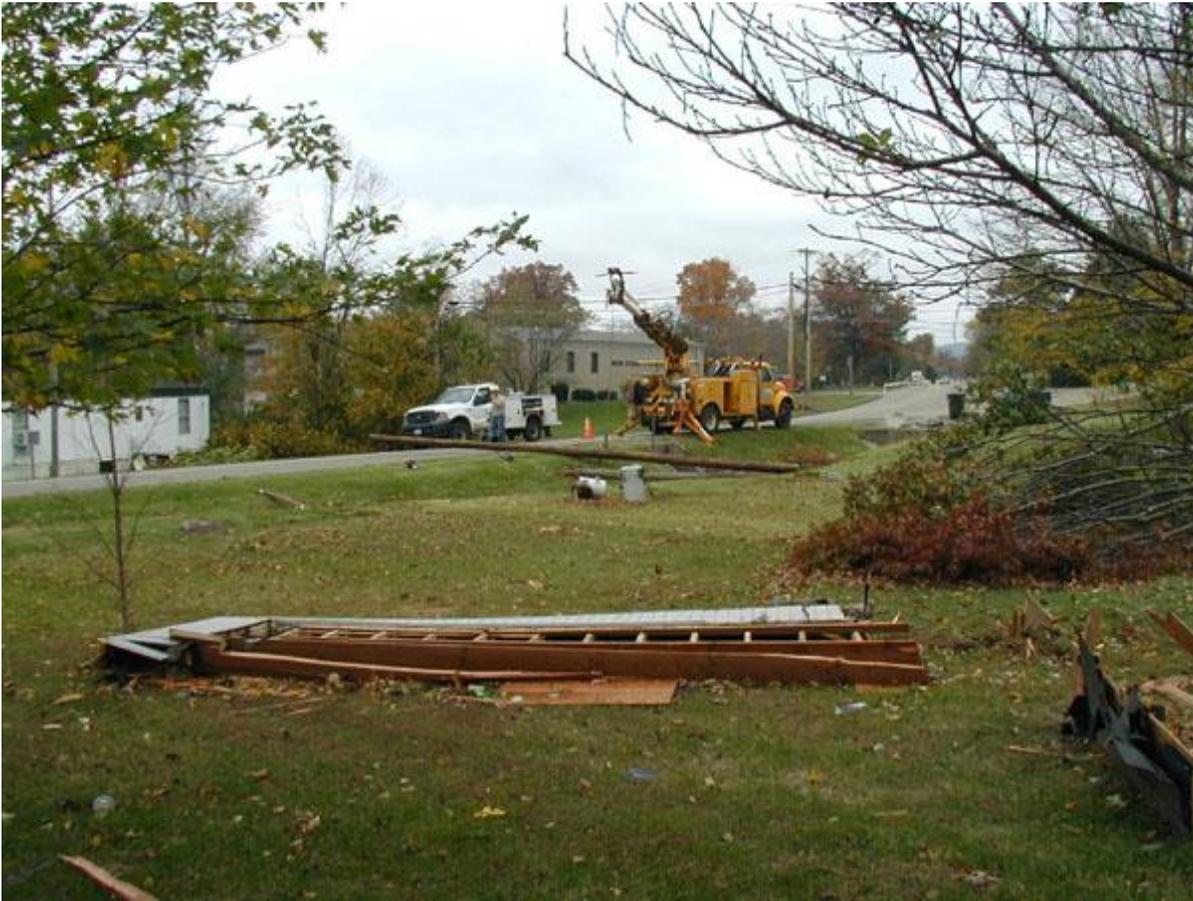
Iron County Health Center in rear center of picture behind the yellow utility company truck. A portion of the Health Center roof carried some 75 yards to the northeast in the lower center of the picture along with missiles in the lower right corner.

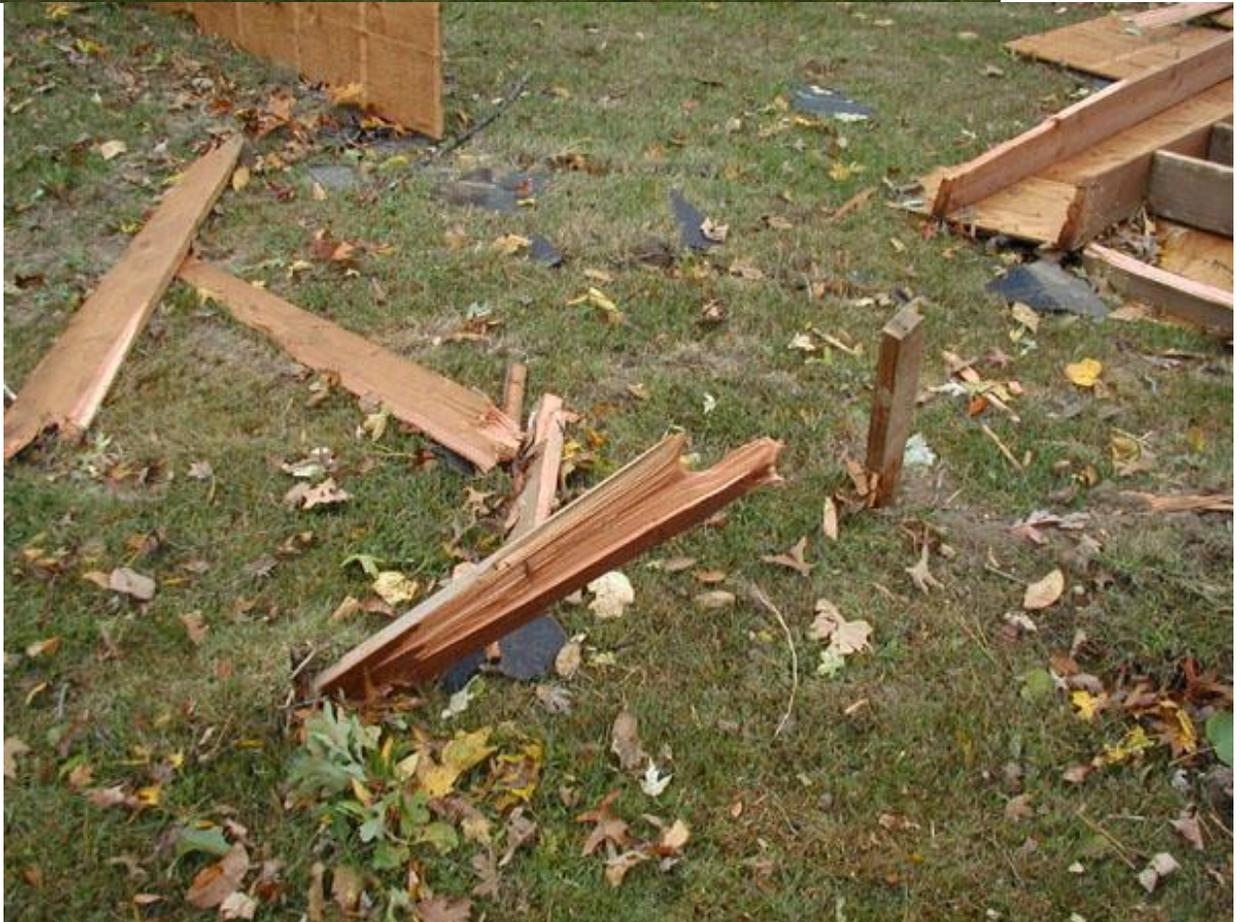
Missiles (pieces of debris) originating from the Iron County Health Center roof driven into the ground around 75 yards away on the north side of Russell Street.

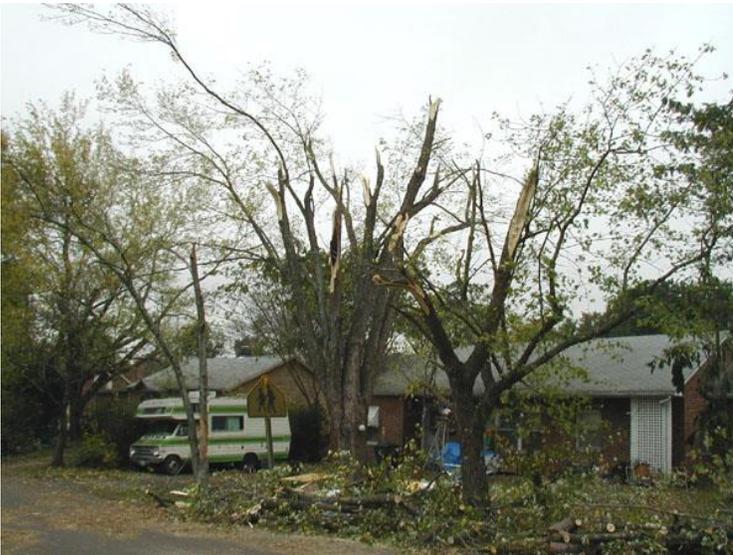
Several trees with the tops snapped off on Edison Ct. in Ironton.

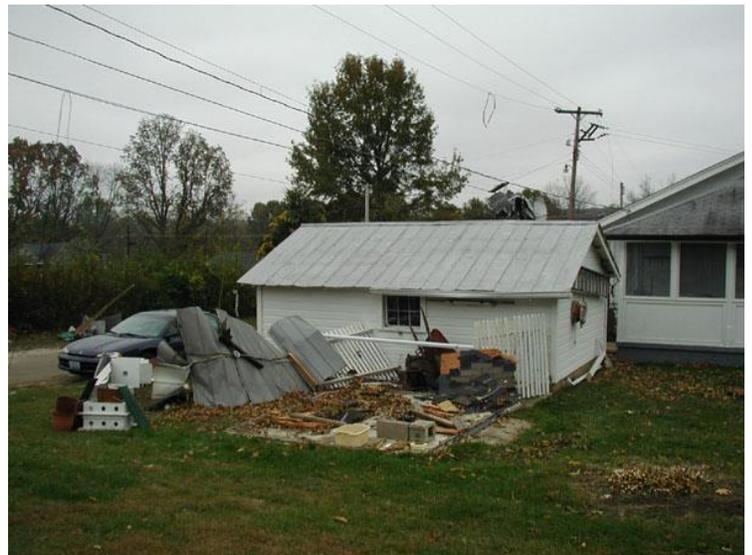
A south view from the rear of a house at the corner of Wayne and Russell Streets in Ironton. Note remnants of the metal shed in the power lines behind the house and its original location in the foreground of the picture.

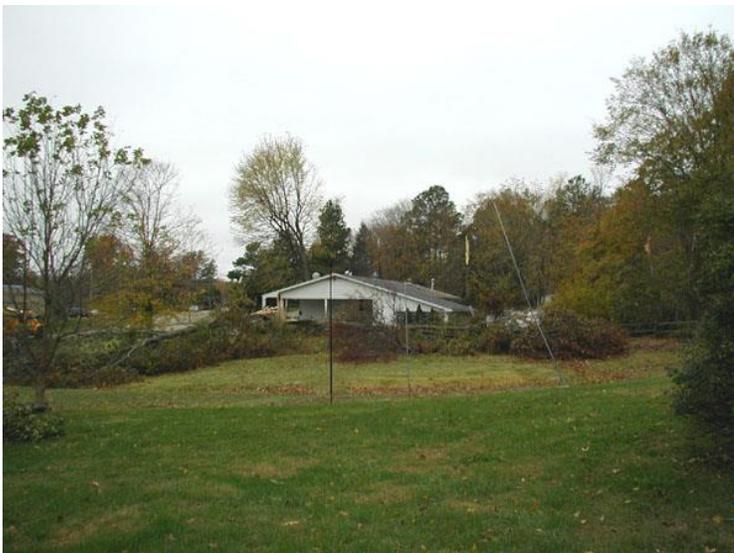
Looking west from Wayne St. in Ironton. Numerous trees either snapped or uprooted.
