# New Years Eve Tornado Outbreak

## December 31<sup>st</sup>, 2010

# Damage Survey

## Sunset Hills EF3 Tornado

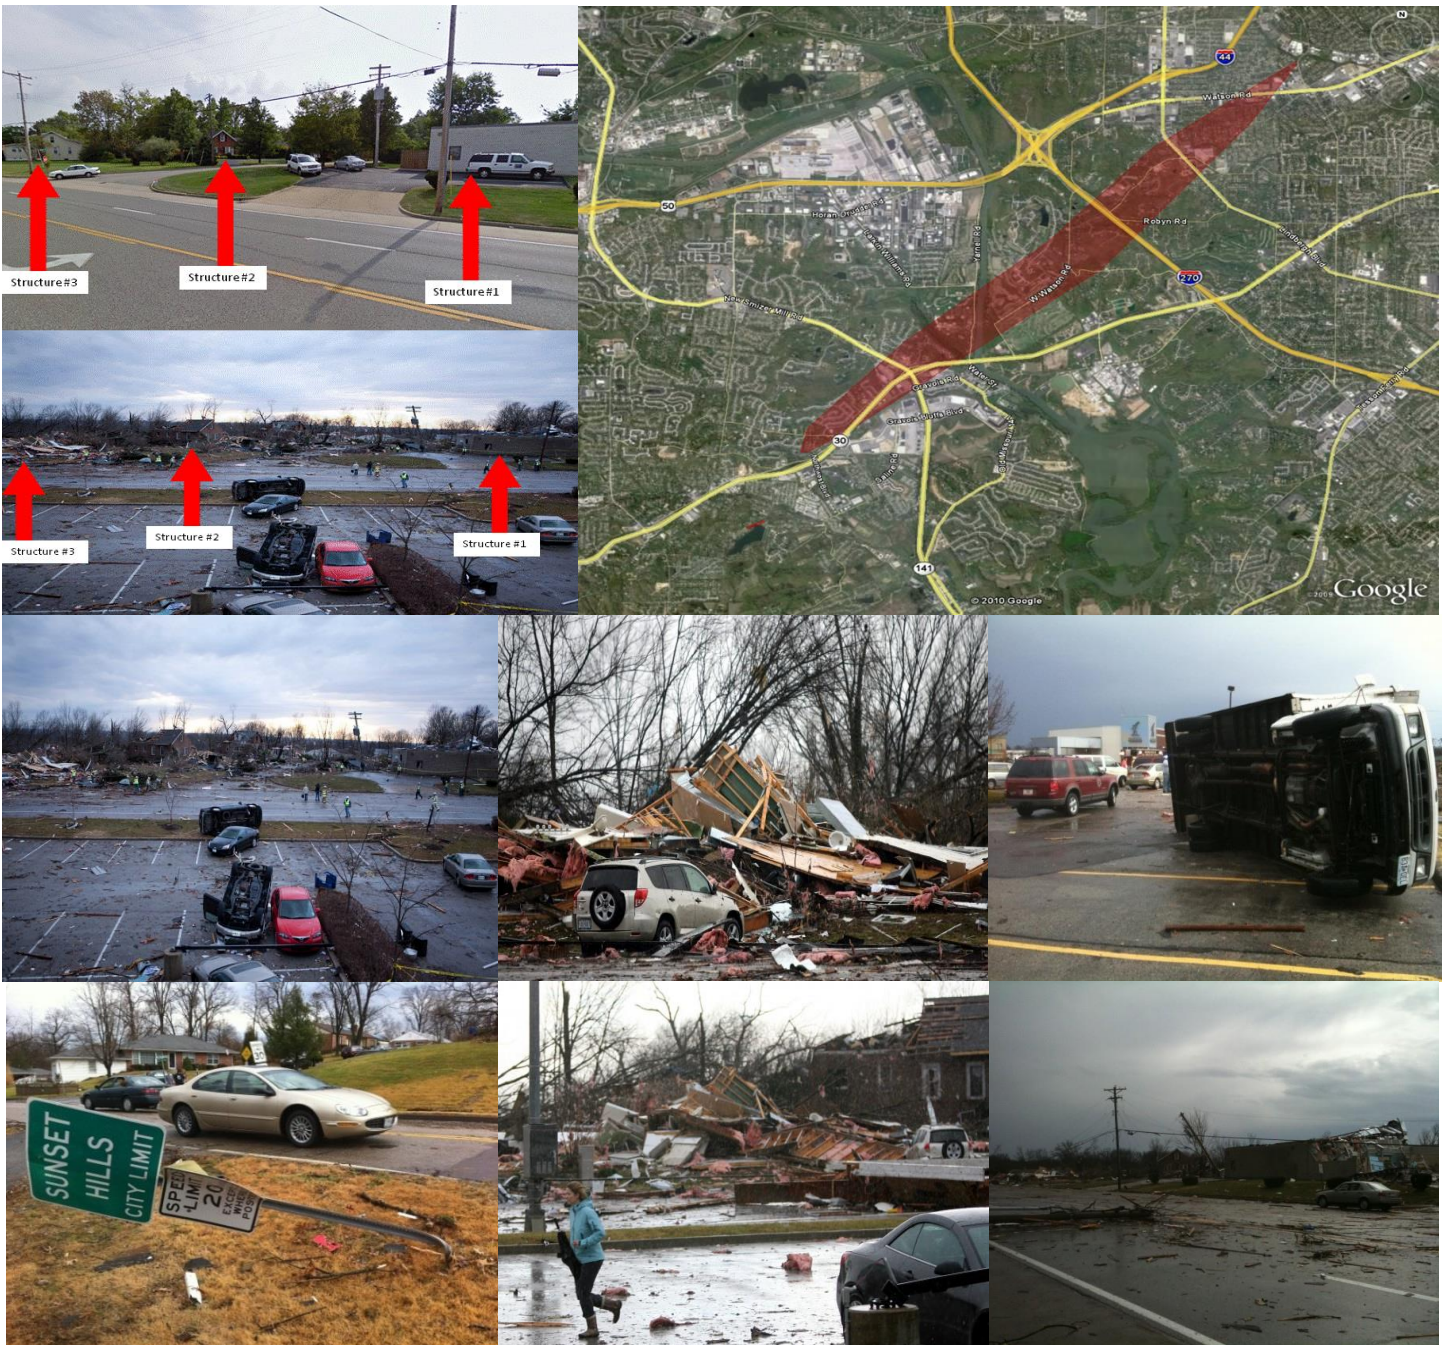
The tornado crossed over Kathy Lane and Fern Glen Drive. Some large tree branches were broken which took down some power lines. This damage was rated EF0 and the damage path was 100 yards wide.

The tornado continued northeast and crossed the area near Maybern Terrace, Sturdy Drive and Crestwood Lane. At Sturdy and Maybern Terrace, two homes suffered roof damage with one home having the roof lifted and partially removed. A couple of large trees were also downed in this area. This damage was EF1 and 100 yards wide. The tornado continued northeast to Watson Road with minor tree and roof damage noted. Six power poles were pushed over along Watson Road. The tornado continued northeast with additional damage to trees and roofs until it weakened and lifted at the intersection of Rayburn Avenue and Sappington Road.

The maximum damage for this tornado has been rated at EF3, with a path length of 6.7 miles and a maximum width of damage of 440 yards. One death and six injuries were reported with this tornado.

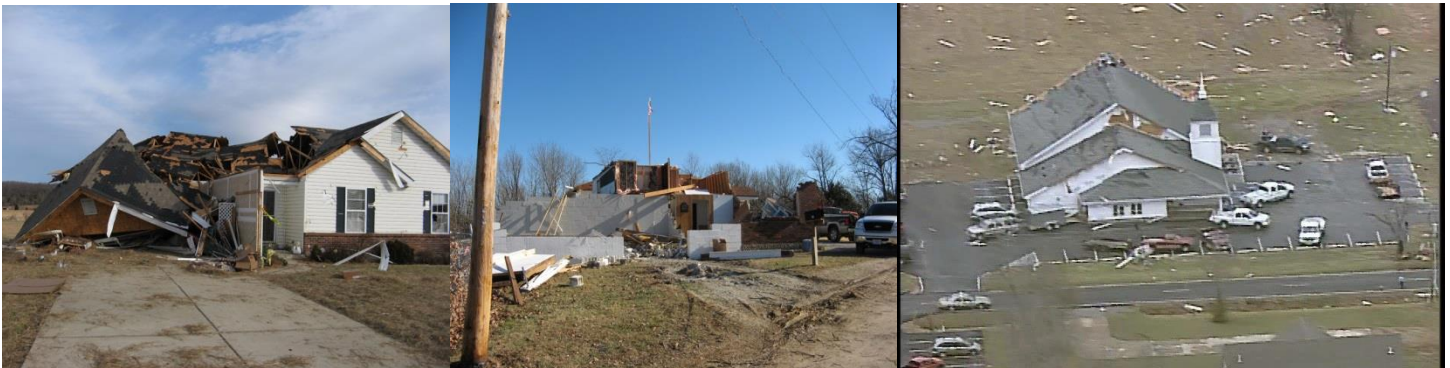
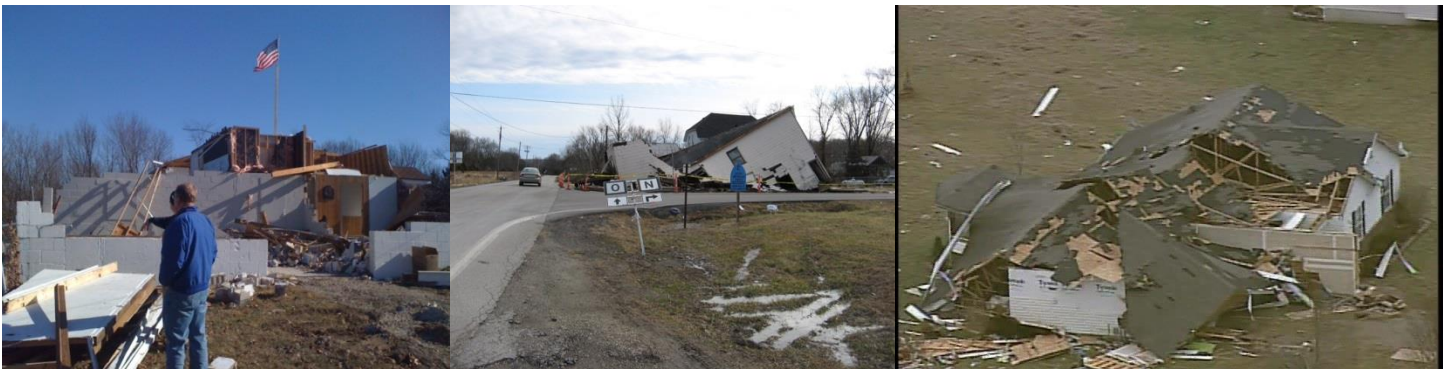
At 11:19 am, the tornado touched down around three quarters of a mile southwest of Bruns Bridge on Mill Hill Road and four tenths of a mile east of the northern end of Ely Road, within the Meramec River valley. The tornado moved rapidly northeast at 50 mph crossing the Meramec River six times while producing extensive tree damage along its entire path to Robertsville. Large sections of trees were completely leveled within wooded areas in rural southeast Franklin County. Over two dozen structures were also damaged along the path to the southwest of Robertsville, including one house that was totally destroyed at the intersection of Eagle Ridge Road and Woods Creek Road, and another building on south Oak Drive. In Robertsville, seven homes were damaged on Hayfield Drive in the Hayfield Estates subdivision, with two sustaining significant damage. The tornado then hit the Shiloh Baptist Church causing severe damage to its west facing wall, and leveling the old church sanctuary just north of the church. The tornado then destroyed a building at the intersection of Route O and Route N as it exited town. The tornado weakened some as it moved northeast of Robertsville moving across the southeast portion of the Robertsville State Park and crossing Highway N just south of Mueller Road, about six tenths of a mile north of Catawissa. The tornado then continued northeast, crossing Solidarity Drive, which is on the Franklin/Jefferson county line, into Jefferson County.

The tornado continued to the northeast. The path narrowed as it crossed Highway F just west of Lake Cattails. The tornado finally lifted around 11:35 am near the northeast corner of Lake Cattails, 2 miles southeast of Pacific. The damage along this segment consisted of snapped trees, tree limbs and downed trees, and missing or damaged shingles on a few homes. Nearly all of the damage to the northeast of Robertsville consisted of snapped or downed trees and minor superficial damage to a few buildings and homes. The damage for this tornado has been rated at EF-2 with a total path length of 12.4 miles. Width of damage in most areas was 175 yards, although at its widest point the damage was around 370 yards.

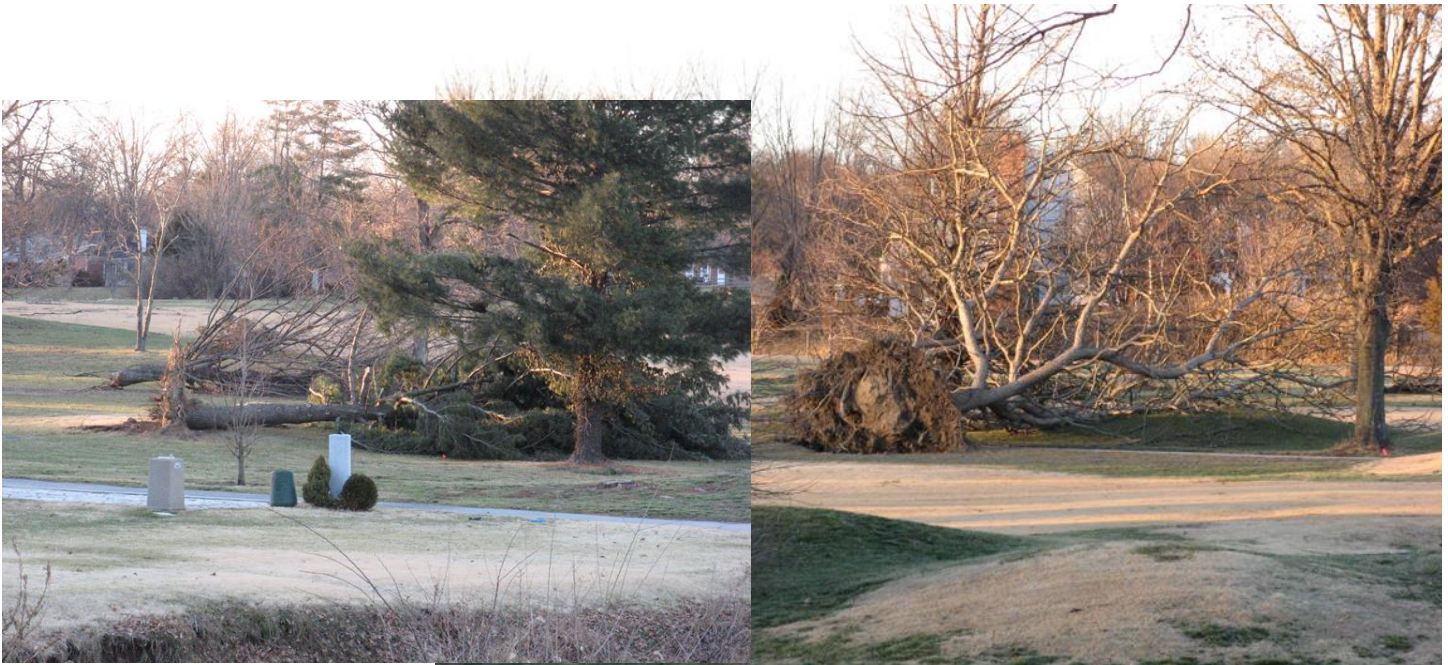
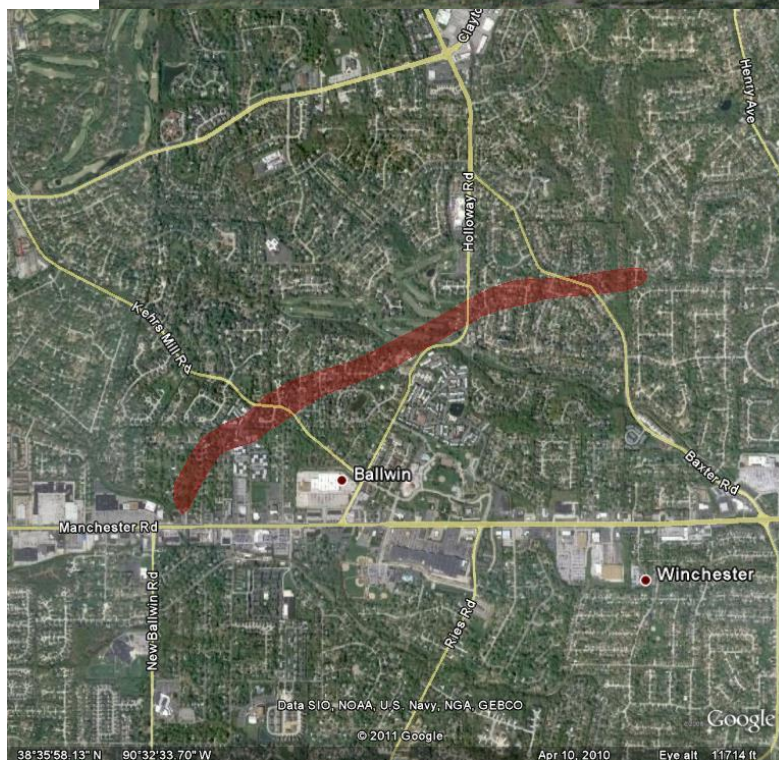
The initial tornado touchdown occurred at 11:48 am just northwest of the intersection of Manchester Road and Birchwood Drive. The tornado traveled quickly northeast at around 45 mph crossing Kehrs Mill Road, passing through the east side of the Ballwin Golf Course, then crossing Holloway Road and Baxter Road. The tornado lifted just east of the intersection of Brass Lamp Drive and Morewood Court between 11:50 and 11:51 am.

There were numerous occurrences of tree damage along the tornado path including snapped trees and tree branches and uprooted trees. Nearly three dozen homes sustained damage, although the vast majority of this damage was superficial consisting of damaged fascia, soffit, and missing/damaged shingles. The maximum damage for this tornado has been rated at EF1, with a path length of 1.76 miles and a maximum width of damage of 175 yards.

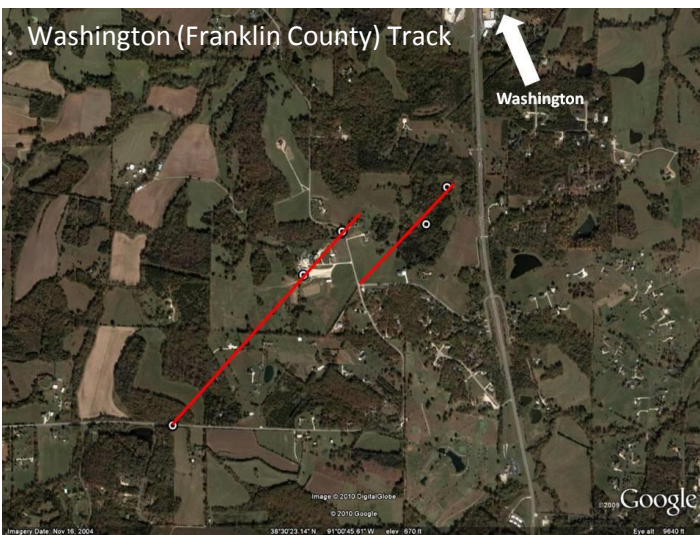
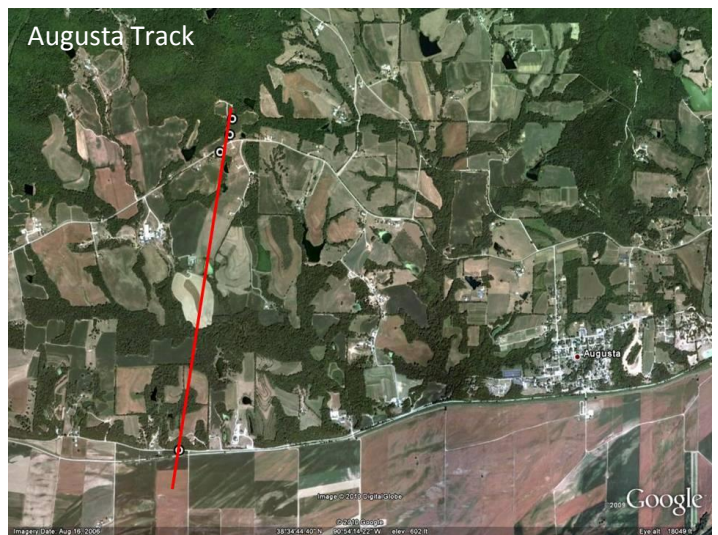
A survey of Franklin County a few miles south of Washington, MO revealed two short tornado tracks. The first tornado touched down along County Club Road and produced minor tree damage. It continued northeast and struck a farm where it removed the majority of the roof from a large metal pole barn. Another outbuilding sustained roof damage and the residence had some shingles blown off. The damage to the pole barn is rated EF1 intensity while the rest of the damage at this location was EF0. The tornado crossed Country Club Road near a sharp curve to the west. A house had shingles missing at this location as well as minor tree damage. The tornado lifted just past this point. The maximum intensity has been rated EF1 with maximum wind speeds of 90 mph. The path width was 100 yards and a path length of 3/4 of a mile.

A second weaker tornado formed near the intersection of Country Club Road and Country Club Lane where it blew over a road sign and produced minor trim damage to a home. The tornado continued northeast and passed through a new subdivision and produced minor tree damage. The tornado lifted before reaching Highway 47. The intensity of this tornado has been rated EF0 with a path width of 50 yards and a path length of 1/2 mile.

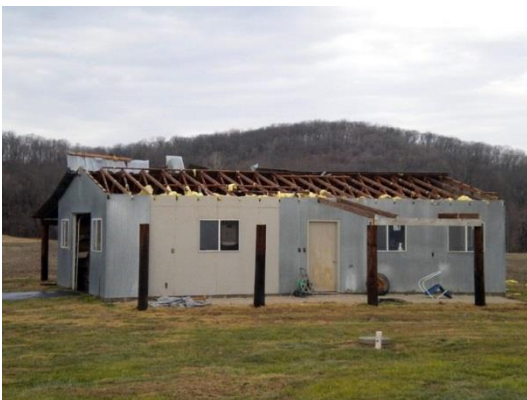
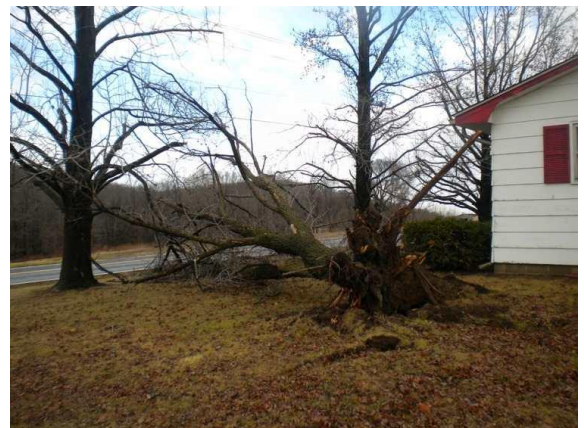
The tornado first touched down on the Missouri River flood plain south of Augusta Bottom Rd. A barn was knocked down along Augusta Bottom Road and had part of its roof thrown across the road. The tornado proceeded to move up the bluff and continued north-northeast where it uprooted a tree and produced minor exterior damage to a house on the south side of Highway 94. The tornado crossed Highway 94 and removed part of the metal roof of an outbuilding. The roof debris was blown several hundred yards from the structure. Some of the sheet metal could be found in a tree line well north of the building where the tornado lifted. Maximum intensity is rated EF0 with a maximum width of 50 yards and a length of 2 miles.

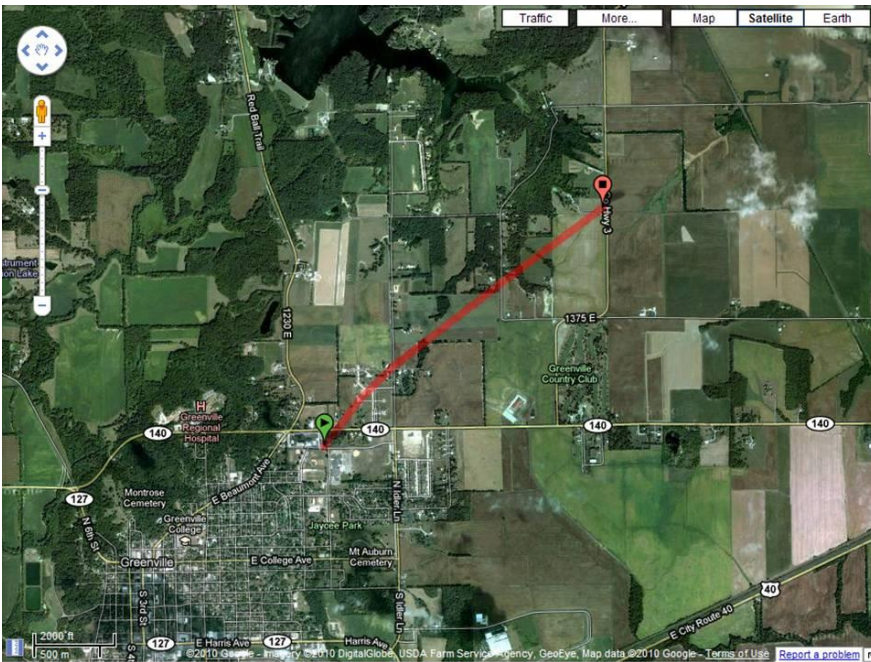
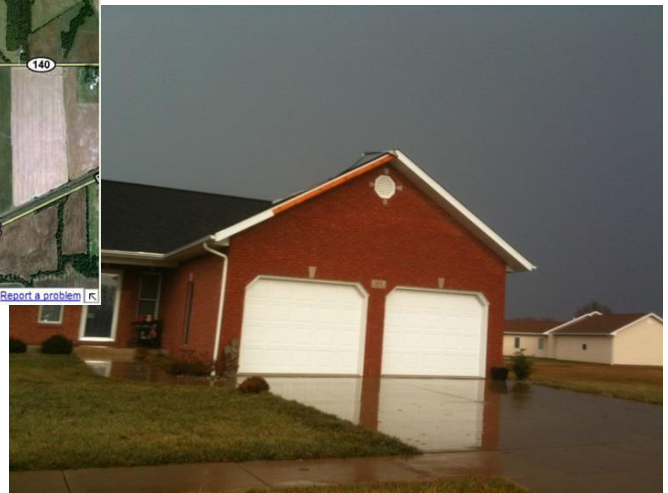
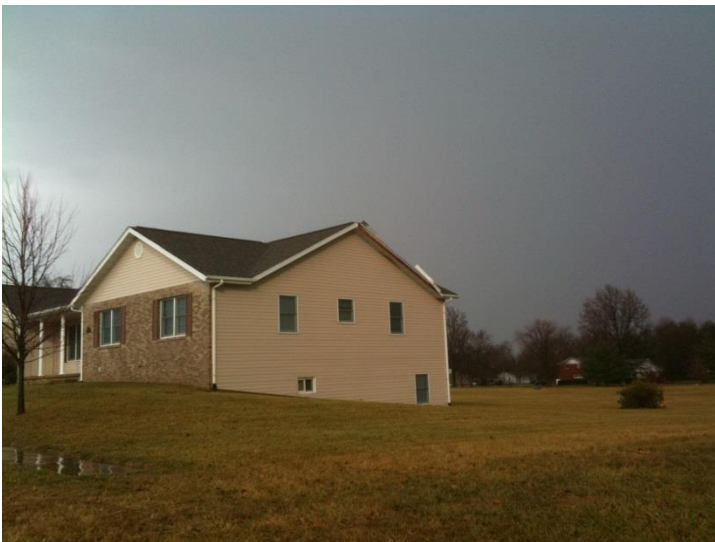
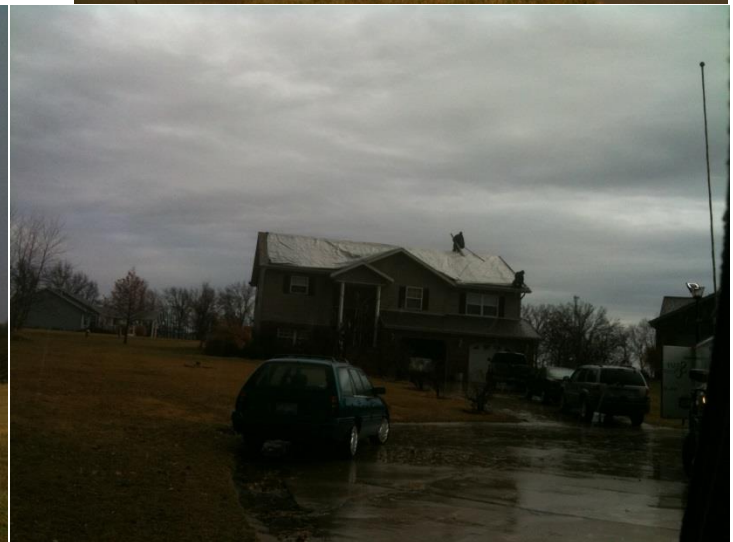
National Weather Service personnel conducted a storm survey on Friday afternoon and determined that an EF-0 tornado caused the damage in and northeast of Greenville, Illinois on December 31, 2010.

Tornado damage was first noted on the north side of Greenville near the intersection of North Hena and North Dewey Streets. An agricultural building at the high school sustained roof damage with some additional minor roof and tree damage noticed at an adjacent house. Wind speeds in this area were estimated to be near 85 mph. The tornado then moved northeast causing significant damage to a large tree on the north side of Illinois Route 140. Minor roof and siding damage was noted on several houses on Cloverfield Lane and North Idler Lane. The tornado continued northeast producing additional minor roof and tree damage on Country Club and Woburn Roads before dissipating. The maximum damage for this tornado has been rated at EF0, with a path length of approximately 1.7 miles with a maximum width of 100 yards.
