## Scurry County Damage Survey Results

On September 17, 2016, the National Weather Service in Midland conducted a damage survey for a downburst associated with a severe thunderstorm that impacted Snyder on the evening of September 16...

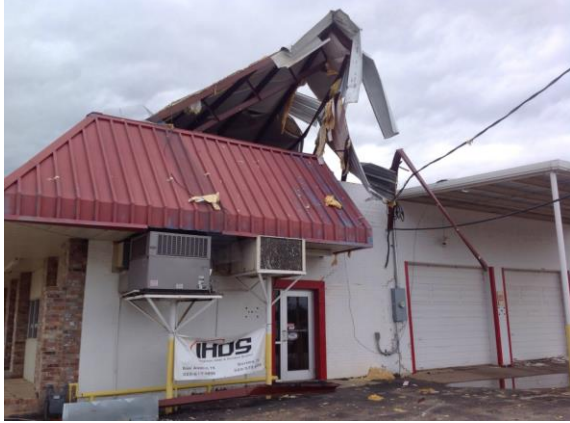
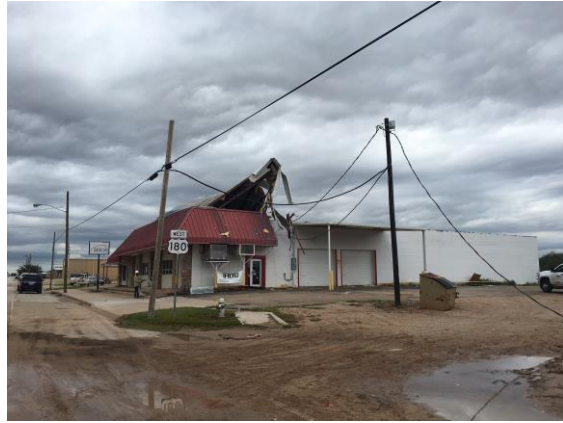
Point A (SE Corner of block at Hwy 180 & Ave X)

**Roof of business (Point A) was lifted and parts of the building were thrown to the southeast on Hwy 180 which also took out some power poles across the street.**

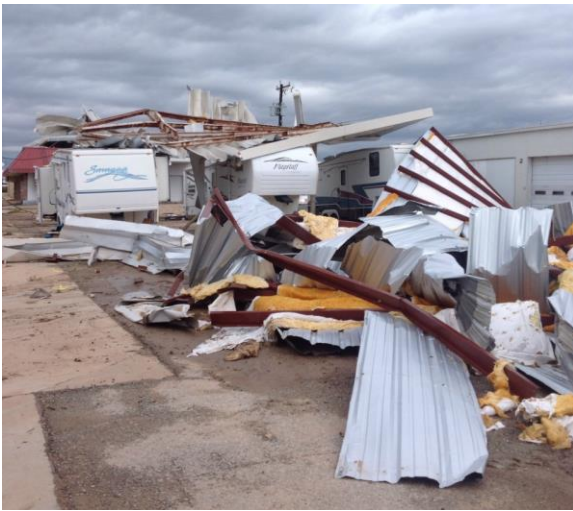
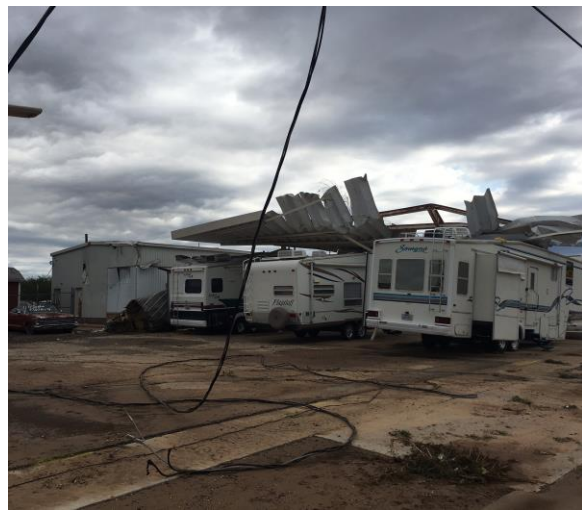
Point B (Along Hwy 180 between Ave X and Ave W; just east of Point A)

**Parts of the roof seen on the ground shown (Point B) was moved off Hwy 180. A carport seen in the image behind parts of the roof was damaged as well.**

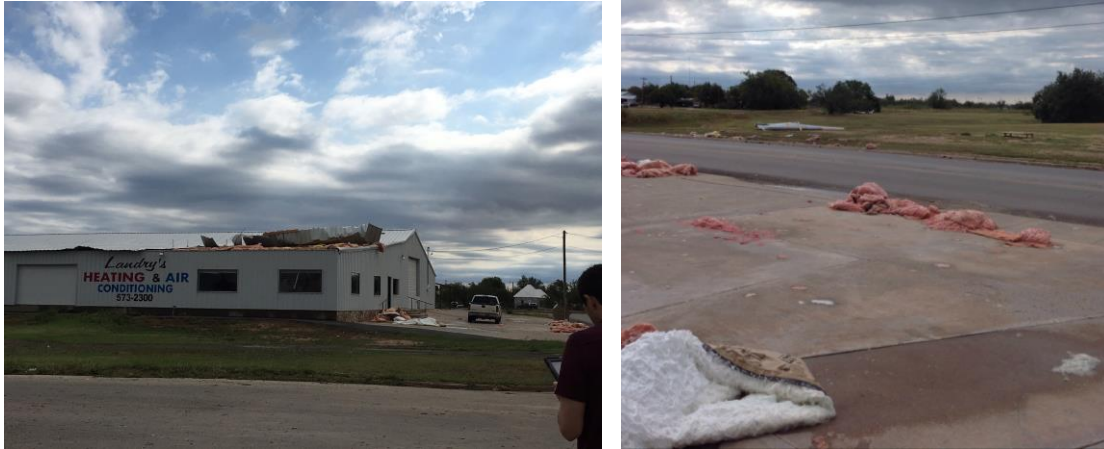
Point C (Along 30<sup>th</sup> St at the intersection of Avenue Q

**Point C:** Wind peeled back parts of the roof and severe northwest winds blew parts of the roof to the southeast across the street into the field.

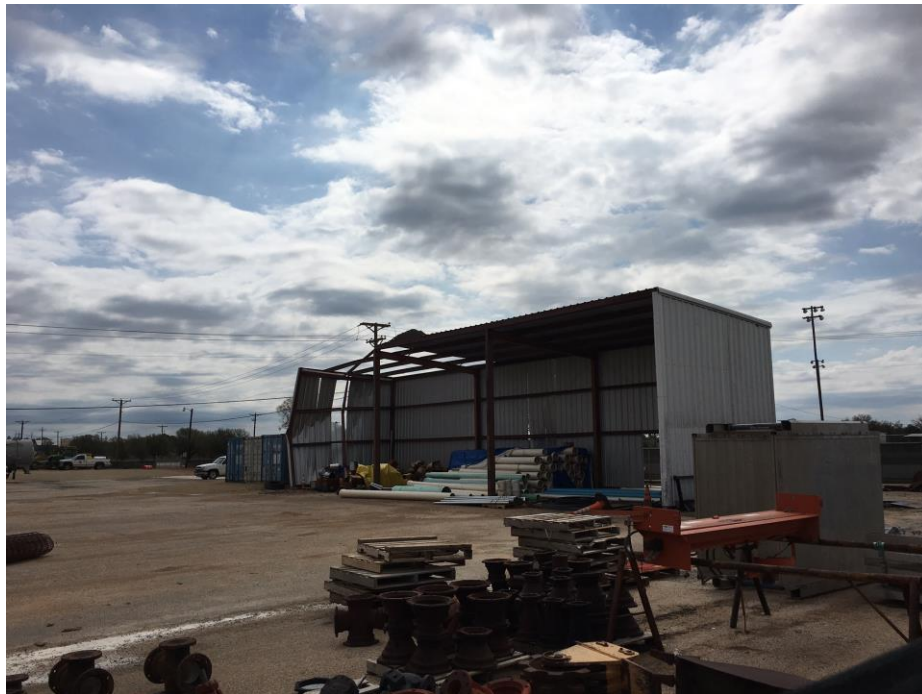
Point D (Along 37<sup>th</sup> St at the intersection of Avenue M)

**Point D:** Winds damaged part of structure with opening facing to the northwest. Parts of the structure were blown to the southeast.

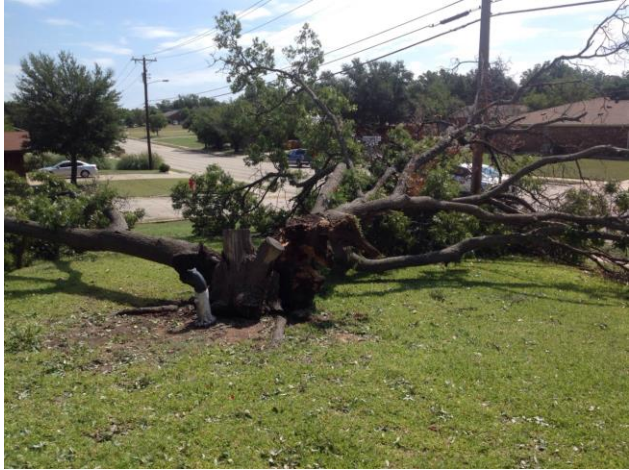
Point E (left)  
(Along 37<sup>th</sup> St at the intersection of Avenue M)

**Point E:** Large tree blow over to the SE.  
Owner mentioned that parts of the tree's base were either dying or dead.
