National Weather Service Office Tampa Bay Area

Official Damage Survey Report for the North Fort Myers Tornado that occurred the afternoon of

June 8th, 2008.

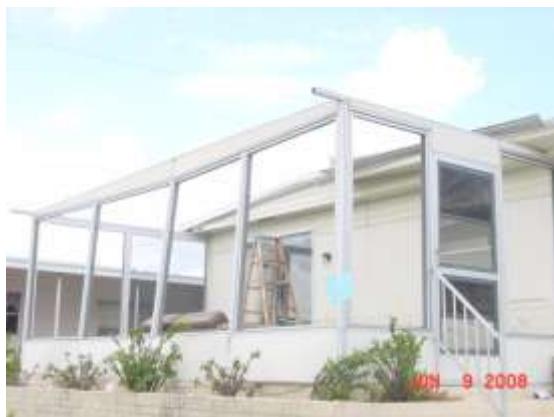
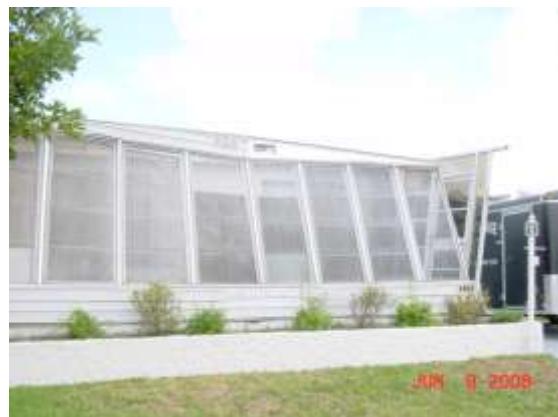
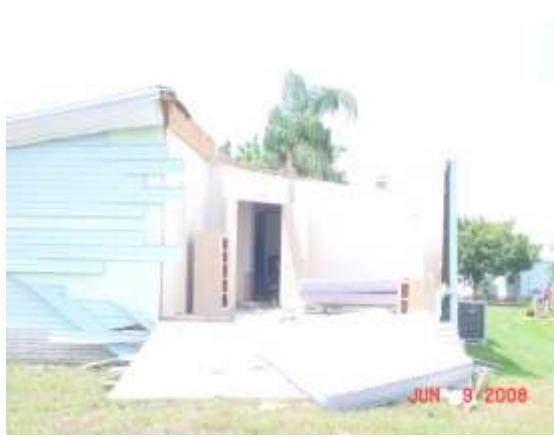
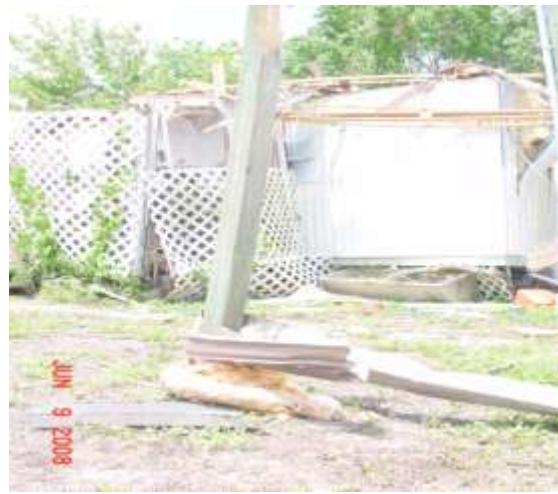
The survey team concluded that the tornado that moved through the area was a high end EF(0) tornado with isolated pockets of EF(1) rated damage. This would place wind speed estimates for the tornado between 75 to 100 mph, with the majority of wind estimates between 75-85mph.
