Tornadoes - June 28th 2018

Damage Survey Results from Carter County, MT and Harding County, SD

Summary of Carter County Tornadoes

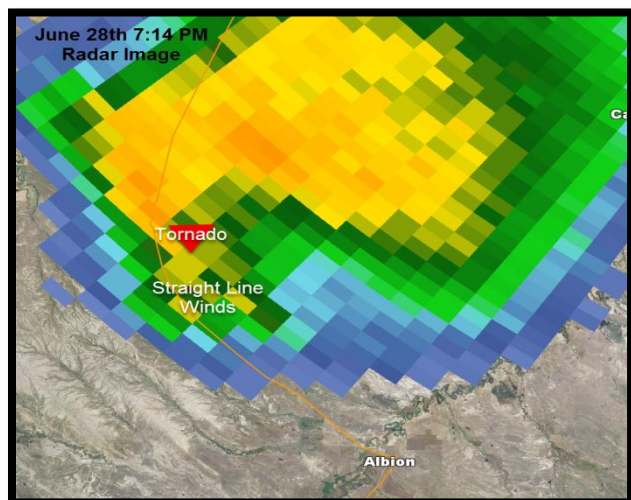
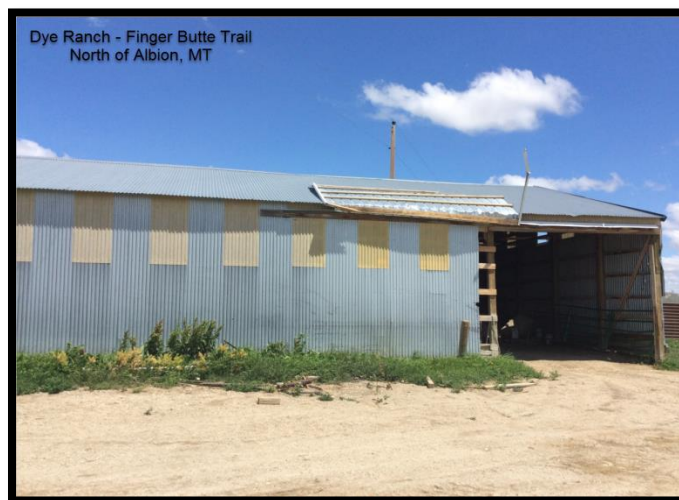
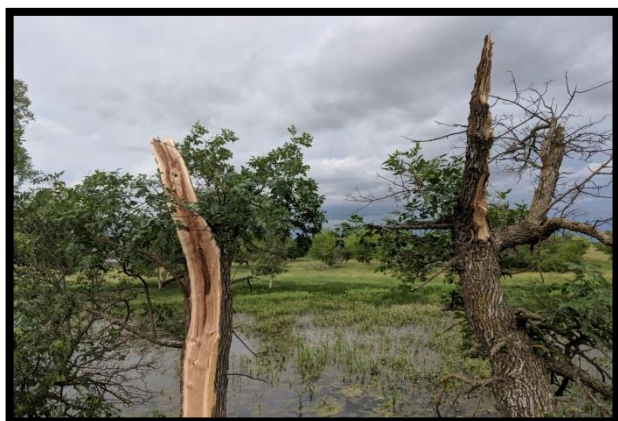
Around 7:17 PM the first tornado was spotted crossing SR 323 in Carter County about 12 miles north of Albion in the Finger Butte Area. This tornado was spotted by a rancher about a mile to the south. His property sustained straight line wind damage on the south side of the storm, including: trees uprooted, a barn roof blown off, a shed destroyed, and a horse trailer flipped over. This damage was consistent with winds 70-80 mph.

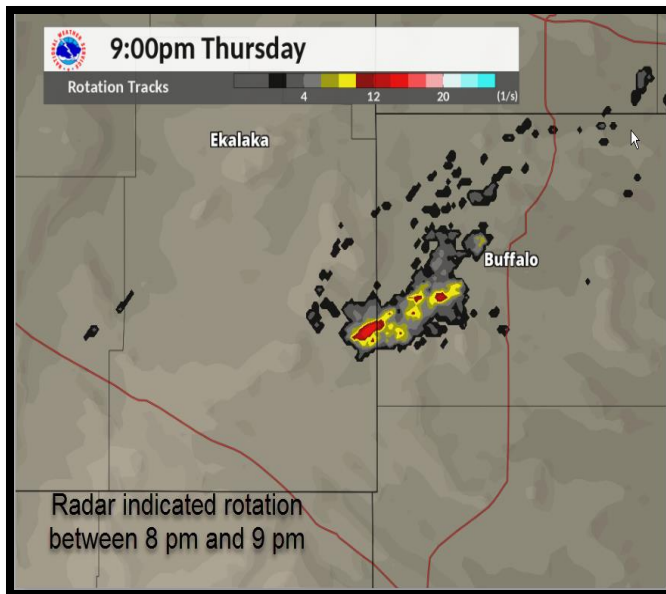
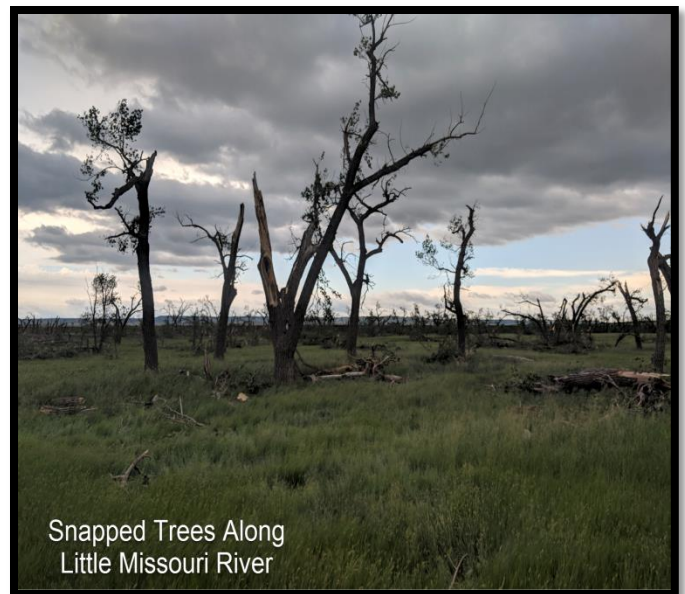
Damage survey and eye witness accounts confirm the tornado initially moved north-north-east along the Little Missouri River. As it approached the river it intensified to 120 mph (EF-2) producing an increasingly wider swath of snapped trees several hundred yards wide. The tornado started to turn more to the east at this time, moving on a northeasterly track as it crossed the Little Missouri and moved across the Montana/South Dakota border.

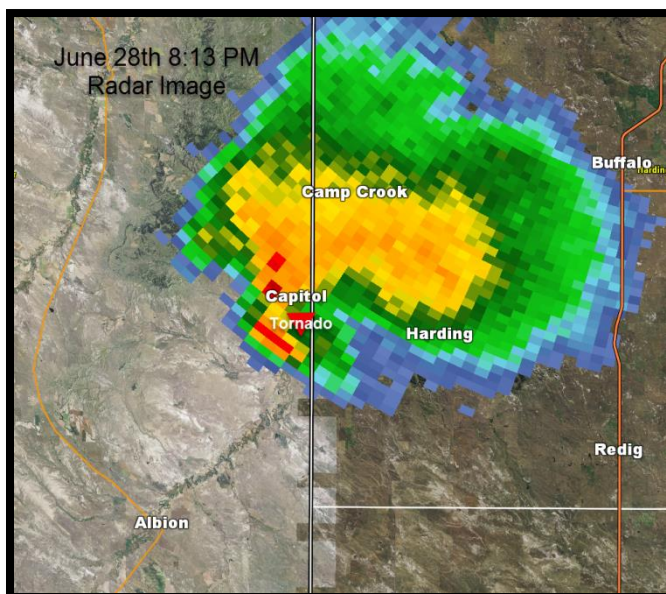
In South Dakota, this storm increased to an estimated $\frac{1}{2}$ mile wide and damage observed was consistent with an EF-3 tornado rating, with winds estimated at 136 mph. Preliminary damage in South Dakota included one home destroyed, shed destroyed, trailer toppled over, heavy hay bales moved, along with tree damage (even debarked in some cases). Local residents reported finding numerous dead deer in the debris along the river where the tornado crossed the tree line. Damage in South Dakota is assessed by the National Weather Service in Rapid City and further updates to this information can be found at weather.gov/rapidcity.
