July 8, 2013
Severe Weather
Damage Assessment Report

National Weather Service
Billings, MT

Event Overview

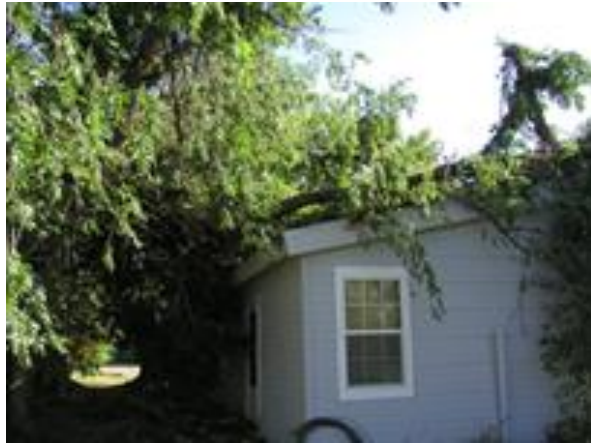
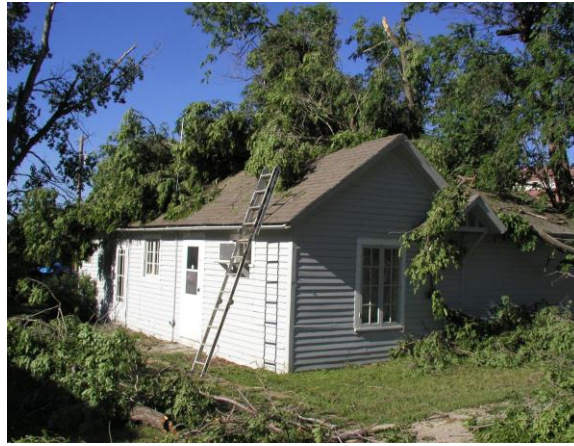
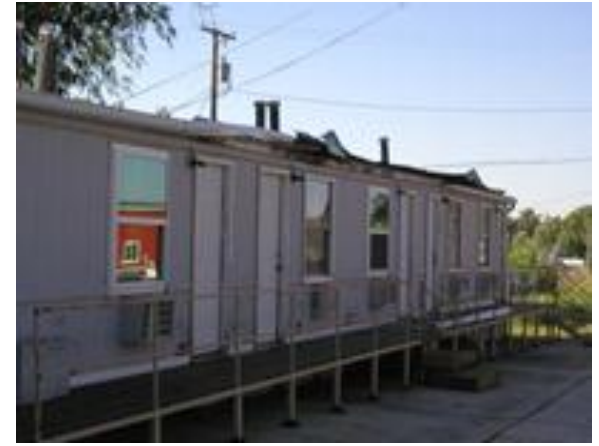
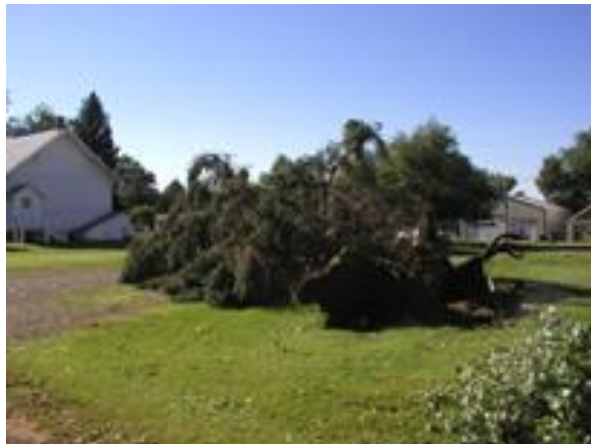
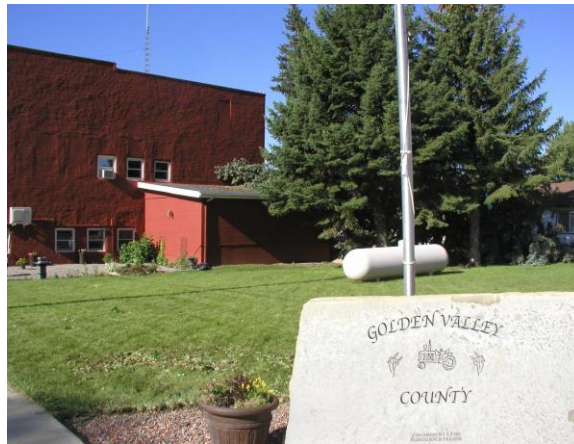
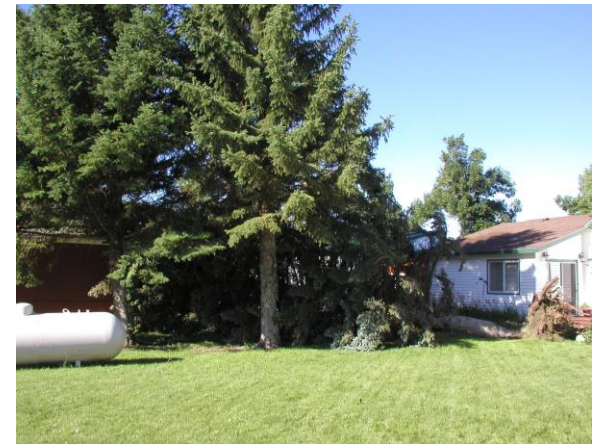
- Event
 - Microburst winds approx 4:00 pm MDT (Estimated speeds upwards of 75 mph)
- Extent
 - Majority of damage in the town of Ryegate, MT
 - Quarter mile wide and a mile long path
- Structural
 - Several structures impacted with mostly minor roof damage
 - Large tree limbs landed on several structures
- Tree
 - Numerous trees impacted with large tree limbs down
 - Several large pine trees were uprooted

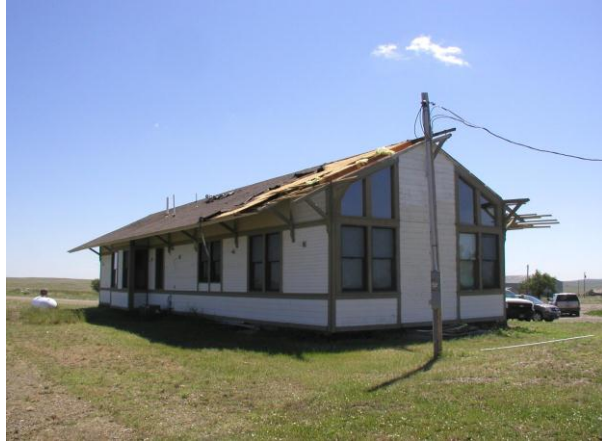
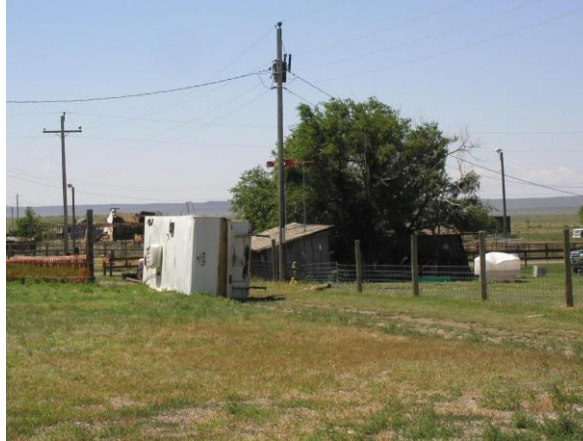
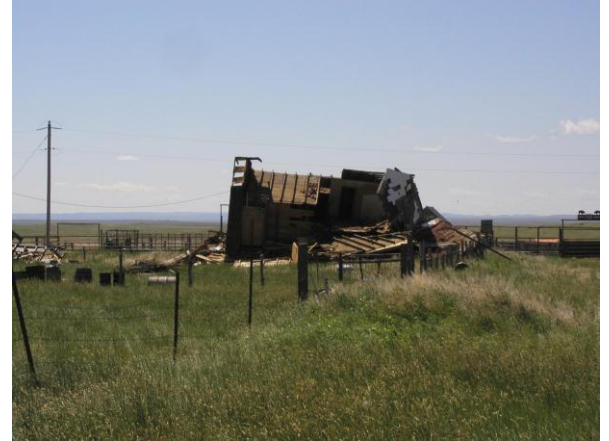
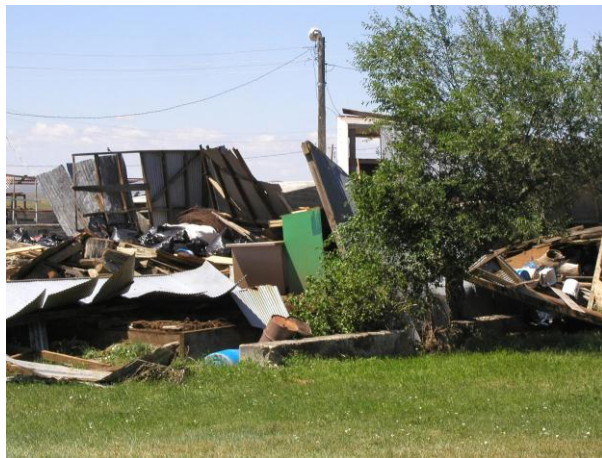
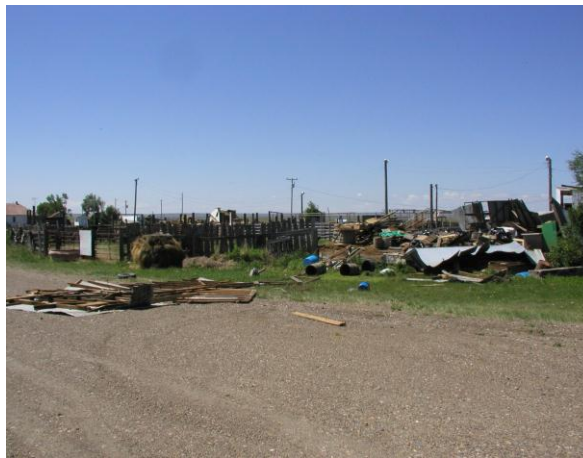
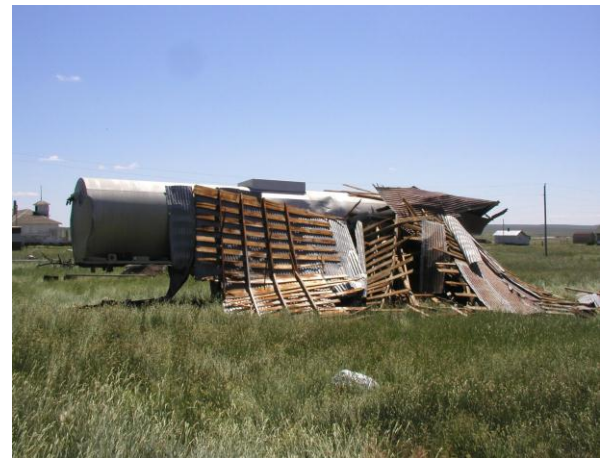
- Event
 - Microburst winds approx 5:15 pm MDT (Estimated speeds upwards of 75 mph)
- Extent
 - In the town of Ingomar, MT
 - Quarter mile wide and a mile long path
- Structural
 - Numerous structures impacted with some damage
 - Corner roof on one house tore off
 - Metal shed destroyed
 - RV rolled

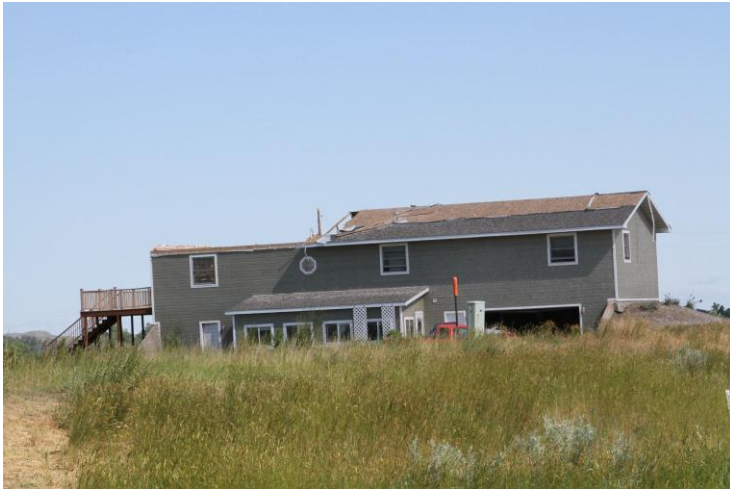
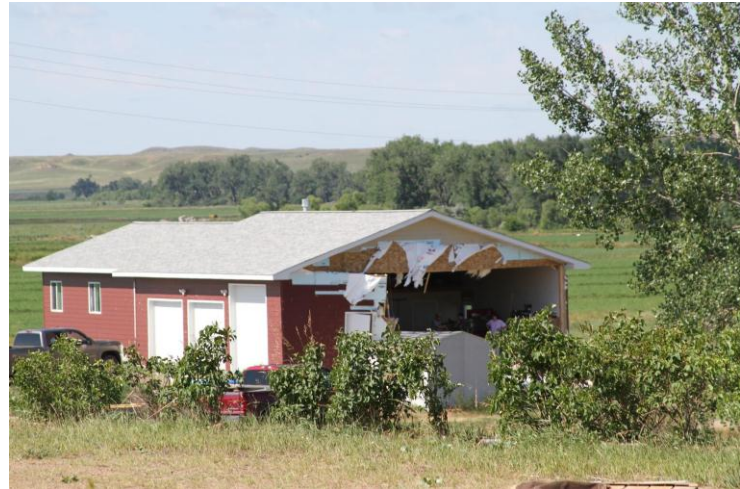
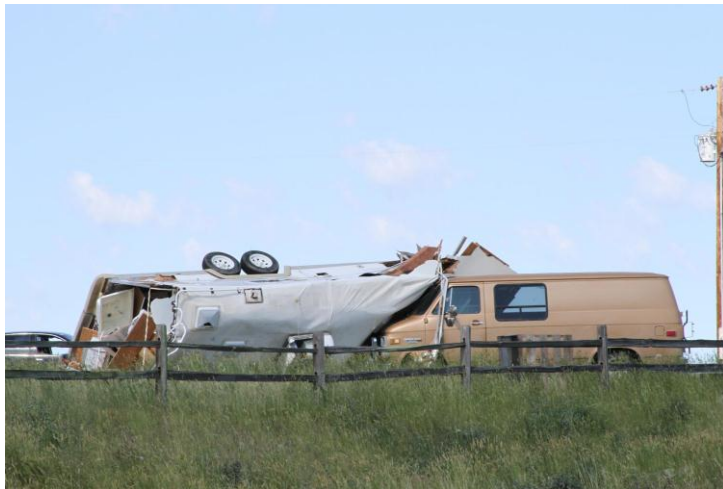
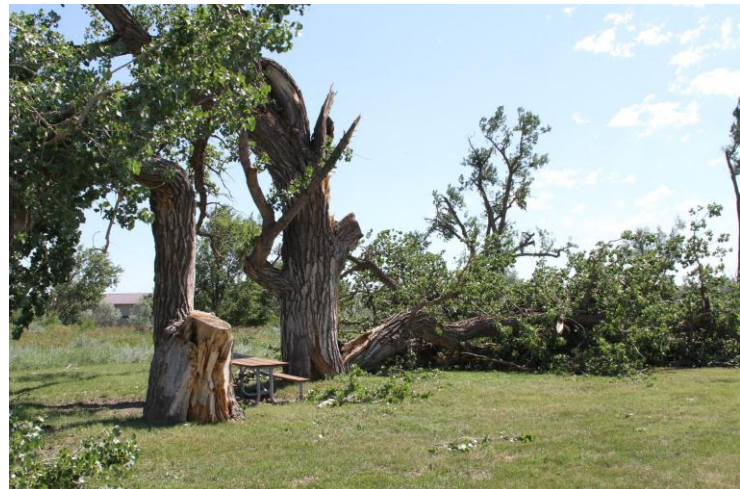
12 Mile Dam (South of Miles City, MT)

- Extent
 - Areal coverage of about one square mile along MT State Road 332 about 13 miles south of Miles City
 - Debris thrown in all directions several hundred yards from point of origin
- Structural
 - Several structures impacted by high winds due to short lived EF1 tornado
 - Parts of several roofs blown off
 - Side of one house blown off
- Tree
 - Dozens of large trees 12-16 inches in diameter uprooted
 - Large tree limbs thrown long distances
- Miscellaneous
 - ~12 power poles knocked down
 - Irrigation pipe system thrown several hundred feet
 - Large camper overturned
- Impacts
 - Tree limbs blocking roads
 - Power outage(s)
 - Campers at 12 Mile Dam (no known injuries)
 - Major structural damage to homes/barns/garages

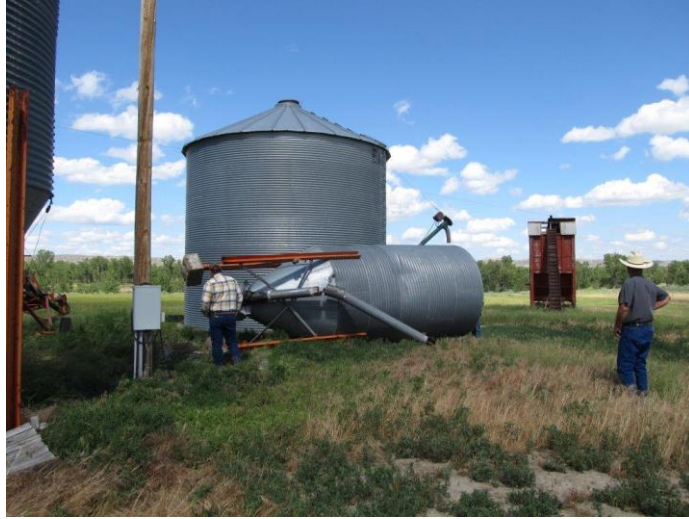
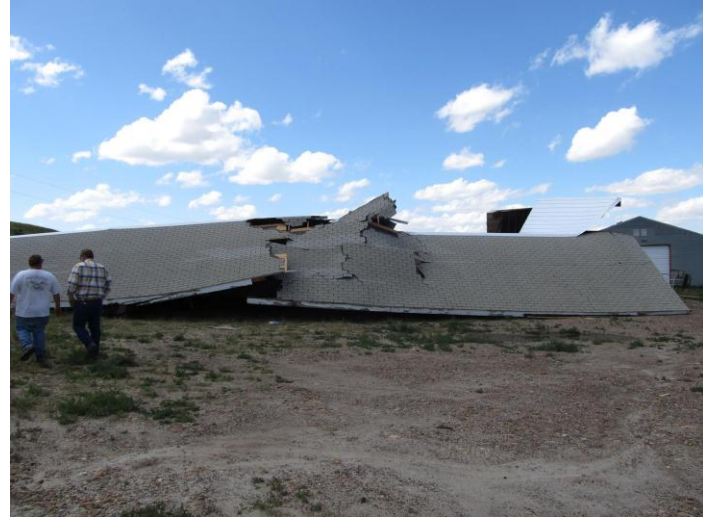
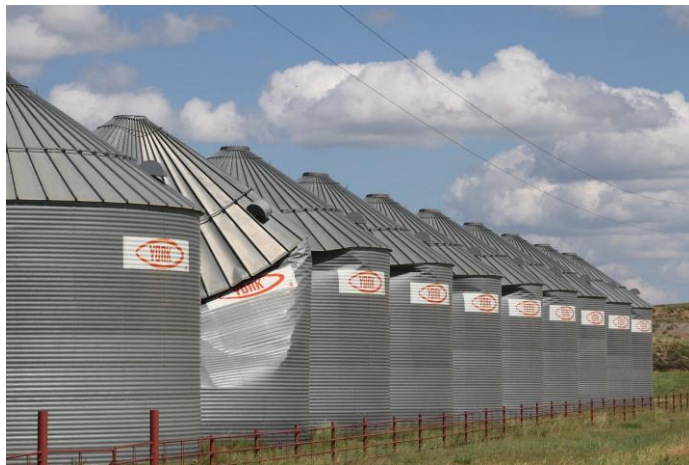
Mizpah, MT

- Extent
 - Areal coverage of about two square miles, along Mizpah Road (30 miles southeast of Miles City)
 - Debris thrown in the southeasterly direction several hundred yards from point of origin
- Structural
 - Several structures impacted by high winds
 - Grain silos indented
 - Several large barn / storage structures completely destroyed
 - Roof of local school house severely damaged
- Tree
 - Large tree limbs thrown long distances
- Miscellaneous
 - Several automobiles within barn structure damaged
 - Large semi-trailer knocked over
- Impacts
 - No known injuries
 - Major structural damage to homes/barns/garages

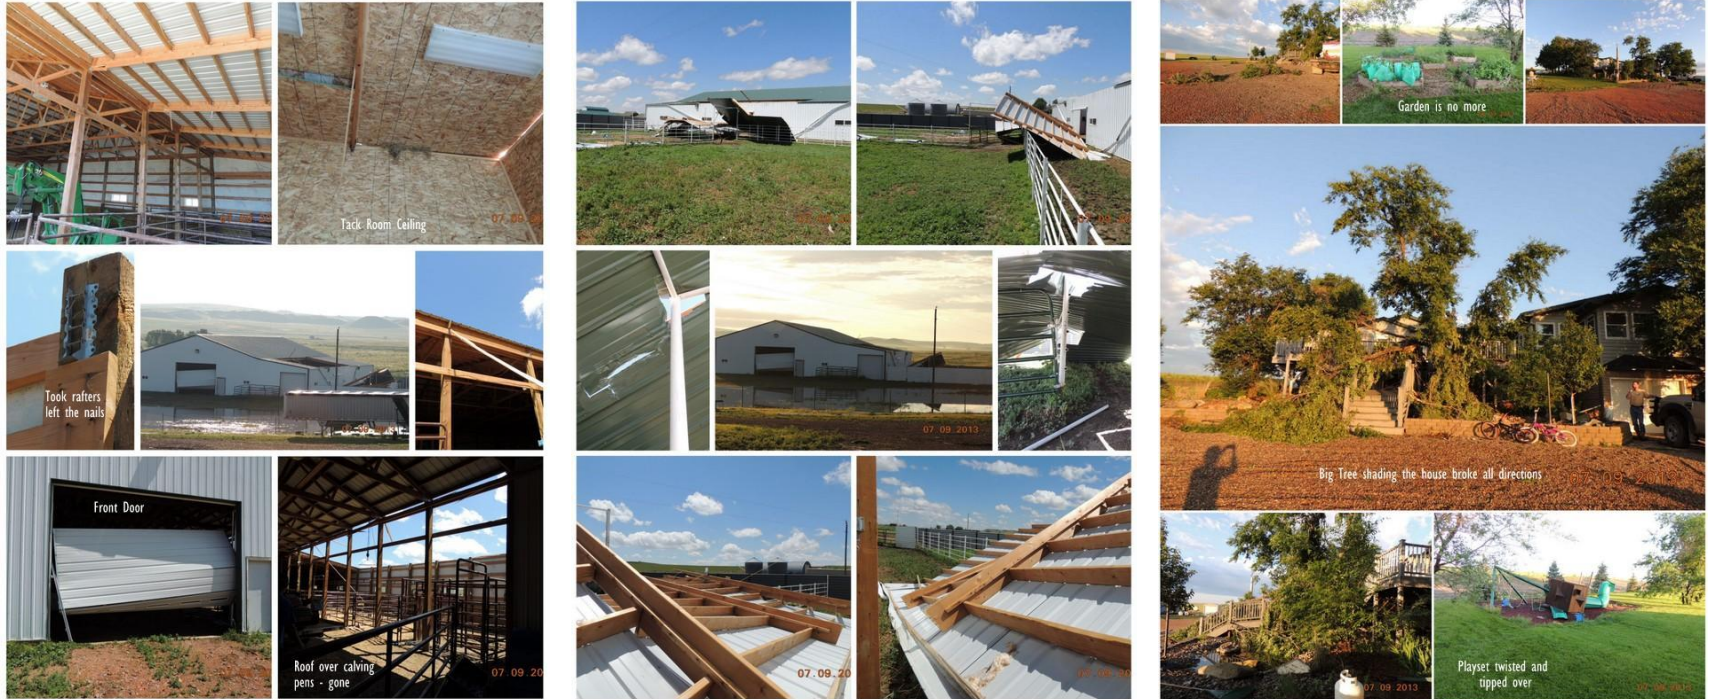
Plevna, MT (4 miles Northeast)

- Extent
 - Areal coverage of about one square mile
 - Debris thrown eastward several hundred yards from point of origin
- Structural
 - Several structures impacted by high winds
 - Large silo separated from tie down
 - Large garage door and roof of structure severely damaged
- Tree
 - Large tree limbs down on back deck of home
- Impacts
 - Major structural damage to barn/garage/silo
