Billings Tornado of June 20, 2010

Overview

June 30, 2010

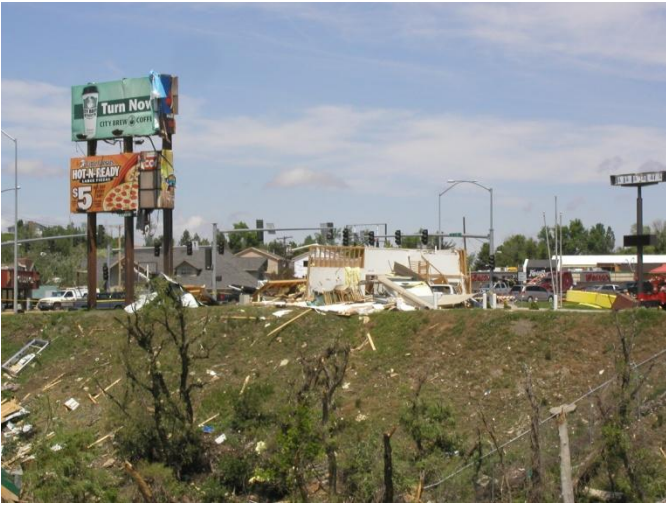
Figure 3: Main Street and Lake Elmo Drive

The damage assessment and eyewitness accounts indicate that the tornado developed near the intersection of Lake Elmo Drive and Main Street in the Billings Heights at approximately 4:24 pm, with significant EF-2 damage to several nearby businesses (Figure 3). Damage included rooftops being blown off of three structures, windows blown out, power poles downed, business signs and billboards blown down along with several trees uprooted. The tornado appeared to weaken slightly as it progressed southeast across Alkali Creek. Limbs were broken off numerous trees in the vicinity of the creek. The tornadic circulation then appears to have strengthened once again as it moved south over the Rimrock Auto Arena at Metrapark. EF-2 damage was again observed to the arena with much of the roof blown off along with other damage to the exterior of the building (Figure 4). Debris from the arena impacted other nearby businesses creating additional damage, mainly in the form of broken windows. Debris from the arena was reported landing as far away as a mile from the tornado touchdown. The tornado then dissipated over the arena around 4:36 pm.

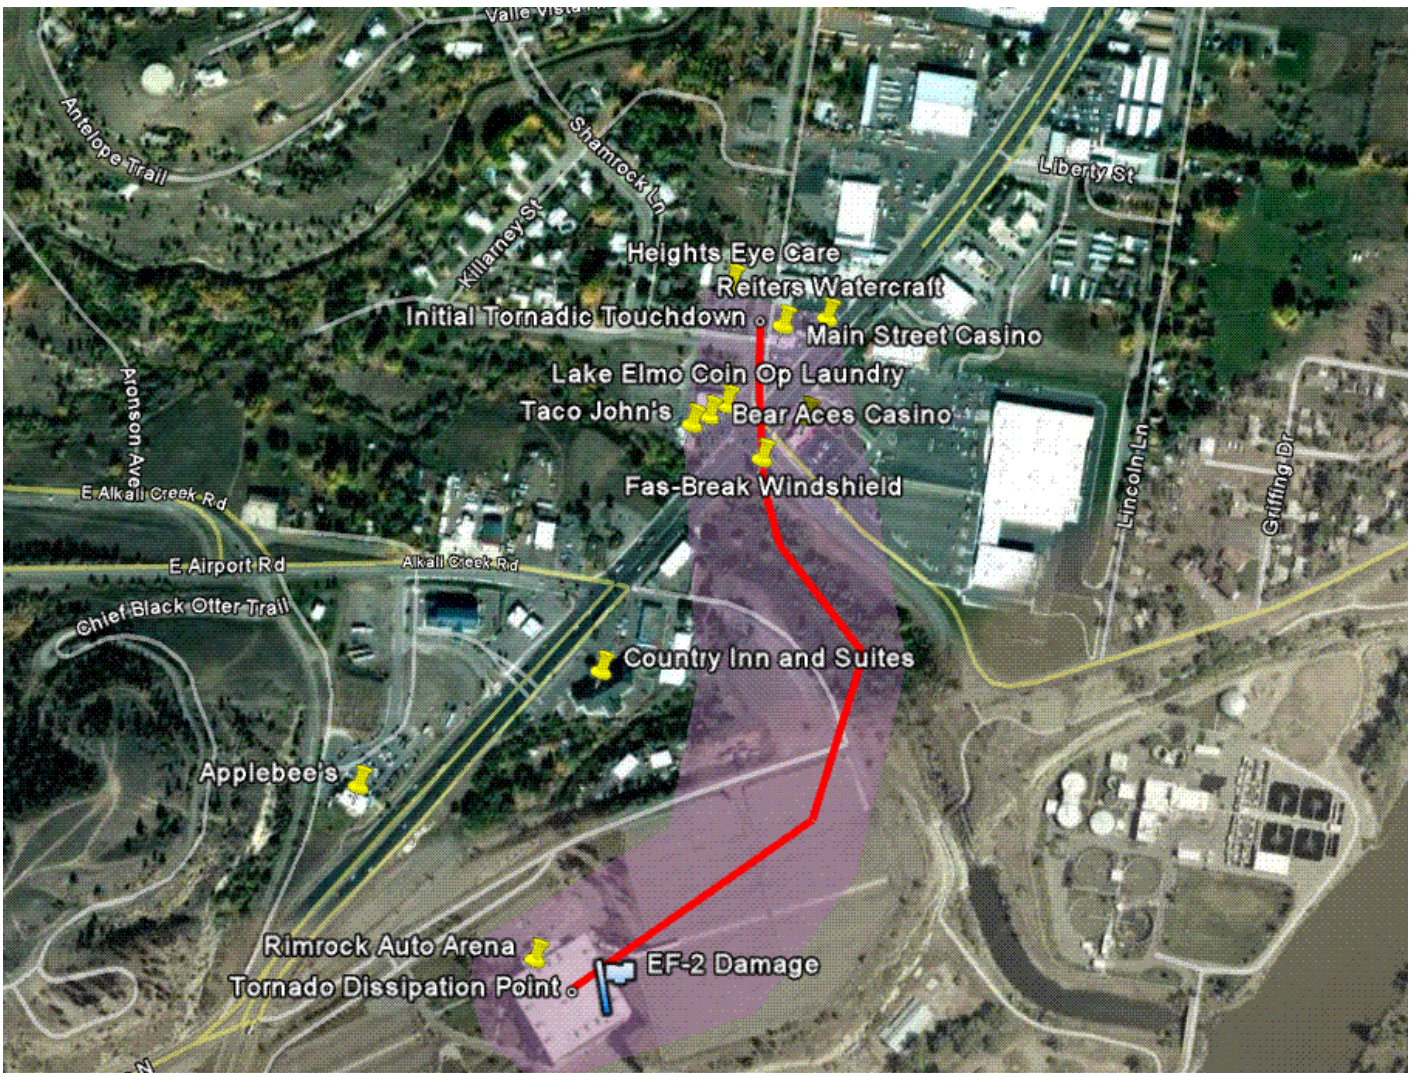
Figure 5: Damage Path

Based on the observed damage, the tornado is being classified as an EF-2 on the Enhanced Fujita Scale. Wind speeds within an EF-2 tornado range from 111-135 mph, and the associated damage observed at the Billings MetraPark and nearby businesses is consistent with this classification. The damage path was 120 yards wide with a length of about a half mile (Figure 5) and on the ground an estimated 12 minutes.

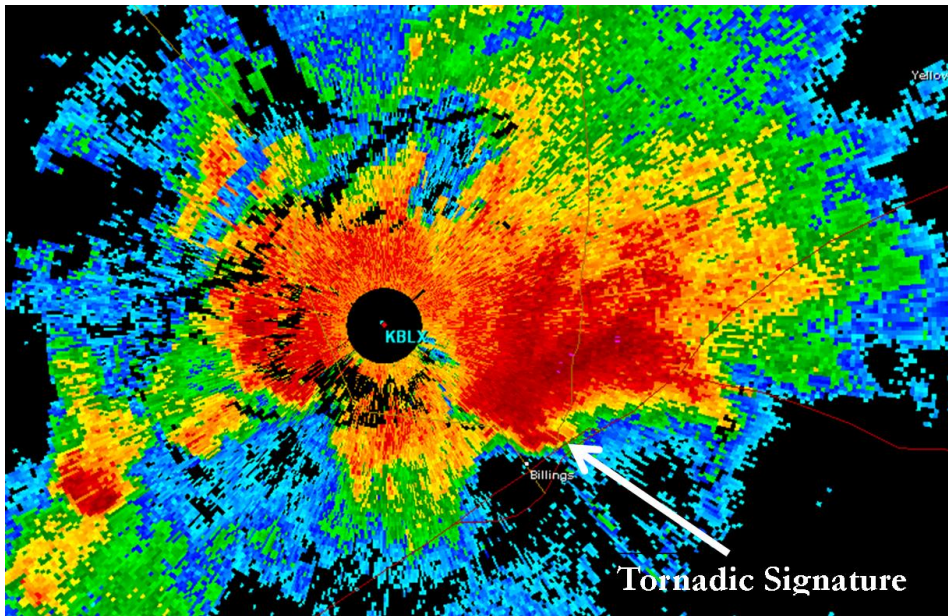
Figure 6: WSR-88D KBLX 0.5 ° Base Reflectivity Image valid Sunday June 20, 2010 at 4:29 pm

The tornadic producing supercell thunderstorm is shown in Figure 6 at 4:29 pm on 6/20/10. This particular storm formed to the southeast of the Billings Doppler Radar (KBLX). The structure of this storm displayed a very distinct hook echo with very strong inflow. Figure 7 shows the storm-relative velocity profile from the same time. As a reference, green colors represent winds flowing toward the radar and red colors represent winds flowing away from the radar. The area of circulation at this particular time was quite impressive.
