# Straight-line Wind Damage South-central Iowa May 17, 2004

NWS WFO Des Moines/Johnston

The National Weather Service in Des Moines Conducted a storm survey on wind damage in Mahaska, Wapello, and Monroe counties on May 18, 2004. The damage was produced by a microbursts in thunderstorms on the evening of May 17. A summary of damage at various sites follows along with representative photographs of the damage.

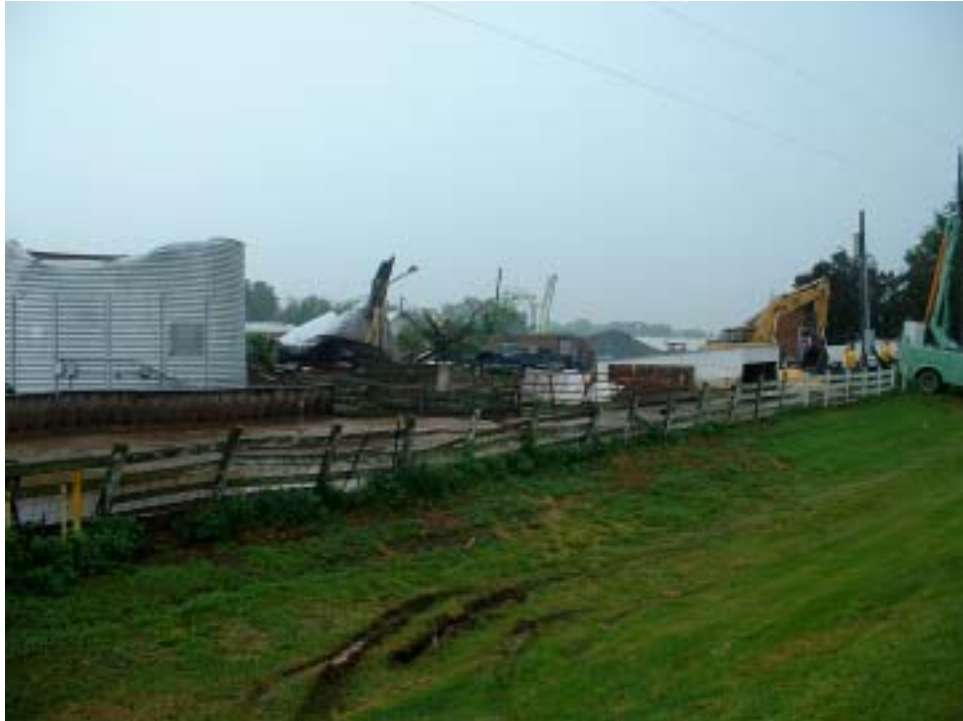
Outbuildings, looking northeast

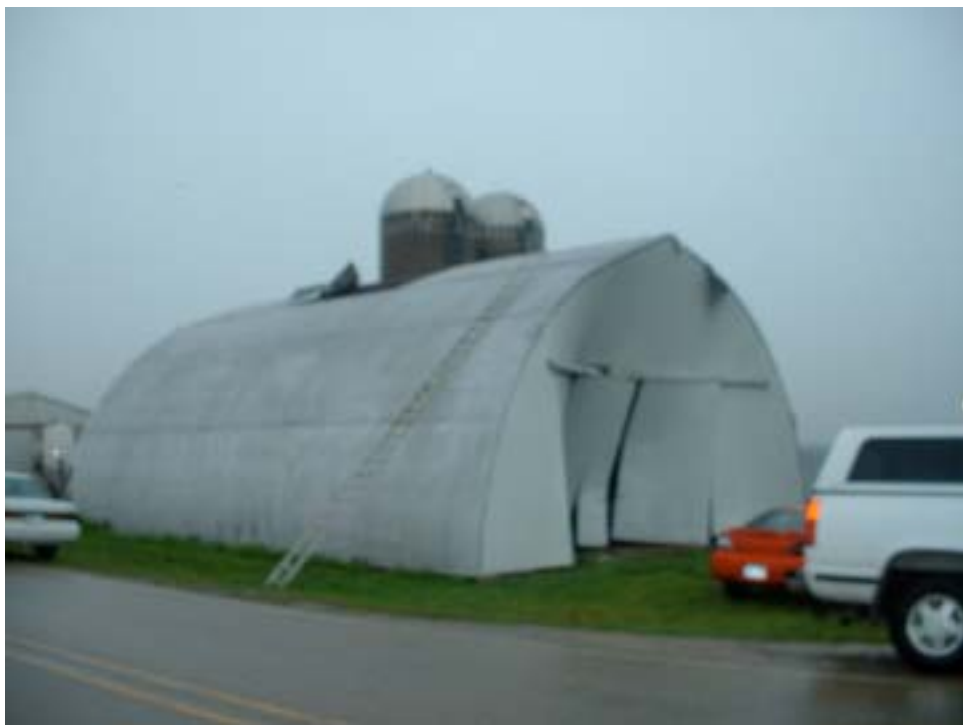
Barn on Wapello Co. side of road, looking south-southeast

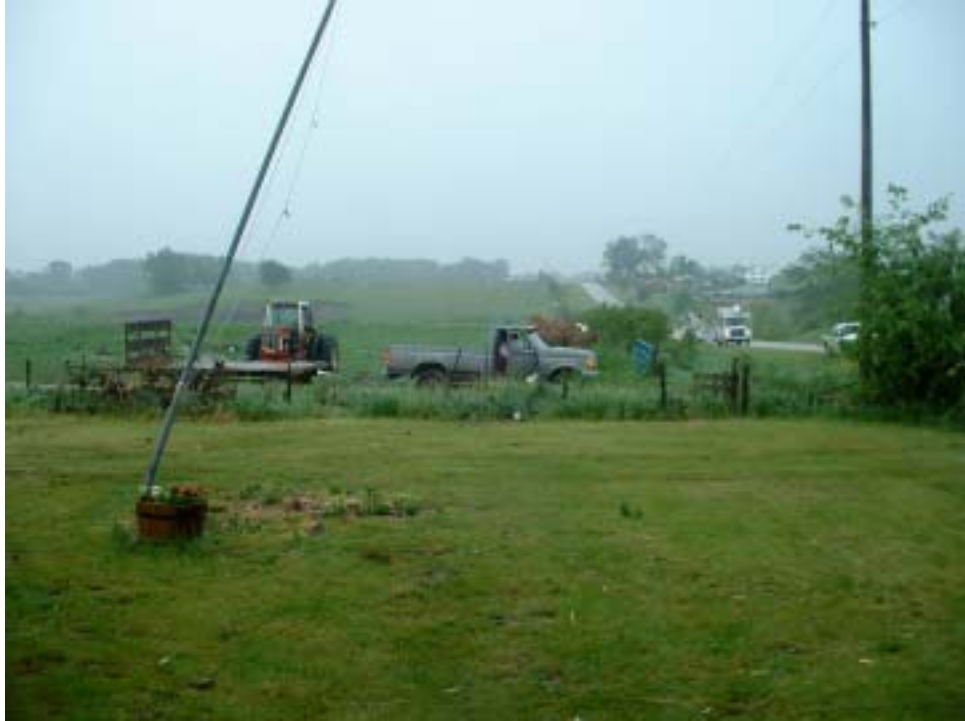
Pole leaning southeast

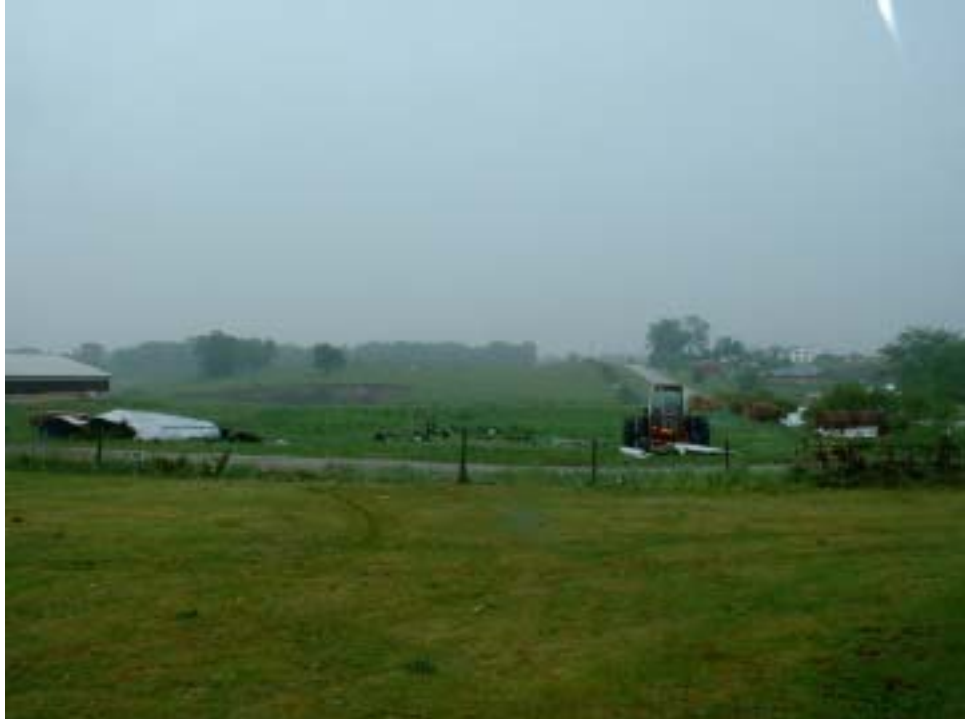
Looking east toward 2<sup>nd</sup> farmstead

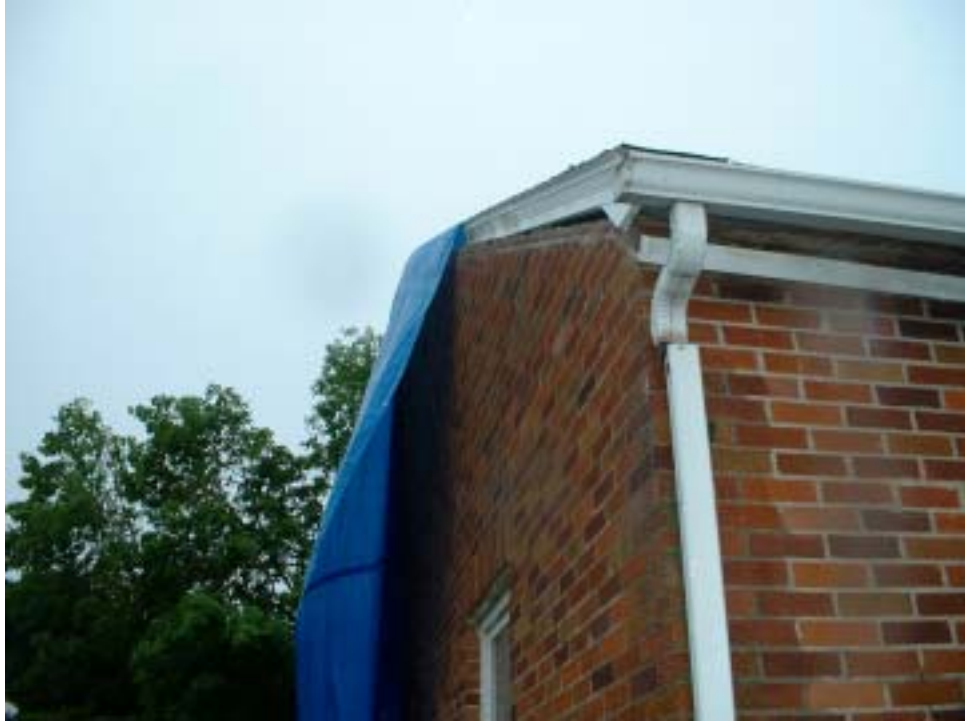
Roof of house displaced

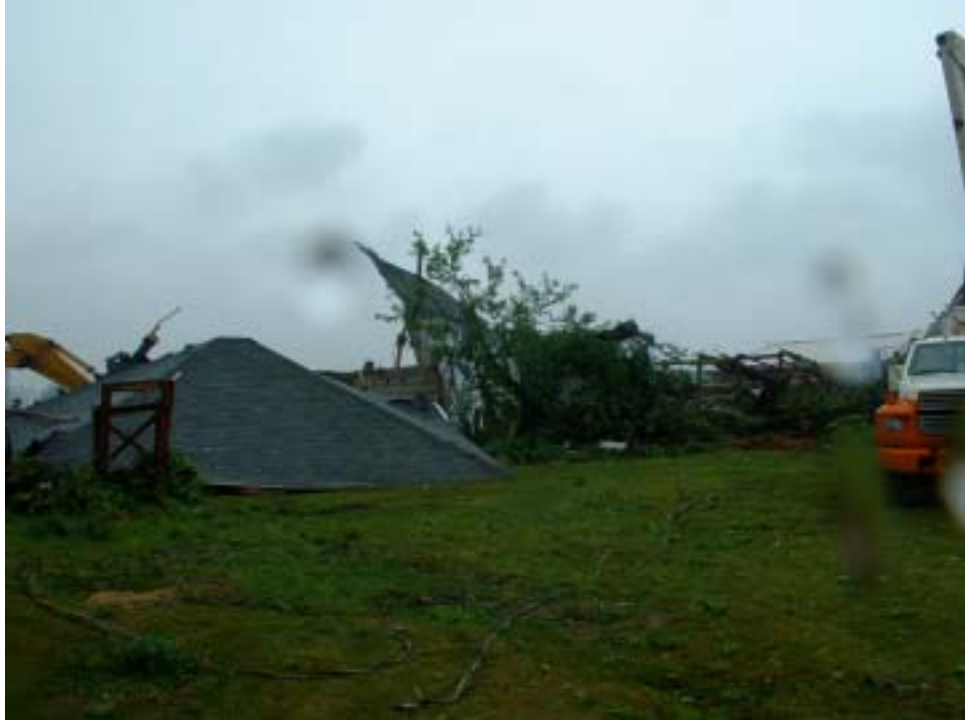
Looking west toward destroyed garage

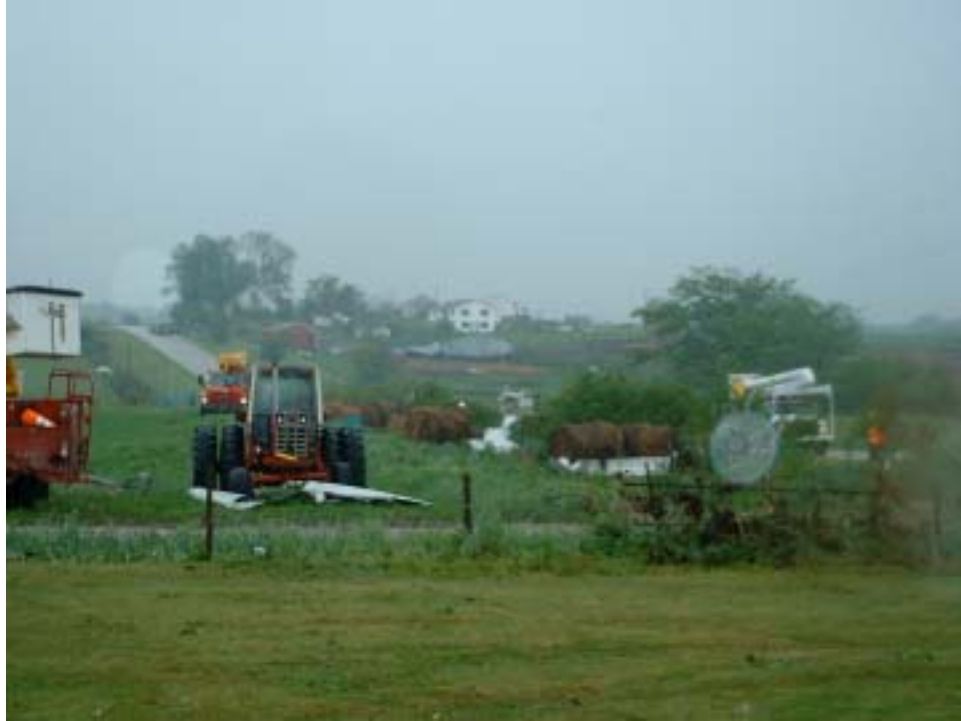
Looking east toward 2<sup>nd</sup> farmstead

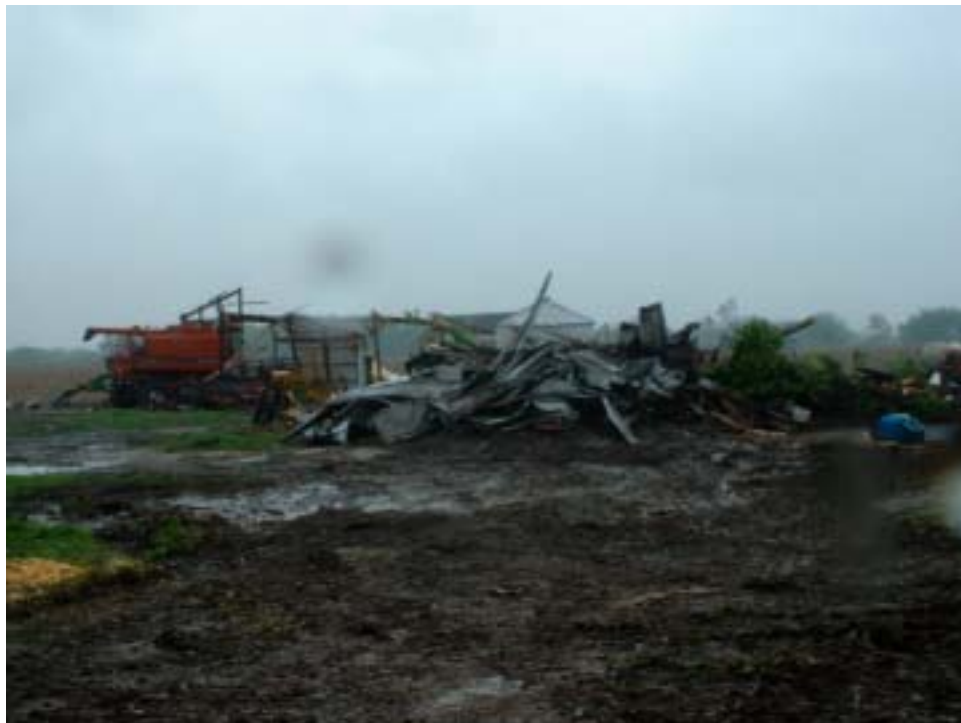
Looking west-northwest

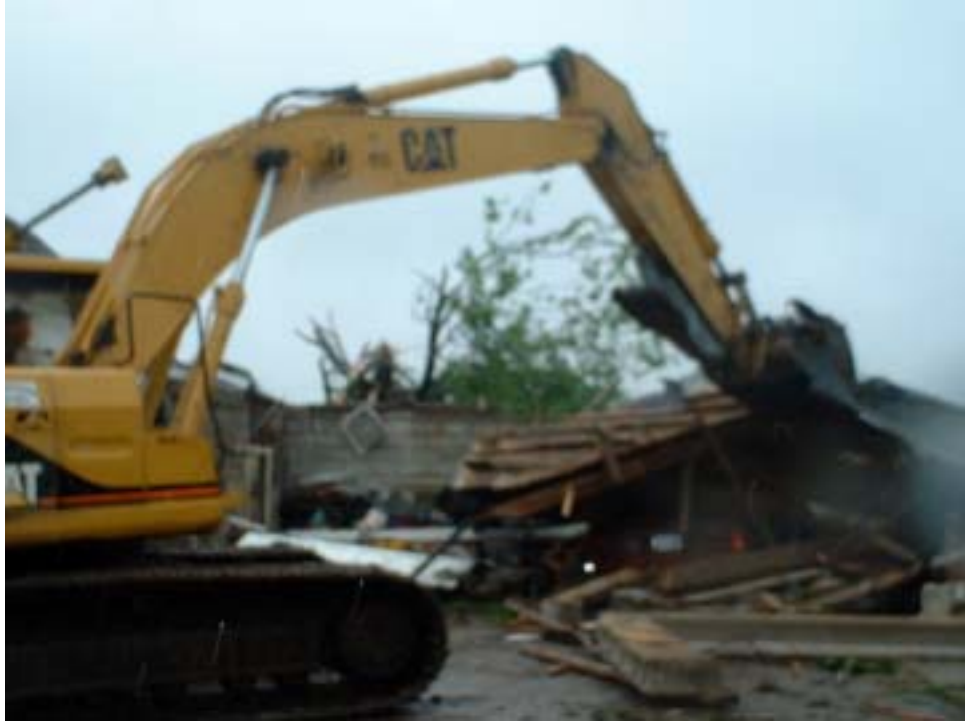
Looking north to destroyed garage

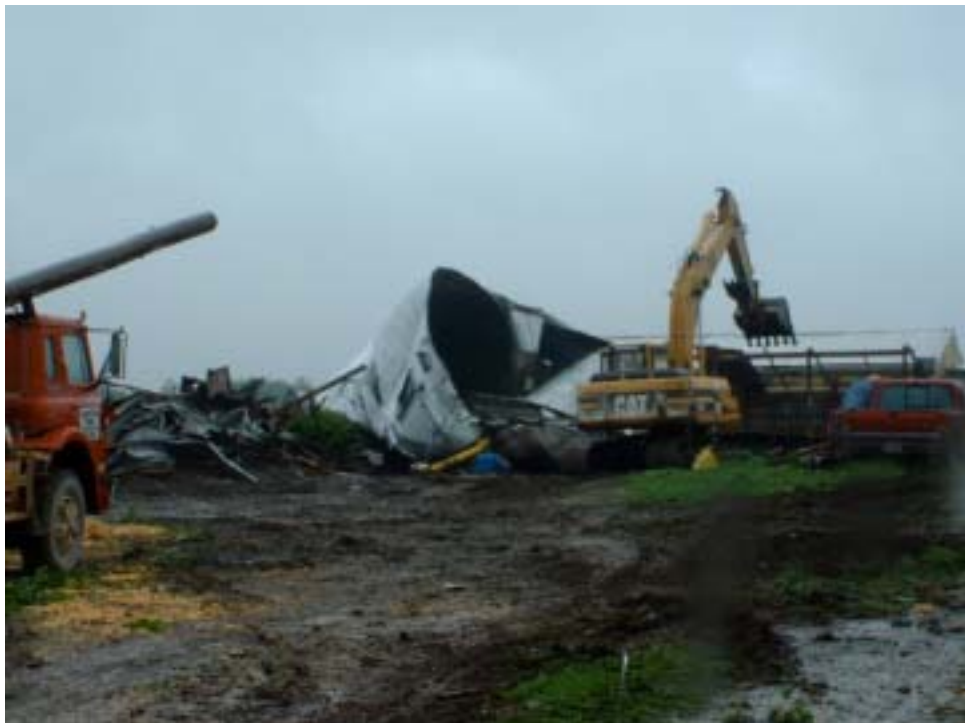
Looking north

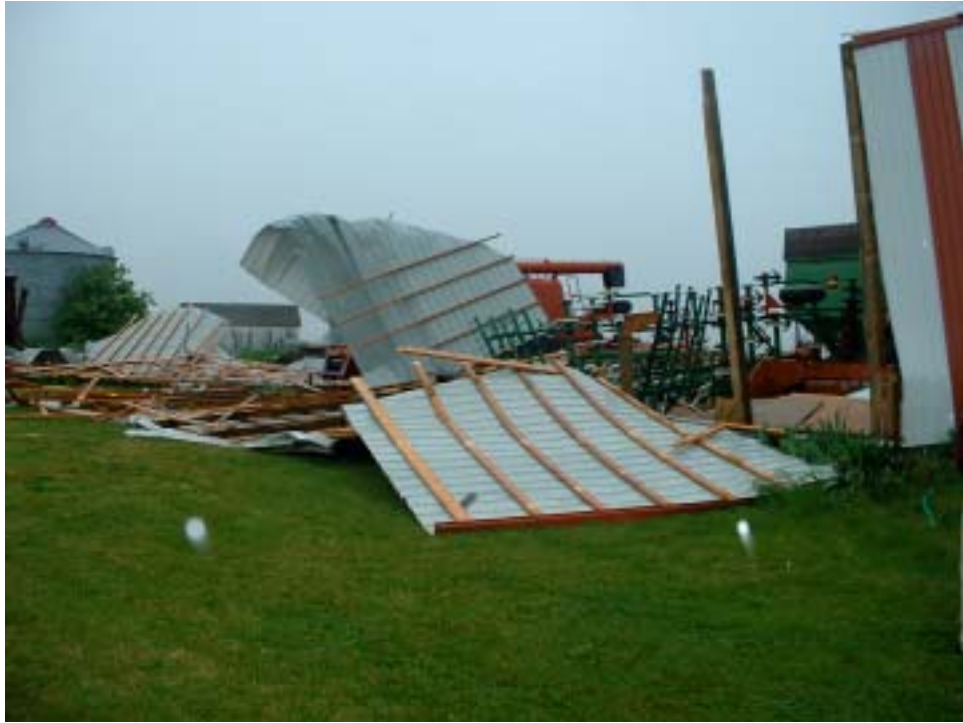
Southwest wind blew down outbuilding, looking southeast

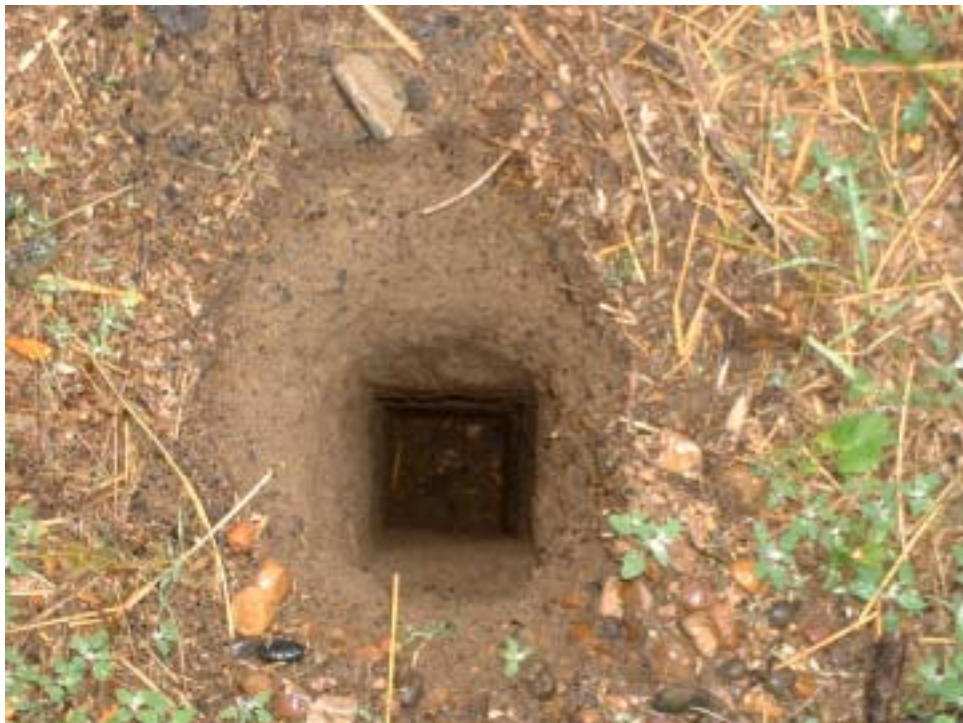
At the southern farmstead, two farm outbuildings were destroyed. Three poles rooted five feet into the ground were lifted complete out of the ground. The roof of a shed was peeled back.

Hole left over after pole was removed by wind

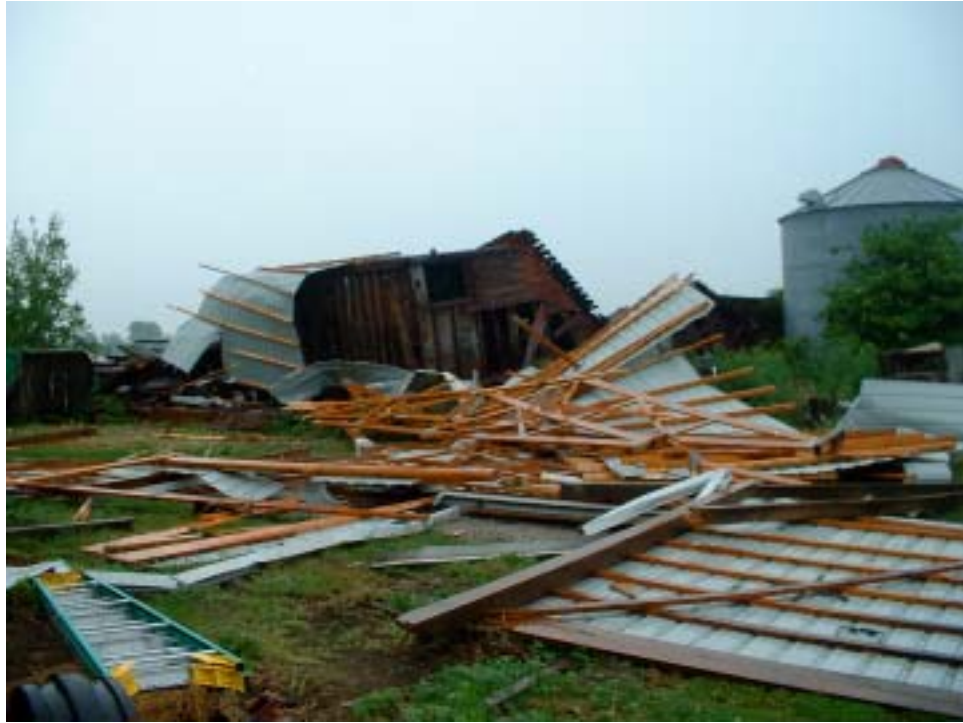
Barn remnants looking southeast

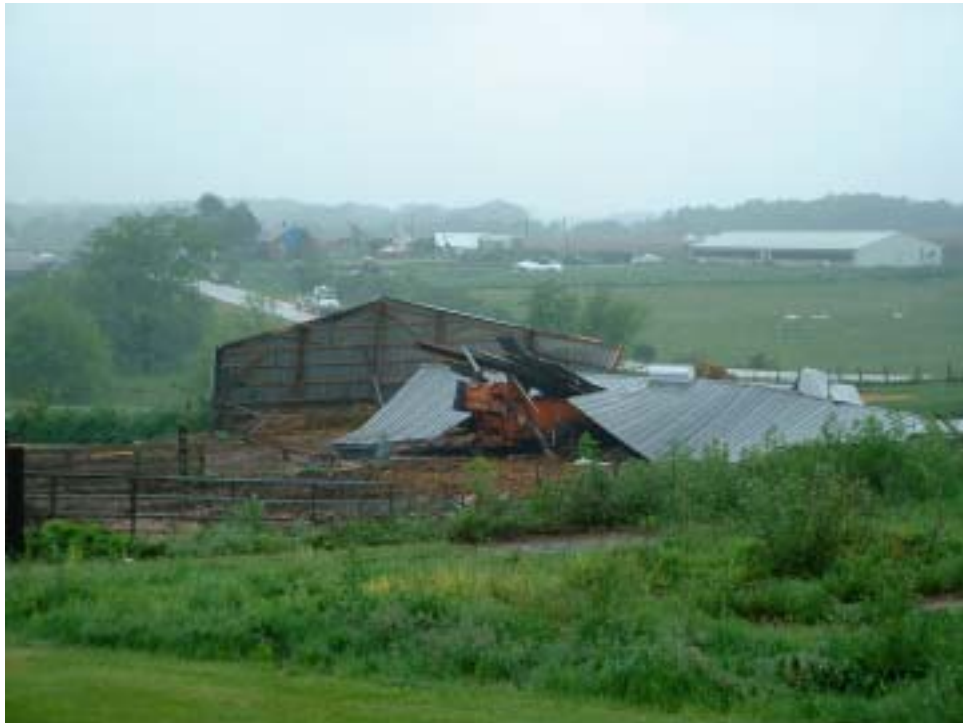
Looking from the Wapello Co. farmstead back to the northwest toward the Mahaska Co. farmstead

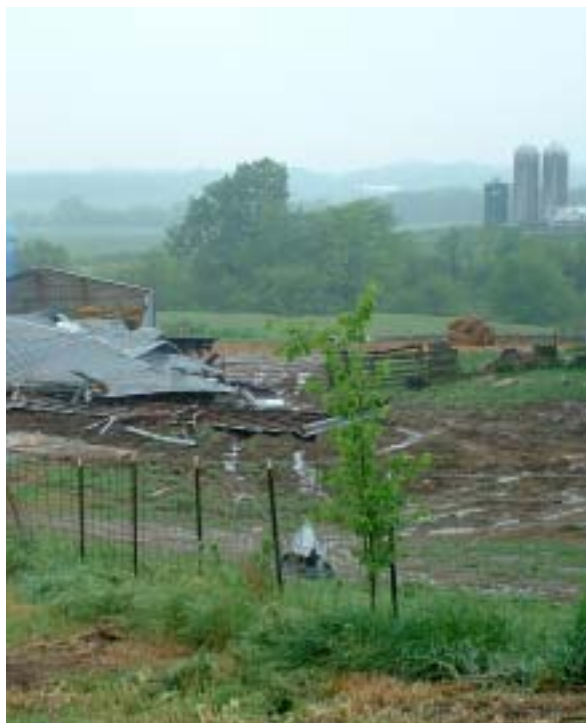
Destroyed barn between the two farmsteads
