# PARKERSBURG - NEW HARTFORD, IOWA EF-5 TORNADO

May 25, 2008

43 Mile Damage Track

National Weather Service - Des Moines, Iowa

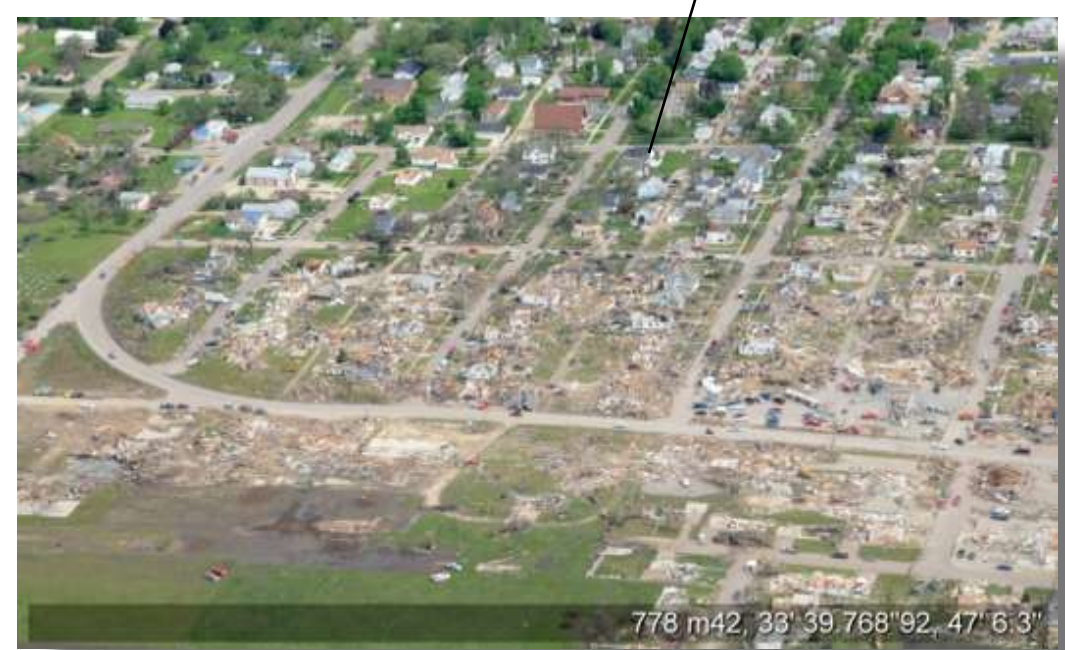
The most severe destruction in Parkersburg occurred south of the tornado core, which tracked directly over the First State Bank (left photo). Several fatalities occurred in the neighborhood of the center photo, as floors were swept away exposing basements. Mature trees were reduced to debarked stubs. The high school (right photo, Getty Images) received EF2-3 damage.

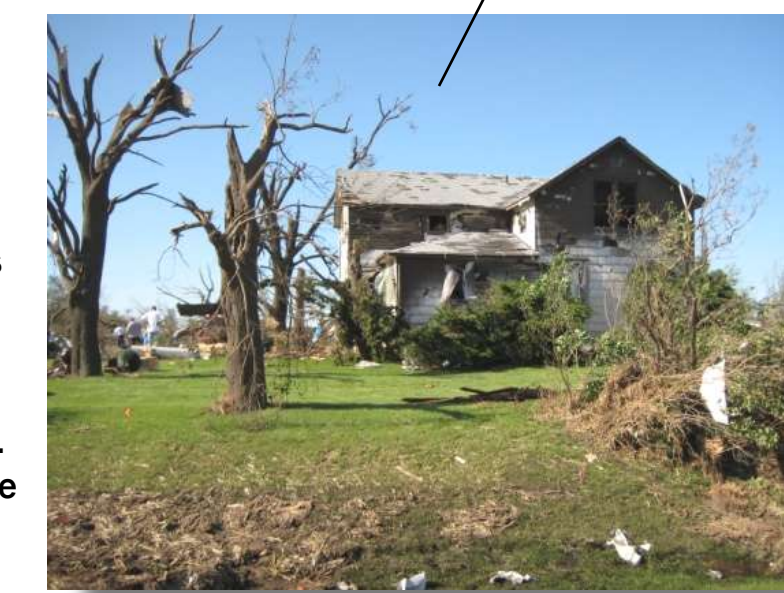
Damage on Adams Rd between Dunkerton and Fairbank was high-end EF2. The house at the farm on the left had several walls down. Photo from John McLaughlin, IowaHelicopter.com

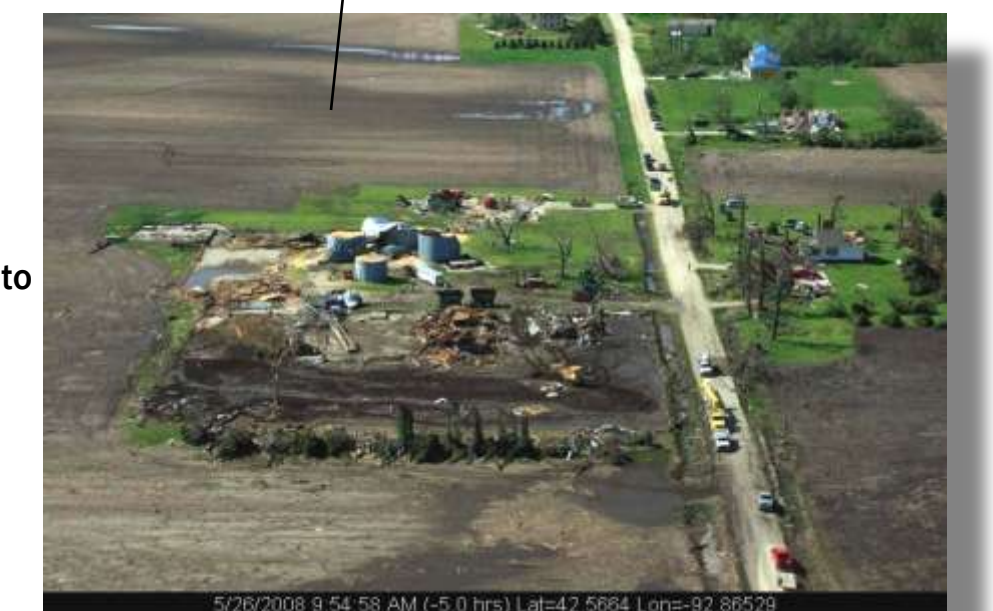
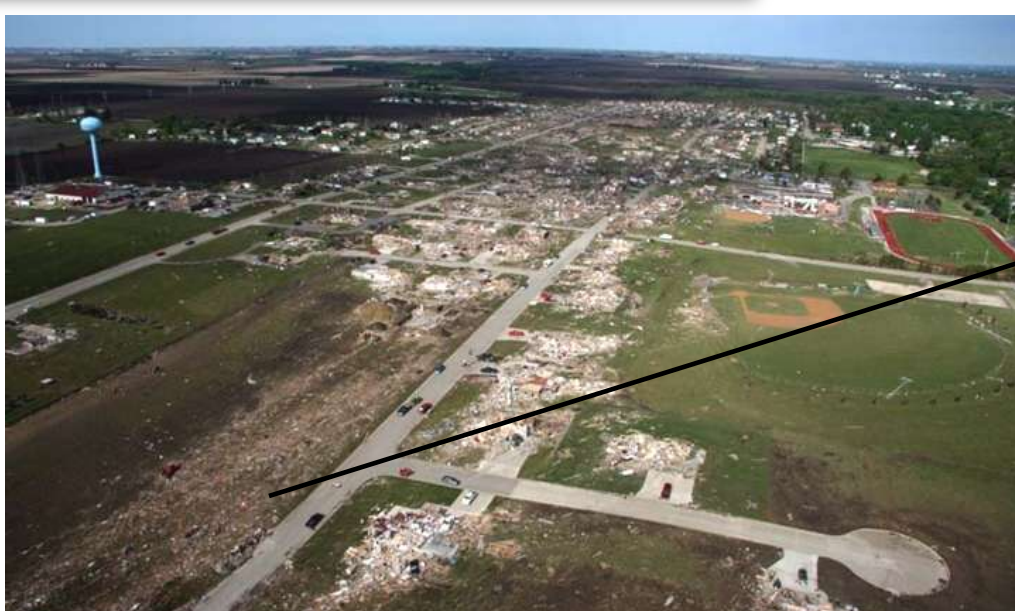
Aerial photos from the Civil Air Patrol and IowaHelicopter.com show the path of the destruction through south and east Parkersburg. Damage was EF4-5 at the core of the track.

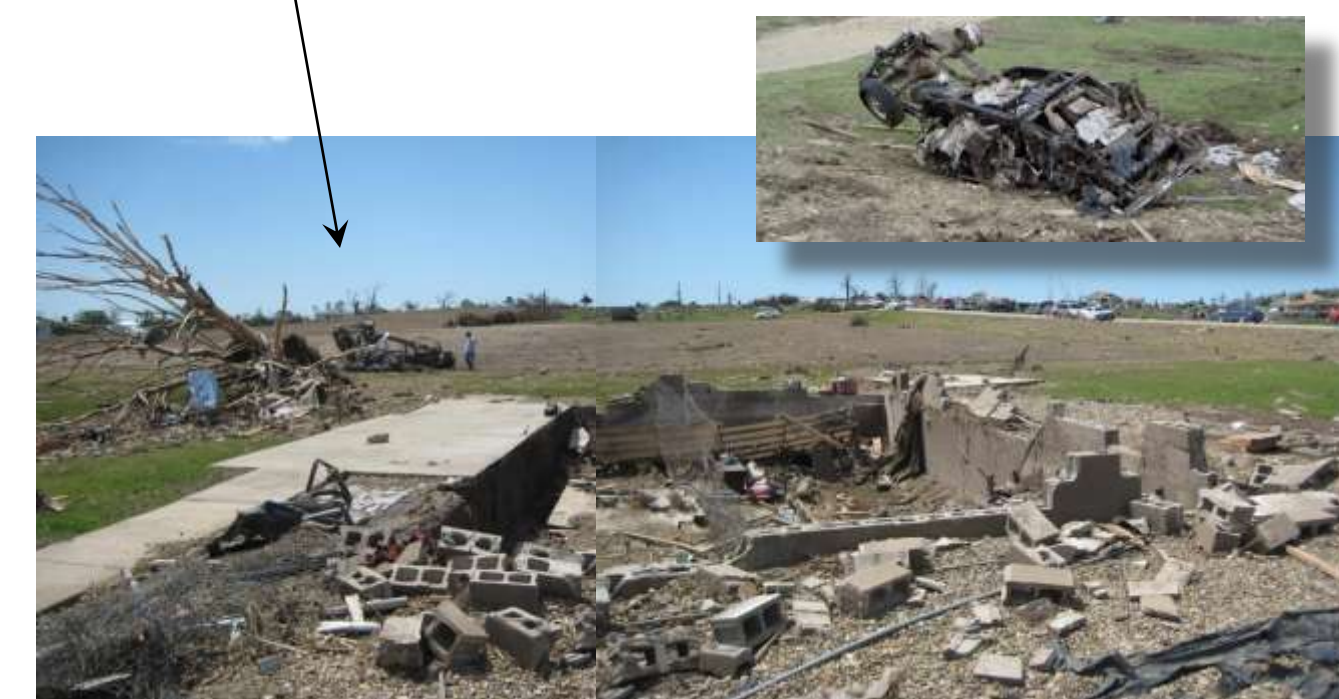
North of New Hartford, a woman was killed as her home was swept away. Only vehicle frames and tree trunks remained. Even the basement was cleared. The tornado was rated EF-5 at this location. The New Hartford cemetery is in the background. NWS survey photos.

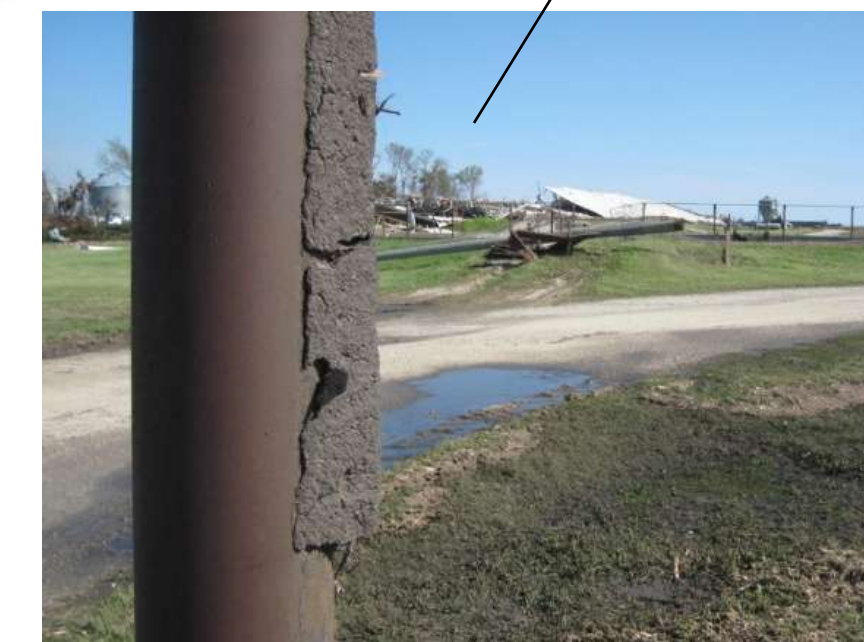
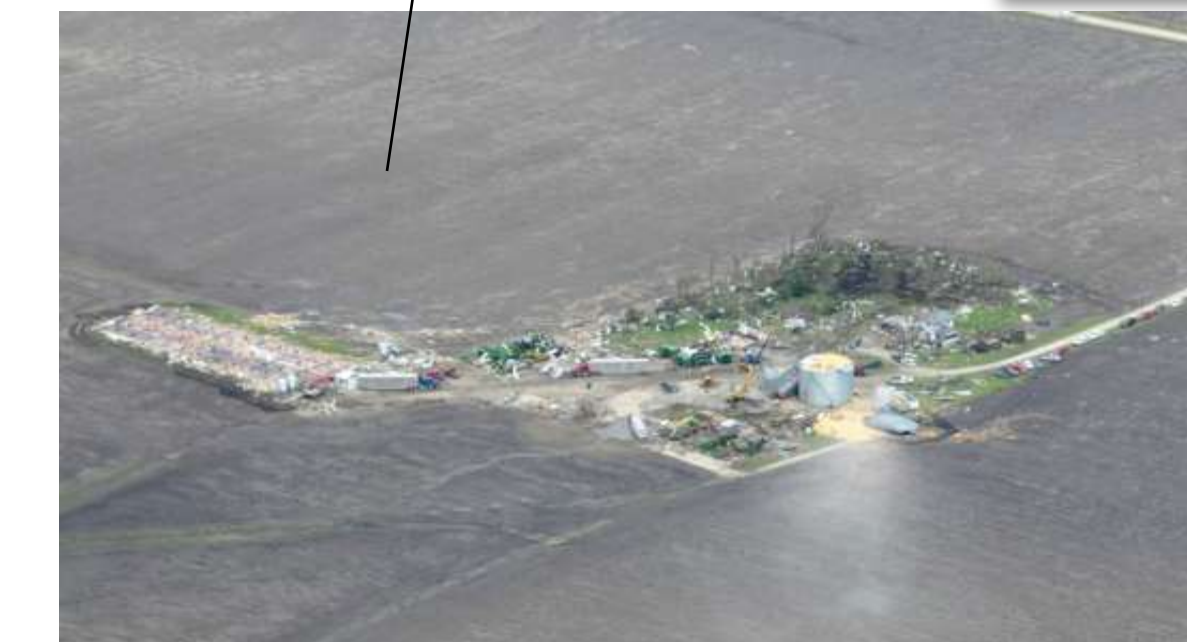
Damage on Lester Rd northwest of Dunkerton approached EF3 at several farm sites. Many hog confinement buildings were flattened. Here, hogs can still be seen in the building with some being loaded onto trucks. Civil Air Patrol photo.
