## Survey Completed in Pocahontas County

...FINAL DAMAGE SURVEY RESULTS FOR POCAHONTAS COUNTY...

...EF1 TORNADO IN POCAHONTAS...

THE FOLLOWING IS A FINAL ASSESSMENT FOR THE DAMAGE THAT OCCURRED OVER POCAHONTAS COUNTY ON JULY 22, 2010.

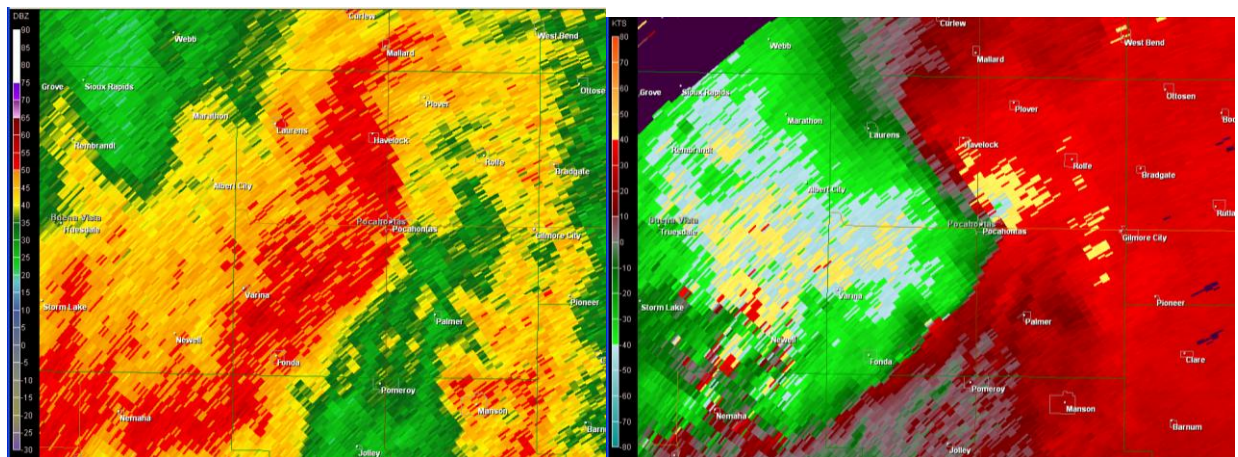
Figure 2. The left image shows the KDMX 0.5 degree radar reflectivity at 241 am CDT on July 22, 2010 with a definitive bow structure moving over Pocahontas. The right image shows the corresponding KDMX 0.5 degree storm relative motion velocity indicating a strong circulation just passing over Pocahontas several thousand feet above the ground.

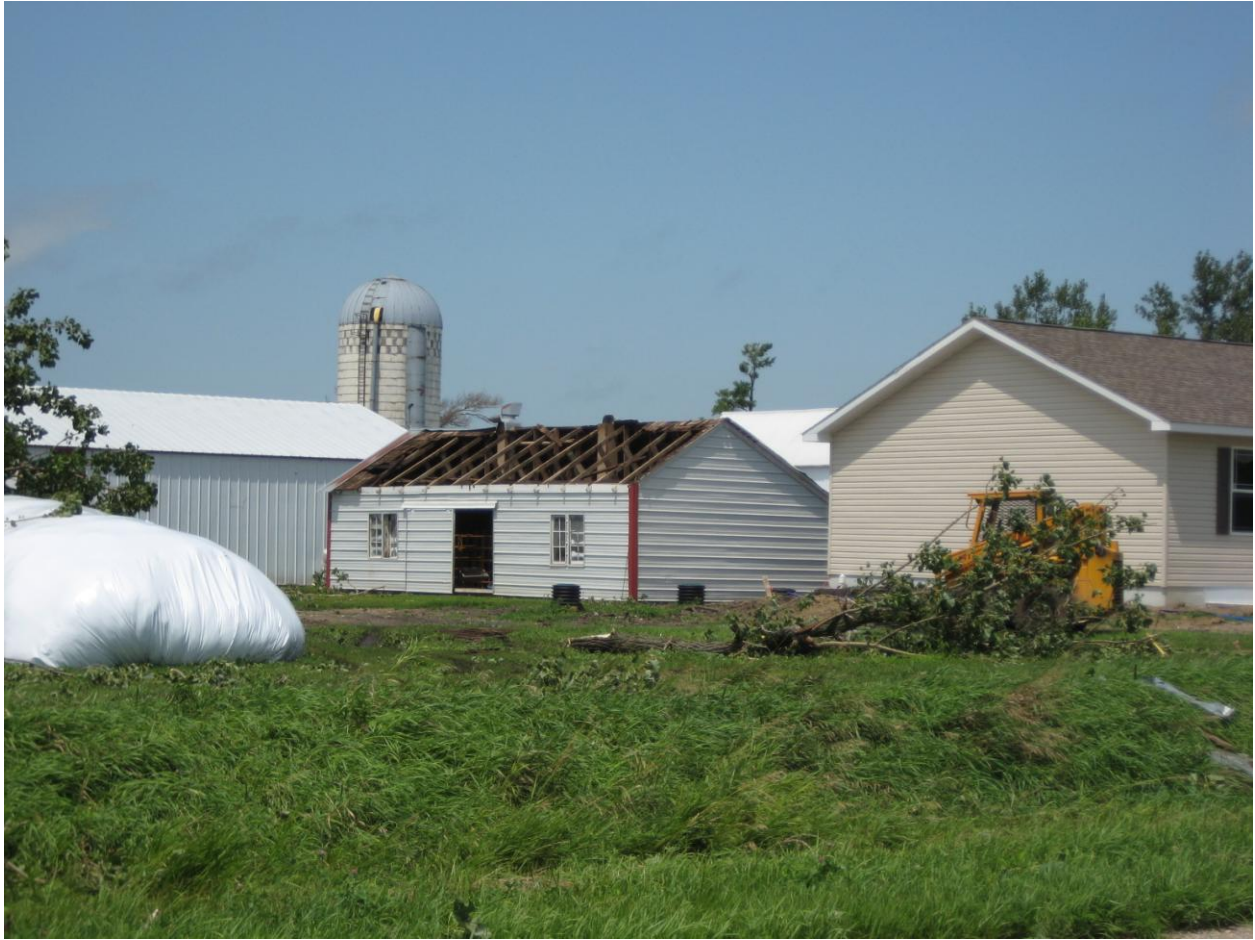
Figure 3. A building with roof damage near on the south end of Pocahontas.

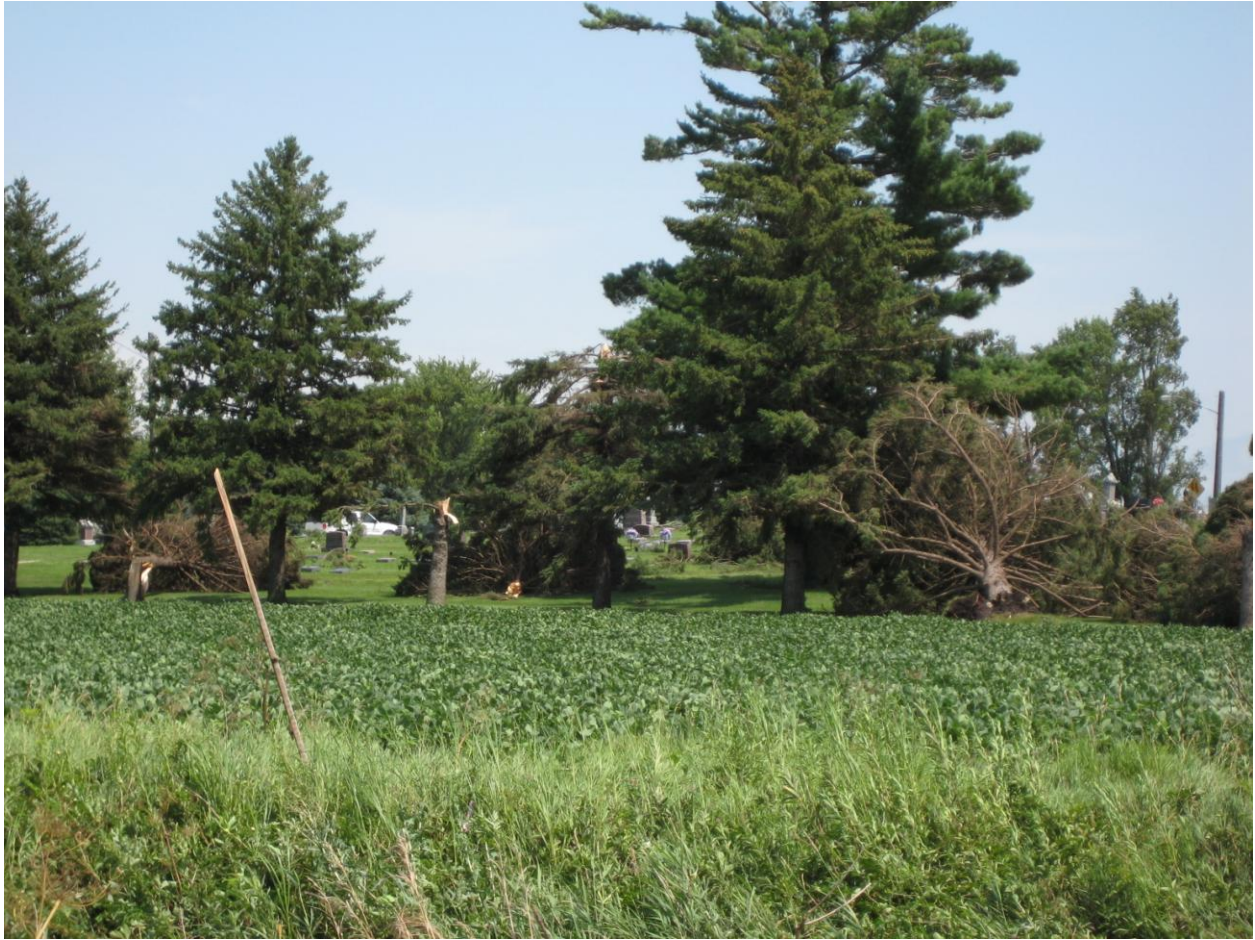
Figure 5. Large trees snapped off near cemetery in southeast Pocahontas.

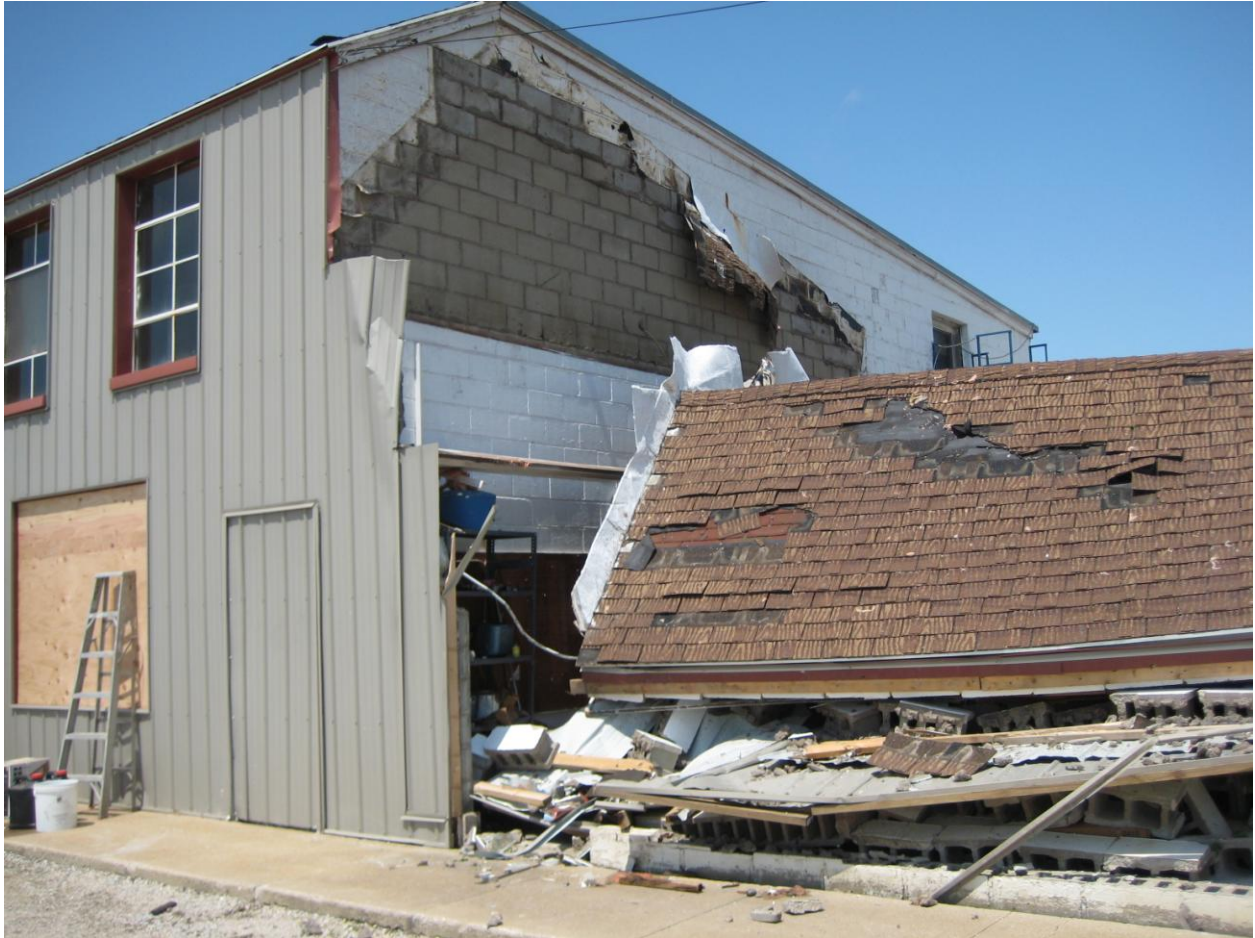
Figure 7. The cinder block wall of this building collapsed and the roof was torn off the side of the parent building in eastern Pocahontas.
