National Weather Service Des Moines

May 11, 2014 Storm Survey for Guthrie, Dallas, and Boone Counties

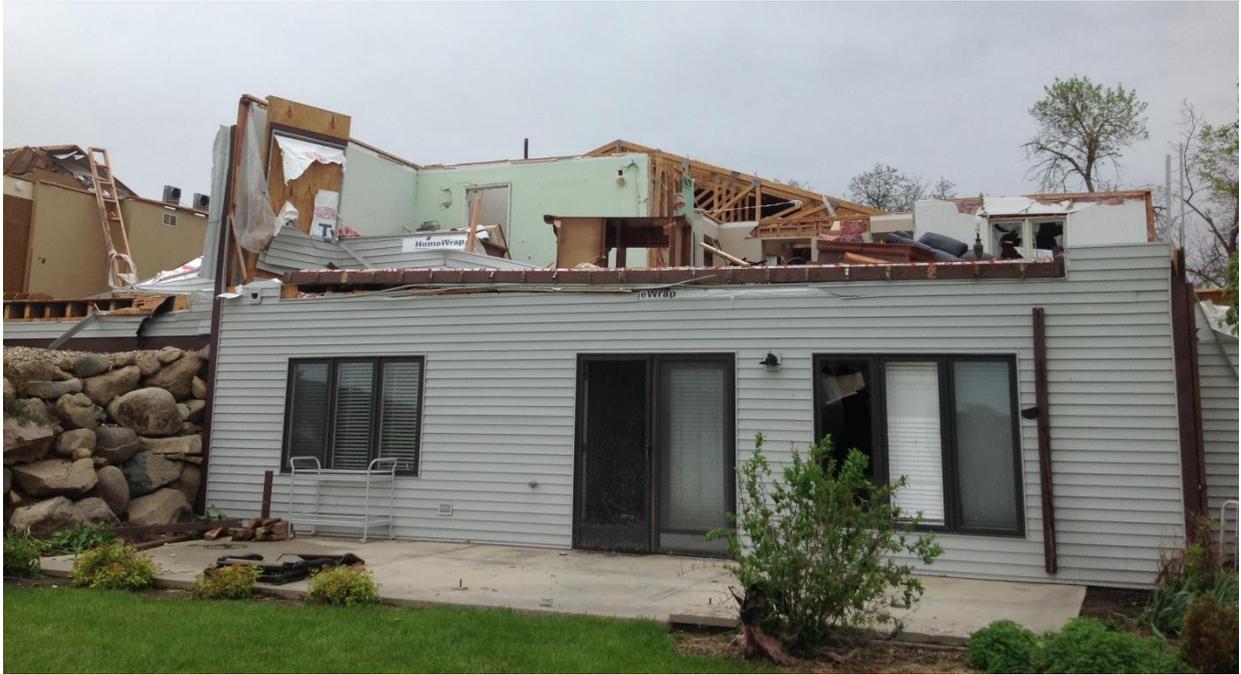
A row of condos on the east side of Lake Panorama had their roofs and second story walls removed. The tornado was rated at a low end EF-2 at this location.

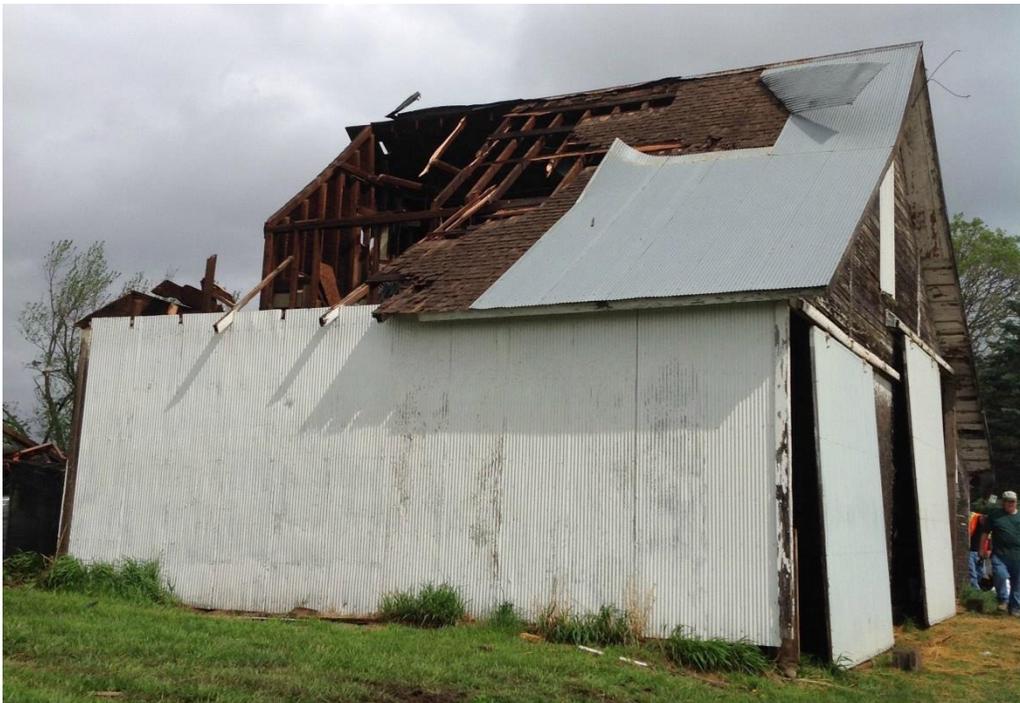
A partially destroyed barn early on in the track of the tornado south of Guthrie Center.

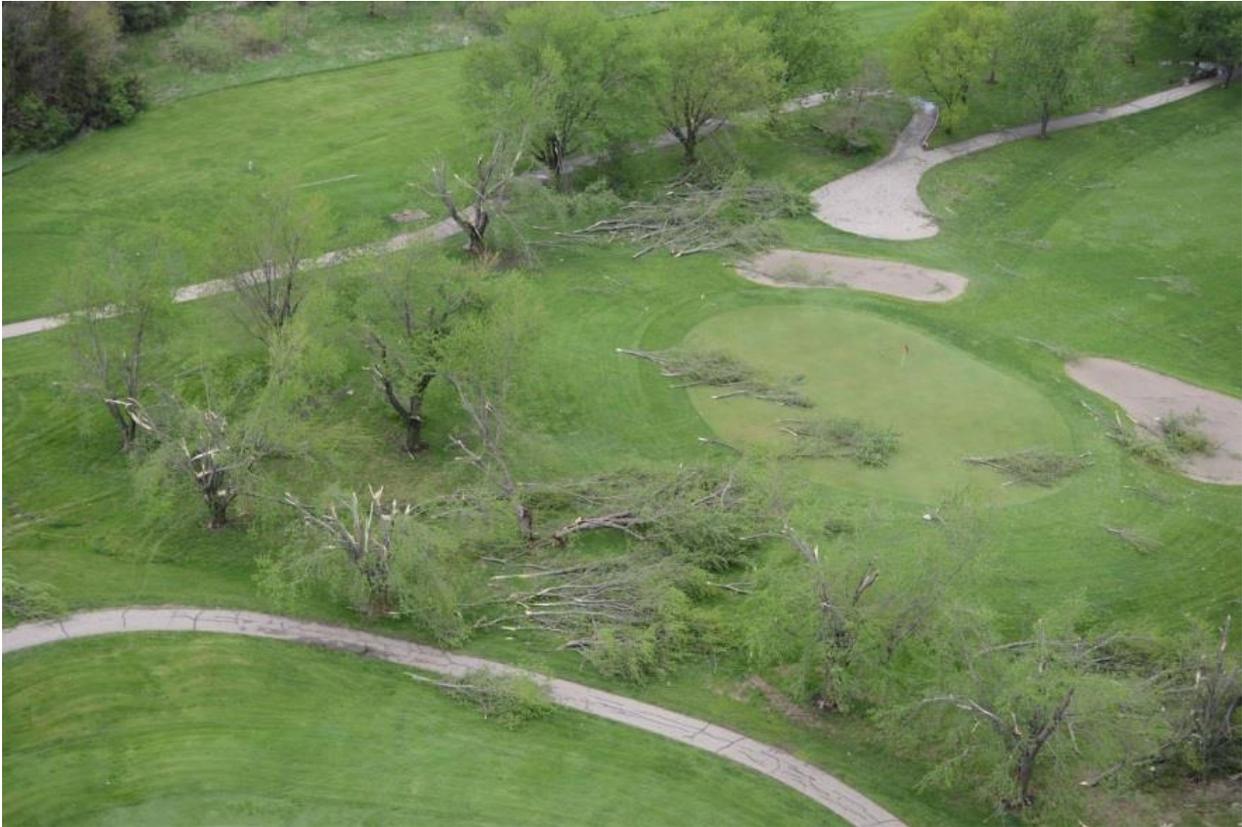
Trees downed at the Lake Panorama National Golf Course. Photo Courtesy of John McLaughlin, Iowa Helicopter. Used with Permission.

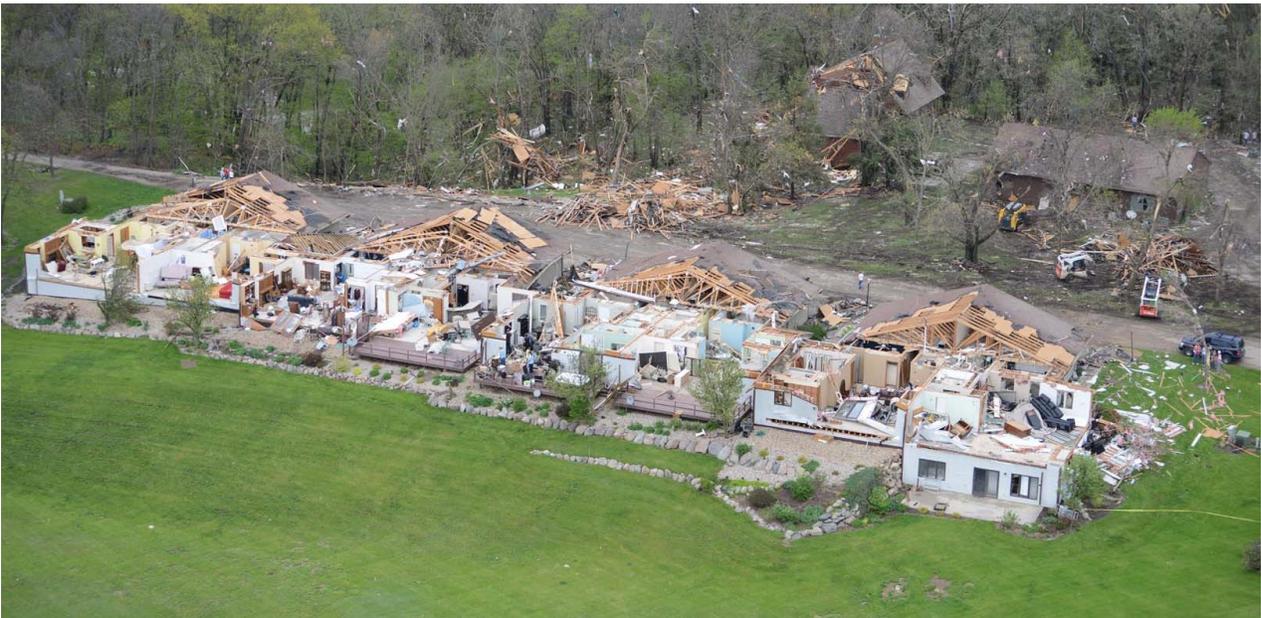
Aerial photo of the EF-2 damage to the condos. Photo Courtesy of John McLaughlin, Iowa Helicopter. Used with Permission.

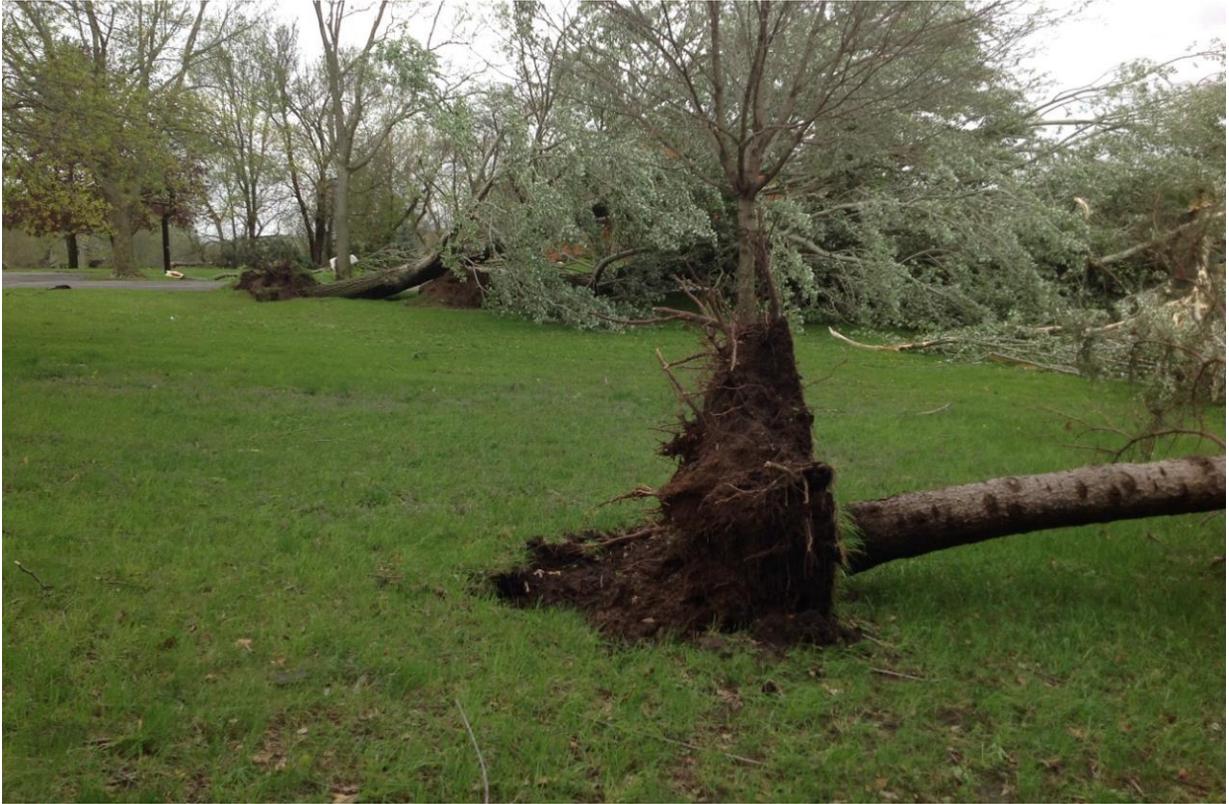
Many trees were uprooted along the tornado's path.

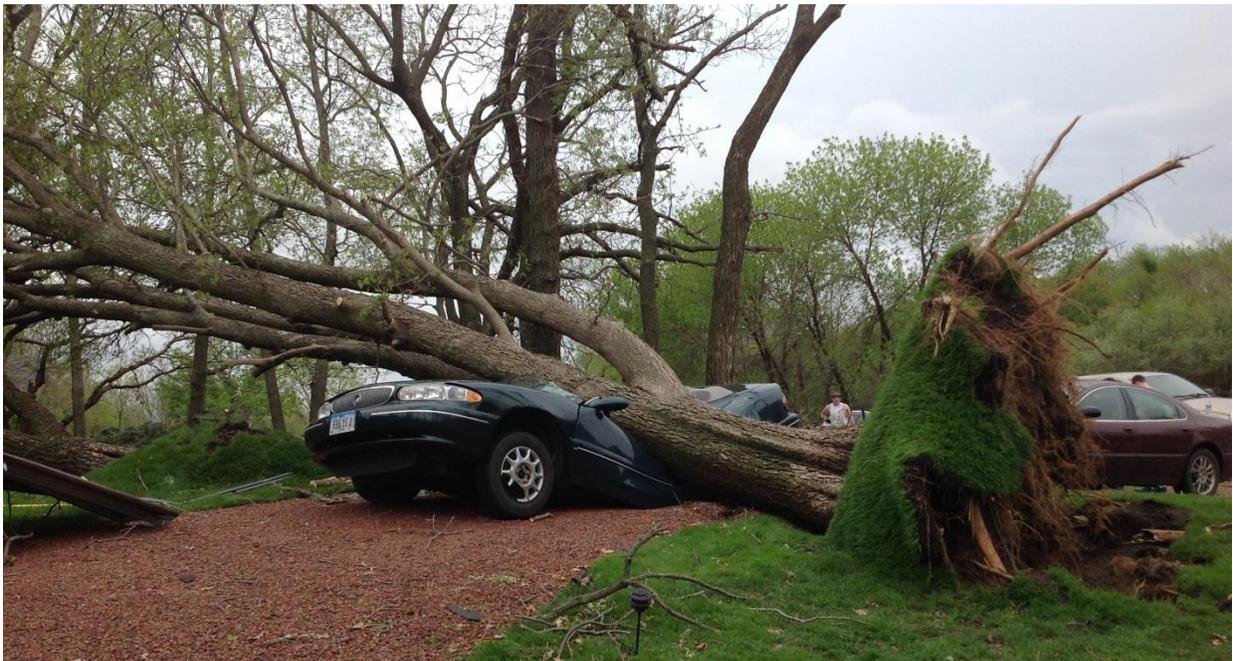
A falling tree crushed a car in a driveway.

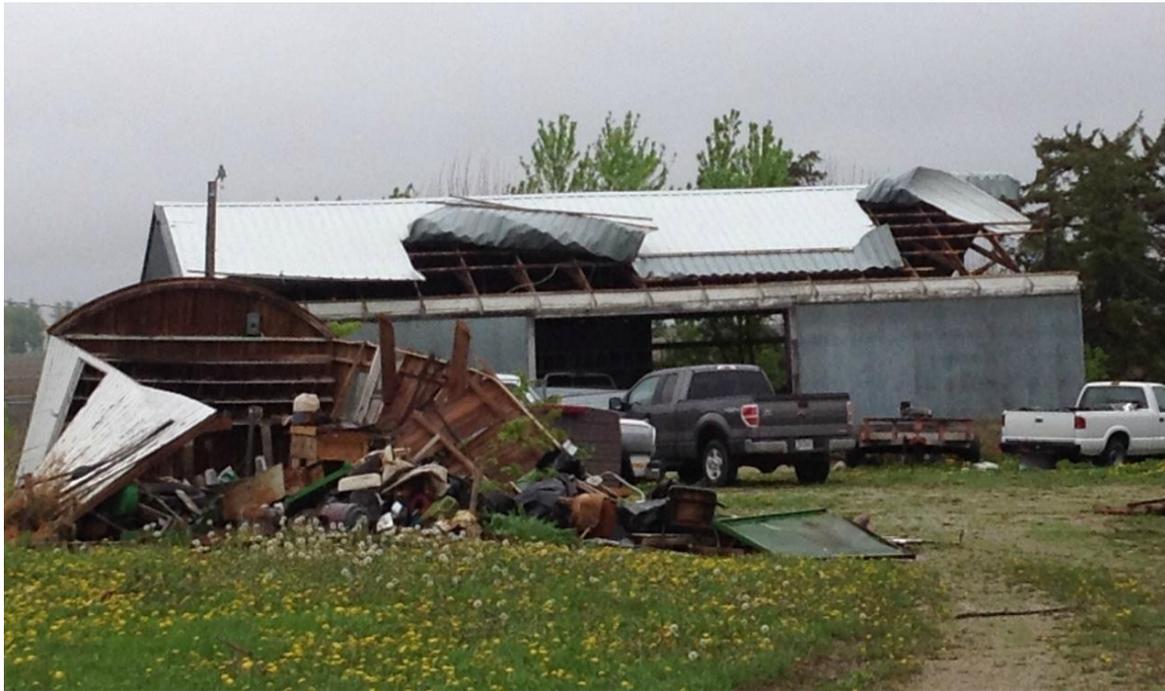
Farm buildings damaged by the tornado.

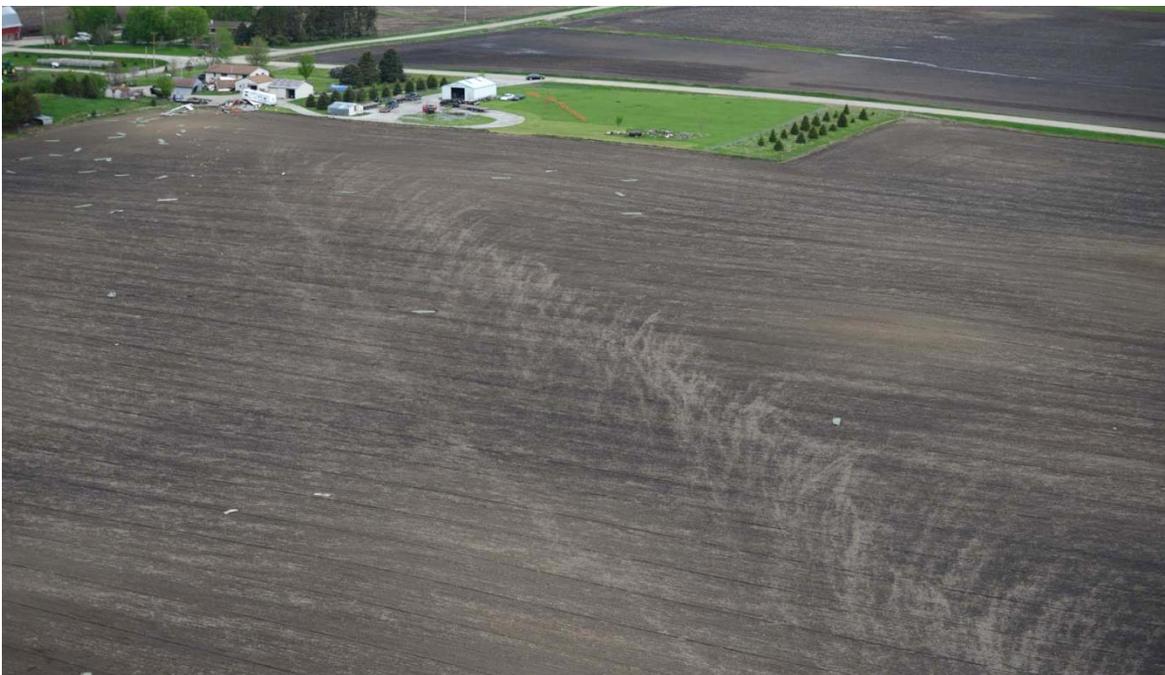
Scouring of the field northeast of Dallas Center denotes the track of the tornado. Photo Courtesy of John McLaughlin, Iowa Helicopter. Used with Permission.

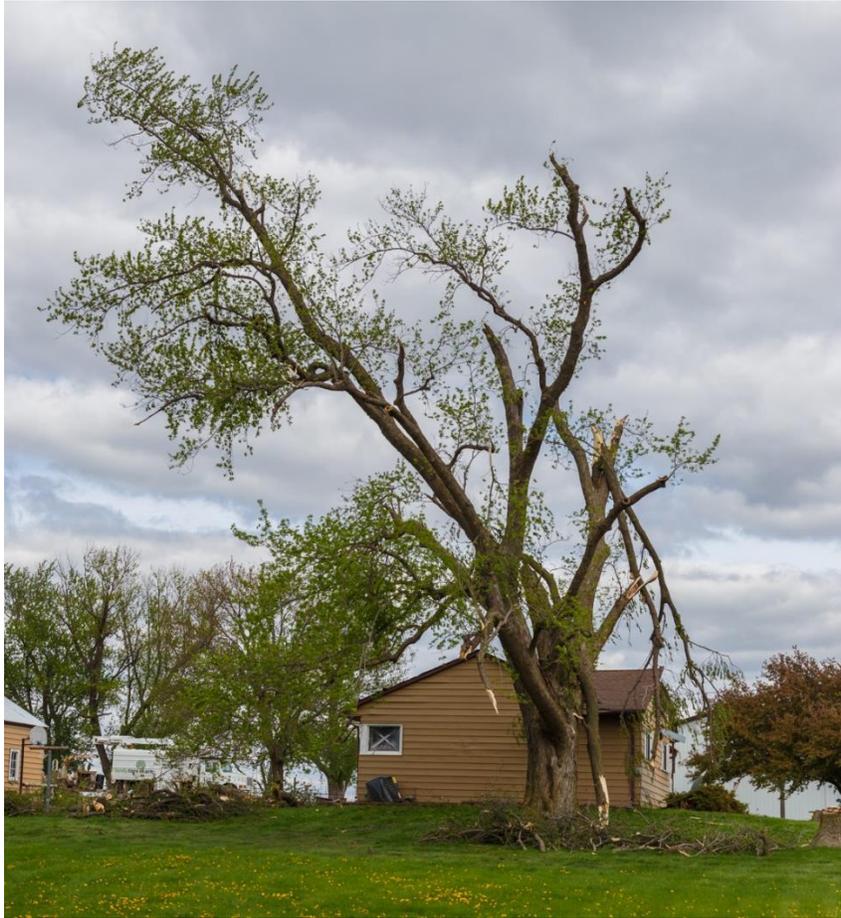
Tree damage at the farmstead from the tornado.

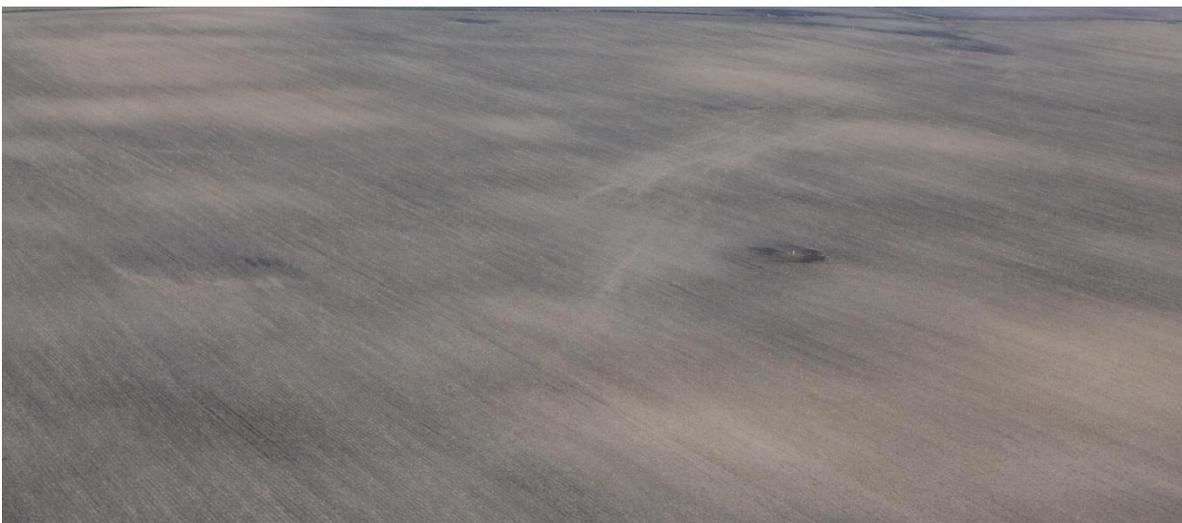
Scouring of the field denotes the track of the tornado. Photo Courtesy of John McLaughlin, Iowa Helicopter. Used with Permission.
