NWS Damage Survey

Cloudcroft Wind Event (March 13, 2019)

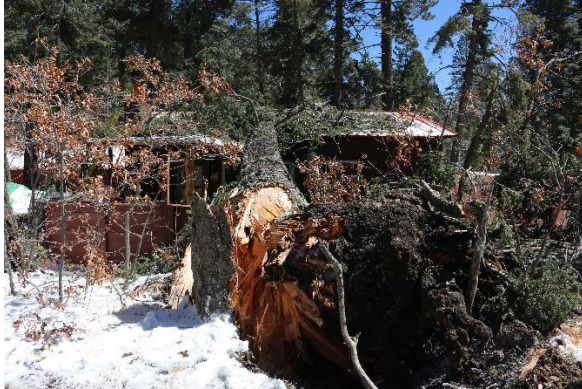
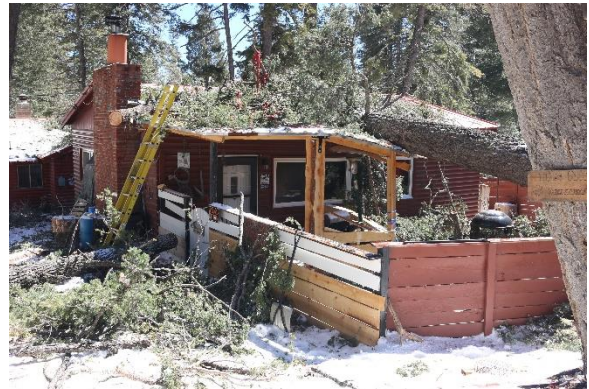
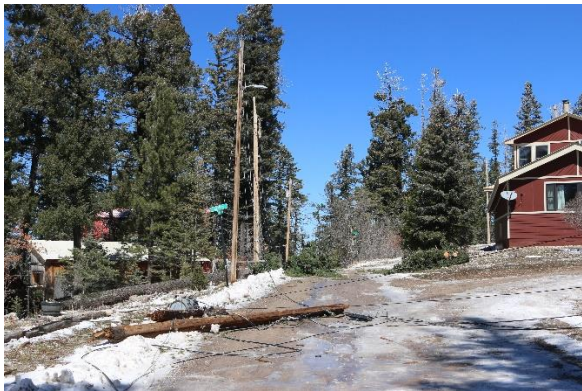
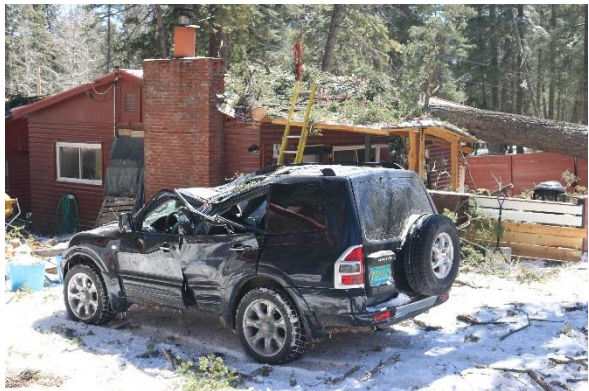
Location 1: Damage Images

Estimated Max Wind Speed: 107 MPH

A total of three large trees fell on this property. The largest measured approximately 4 feet in diameter at its base. The estimated wind gust of 107 MPH snapped this tree completely at its base, with the tree falling onto the home. Shortly thereafter another large tree across the street was uprooted and also fell into the home. Finally, a third tree in the yard next door was uprooted and fell on a car parked next to the home. In addition, several power lines came down as a nearby utility pole was also snapped (likely by a falling tree).

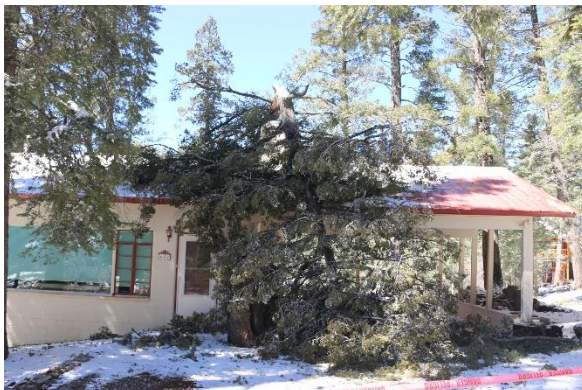
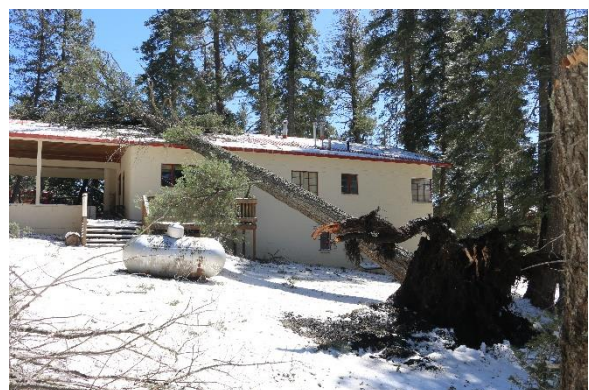
Location 2: Damage Images

Estimated Max Wind Speed: 90 MPH

A nearly 100' tall ponderosa pine with a trunk measuring a little more than 2 feet in diameter was uprooted in the back yard of this home, falling directly on the roof. Upon impact, the trunk of the tree snapped in half with the top portion of the tree landing in the front yard.

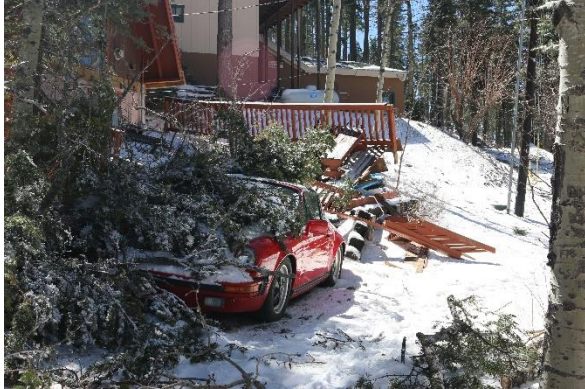
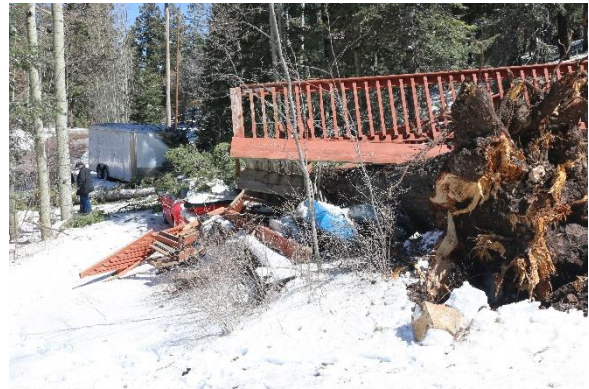
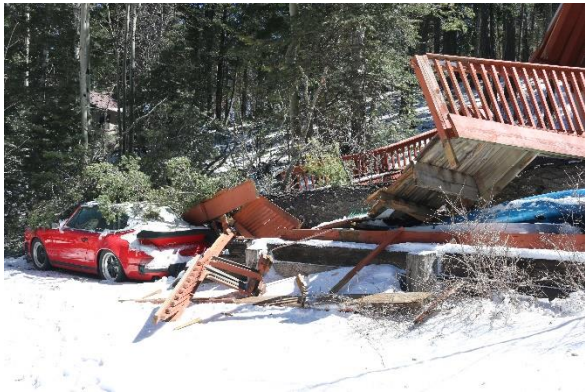
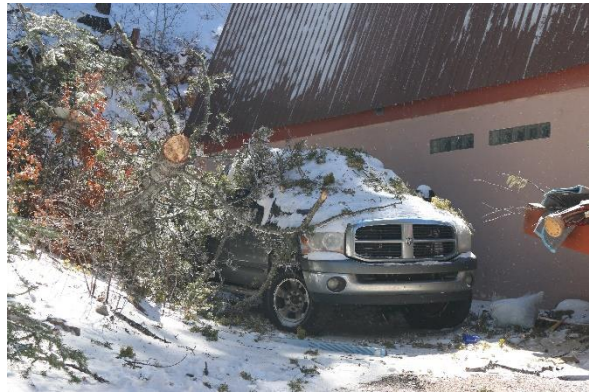
Location 3: Damage Images

Estimated Max Wind Speed: 94 MPH

Two separate trees came crashing down on this residence in southern parts of Cloudcroft. One tree was uprooted, falling across the front deck of the home and crushing a red Porsche parked in front of the home. A second tree, approximately 2 feet in diameter snapped in half, falling on a truck that was parked next to the house.

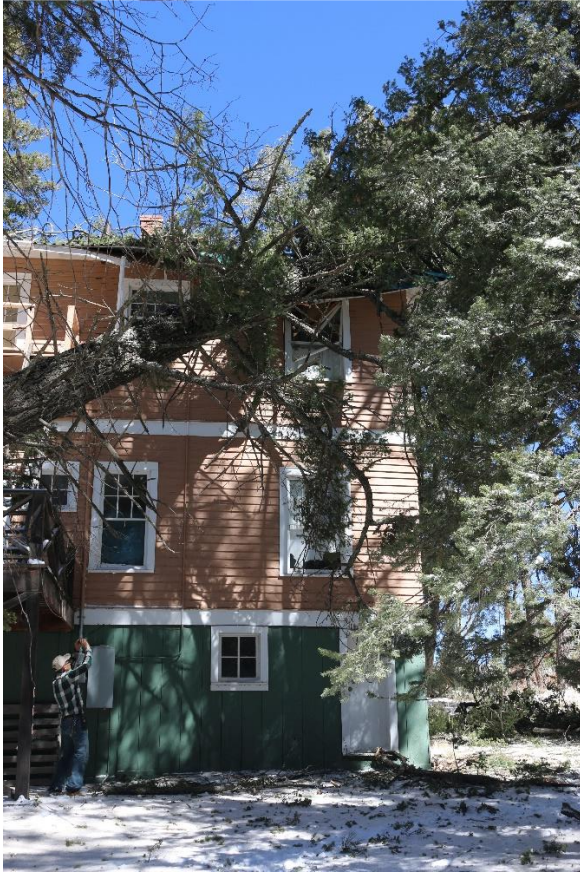
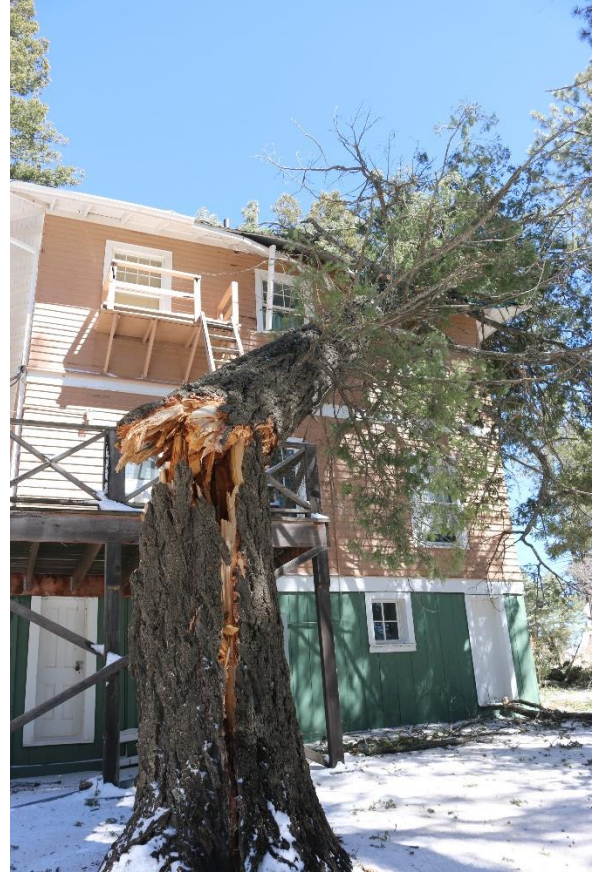
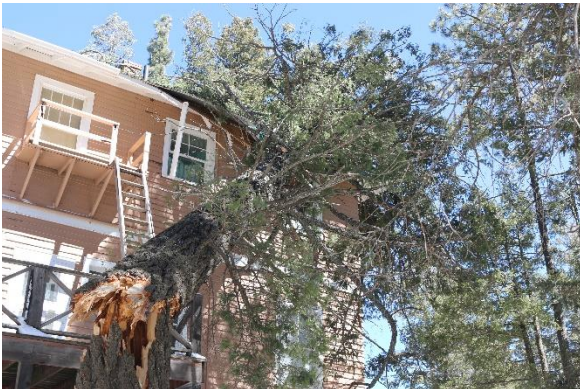
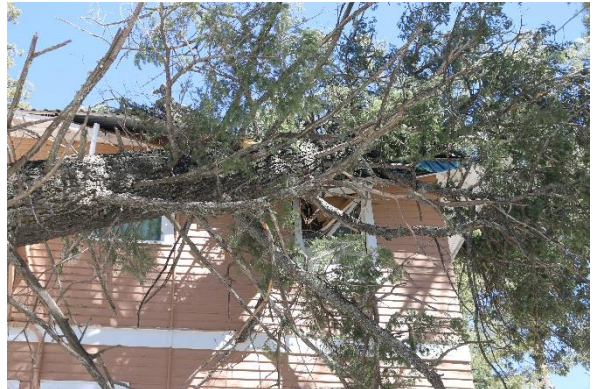
Location 4: Damage Images

Estimated Max Wind Speed: 101 MPH

A very tall ponderosa pine with a trunk diameter of almost 3 feet completely snapped just above its base, allowing the entire tree to fall onto the front of a two-story house. The max wind gust here was estimated to be around 101 MPH. This house is actually located just next door to location 2 where a tree was uprooted by a 90 MPH wind gust less than 15 minutes earlier.

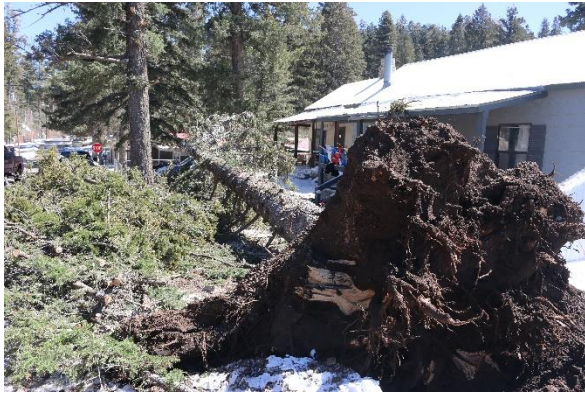
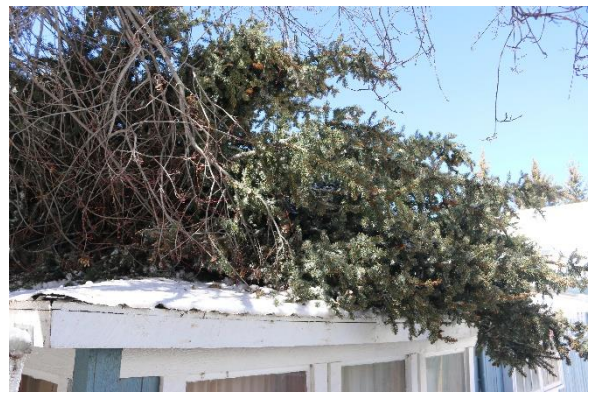
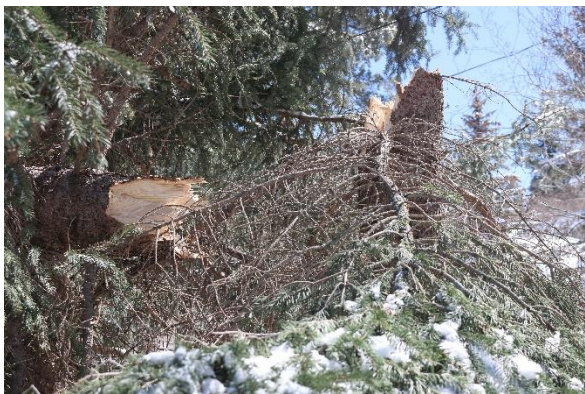
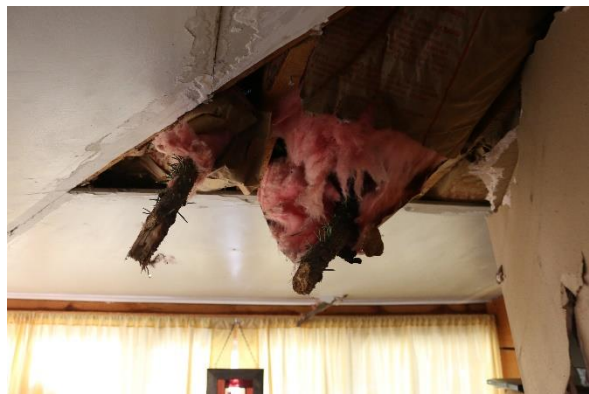
Location 5: Damage Images

Estimated Max Wind Speed: 94 MPH

Two trees fell on this property just south of Highway 82. The first was uprooted and fell across the front yard, narrowly missing this house. However, a second tree from the next-door neighbors back yard also was uprooted and fell directly on the home, puncturing a hole in the bedroom ceiling.
