# **Hurricane Alicia Galveston and Houston, Texas August 17-18, 1983**

**Committee on Natural Disasters  
Commission on Engineering and Technical Systems  
National Research Council**

NATIONAL ACADEMY PRESS Washington, D.C. 1984

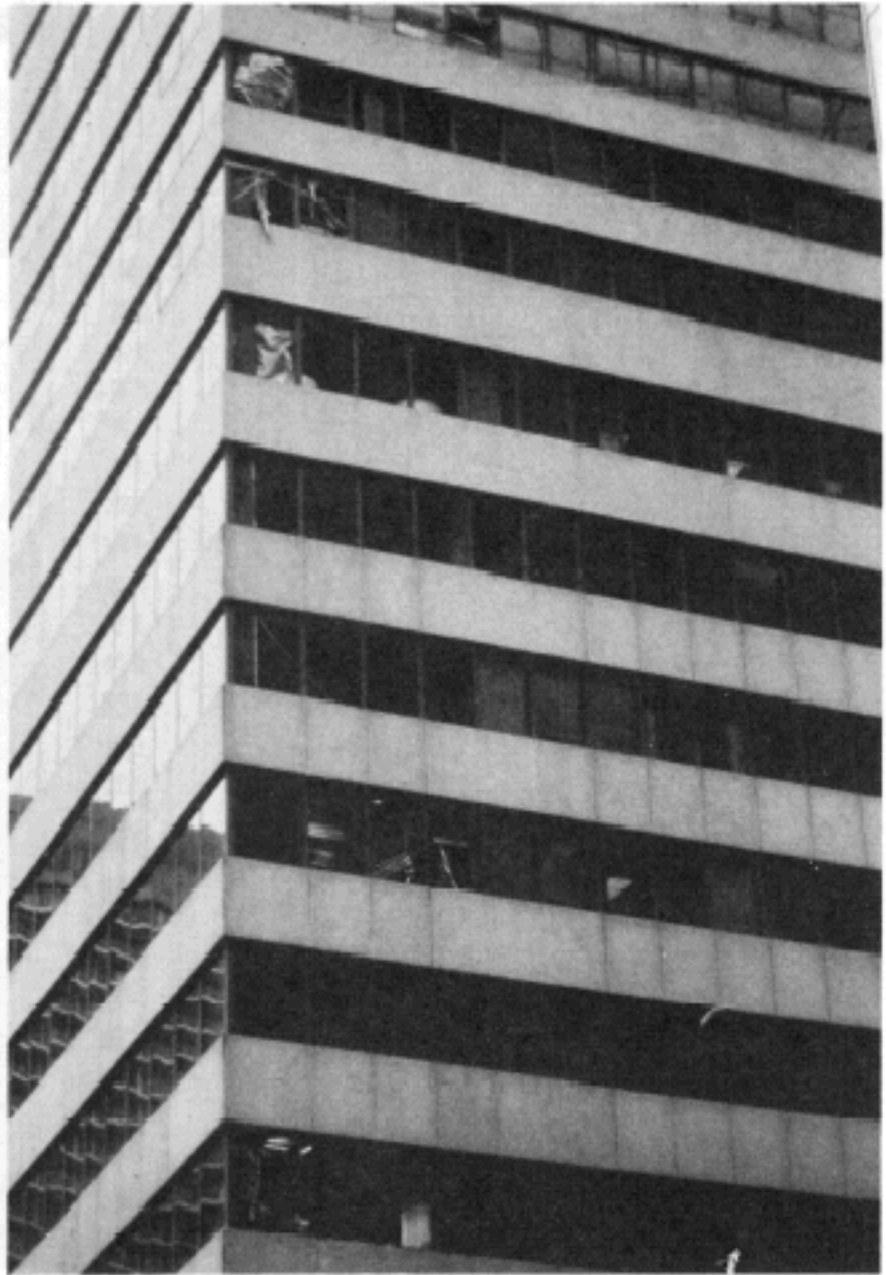
Hotel [Figure 4.10](#) shows the nature of glass damage to the Sheraton-Houston Hotel. The damage was more significant on the northeast face of the building.

FIGURE 4.10 Window damage to the Sheraton-Houston Hotel.

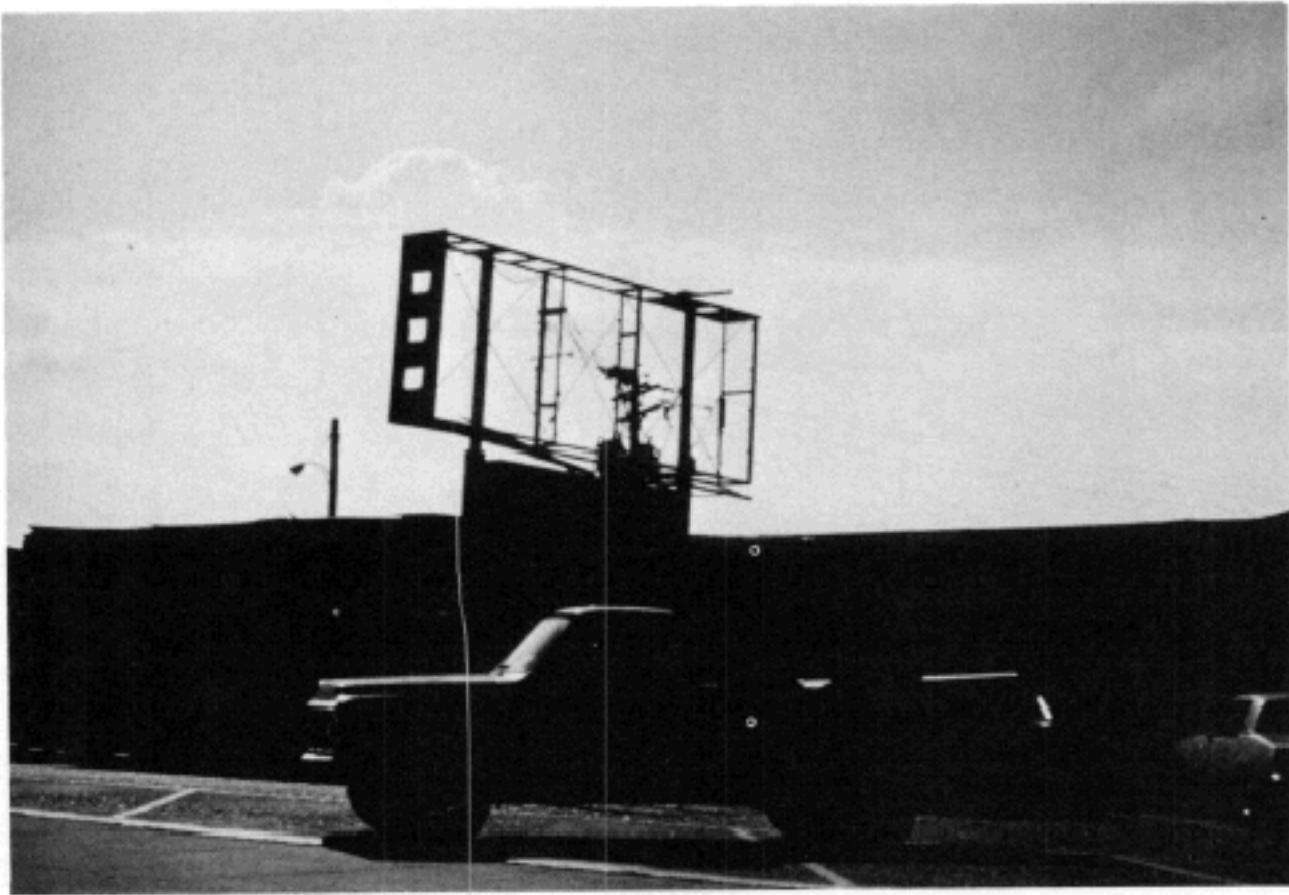
FIGURE 4.14 Damaged billboard.

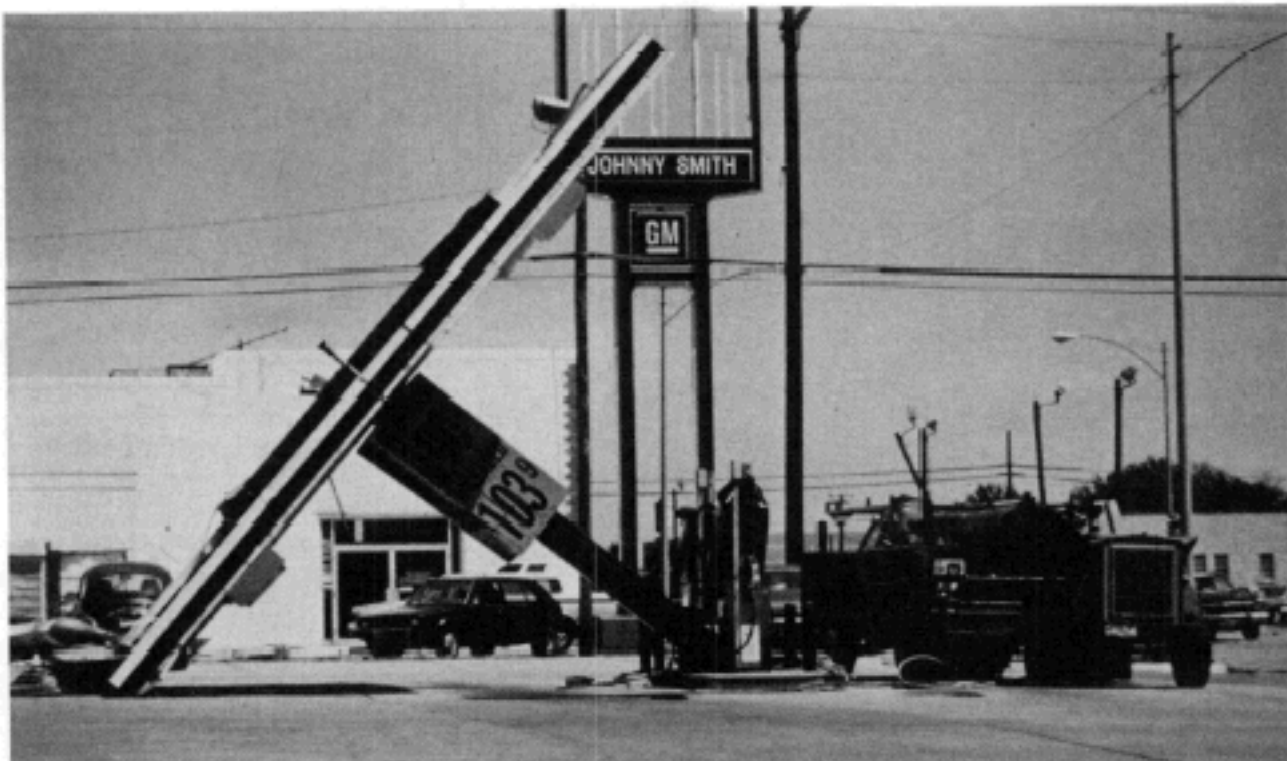
FIGURE 4.15 Example of failure of a roof support pedestal column.

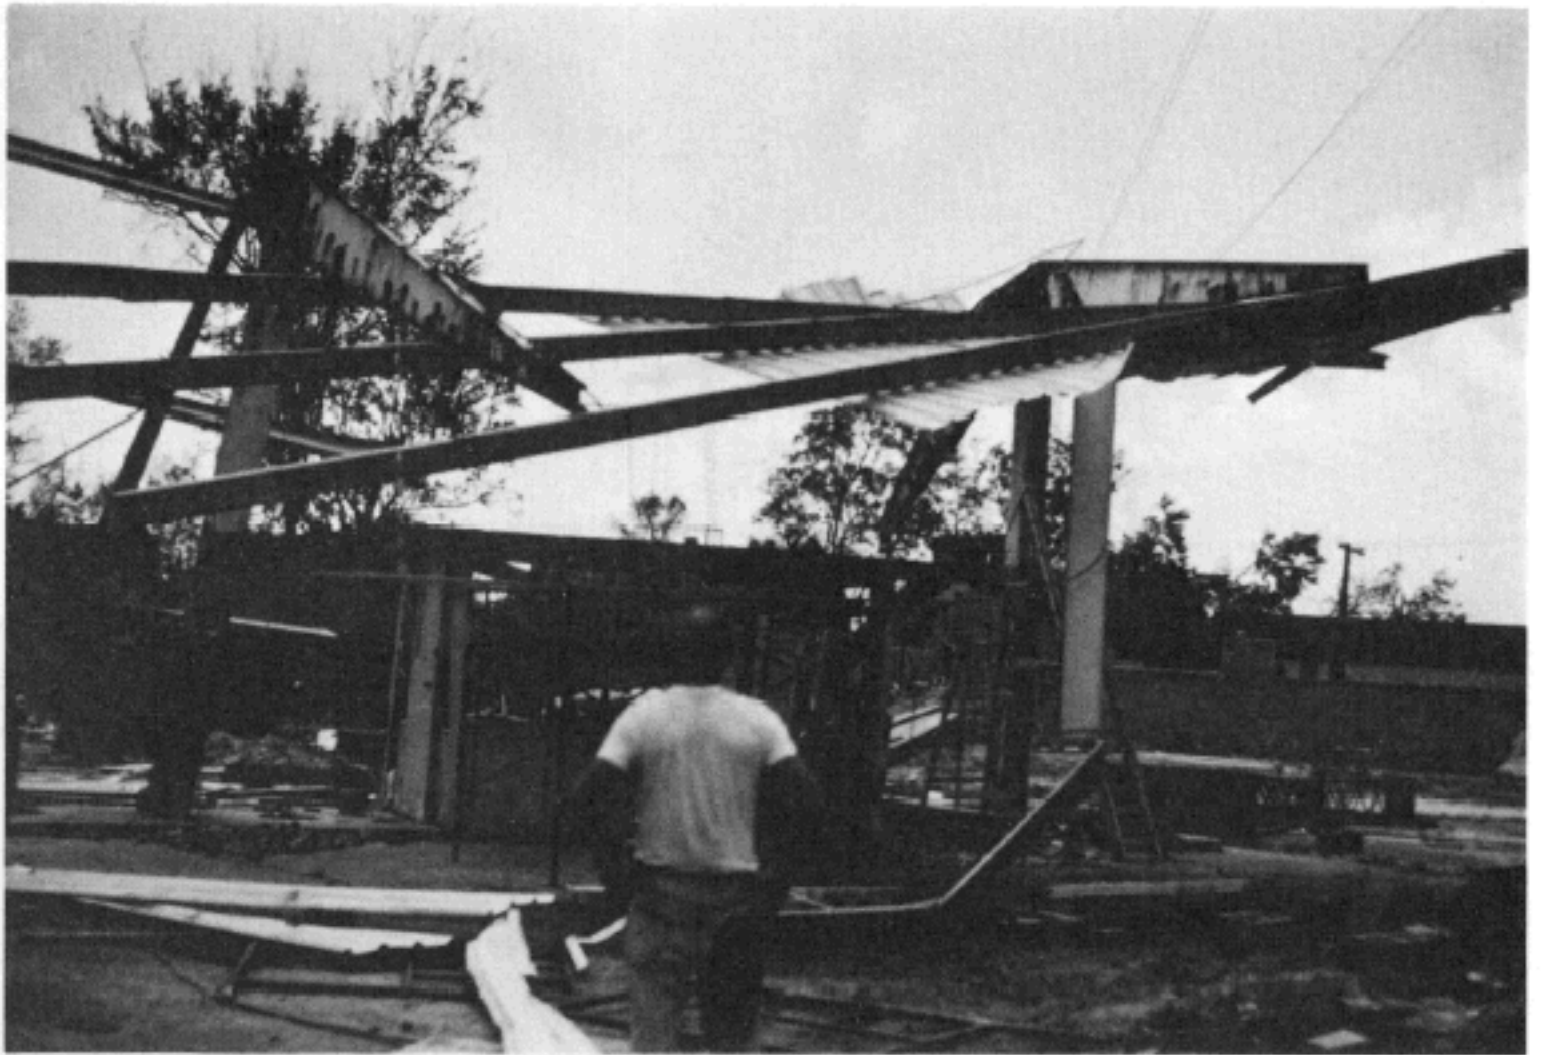
FIGURE 4.16 Failure of sheet metal roof at a gas station.

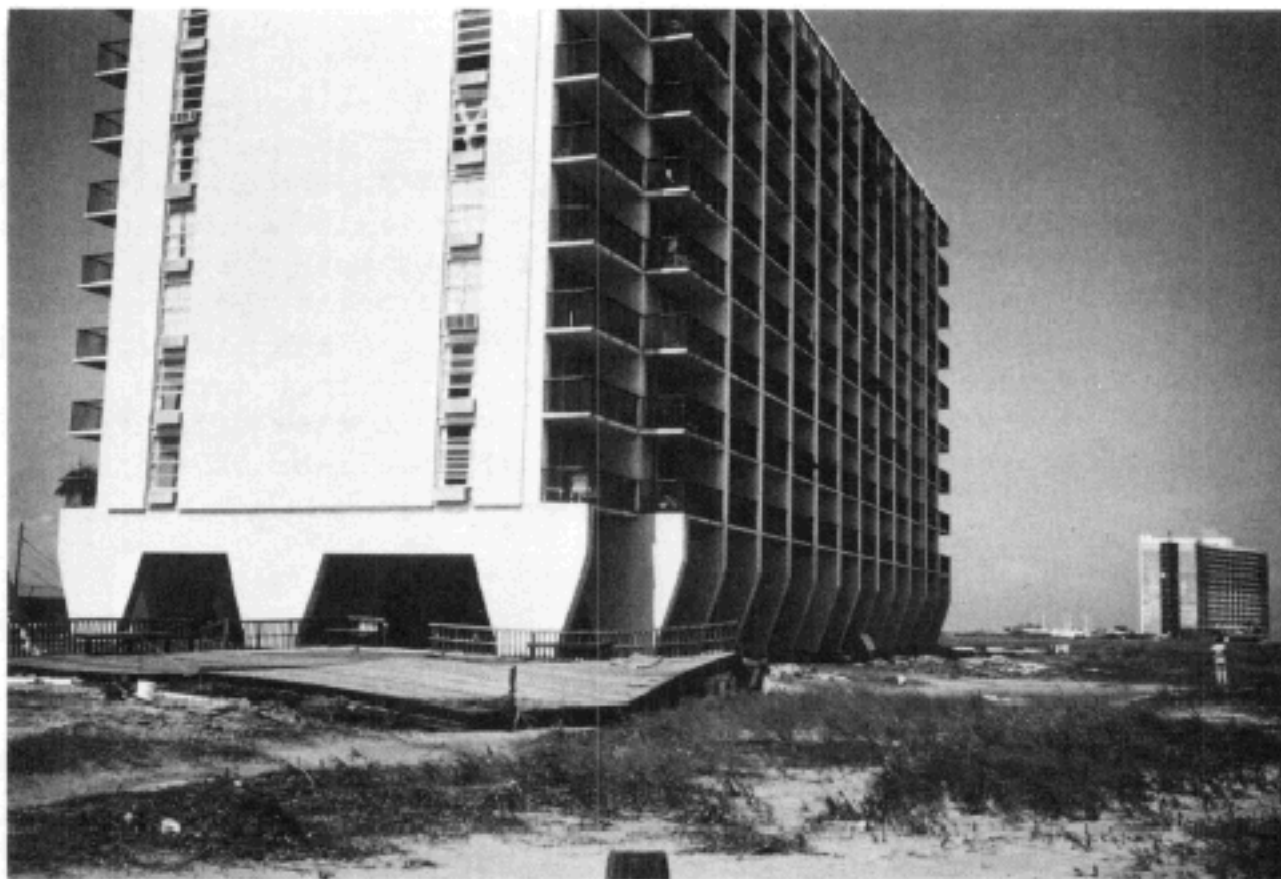
FIGURE 4.19 General erosion and damaged deck around Islanders Inn and the Galvestonian (in the background).

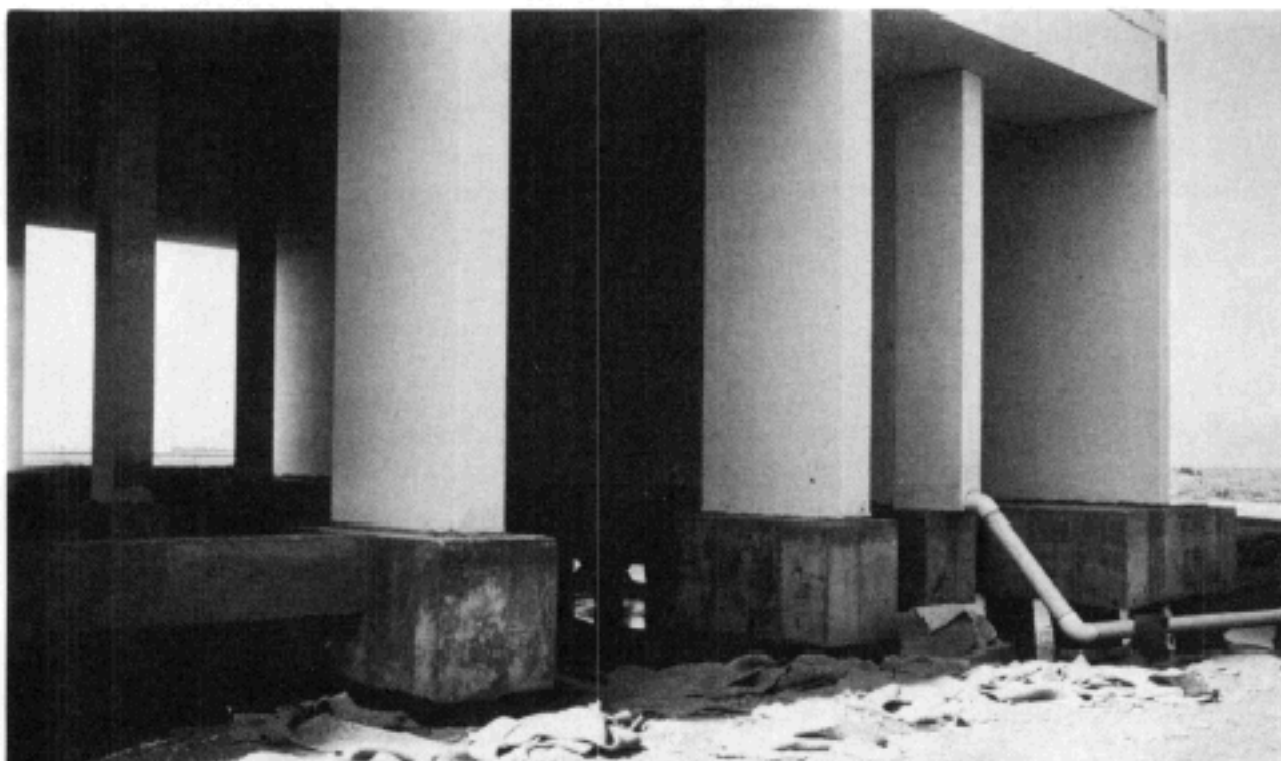
**FIGURE 4.20** Erosion around the foundation of the Galvestonian.

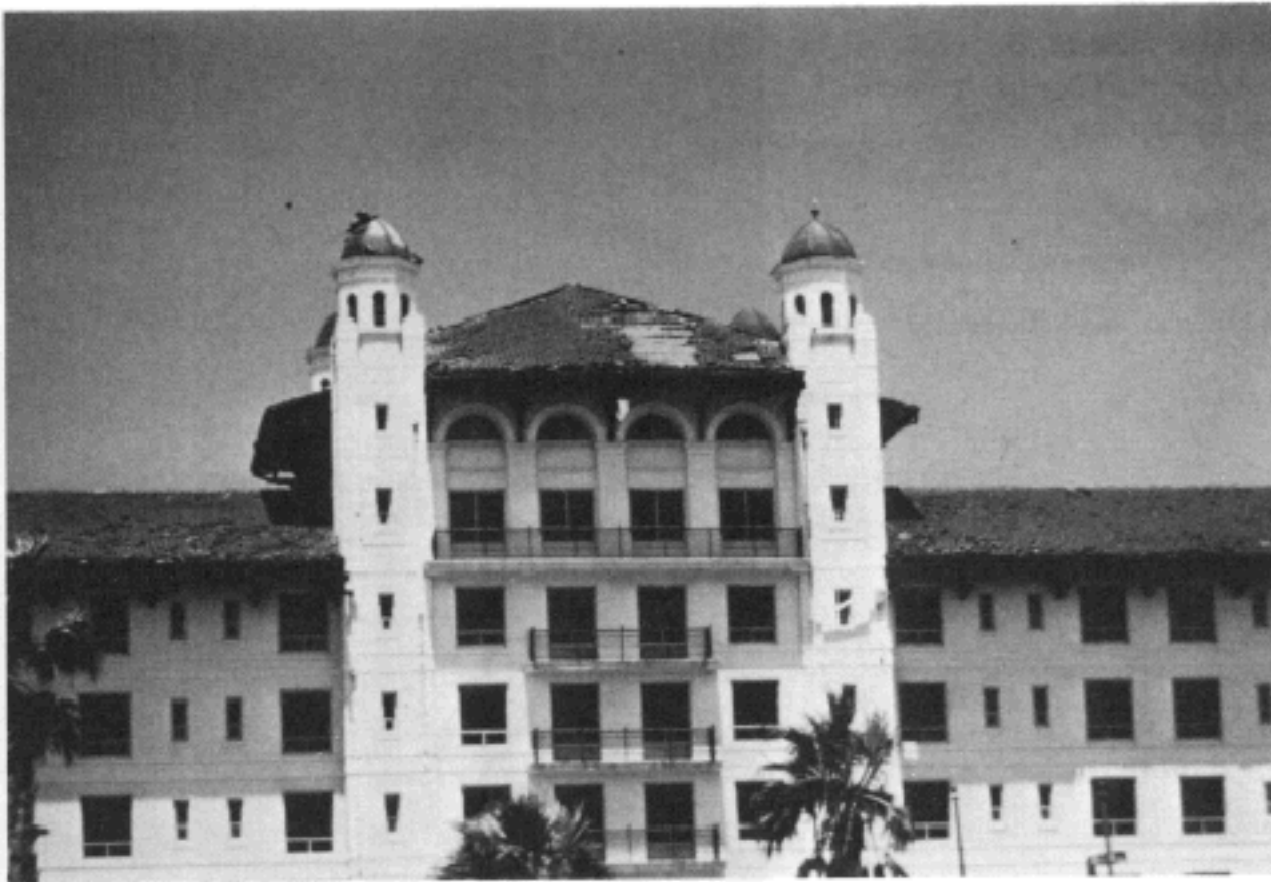
FIGURE 4.22 Damage to tiled roof of the Hotel Galvez.

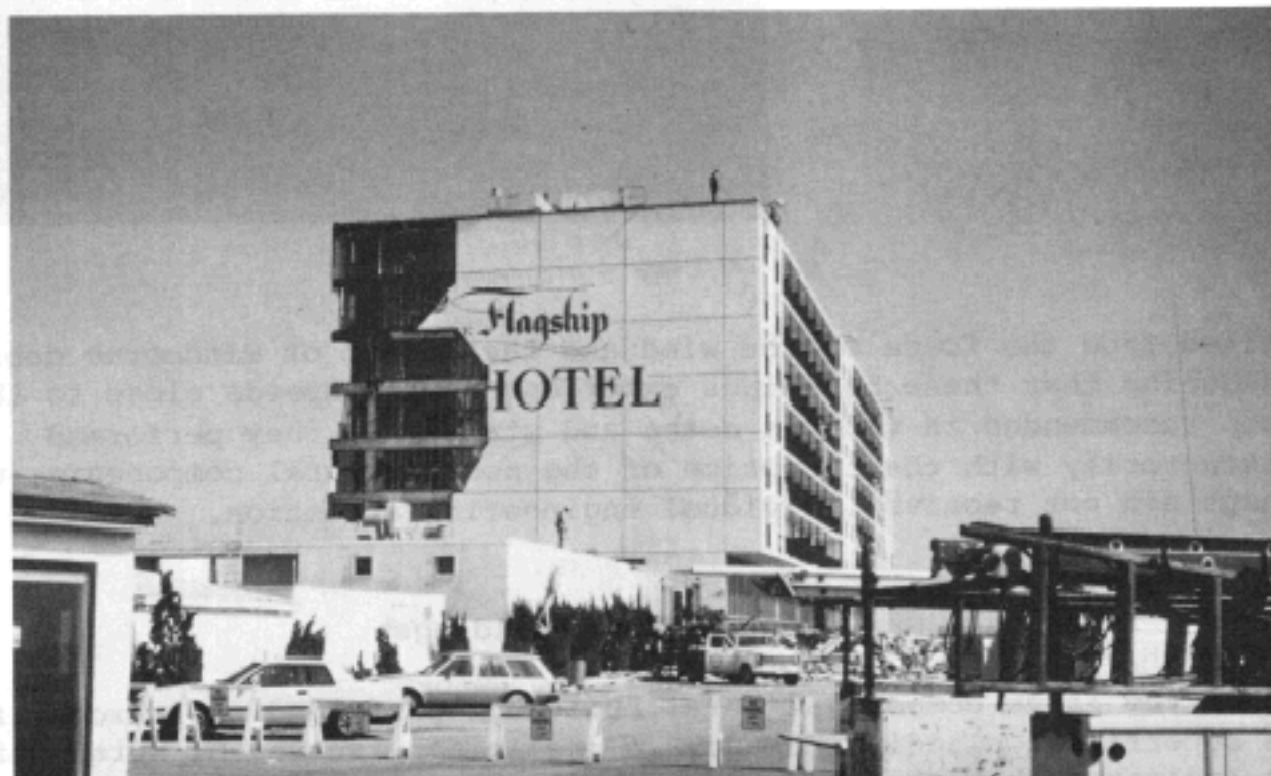
**FIGURE 4.23** Damage to the facade of the Flagship Hotel.

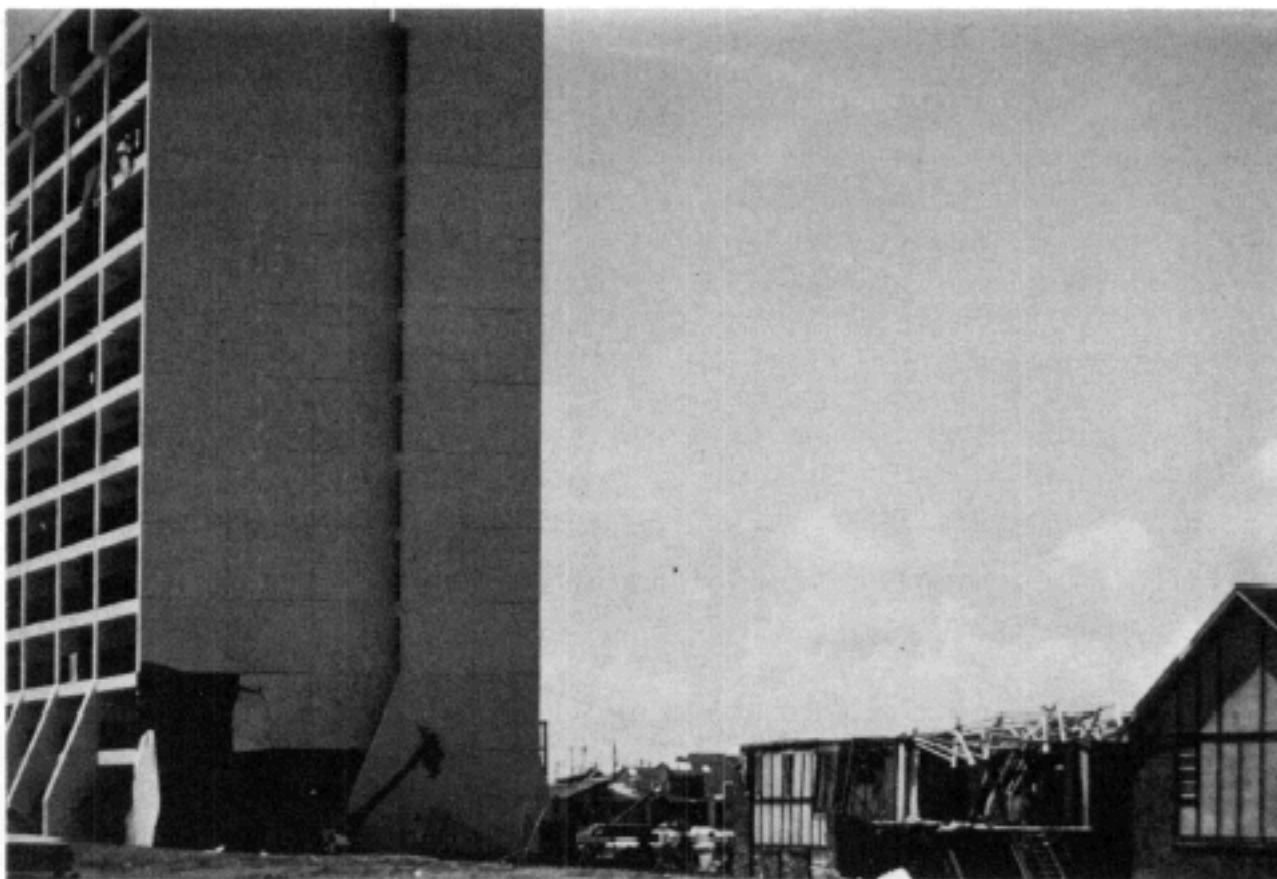
FIGURE 4.24 General view of damage to condominiums on the sea-wall.

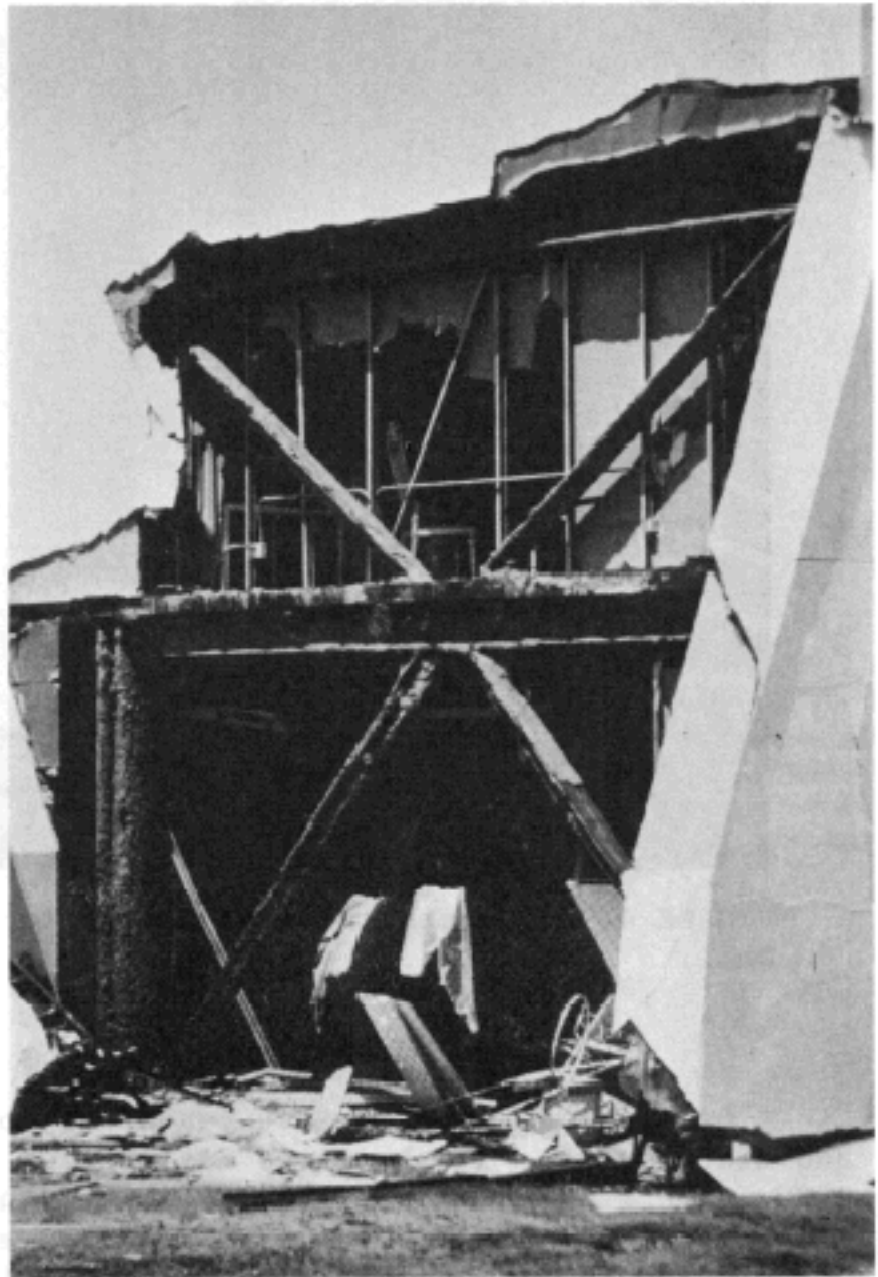
**FIGURE 4.25** Closeup of damage to the facade of By-the-Sea Condominium.

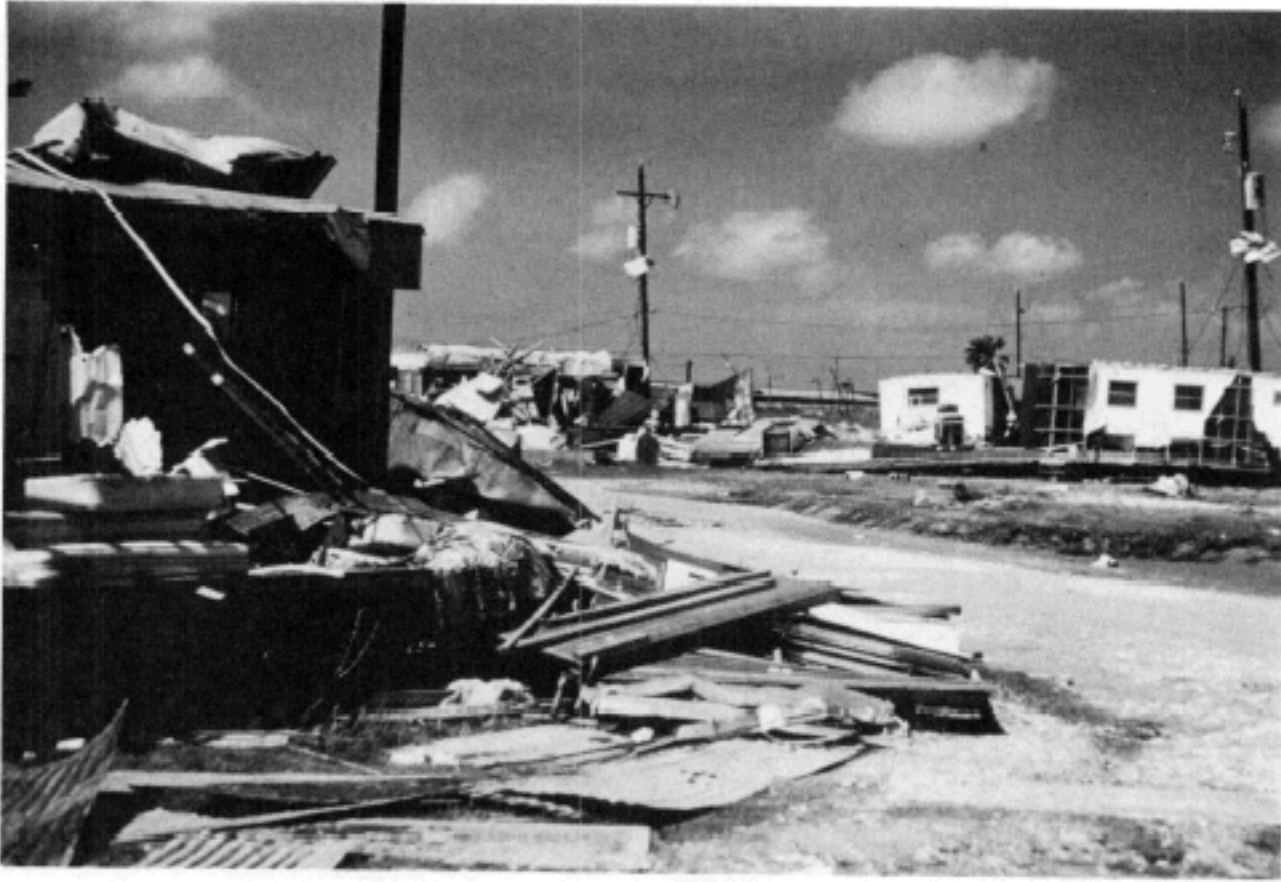
FIGURE 4.26 Damaged mobile home park on East Beach.

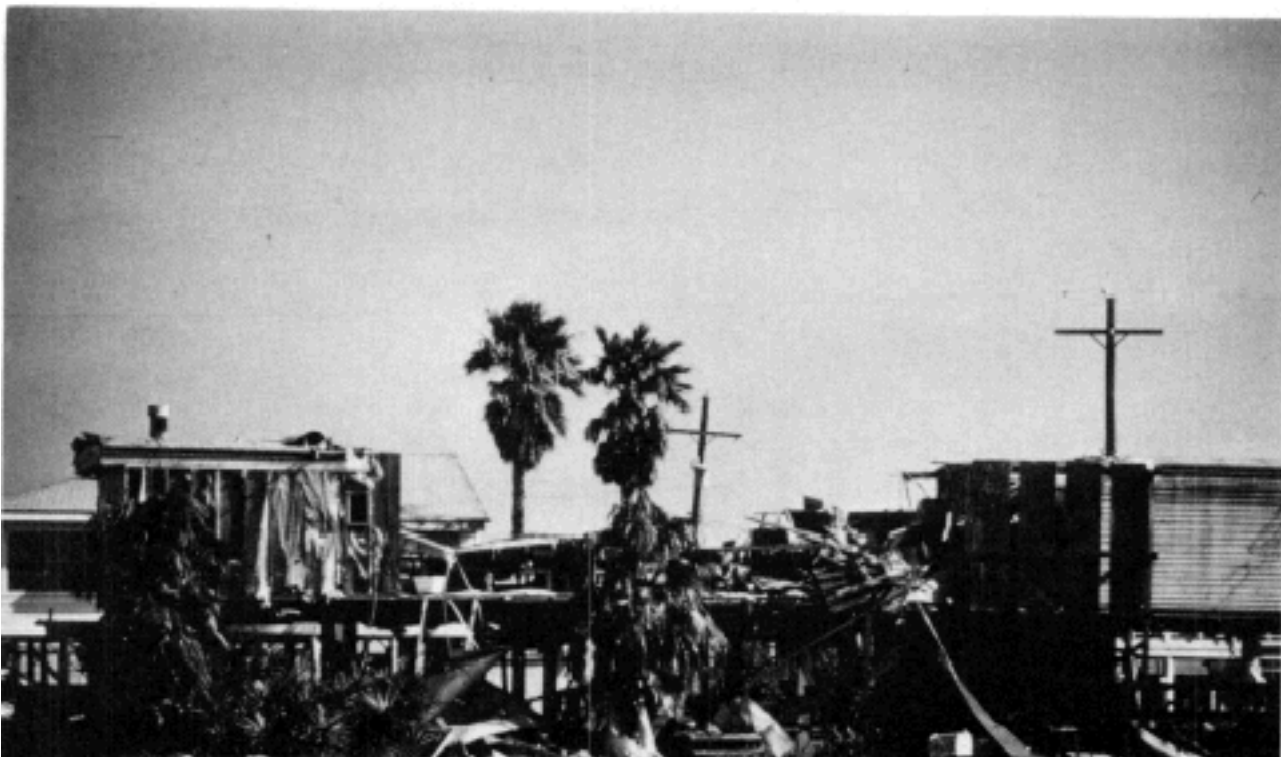
FIGURE 4.27 Damage to an elevated mobile home on West Beach.

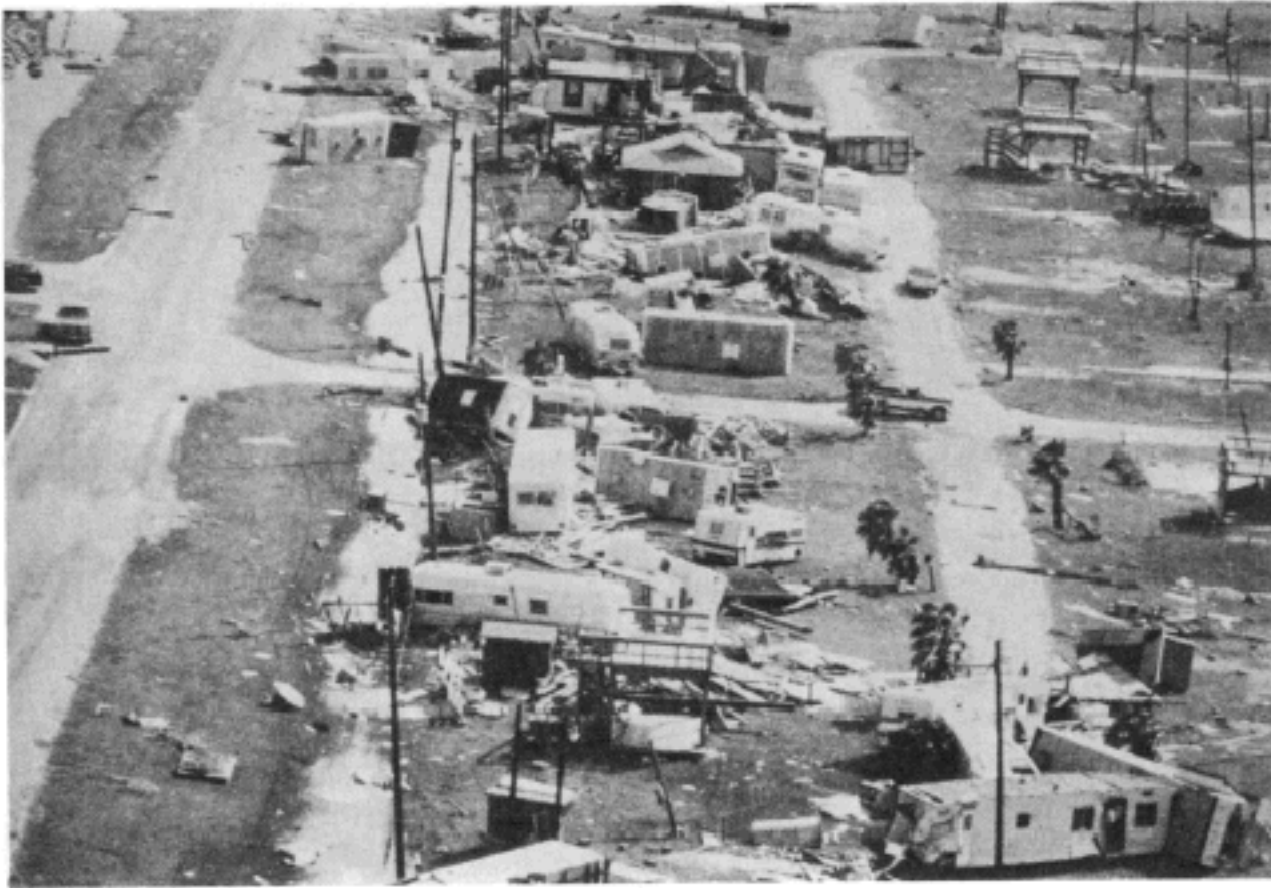
FIGURE 4.28 Damaged mobile home park on West Beach.

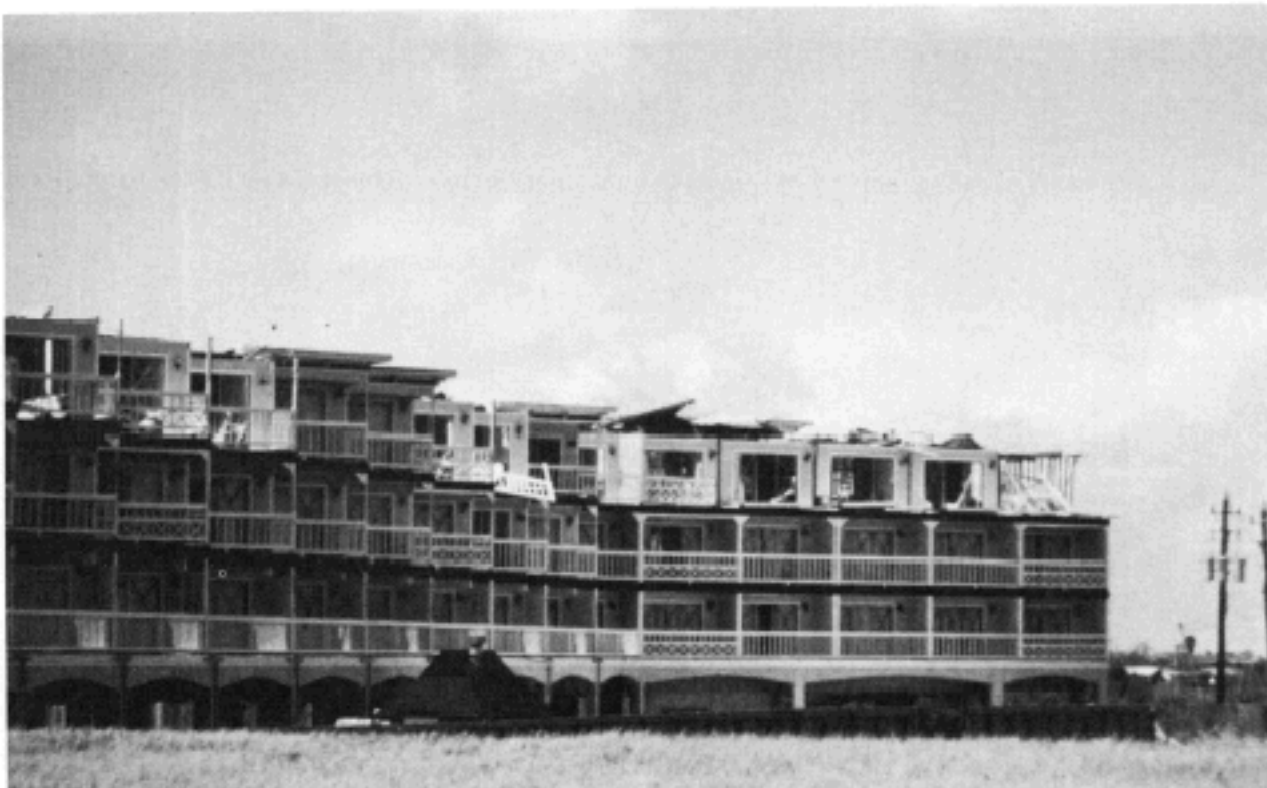
**FIGURE 4.29** General view of the damaged wing of the Victoria Hotel.

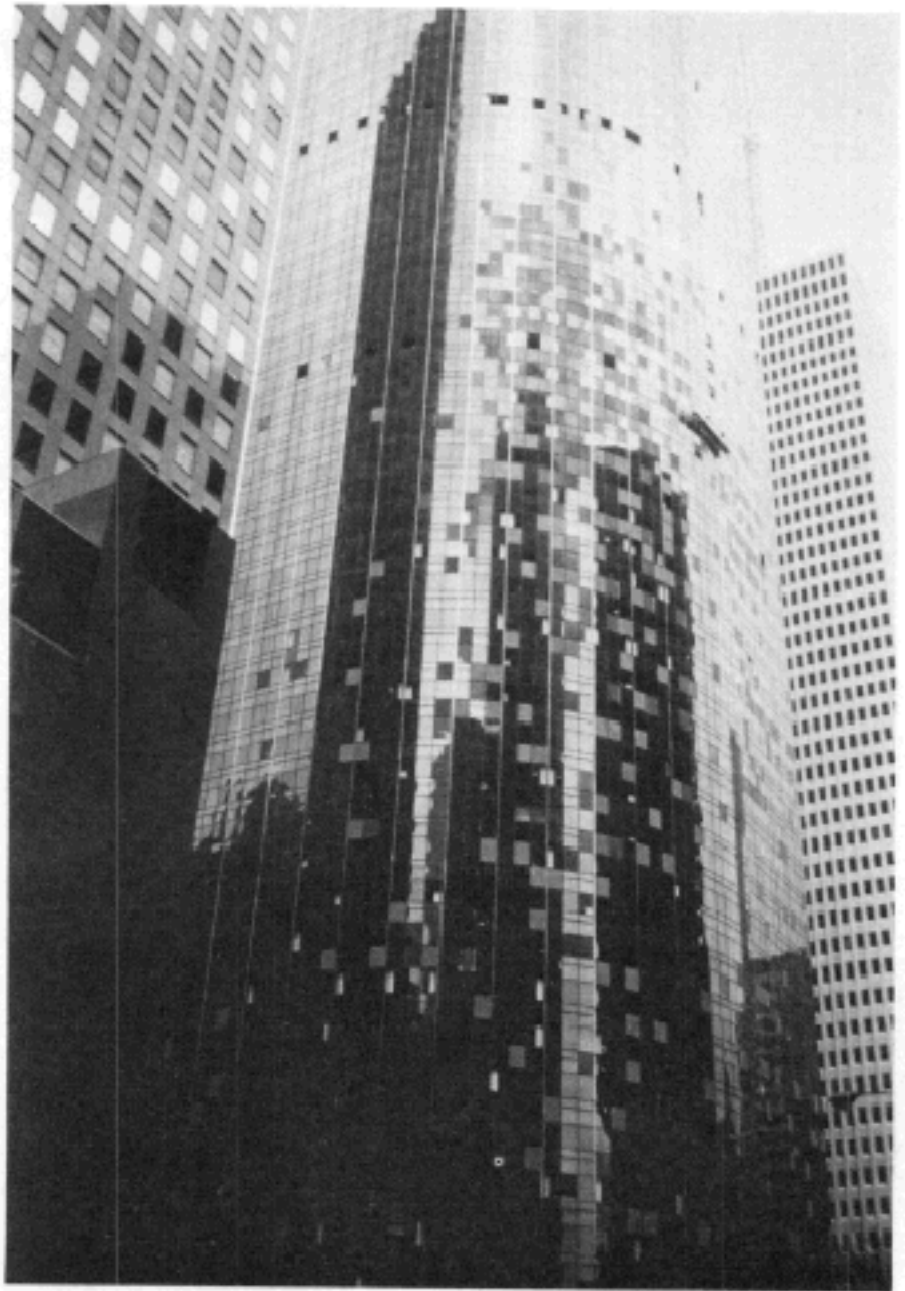
FIGURE 4.3 Glass damage on the southwest face of the Allied Bank Building. Dark shapes are reflections of adjacent buildings.

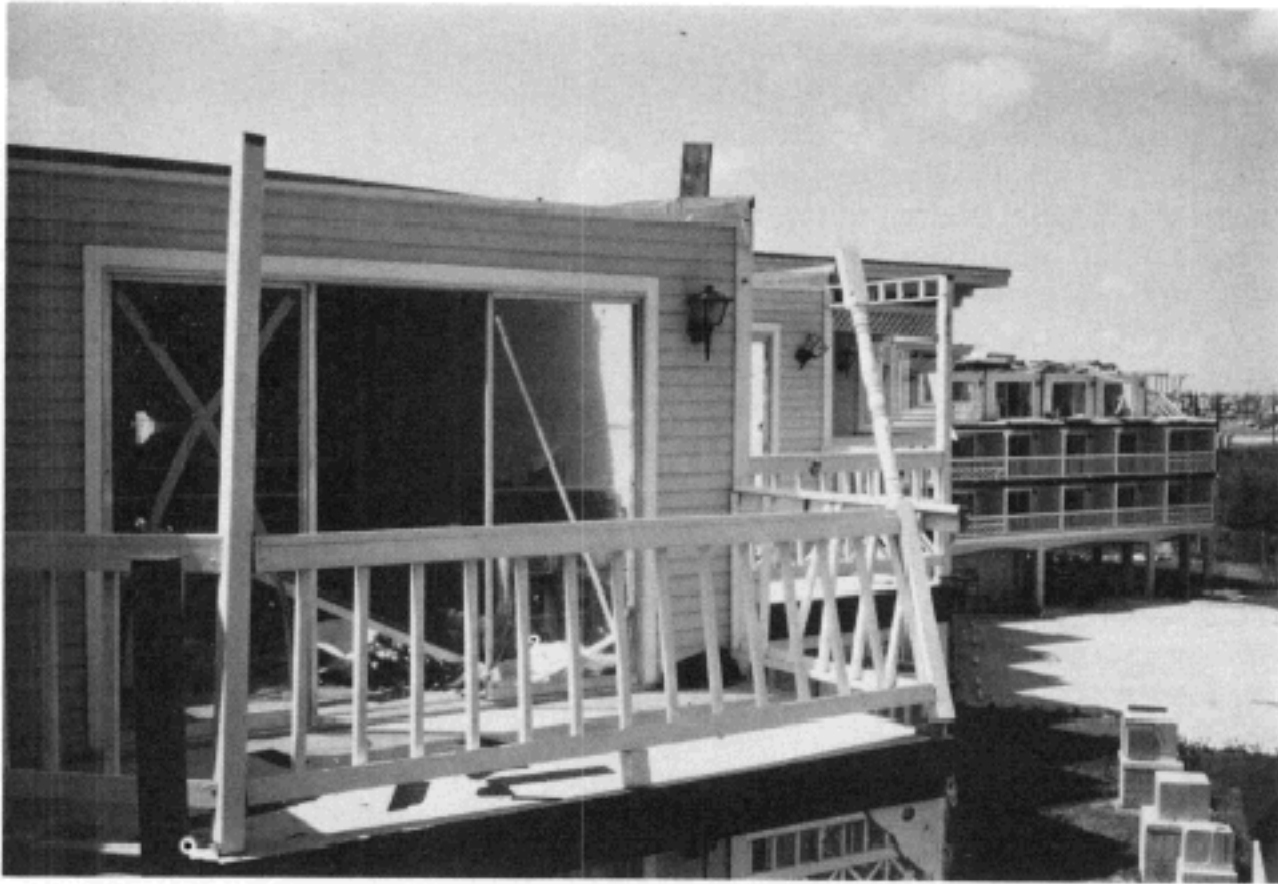
FIGURE 4.30 Closeup of a damaged unit in the Victoria Hotel.

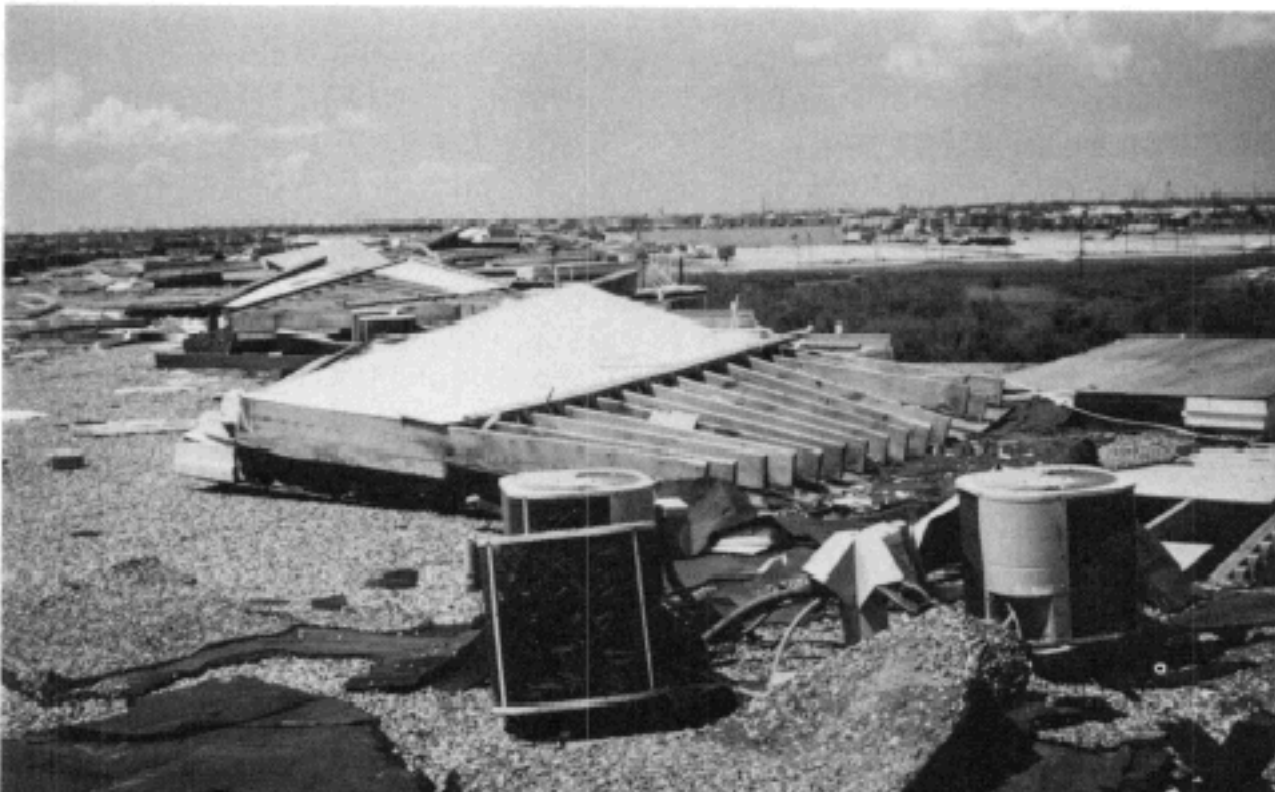
FIGURE 4.31 General view of the roof of the Victoria Hotel, showing damaged overhangs that landed on the roof.

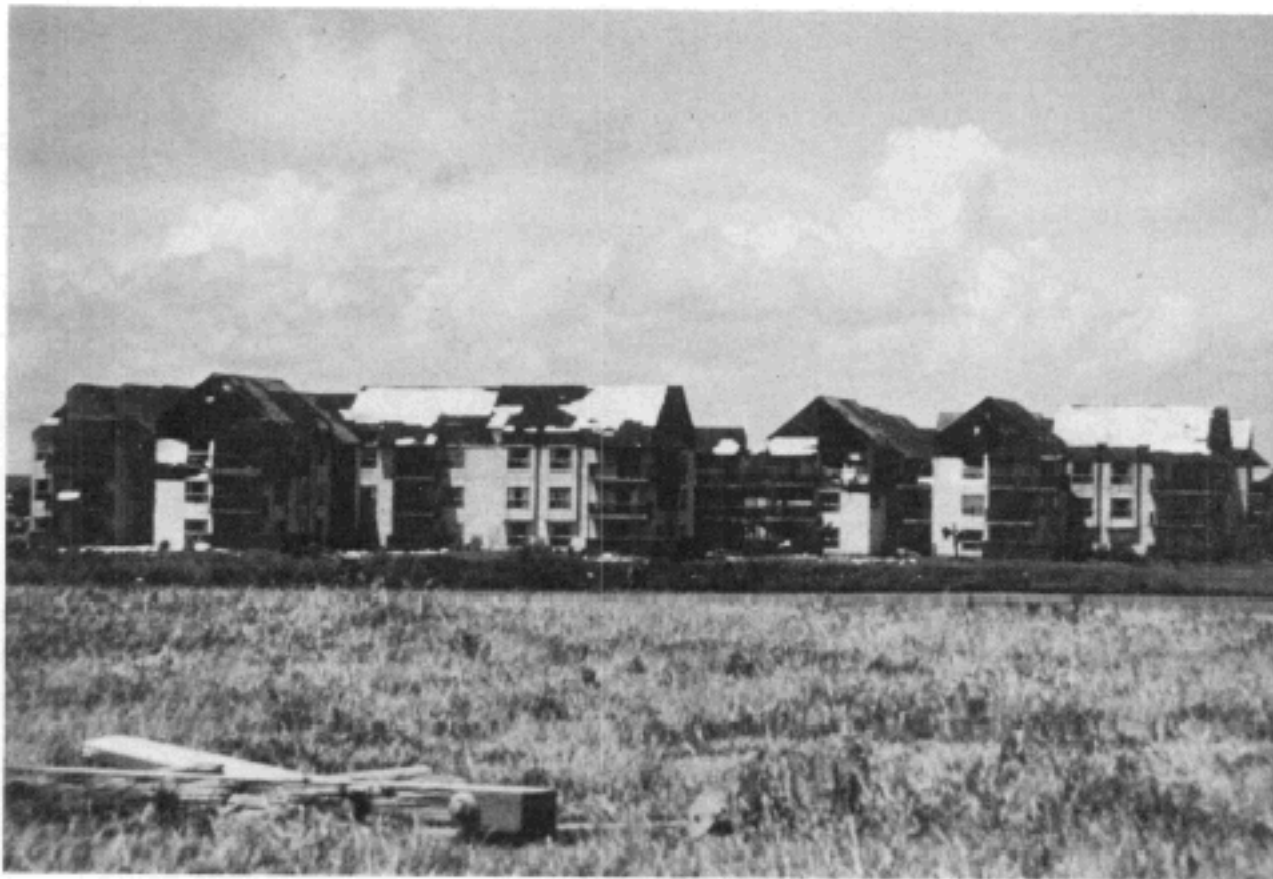
FIGURE 4.32 Roof damage to apartments near the seawall.

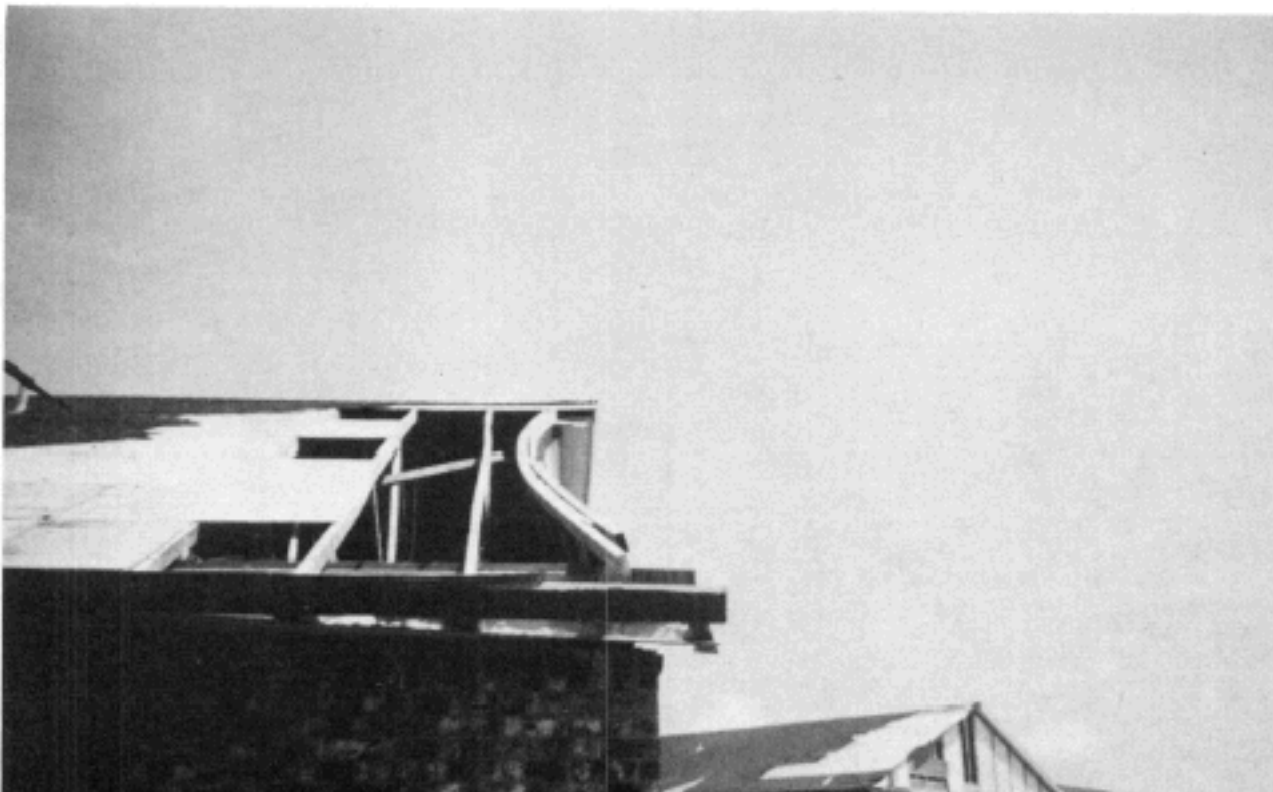
**FIGURE 4.33** Damage to a roof truss caused by lack of bracing between trusses.

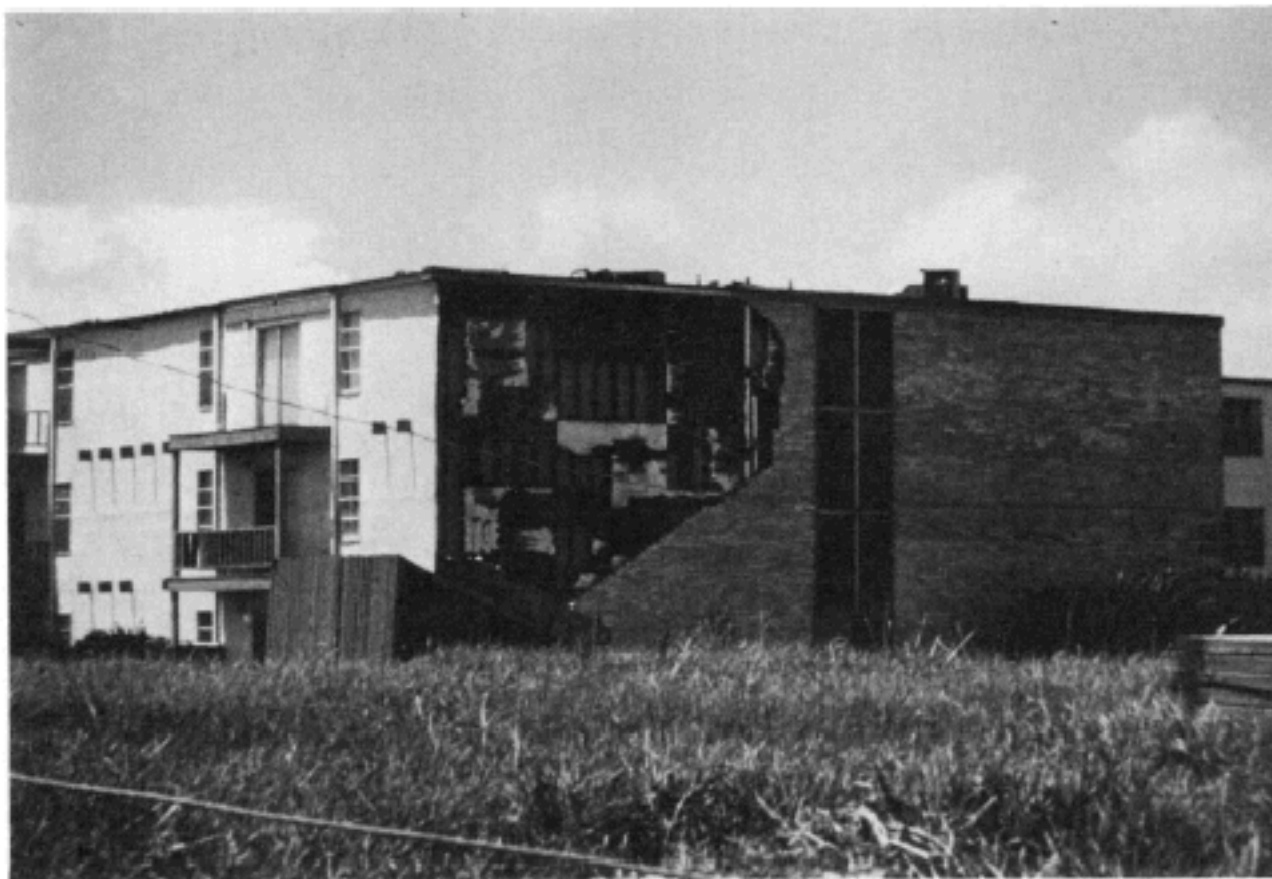
FIGURE 4.34 Failure of veneer brick walls due to lack of ties.
