# **Hurricane Alicia Galveston and Houston, Texas August 17-18, 1983**

**Committee on Natural Disasters  
Commission on Engineering and Technical Systems  
National Research Council**

NATIONAL ACADEMY PRESS Washington, D.C. 1984

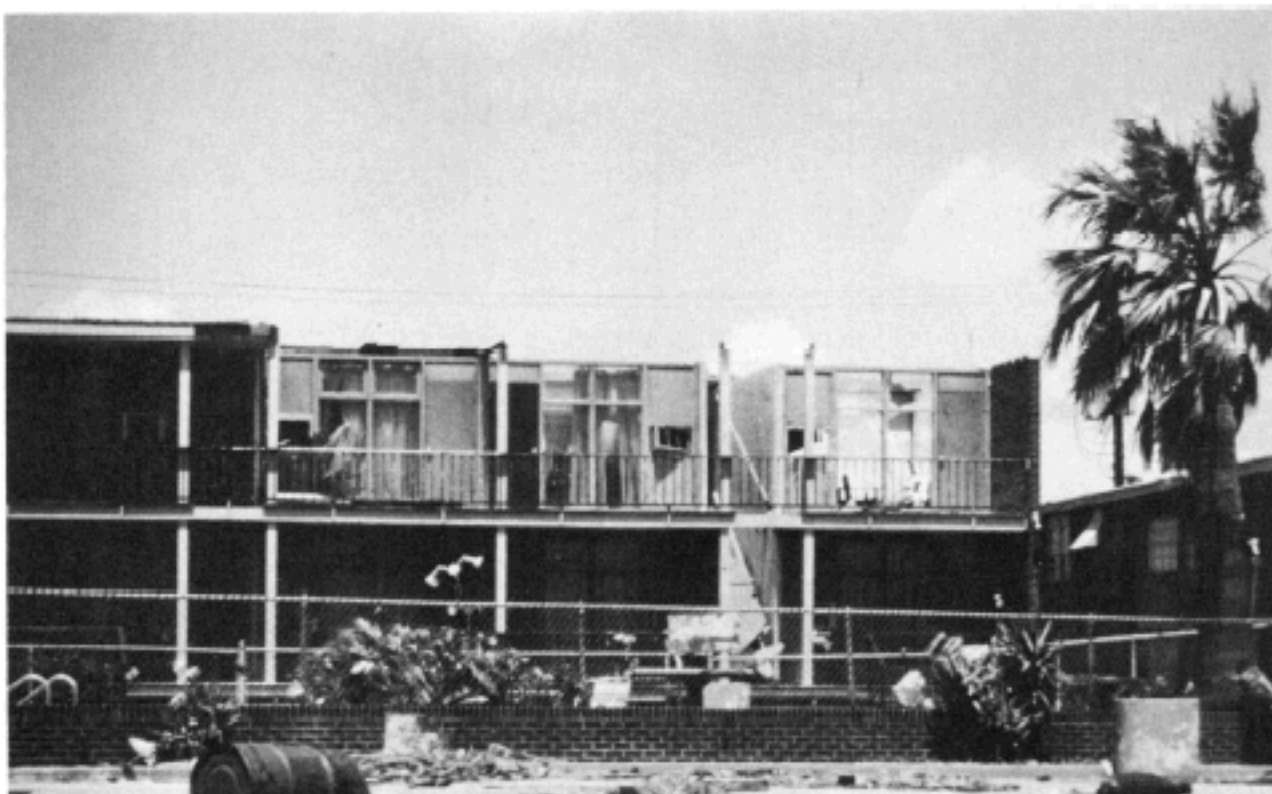
FIGURE 4.35 Partial loss of roof at a motel.

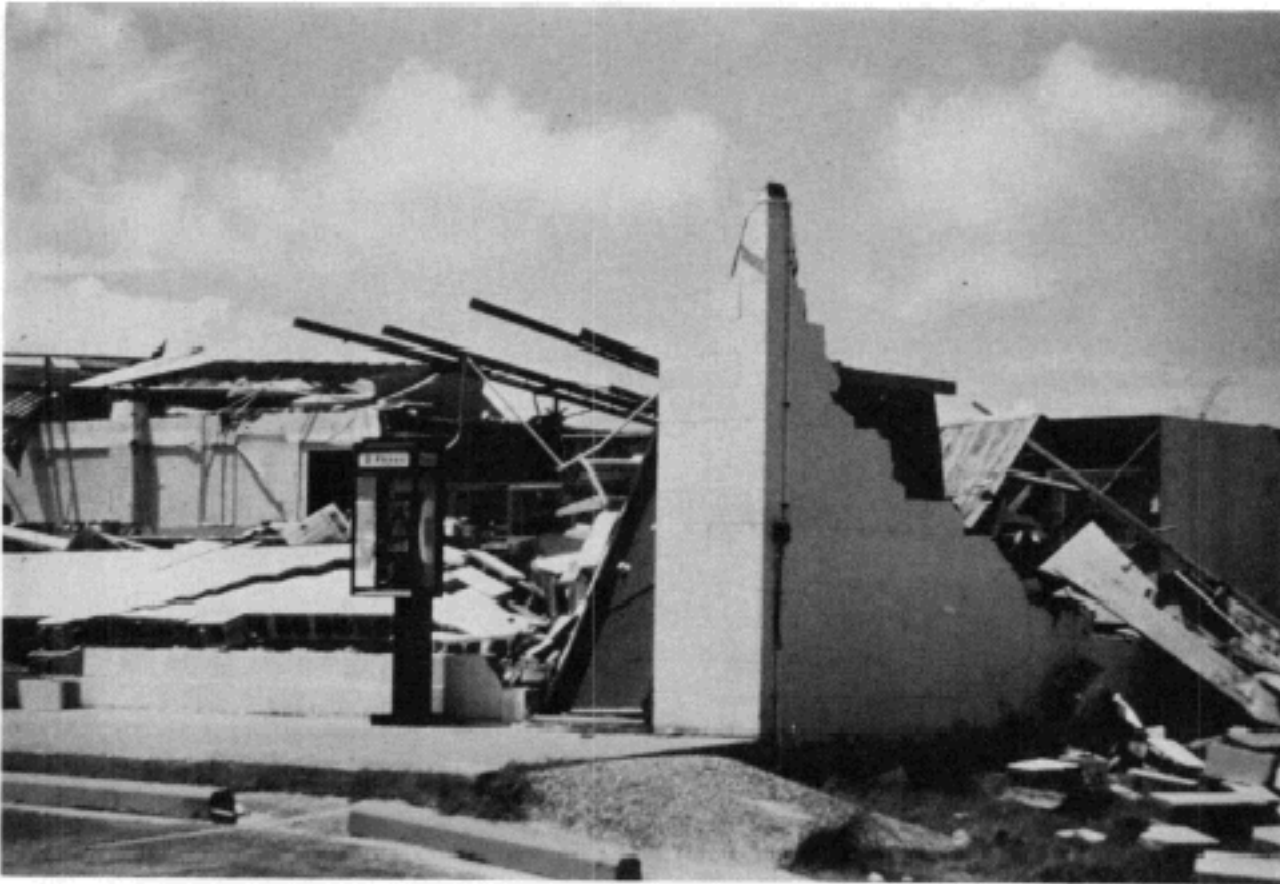
FIGURE 4.36 Typical example of the failure of one of many convenience stores,

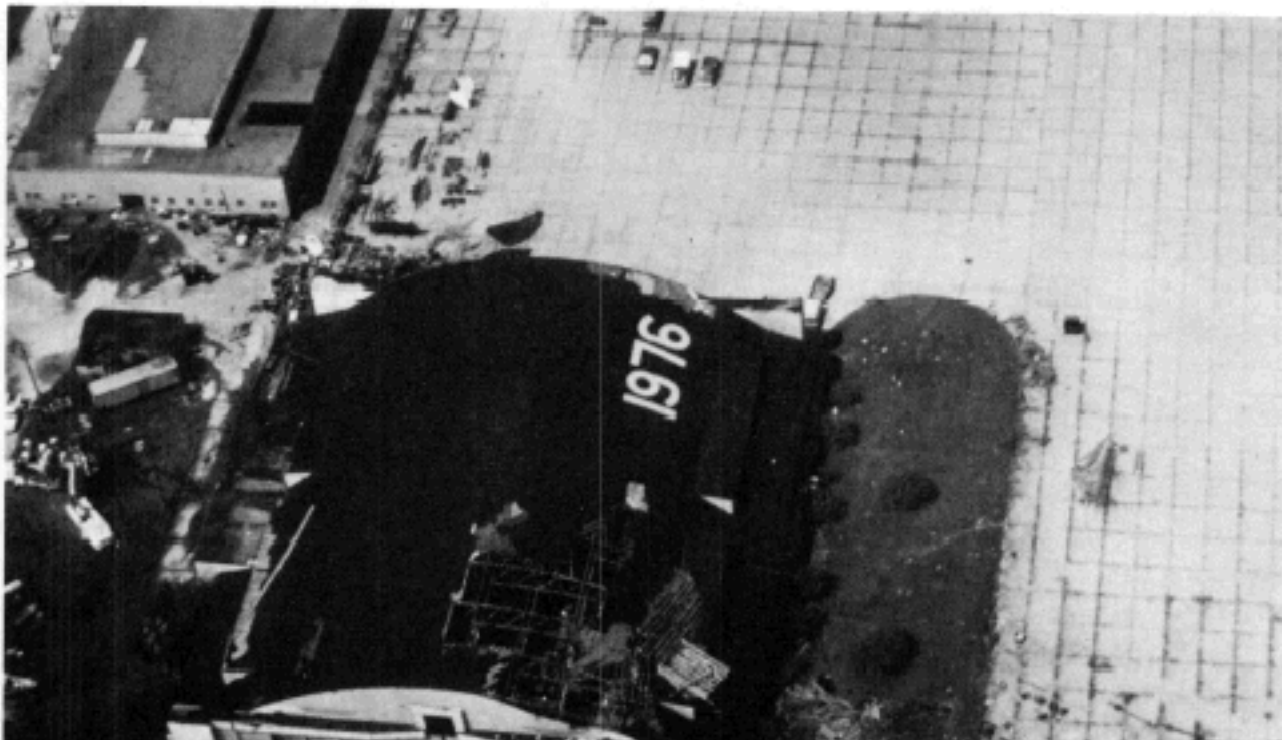
FIGURE 4.37 Wind damage to the roof of a hangar at Galveston Airport.

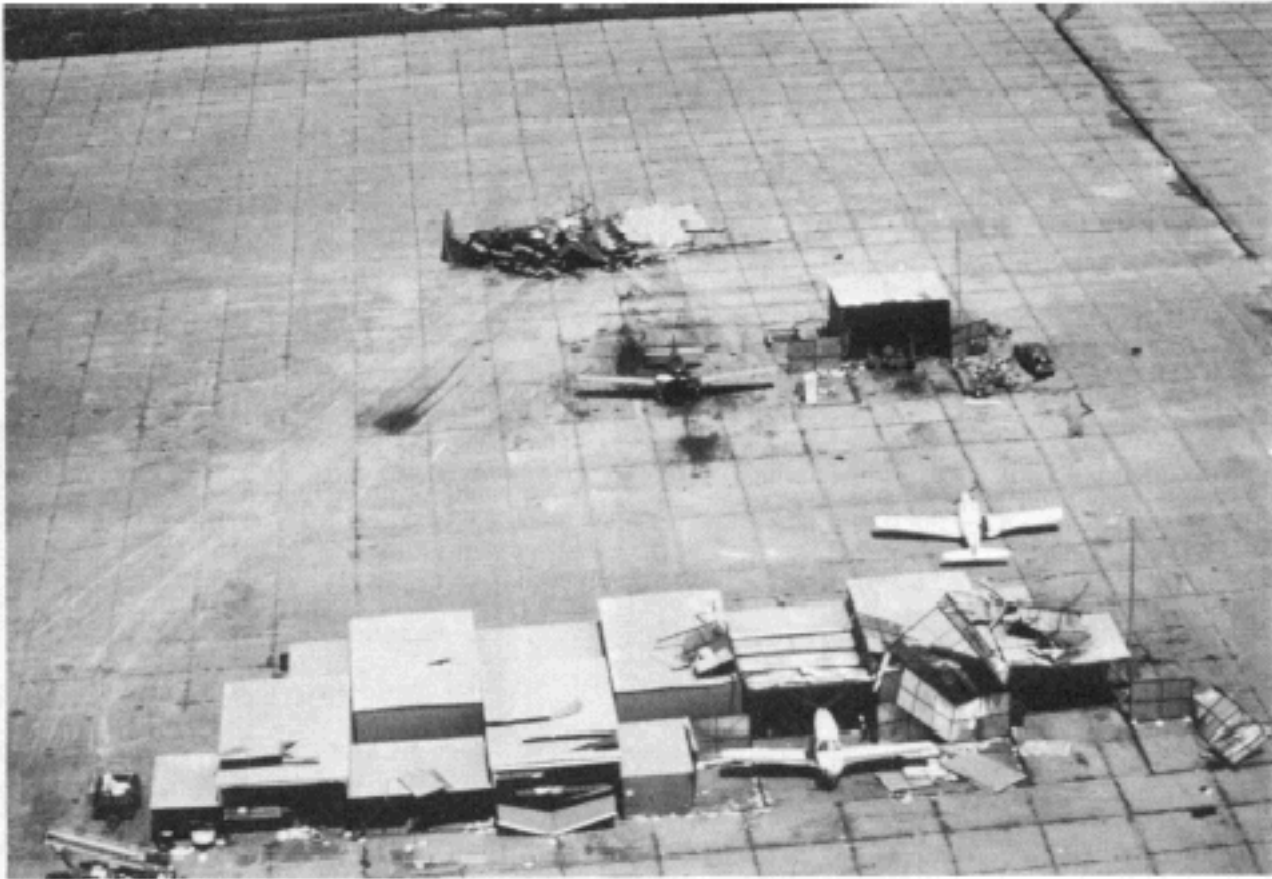
FIGURE 4.38 Damaged hangars and small aircraft at Galveston Airport.

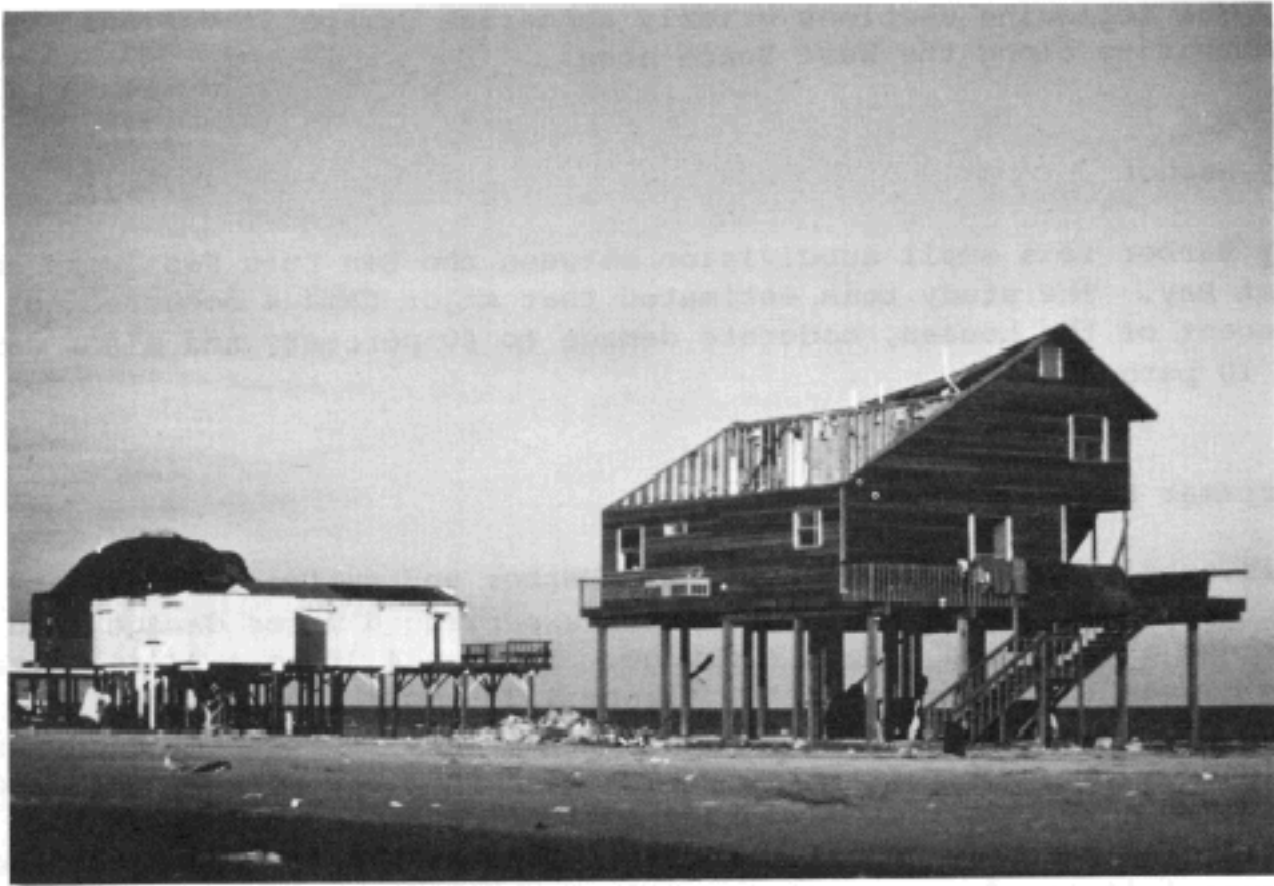
FIGURE 4.39 Example of a roof failure of a house in Terramar Beach.

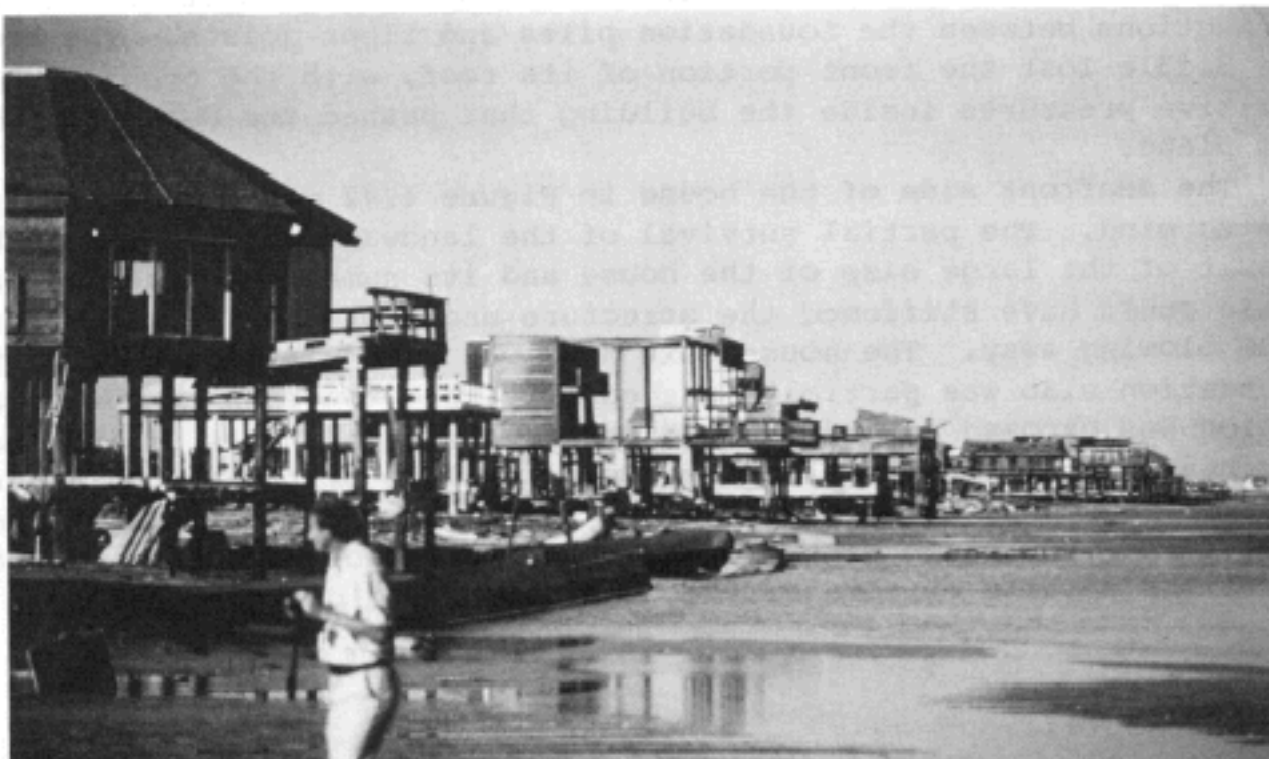
FIGURE 4.40 General view of damaged houses along Terramar Beach.

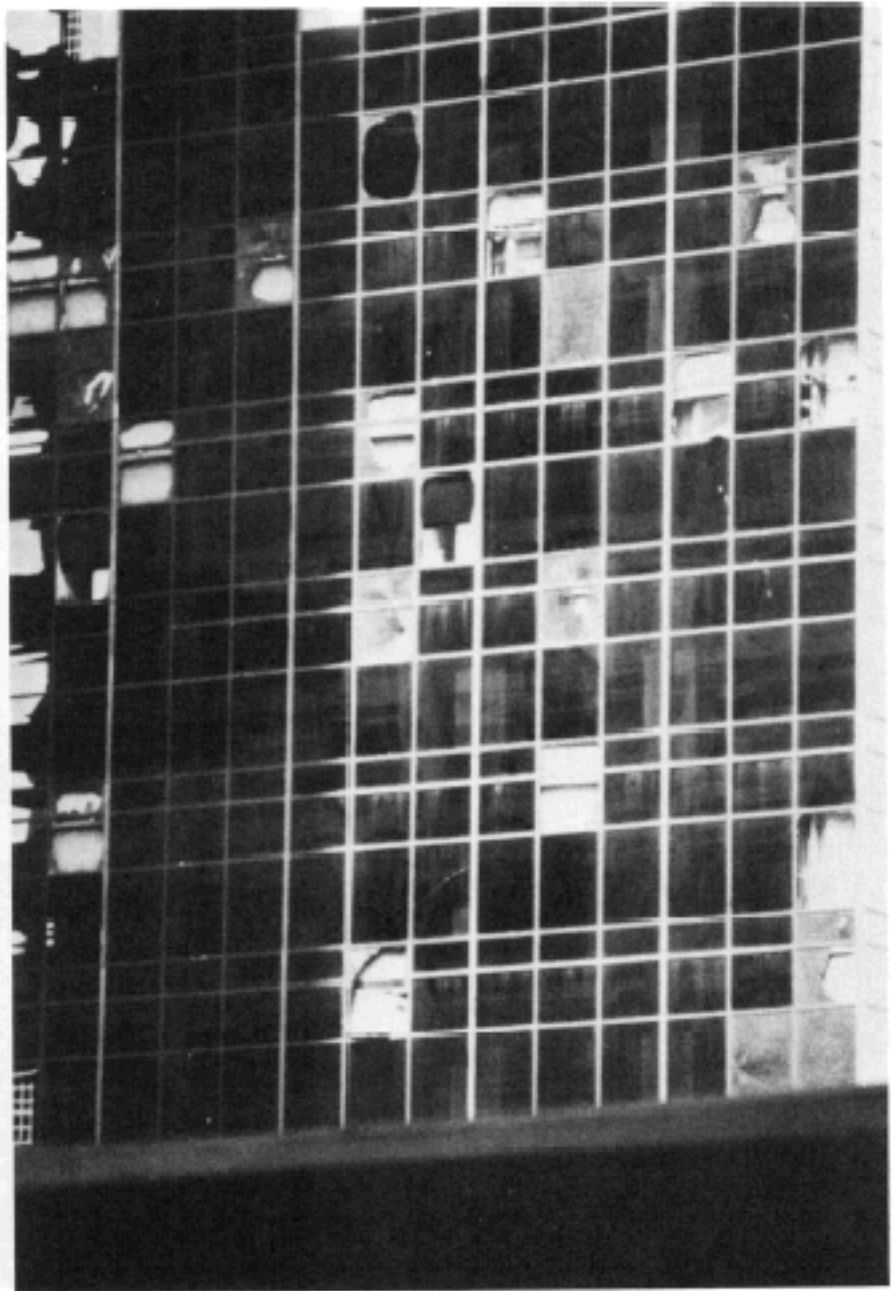
A majority of the glass damage was to the outer vision glass of view-panel and single-pane spandrel glass ([Figure 4.4](#)). It is important to note that damage was more prevalent in the spandrel glass. The building showed very little evidence of damage to window frames. Broken glass still in place after the

**FIGURE 4.4** Closeup of damaged glass on the south-east face of the Allied Bank Building.

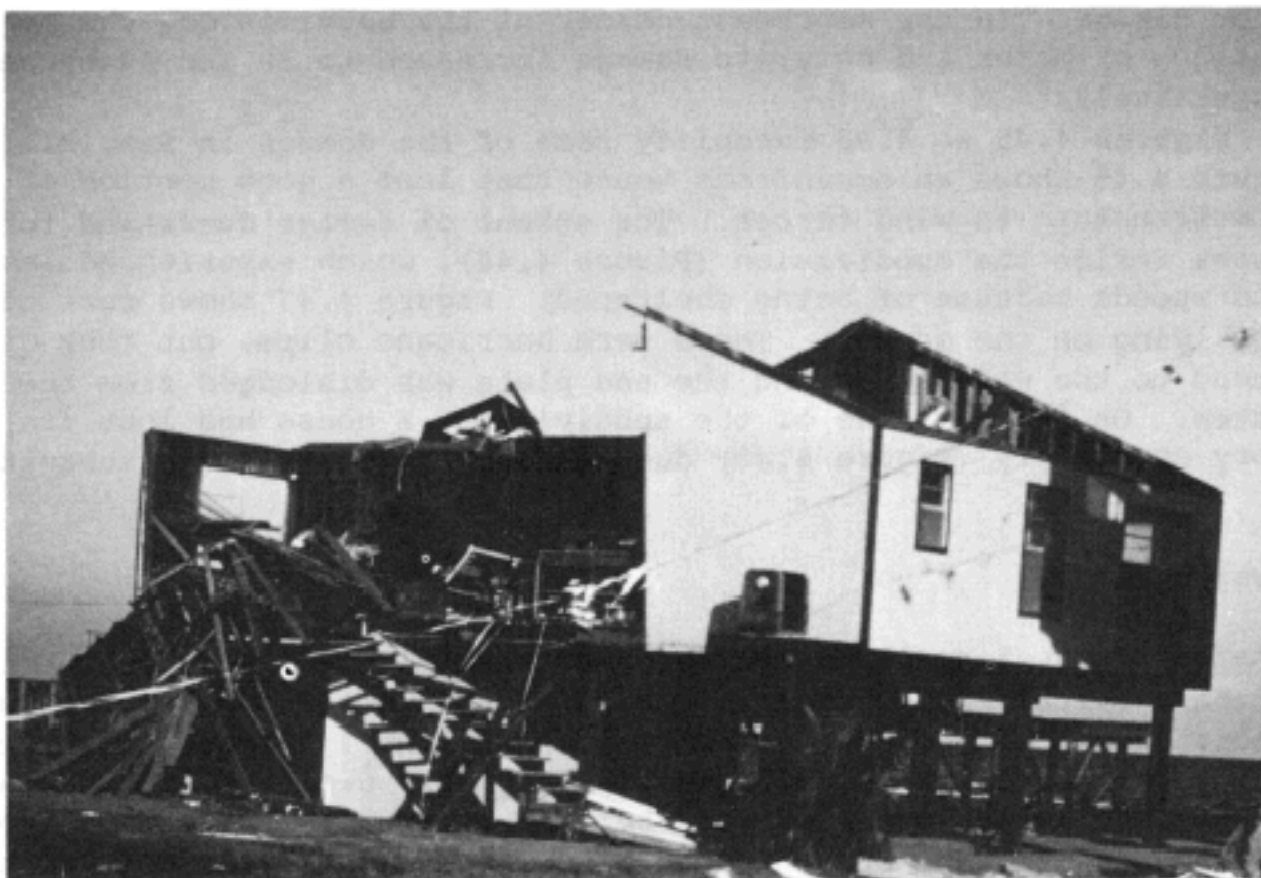
FIGURE 4.45 Damaged house fronting the Gulf in Sea Isle.

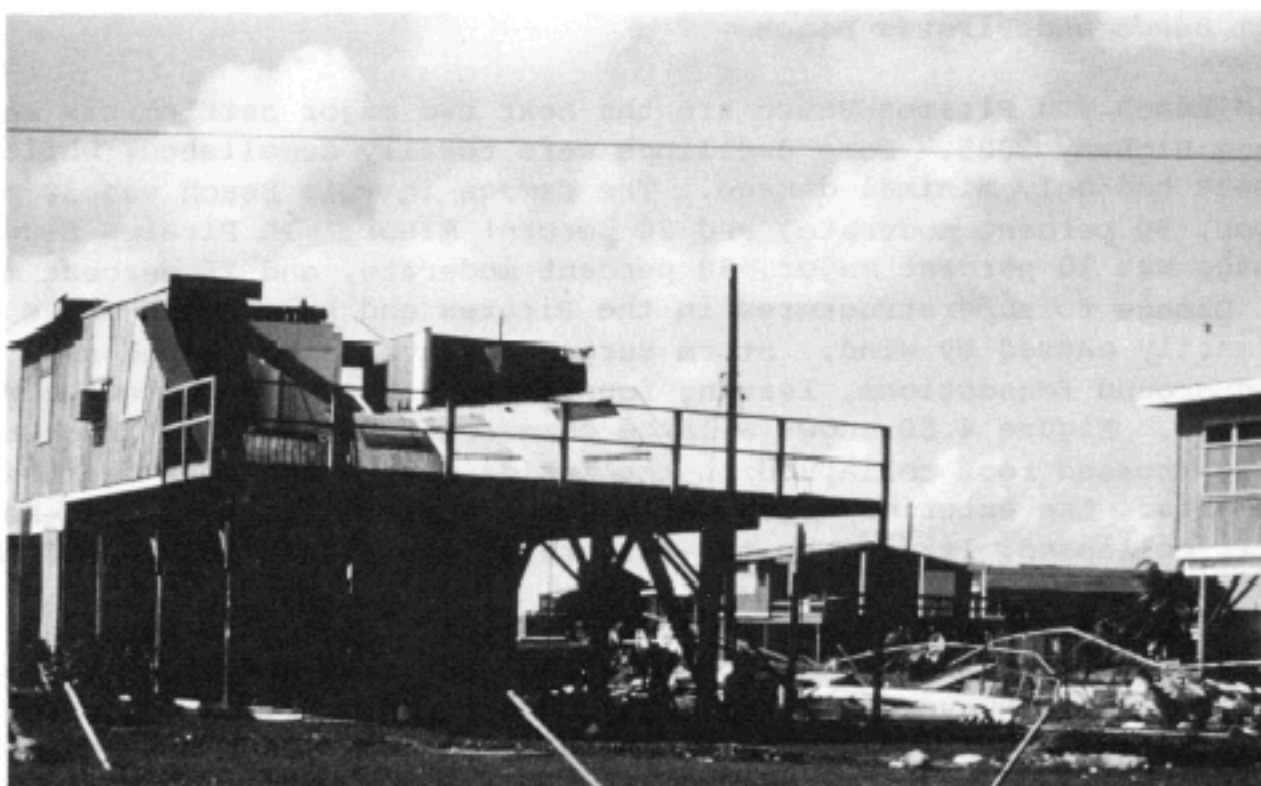
FIGURE 4.46 Damaged house in the second block from the coast in Sea Isle.

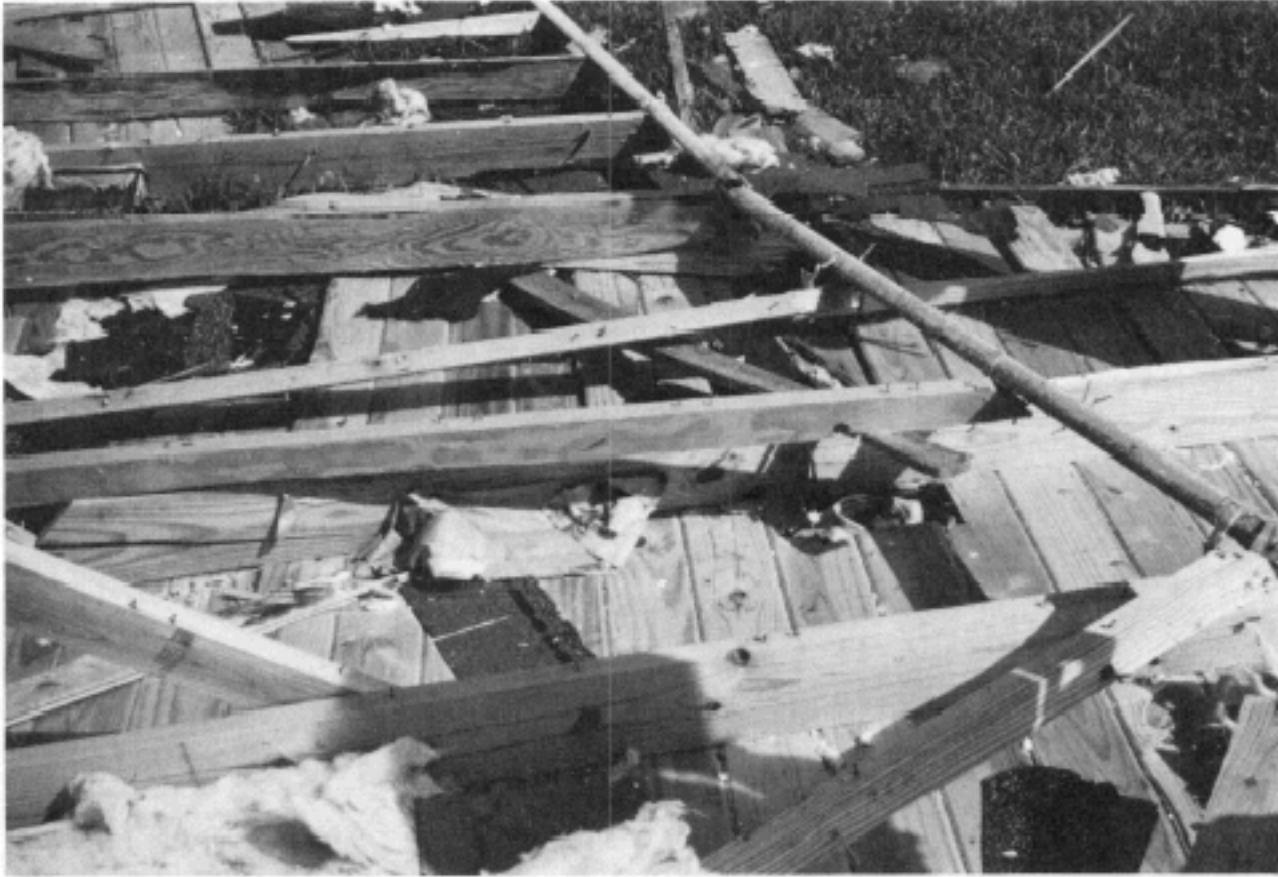
FIGURE 4.47 Details of end plate connections with rafters and hurricane clips.

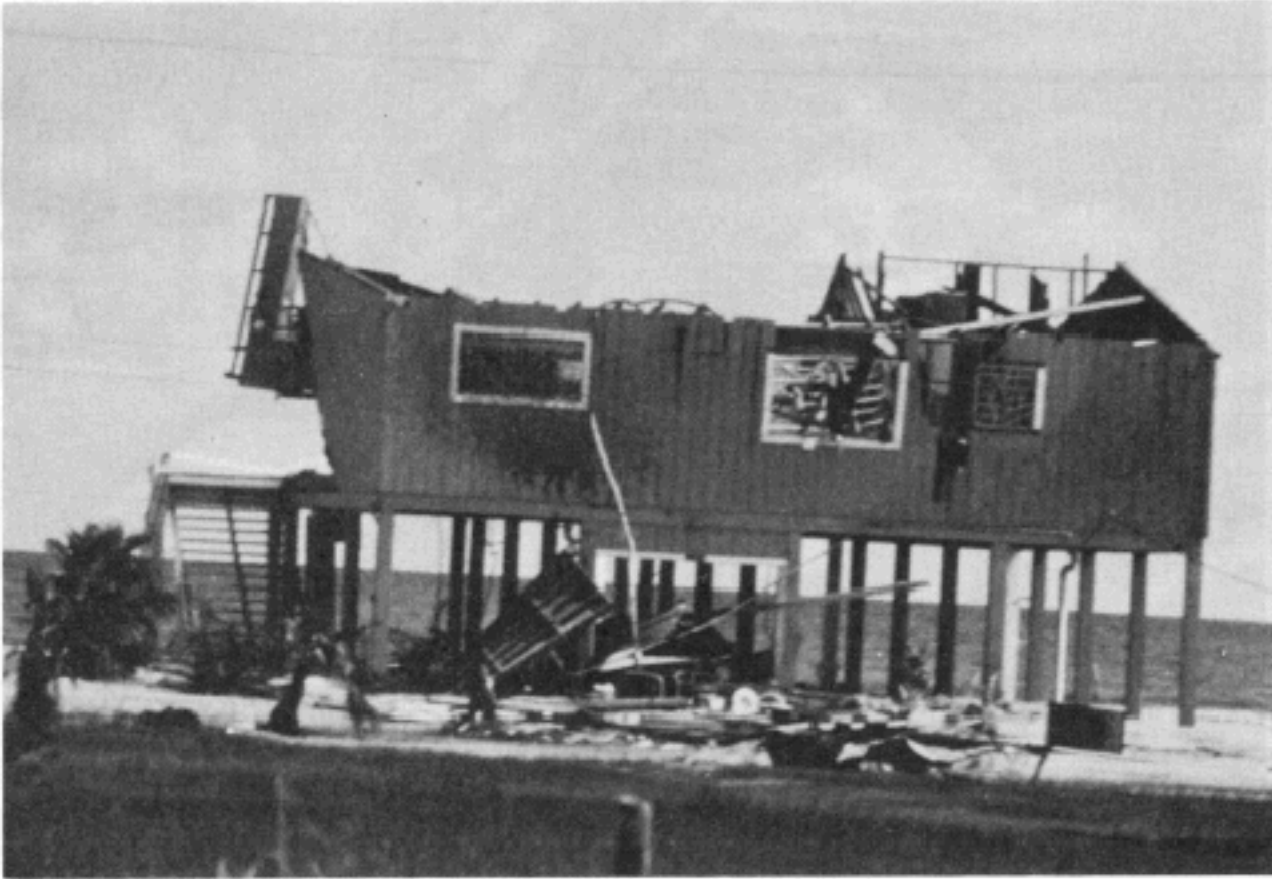
FIGURE 4.49 Damaged house in Jamaica Beach.

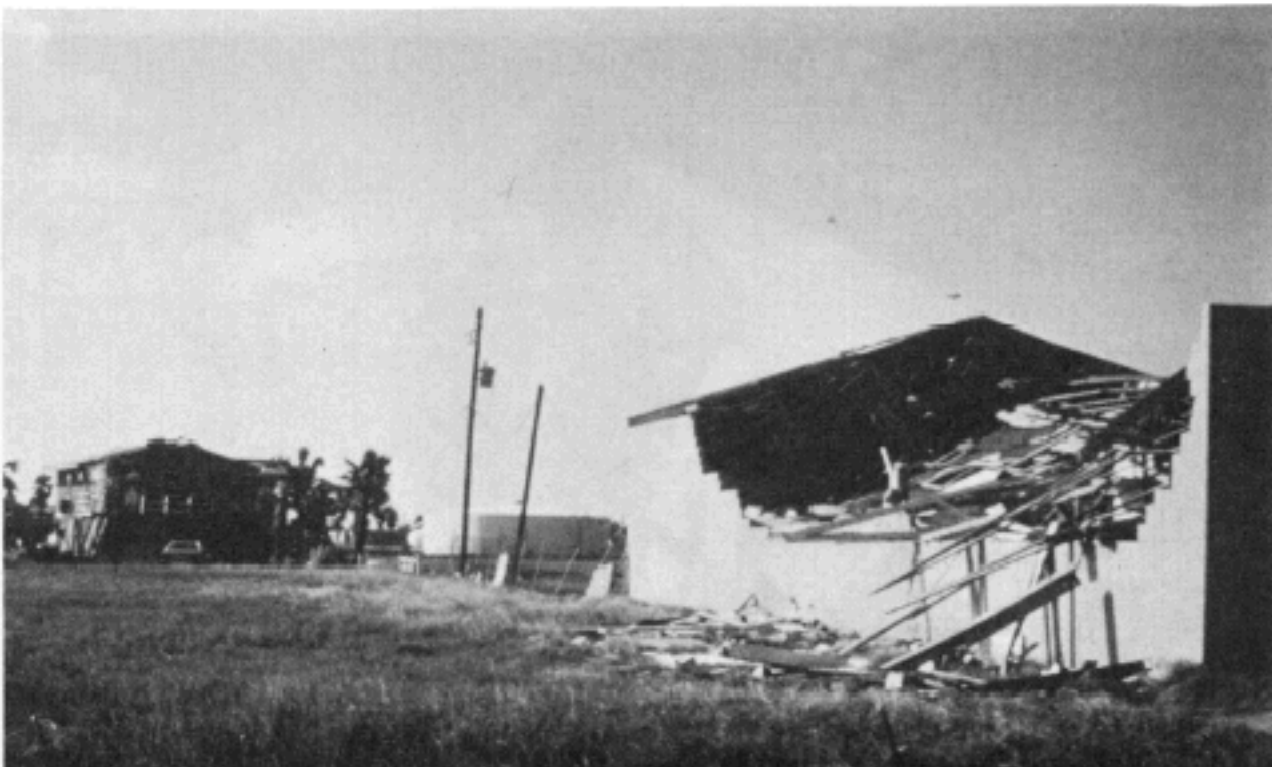
FIGURE 4.50 Damage to a large commercial warehouse building.

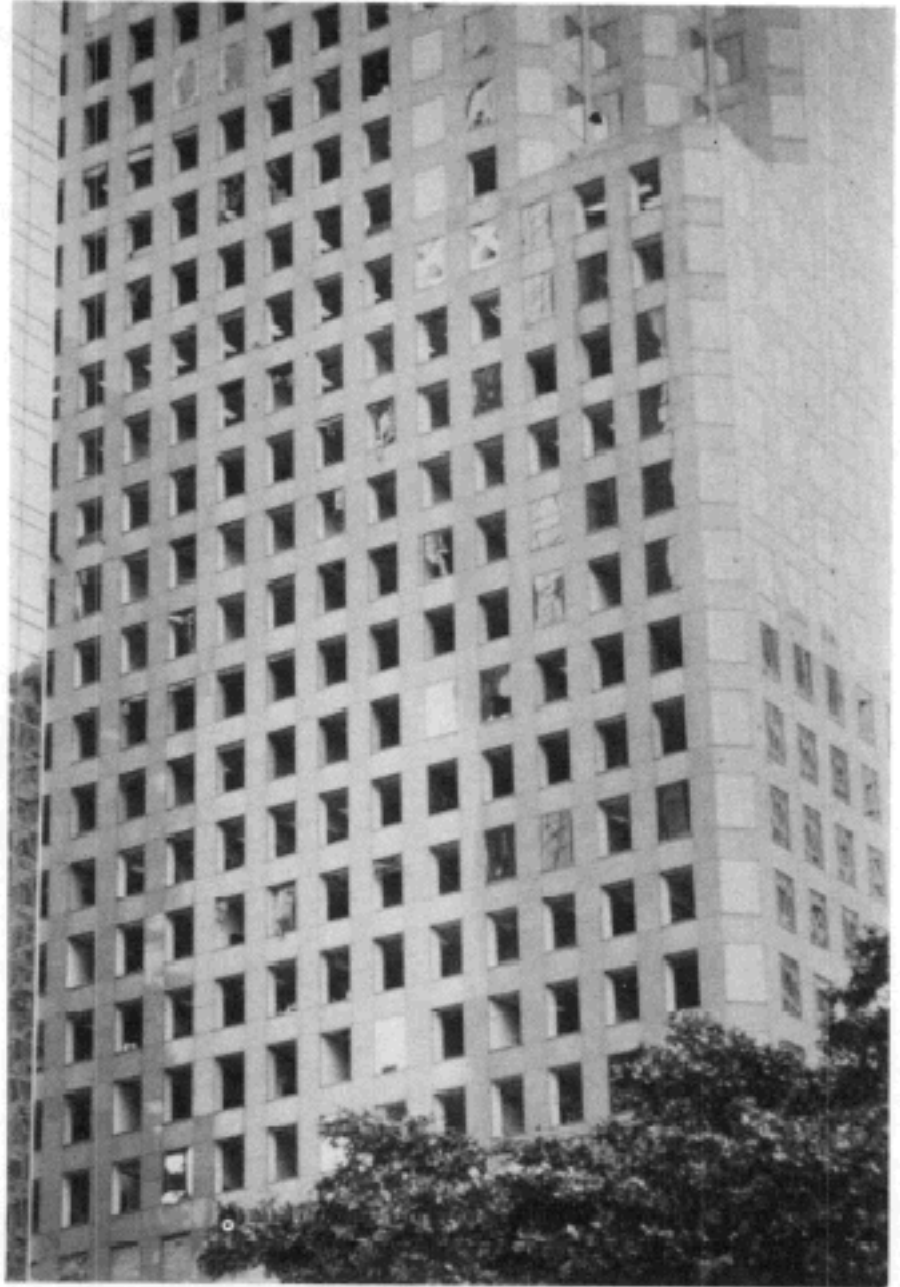
The 51-story InterFirst Plaza at 1100 Louisiana suffered heavy glass damage on the northeast and southeast faces, losing approximately 630 glass panels (16 percent of the total). In addition, a number of glass panels were damaged during cleanup operations when workers knocked out the broken glass remaining in frames, letting it fall to the street below. Falling glass hit other glass panels, producing further damage. [Figure 4.5](#) shows the lower part of the northeast face of the InterFirst Building. The InterFirst Plaza has pink, double-pane, annealed glass on the exterior that does not shatter like tempered glass but instead breaks into large chunks. A closer view of broken glass in the Inter-First Plaza is shown in [Figure 4.6](#). Some window blinds from this building were found near the Houston Library, a couple of blocks to the northwest of the building. Large amounts of paperwork and other office contents were reportedly sucked from this building during the storm. Windowpane damage was largely limited to loss of outer panes. The study team's observations inside the building on many floors showed little water damage. The motion of this building was not monitored. Motion was perceived, however, by the building maintenance crew, who stayed inside the building during the storm. Elevators squeaked during the hurricane, and the building's motion was quite noticeable to occupants.

FIGURE 4.5 Glass damage to the northeast face of the InterFirst Tower.

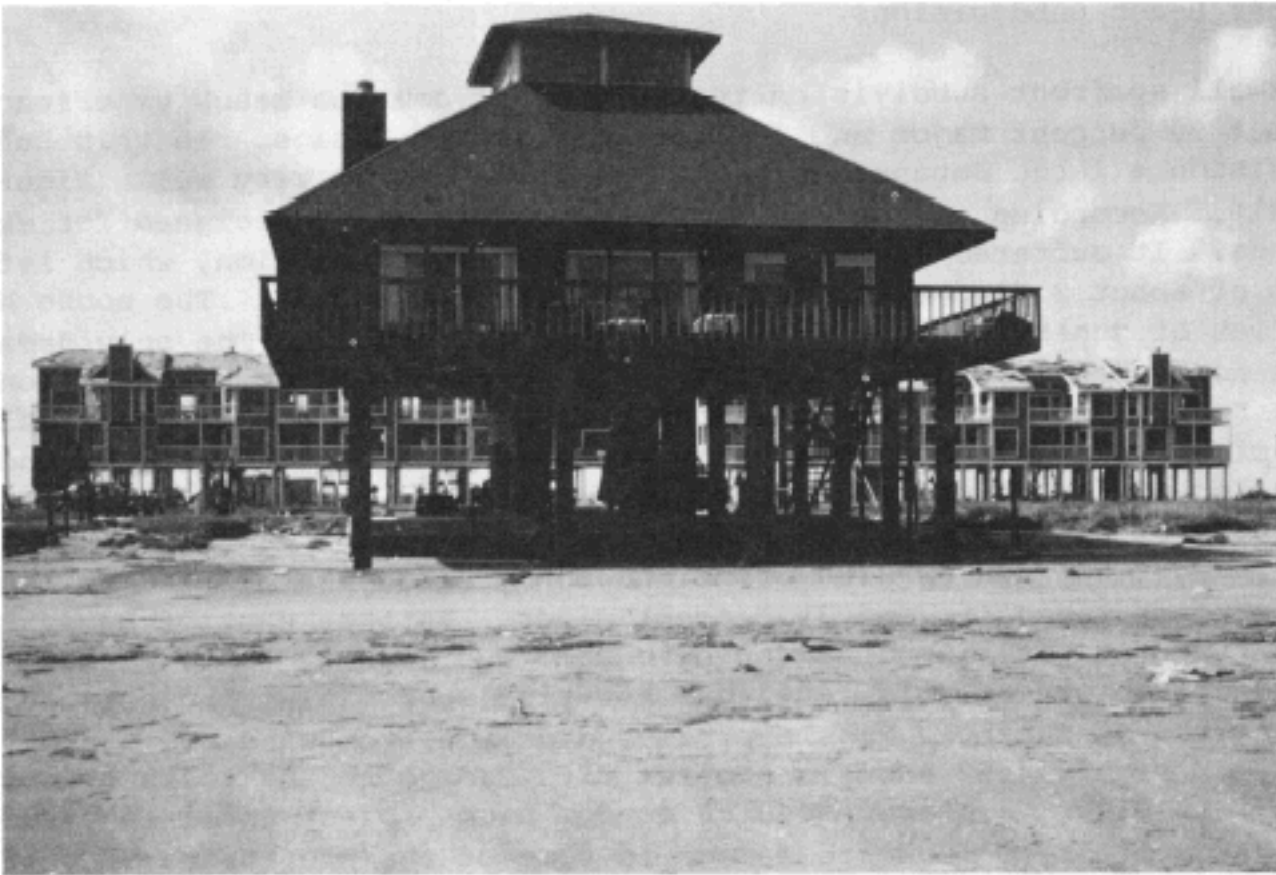
FIGURE 4.51 Example of a well-constructed house that performed very well except for erosion around the foundation.

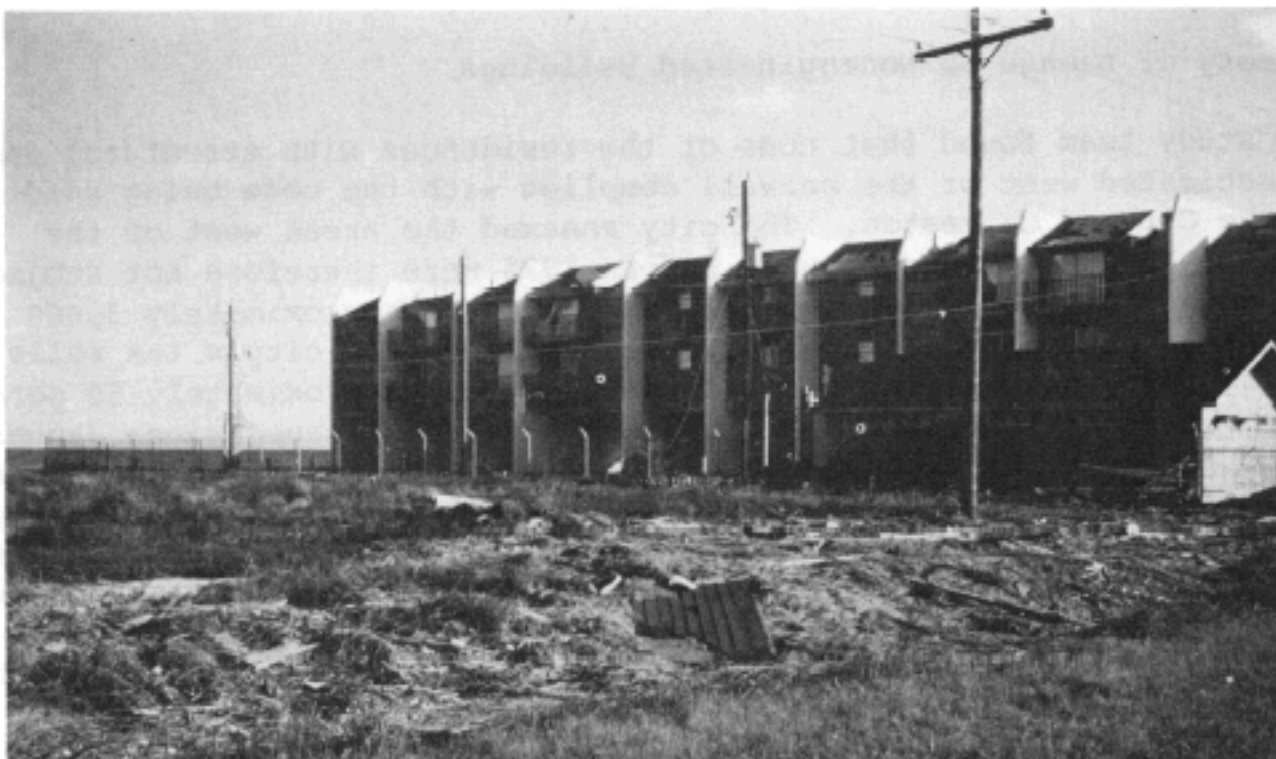
**FIGURE 4.52** Damage to the roof and erosion around foundations of condominium units on the west side of San Luis Pass.

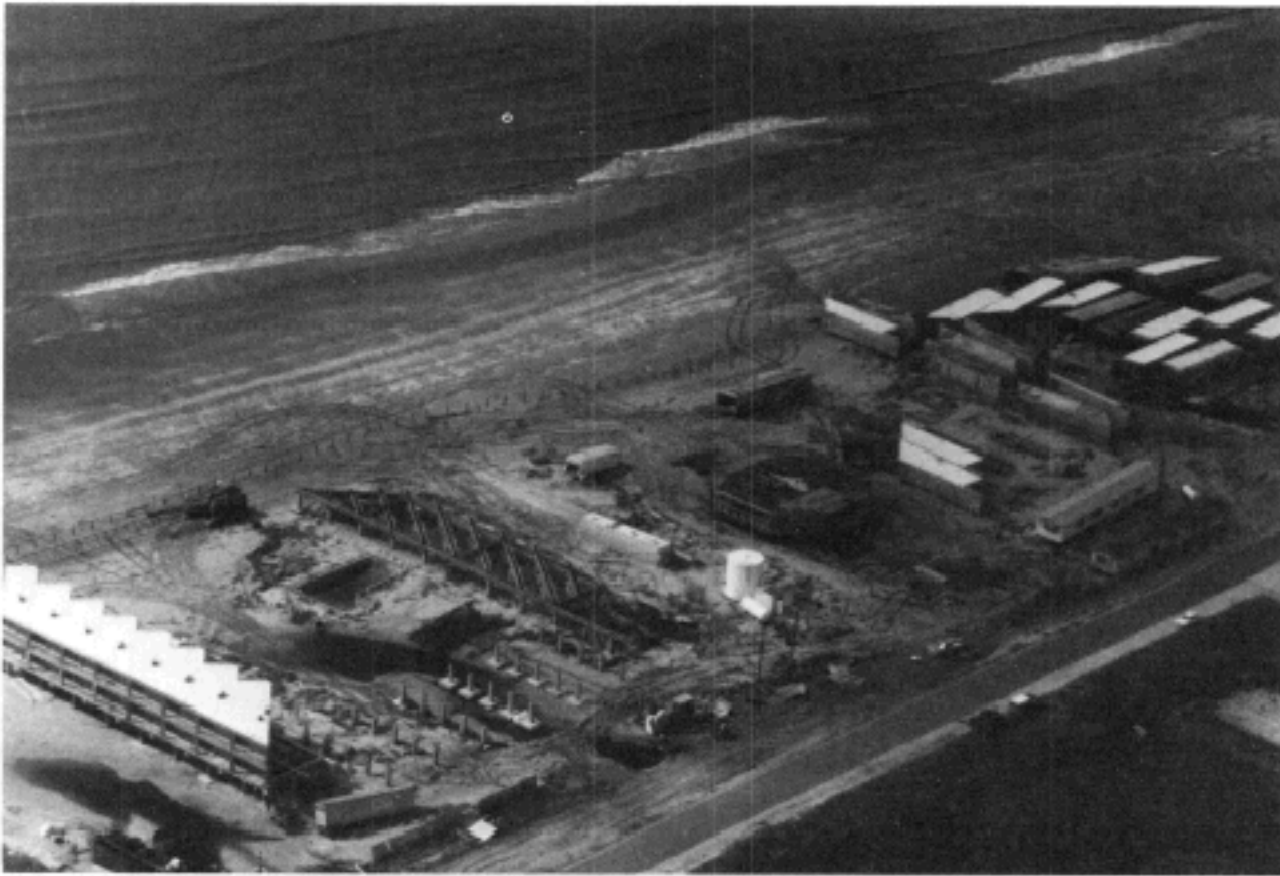
FIGURE 4.53 General view of a modular condominium project that experienced damage from wind and storm surge.

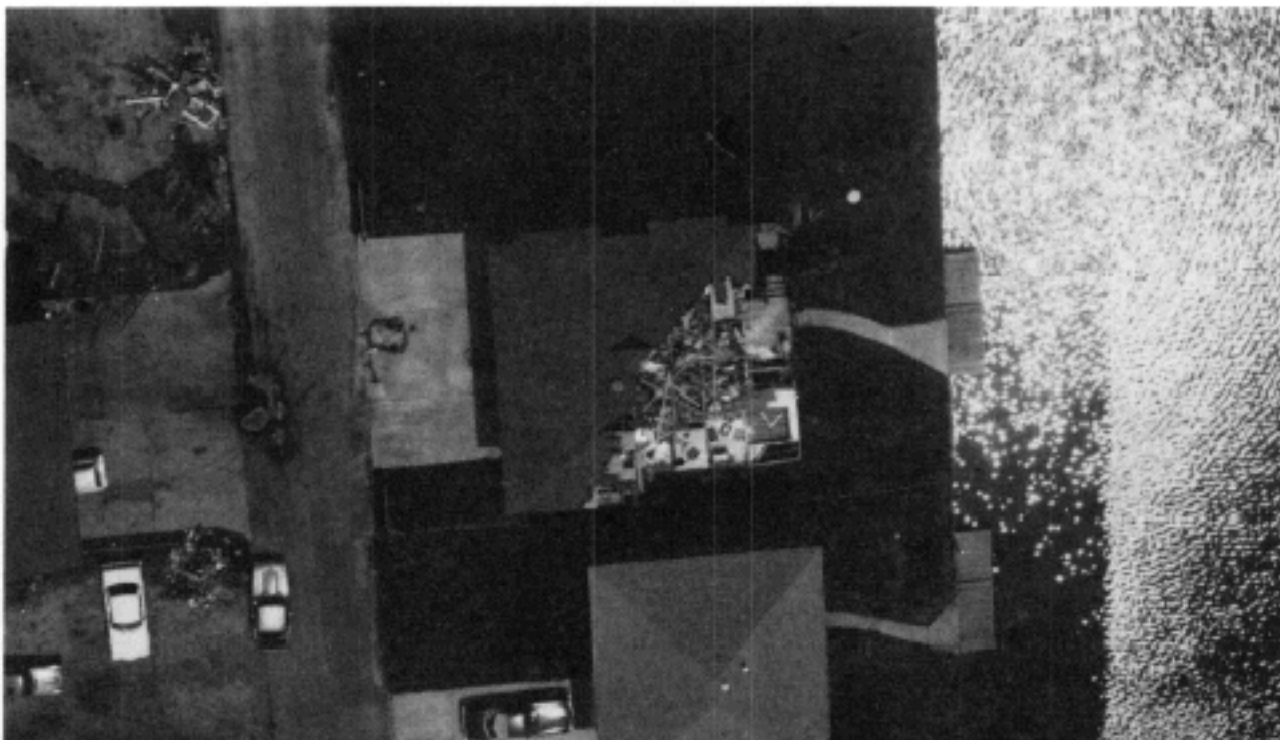
FIGURE 4.54 Aerial view of roof damage.

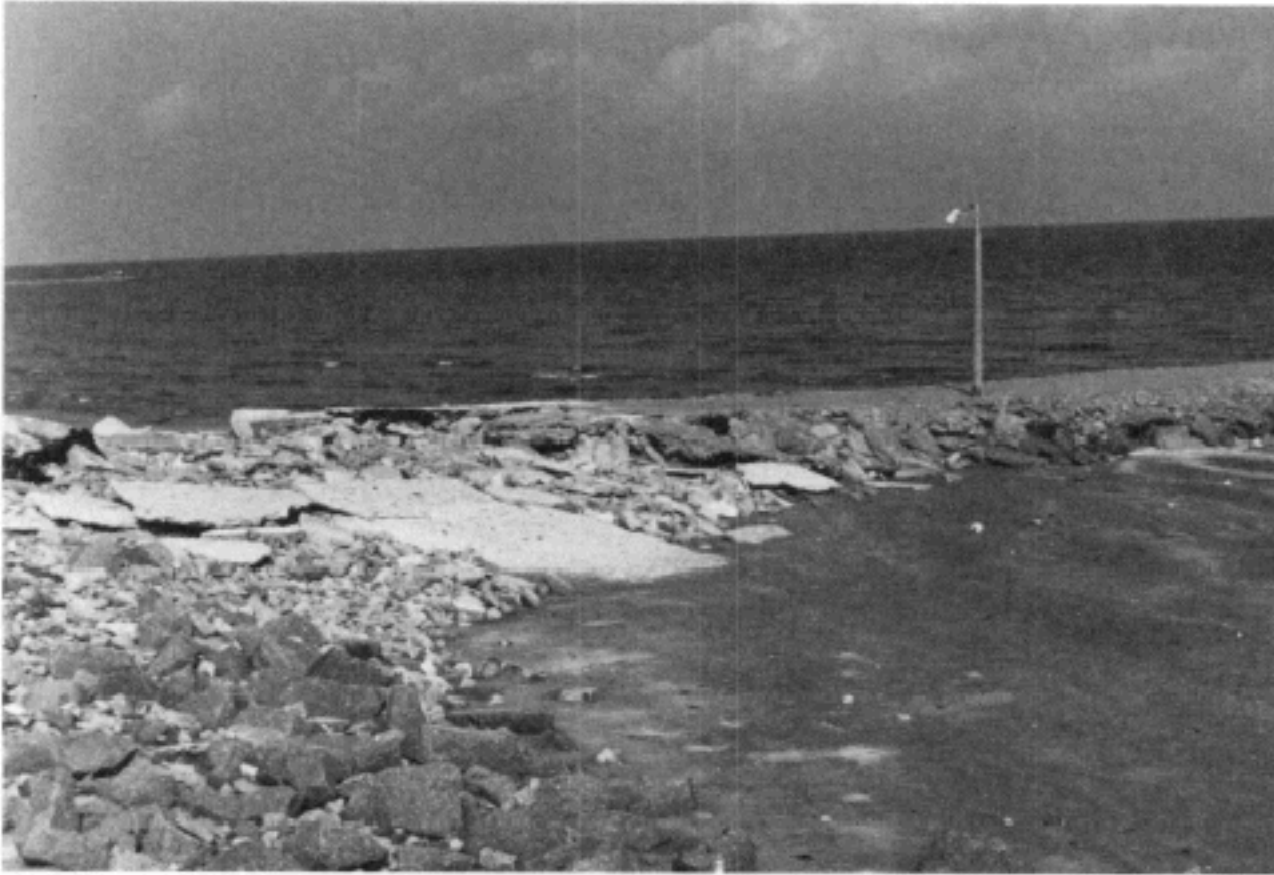
FIGURE 4.55 Damage to groin in front of the Galveston seawall.

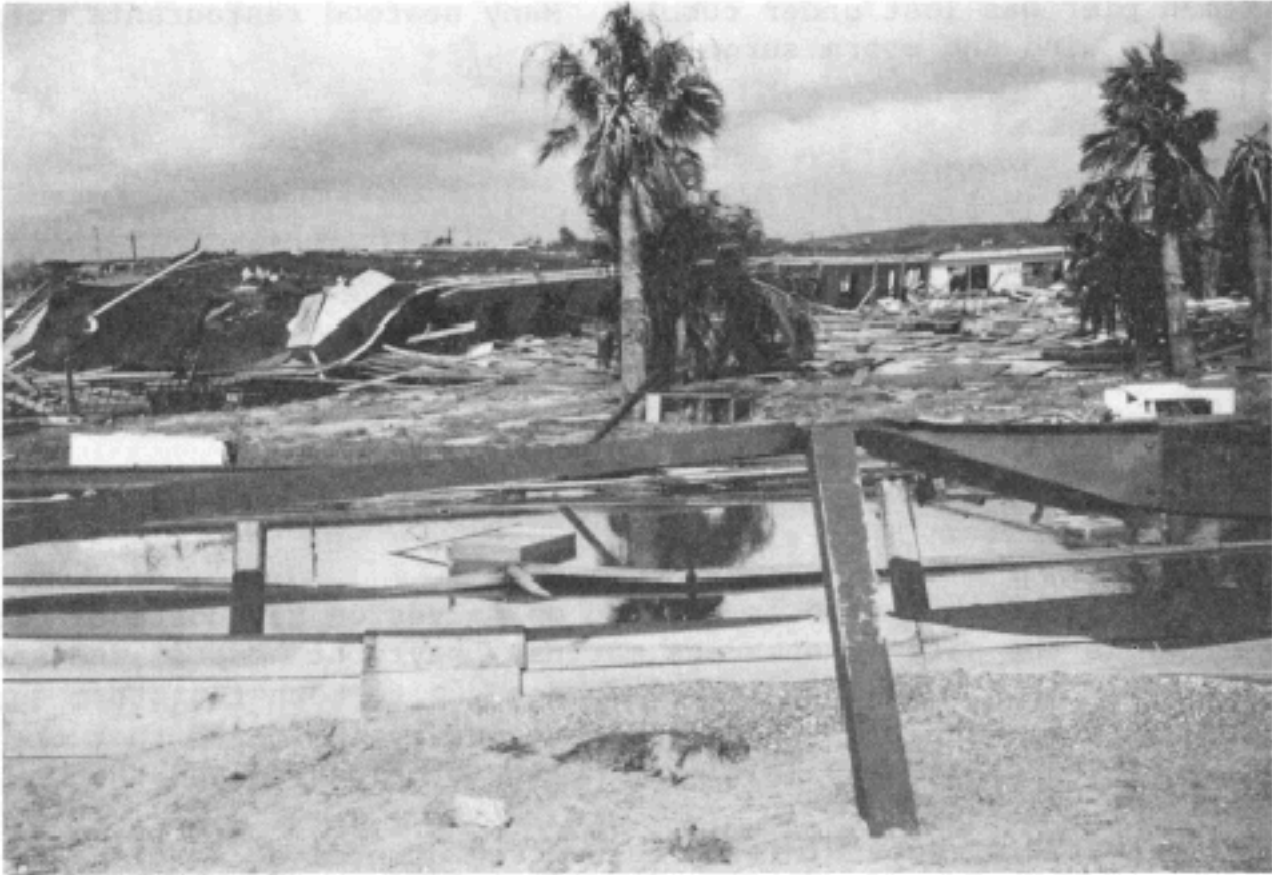
FIGURE 4.57 An elevated motel transported off its foundation by the storm surge.

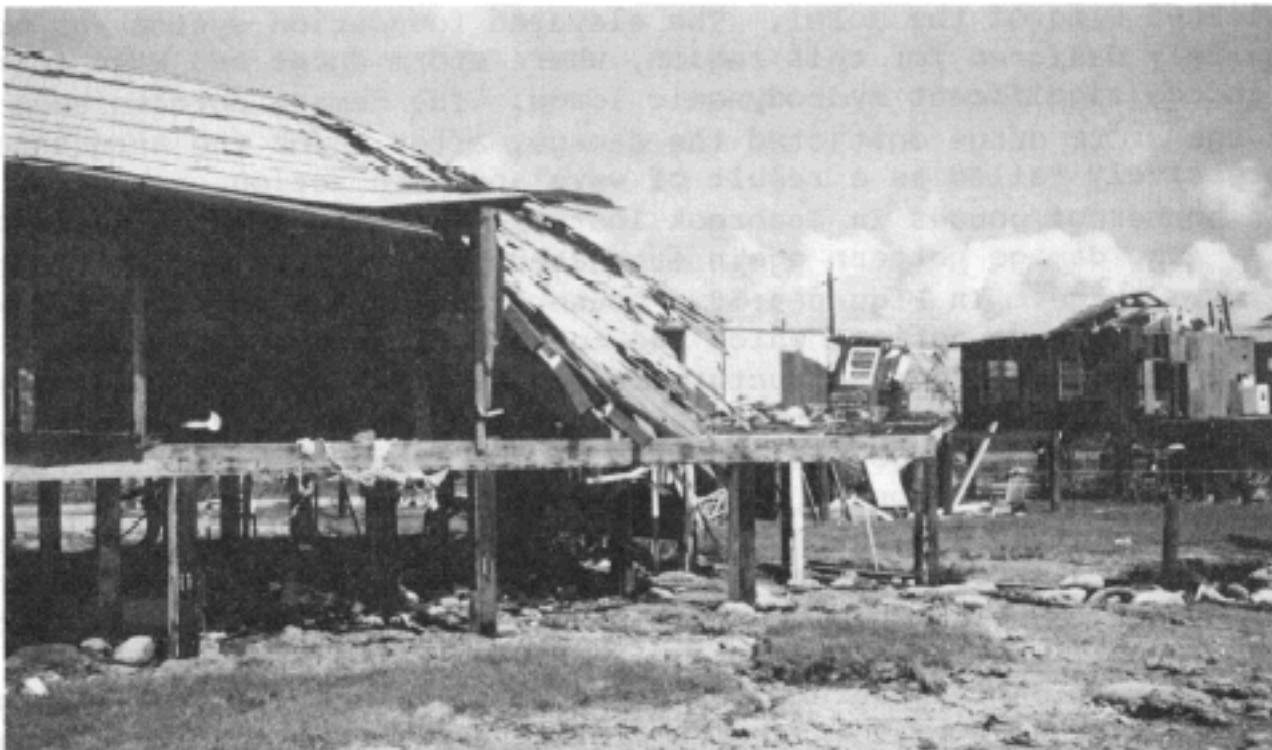
**FIGURE 4.58 Bayfront house with a collapsed roof.**

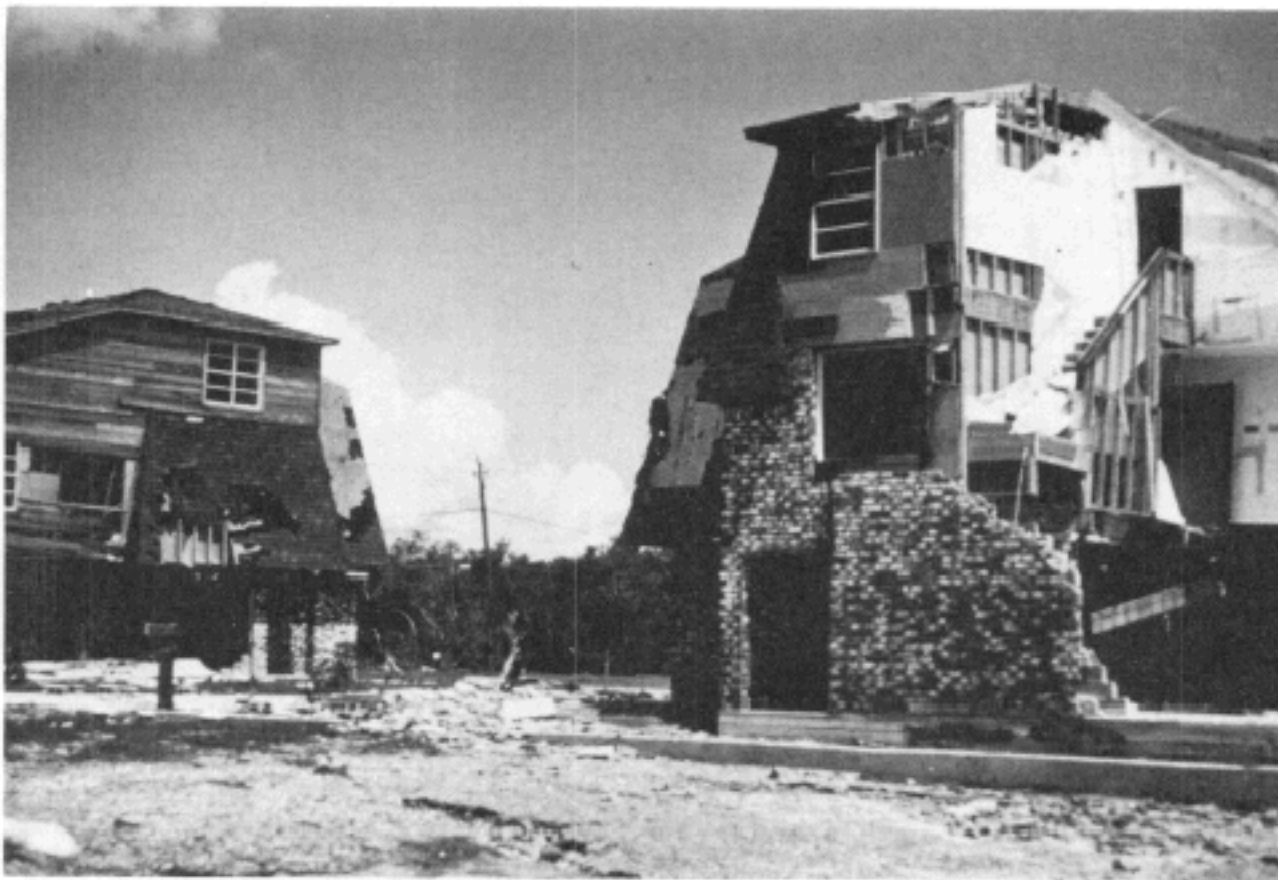
FIGURE 4.59 Failure of the roof and brick veneer wall of a condominium.
