# **Hurricane Alicia Galveston and Houston, Texas August 17-18, 1983**

**Committee on Natural Disasters  
Commission on Engineering and Technical Systems  
National Research Council**

NATIONAL ACADEMY PRESS Washington, D.C. 1984

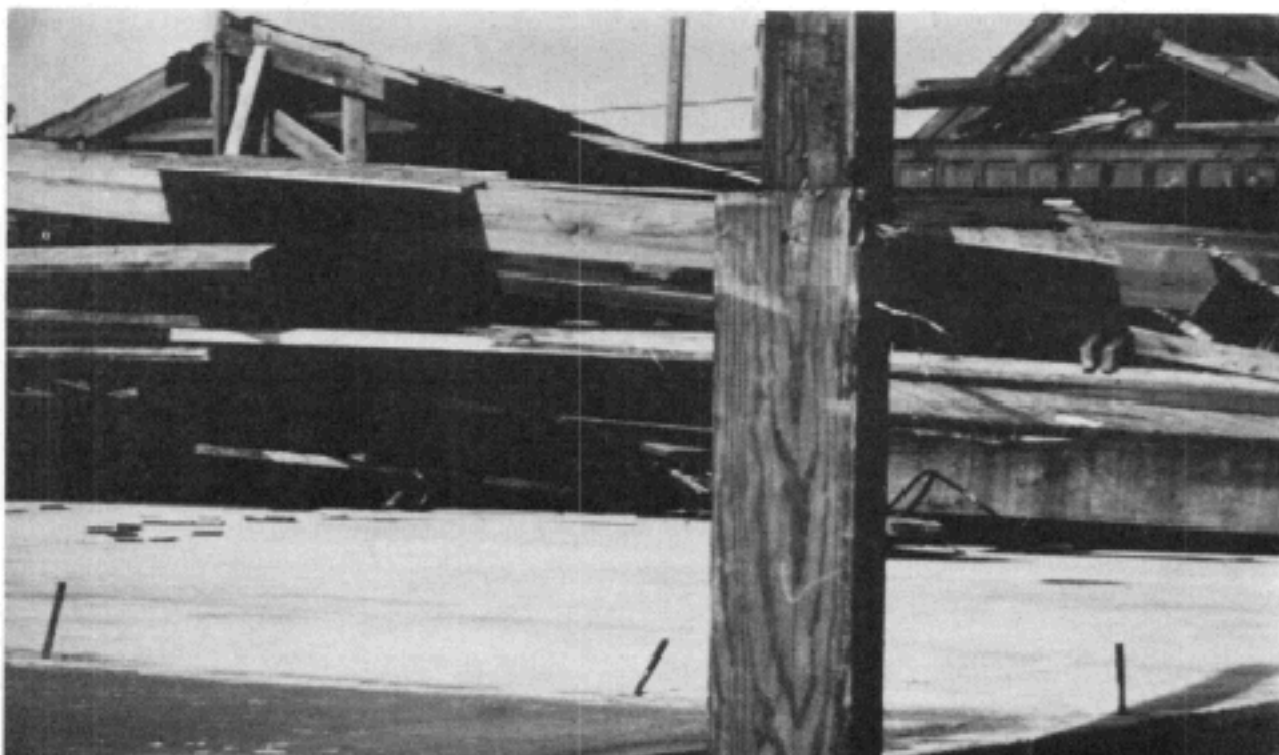
**FIGURE 4.60** House washed away from its foundation slab by storm surge.

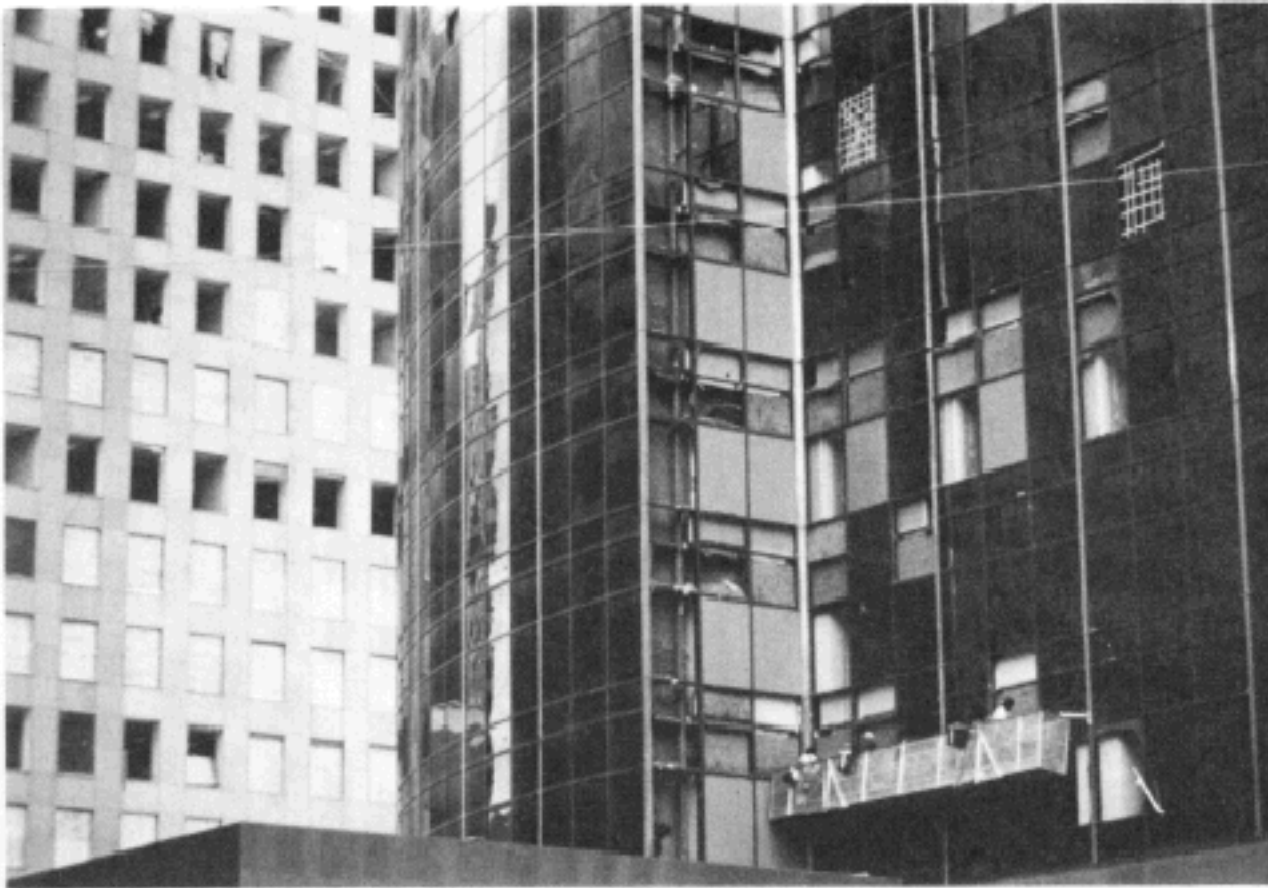
FIGURE 4.6 Closeup of damaged glass on the Allied and Inter-First towers.

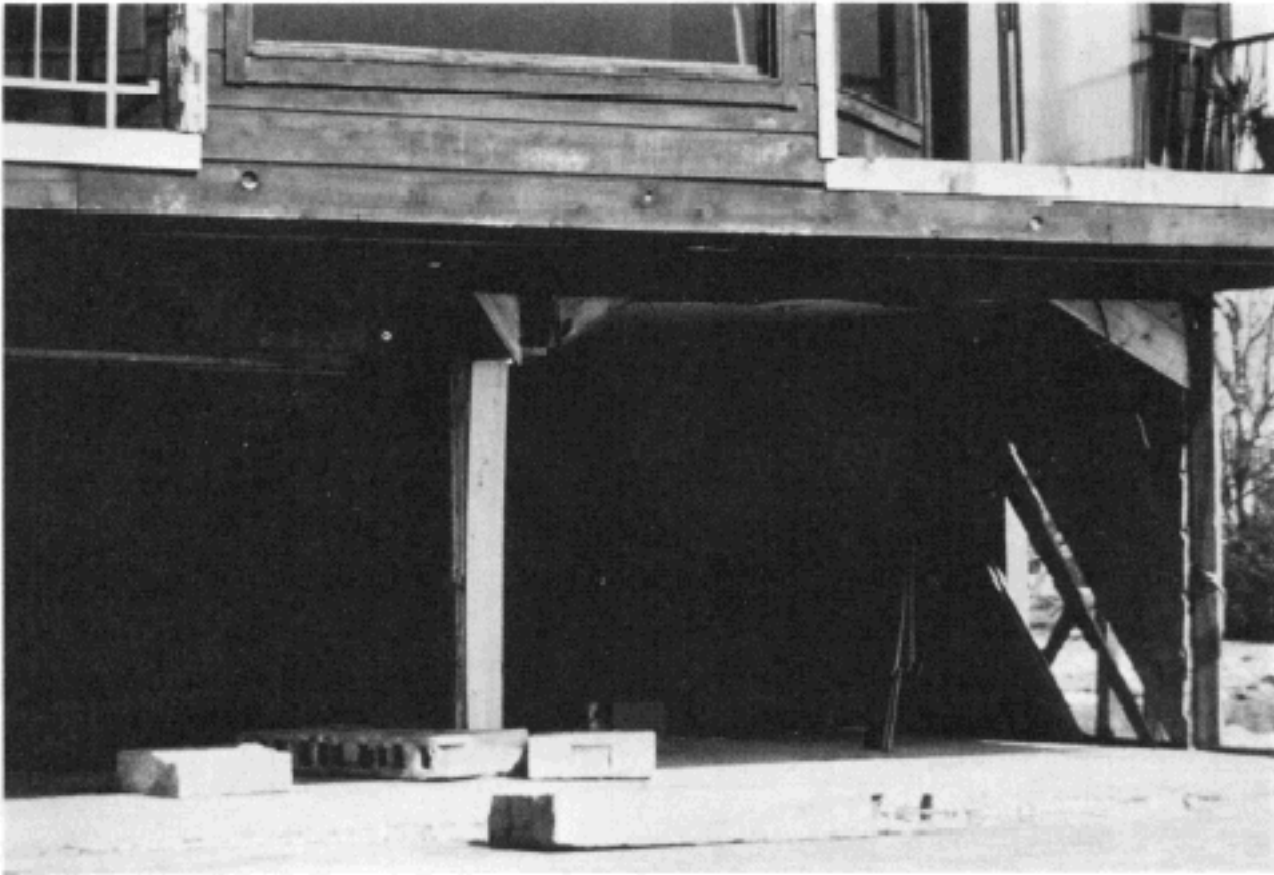
FIGURE 4.61 Damage to a grade-level enclosure.

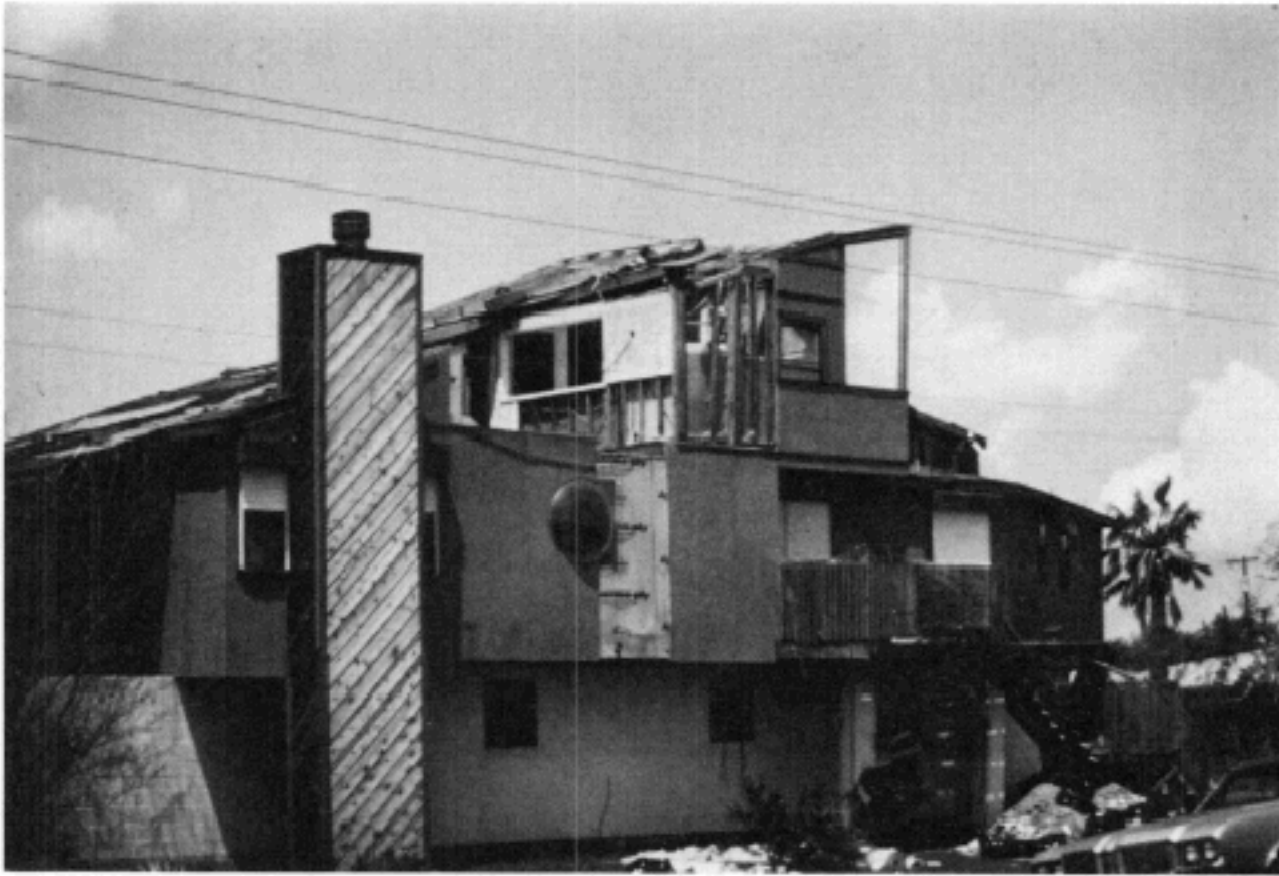
FIGURE 4.63 Roof damage to a condominium in Texas City.

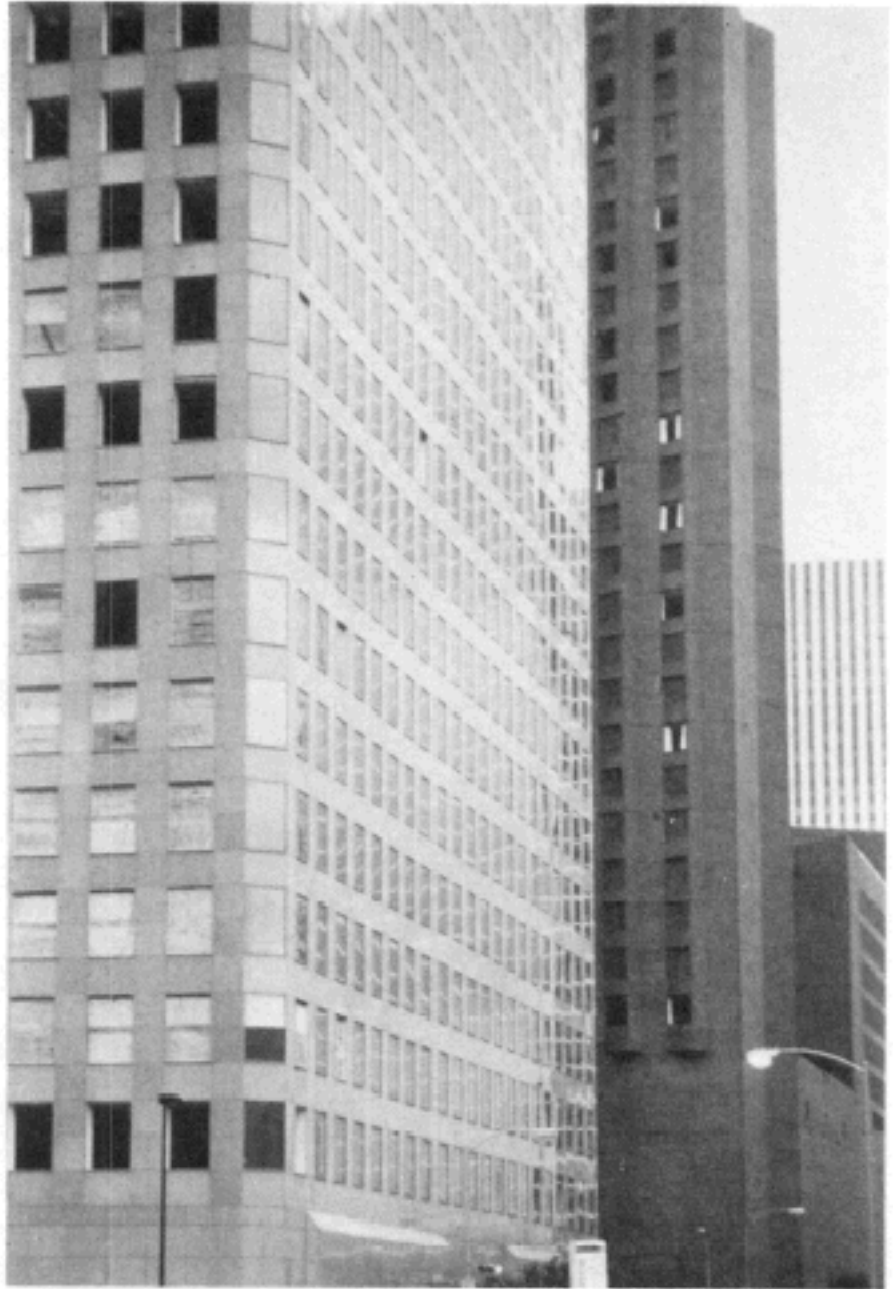
FIGURE 4.7 Window damage to the Hyatt Regency Hotel (the building in the background).

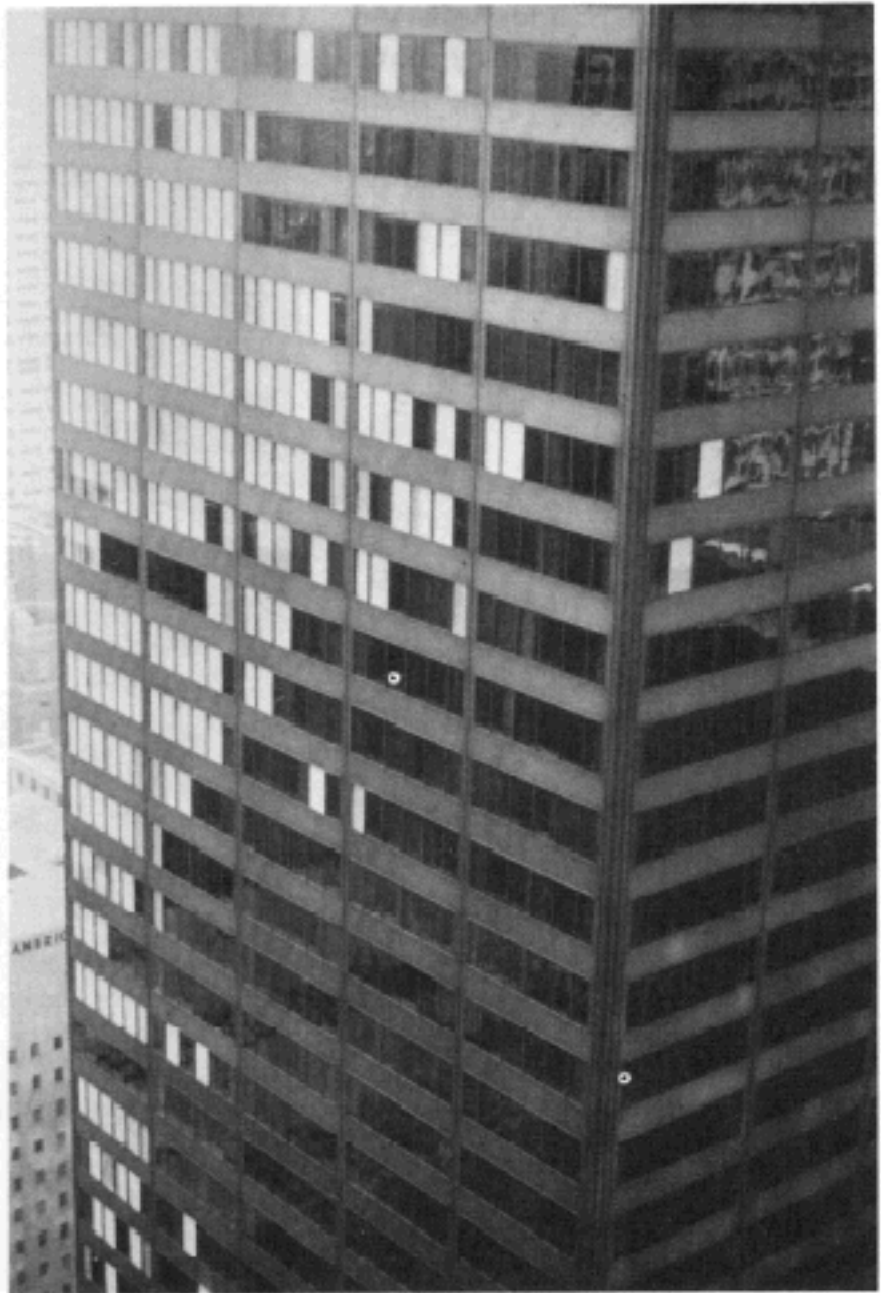
Breakage on the Milam building was concentrated on the northeast face around the level of the top of the Tenneco Building. [Figure 4.8](#) shows the bell-shaped damage pattern. Laminated sloped glazing at the plaza level of the Milam Building developed many cracks but stayed in place.

FIGURE 4.8 Closeup of  
glass damage to the Milam  
Building.

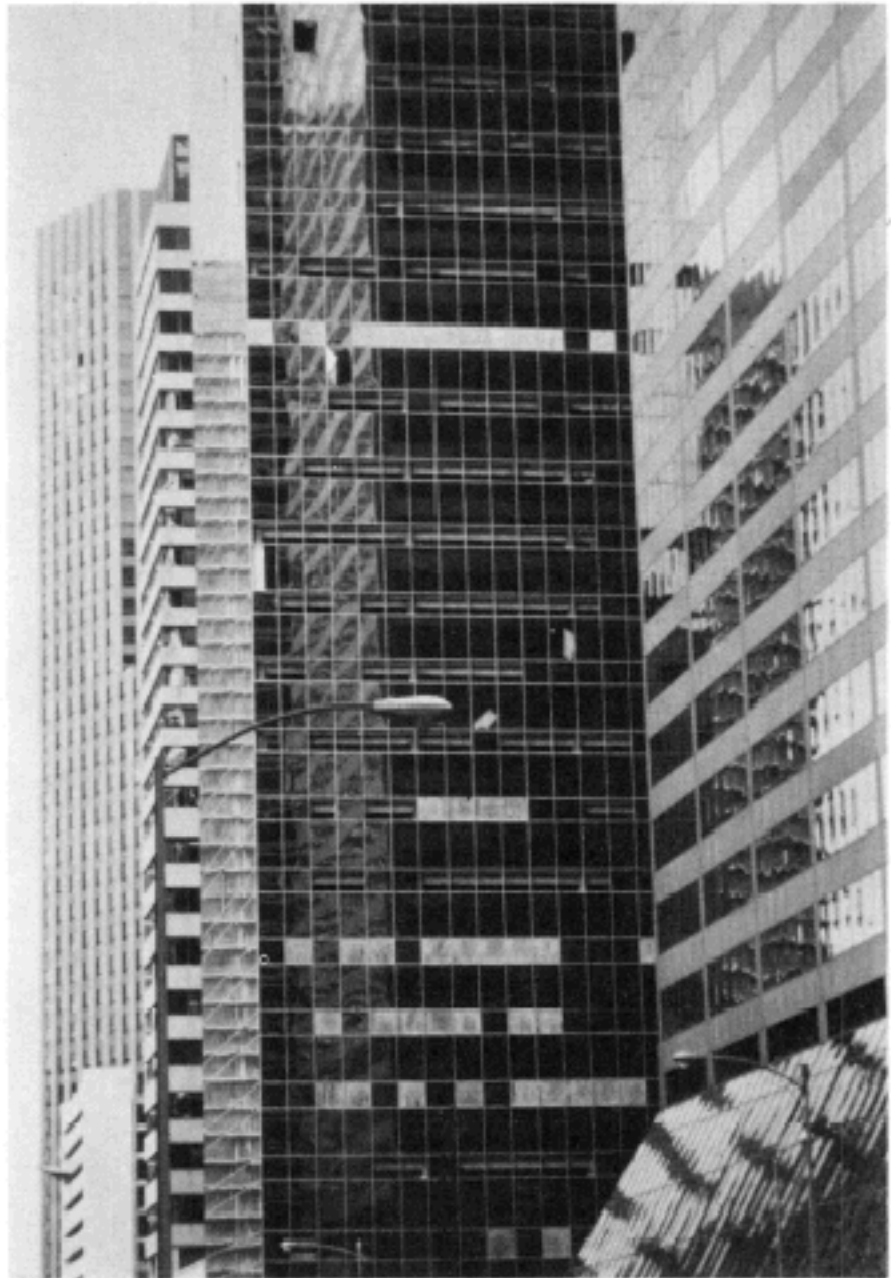
There was general glass breakage on the Entex Building, but damage was concentrated along the east corner of the northeast face ([Figure 4.9](#)). The breakage was more prevalent in the tempered spandrel glass. It should be noted that this building has a history of occasionally losing a glass panel.

**FIGURE 4.9** Glass damage to the northeast face of the Entex Building.

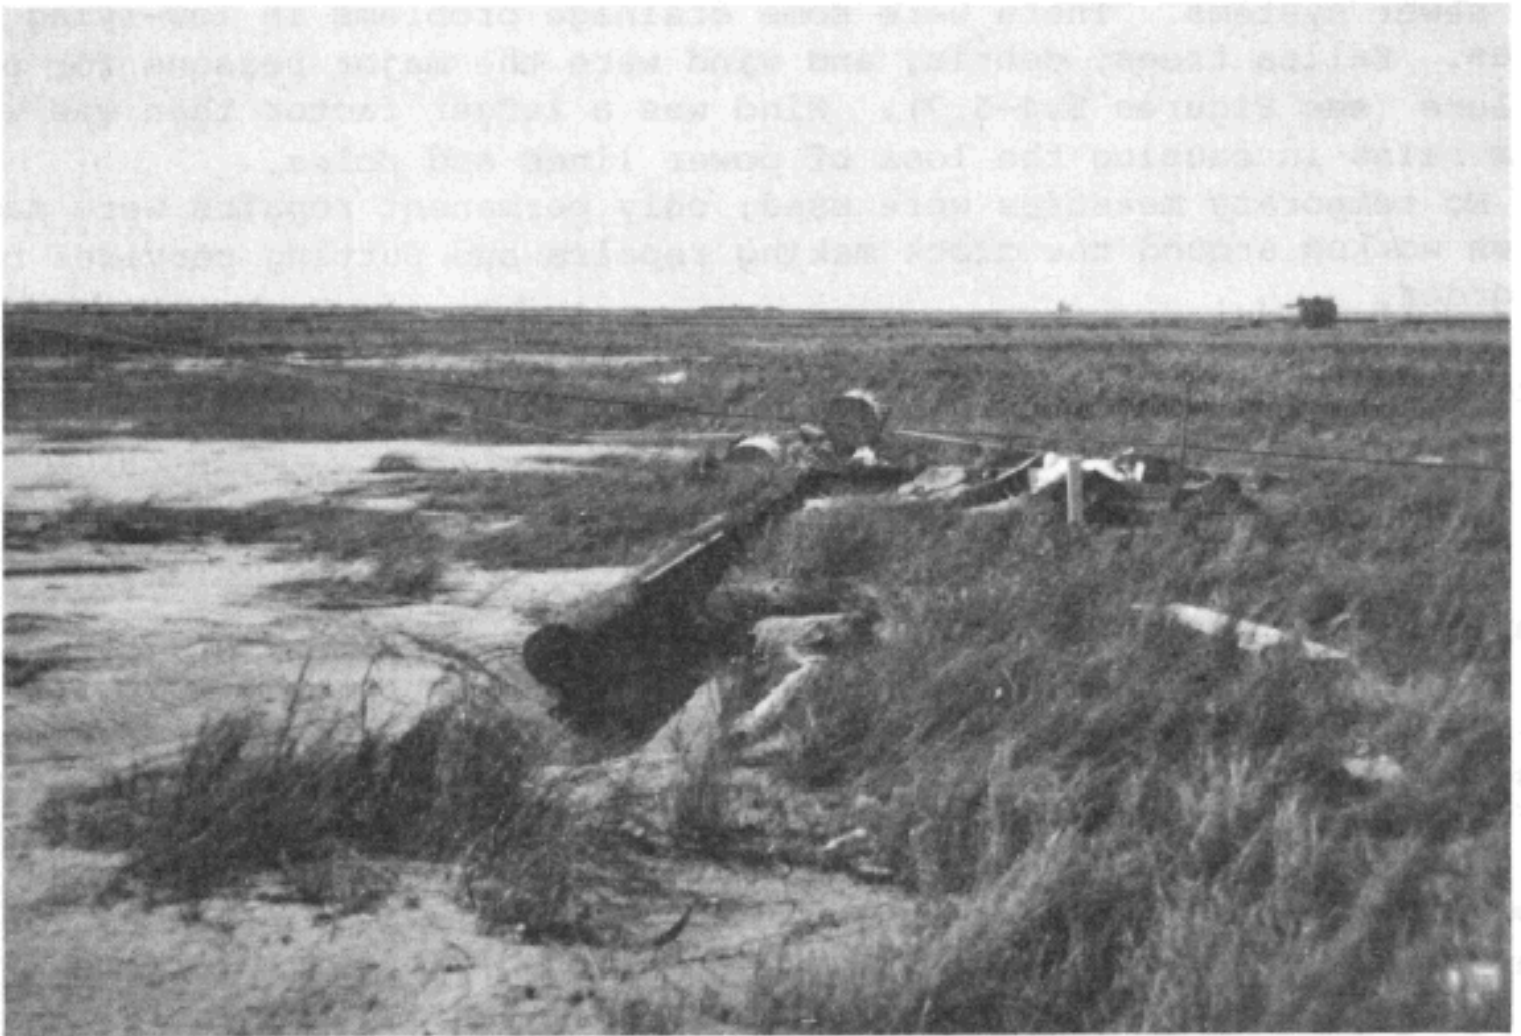
**FIGURE 5.4 Typical failure of transformer pole on East Beach, Galveston Island.**

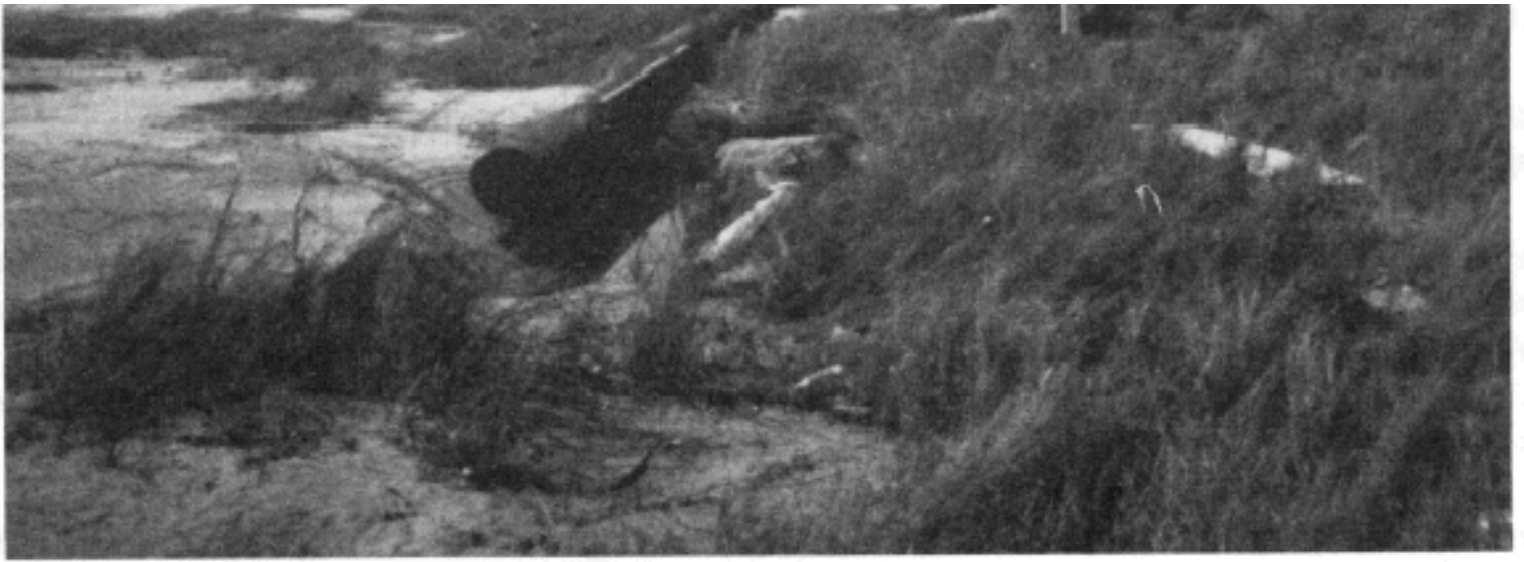
**FIGURE 5.5** Typical failure of utility pole on East Beach, Galveston Island.

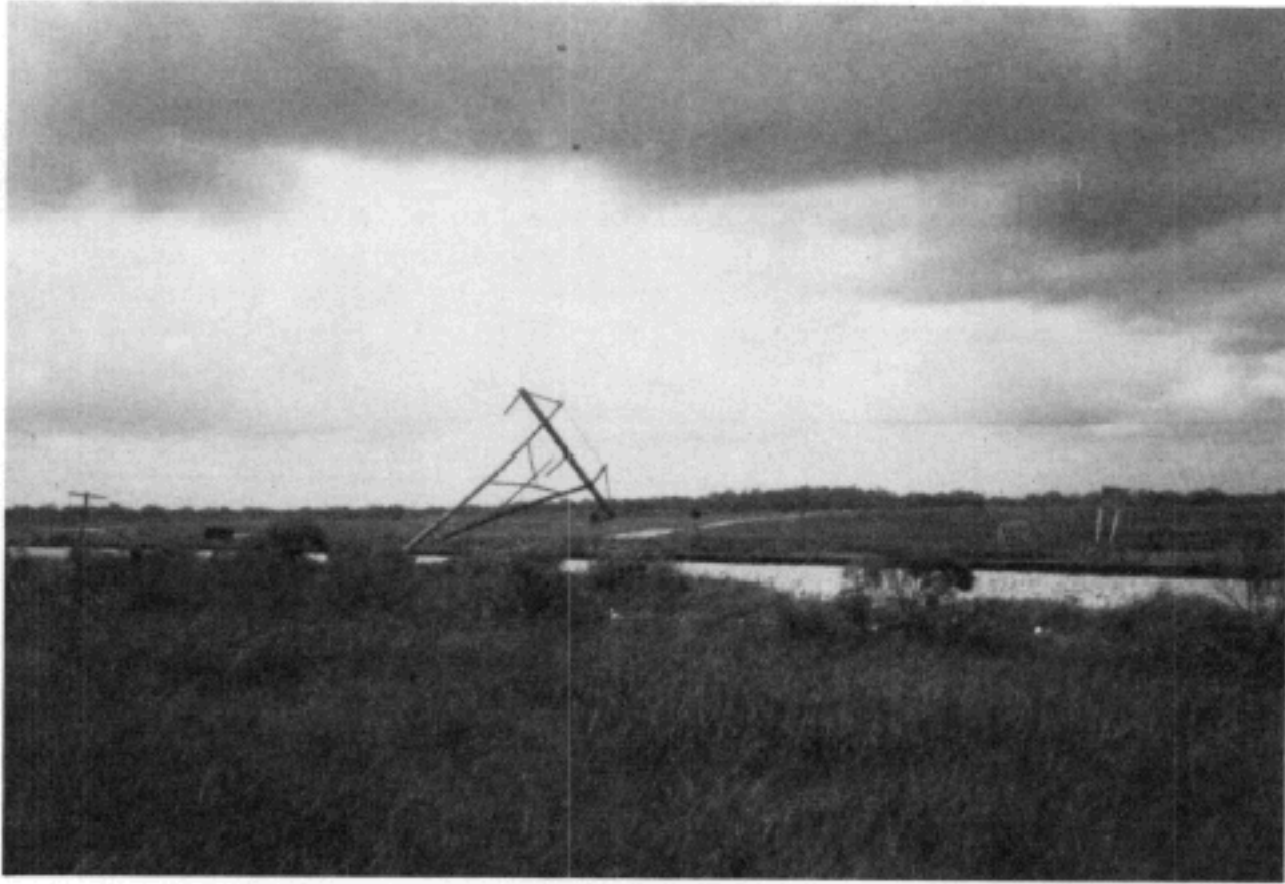
FIGURE 5.6 Failure of primary power pole near Highway 146 south of Bay City.

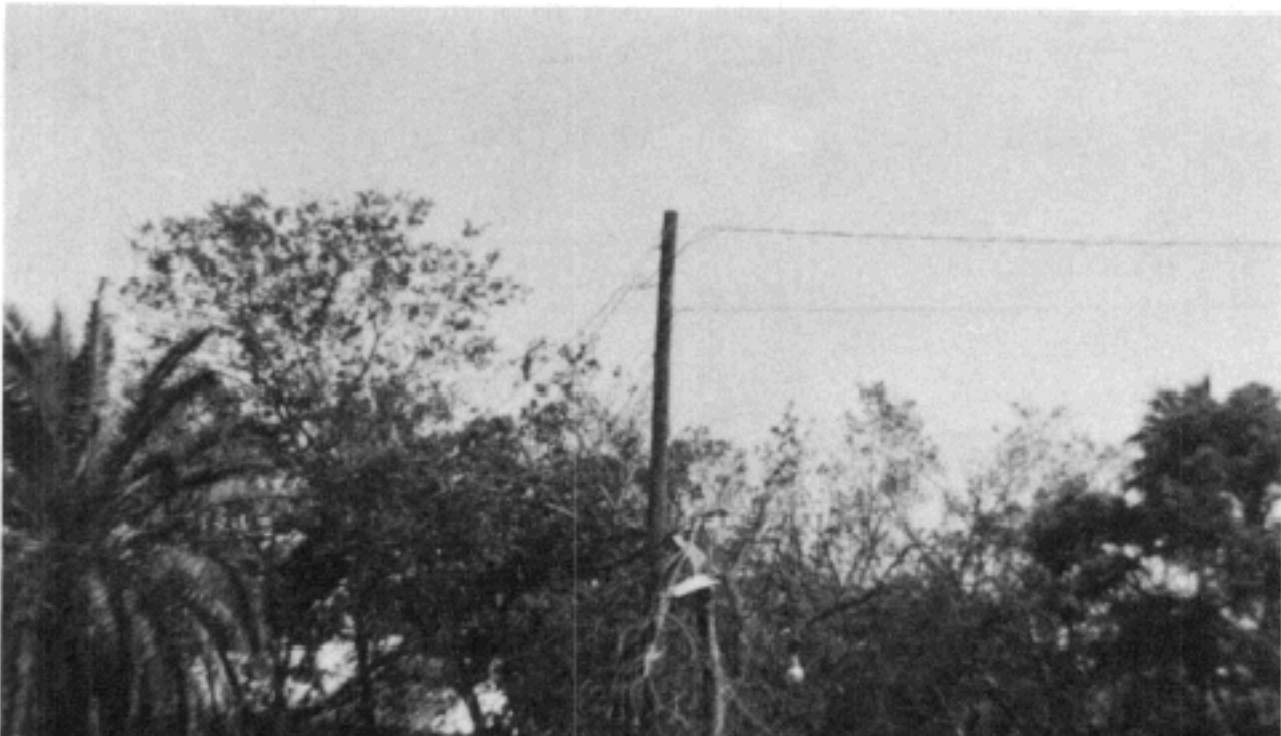
**FIGURE 5.7** Typical failure of utility line caused by fallen trees in Seabrook.

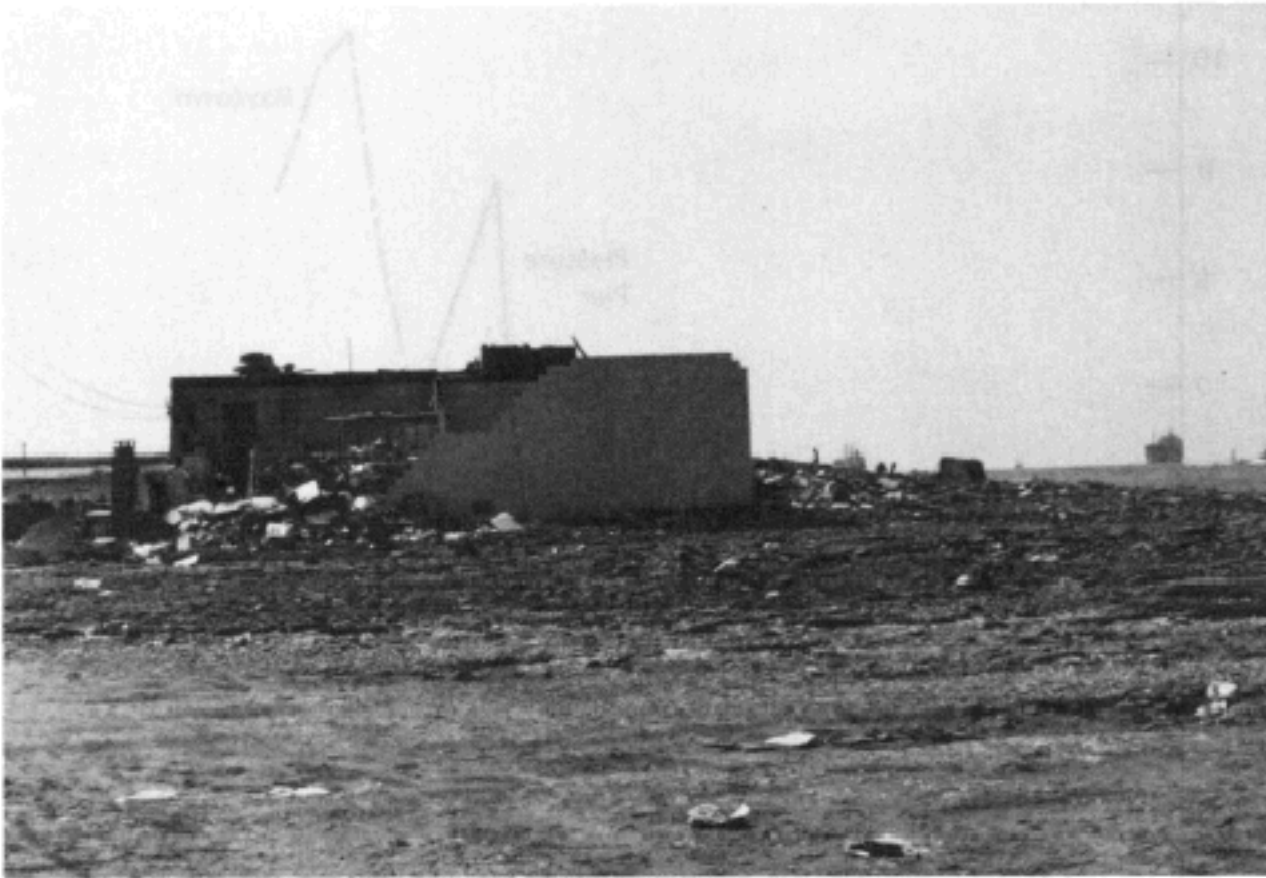
FIGURE 3.4 Scour and building damage near the intersection of the Galveston seawall and the west jetty of Galveston Inlet.

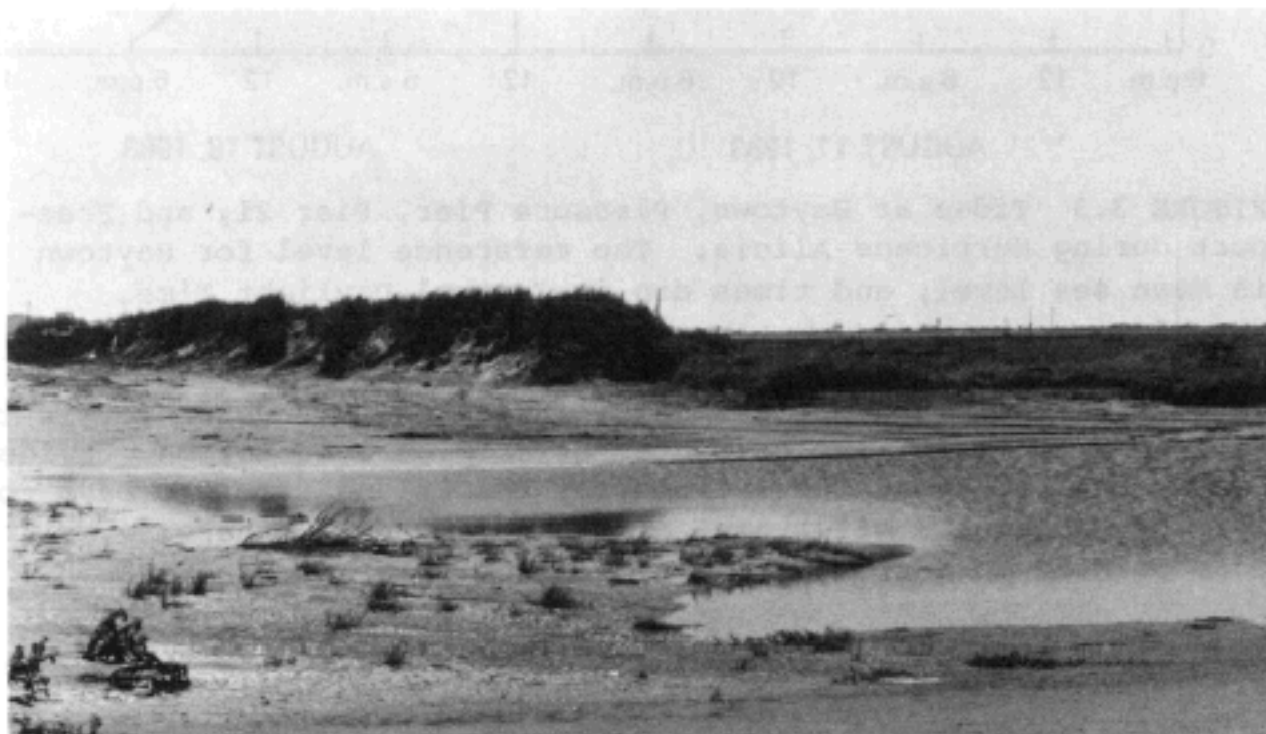
**FIGURE 3.5** Front of scour channel and frontal dune on East Beach showing dune erosion. Scour channel was caused by flow confined between the dune and an adjacent beachfront condominium.

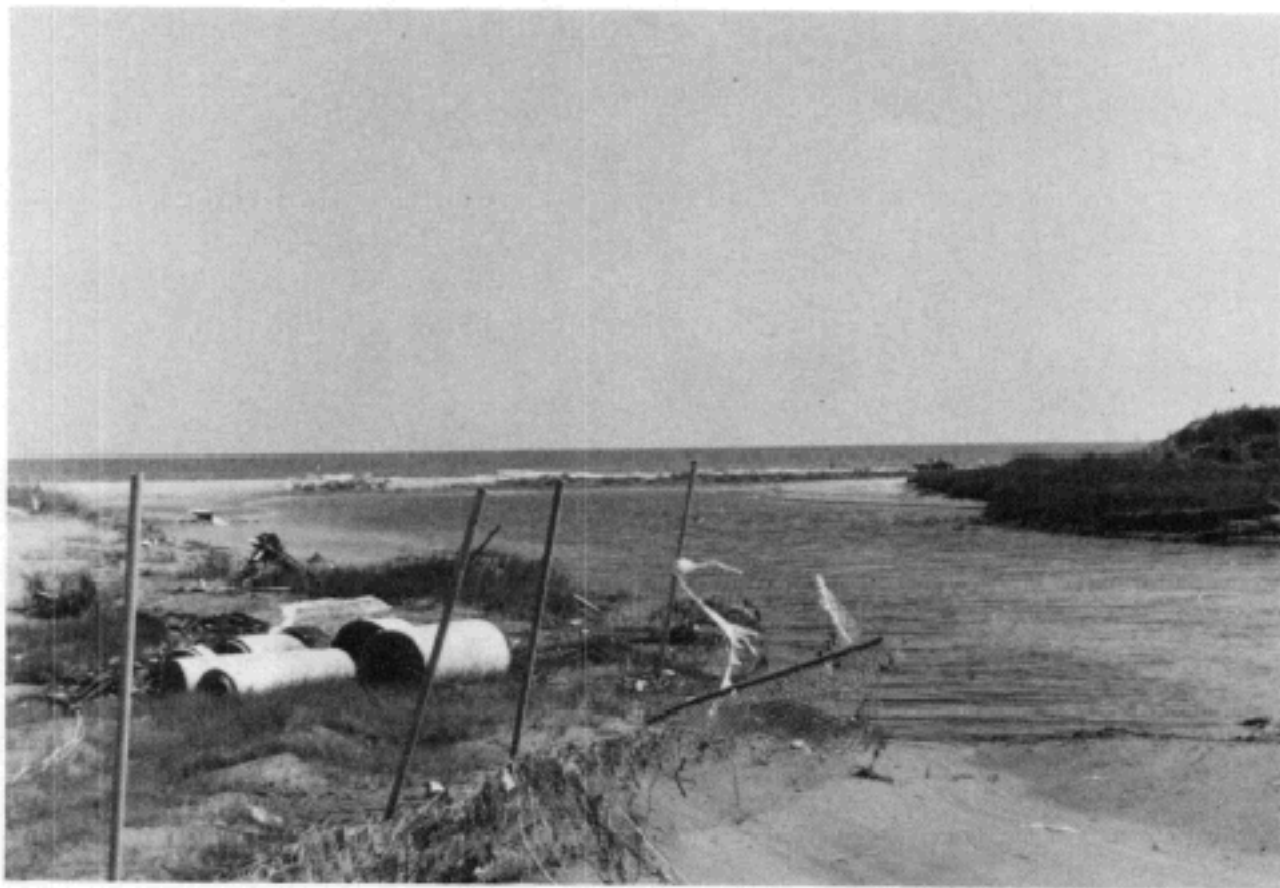
**FIGURE 3.6** Landward end of the scour channel shown in Figure 3.5.
