Event Overview:

Shelby and Macon County Tornadoes of 10/13/2014

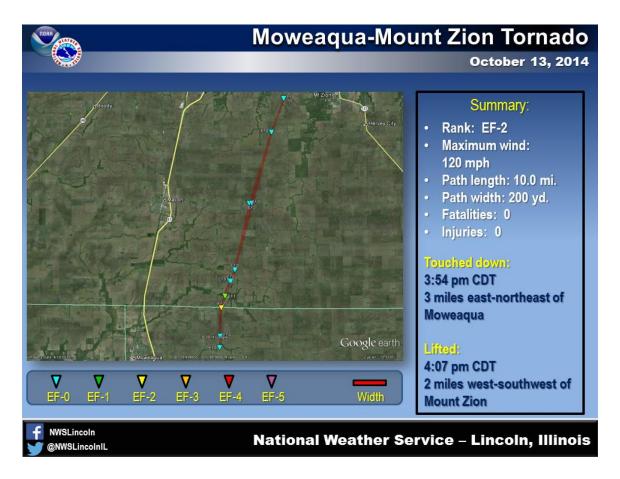
This tornado touched down in far northwest Shelby County, about 3 miles east-northeast of Moweaqua, along county road 1000E between roads 2800N and 2900N. Two machine sheds were destroyed here and trees were broken just to the north. About 20 acres of corn were flattened just to the south, but this was determined to be caused by rear-flank downdraft winds. From here, the tornado tracked north-northeast, and struck a farmstead along the Macon/Shelby County line just east of county road 1000E. The home sustained significant damage to its roof

and windows on the south side of the building, with damage to the attached garage. Several trees were snapped off within a few feet of the base, and several outbuildings were completely destroyed. The tornado peaked at EF-2 intensity at this location.

The tornado tracked into Macon County, crossing Long Grove Creek before curving a bit more due northeast. Several areas of corn and beans were observed to be flattened and bent at different directions from along Crosson Road, northeast past Walker Road, with the greatest crop damage along East Andrews Street Road between Cornthwaite and Sanner Roads. Continuing northeast, the last damage was observed to a barn roof located 2 miles west-southwest of Mount Zion, south of Elwin Road and just west of Karl Road.

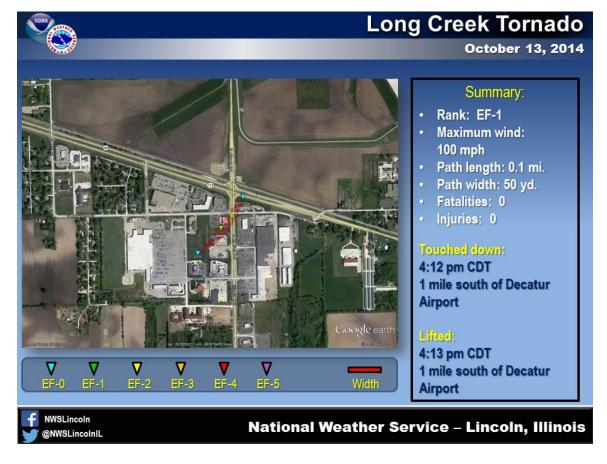
This brief tornado touched down south of the Decatur Airport along Illinois Route 121, just south of the US-36 intersection. A traffic signal mast was rotated about 90 degrees and broken. Power lines were downed in the area. Two trees were snapped off at the McDonald's and a shed and dumpster were overturned at the Arby's next door. The airport itself reported a peak wind speed of 63 mph around this time.

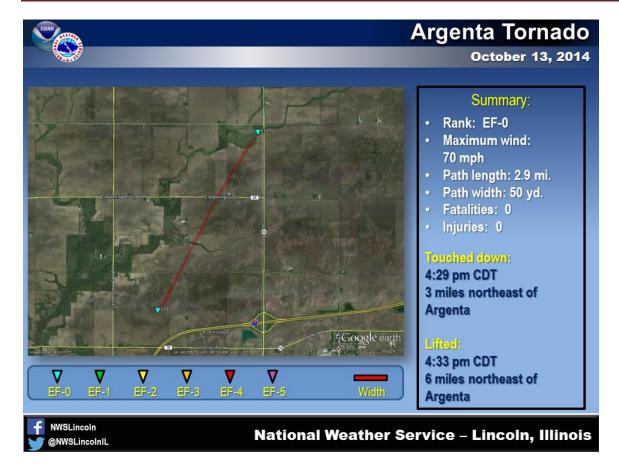
Storm spotters tracked this tornado from near the Friends Creek County Park near Duroc Road, northeast and reaching near the intersection of Macon, Piatt and De Witt Counties along Illinois Route 48 near Lake Fork. This tornado remained in open fields and caused no damage.
