Urgent Survey for 2011 Great East Japan Earthquake and Tsunami Disaster in Ports and Coasts – Part I (Tsunami)

Yasuhiro KAWAI, Taro ARIKAWA, Daisuke TATSUMI, Port and Airport Research Institute (PARI)

The Port and Airport Research Institute is conducting investigations including field surveys just after the earthquake, for recover the ports and coasts in the regions for the Ministry of Land, Infrastructure, Transport, and Tourism (MLITT) .

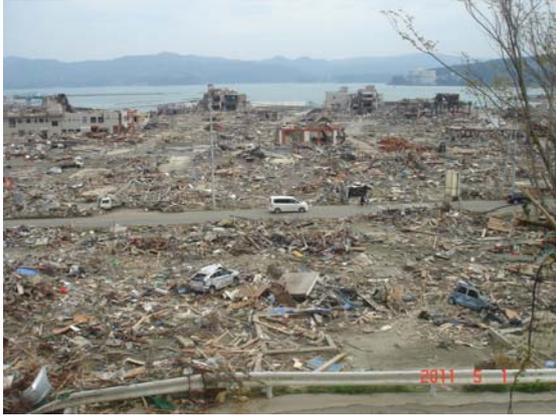
Wooden houses are destroyed by even 2m tsunamis and it was obvious that more than 10m tsunami caused fatal damages to wooden houses (Photo 1 and 2). It is said that some concrete buildings collapsed although the concrete buildings are said to be safe against tsunamis. The impulsive force due to collision of breaking wave front might be a reason for the collapse of concrete buildings as shown in (a) and (b) in Fig.2.

Photo 1(a) Flattened wooden houses and remaining concrete buildings(Minami-Sanriku)

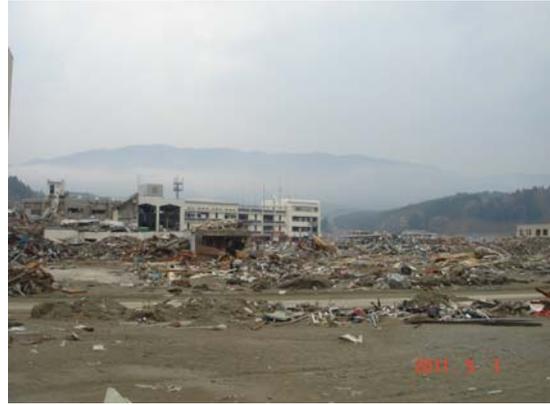
Photo1(b) Flattened wooden houses and remaining concrete buildings(Rikuzen-Kakada)

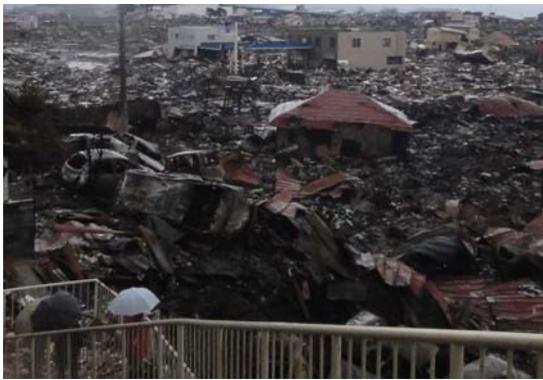
Photo 1 (c) Burnt houses (Ishinomaki)

Cars floated everywhere and were found even in houses and under the debris (Photo 2). Some were found on the roof of concrete buildings. Fires broke out in the debris and spread due to drifting of the debris. Spilled oil spread due to tsunami and caused large-scale fires. Damages to railways and roads were also significant including the damages to bridges (i.e. Minamisanriku-Utatsu). Sendai Airport which is located 1.5 km from the coastal line was inundated and airplanes floated just like cars.

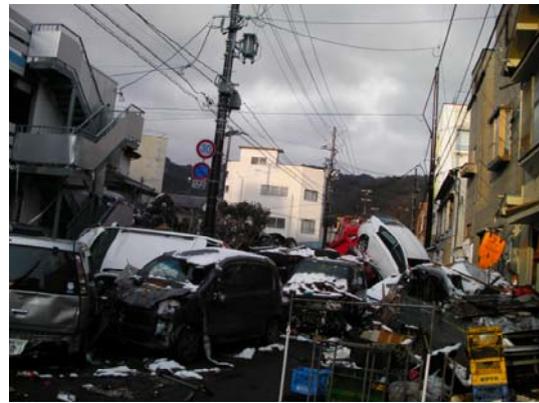
Photo 2 debris and cars piled in a road(Kamaishi)

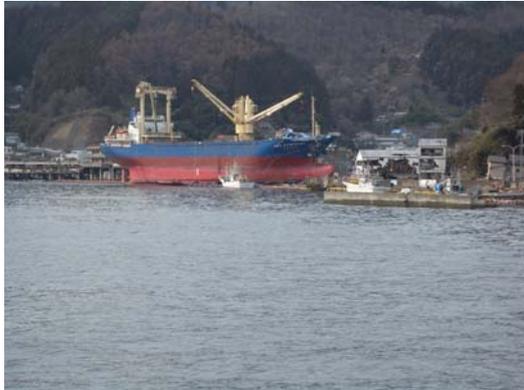
Various damages occurred in ports areas including typical port damages as shown in the middle of Table 1. For example, many ships broke their moorings and collided with port facilities and one was washed on a wharf (Photo 3). According to Maritime News Paper a total of 6 vessels (1 at Ishinomaki, 2 at Souma, 1 at Haramachi, 1 at Onahama, 1 at Kamaishi) of 20 to 200 thousand tons were stranded or caused oil spill within ports. 31 passenger ships were severely damaged including 2 partially damaged according to Tohoku-district passenger ship association. Also small boats including fishing boats were carried far inland areas and it is estimated that more than 17,000 boats were damaged. The severe damage to warehouses and factories in the port industry areas caused the secondary impact on industry in the world. The container terminals suffered from inundation. More than 4000 containers in Sendai Port floated from their foundations and 1000 of them went into the sea.

Photo 3 Ship landed on a quay

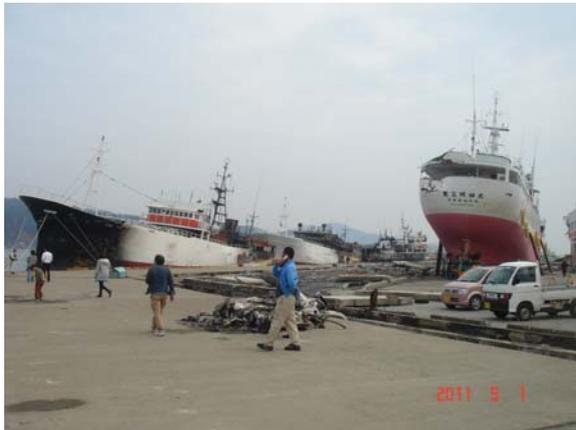
Photo 4 Fishing boats landed on quay and burnt in a fire

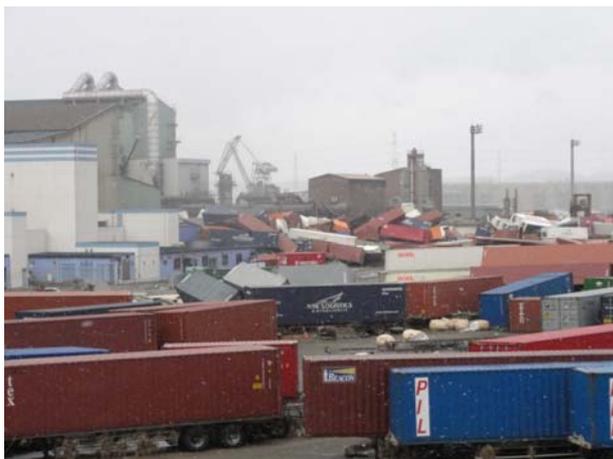
Photo 5 Scattered containers (Sendai Port)

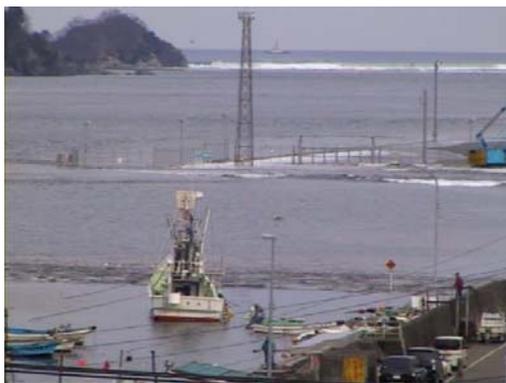
Figure 3 shows a result of numerical simulation for the tsunami at Kamaishi. The tsunami measured by the GPS wave meter 18km off the Kamaishi coast was used as the boundary condition. The figure compares the effect of tsunami breakwater by the two time series of tsunami heights at a tide gauge station of Kamaishi Port with and without the breakwater. The tsunami height is 13.7m without breakwater while 8m with breakwater, reduced to 60 % by the breakwater. The measure value at Kamaishi was around 8 m which agrees with the calculation with the breakwater. It can be said that the breakwater maintained its function until the peak. However, the caissons of the breakwater gradually sunk down and slipped from the breakwater mound due to scouring by the strong current and due to the pressure difference between the front and back walls of the breakwater caissons (Photos 6 and 7)

Photo 6 Overtopping from Kamaishi Breakwater
(Courtesy of Tohoku Bureau of MLIT)

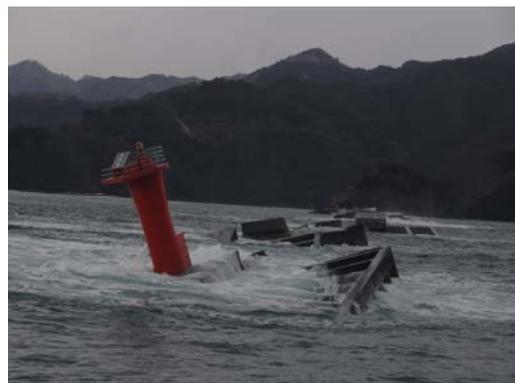
but also the large storm waves. Although the tsunami was very high, exceeding significantly the design tsunami height, the breakwater was relatively strong and tough since the stability design was determined by a large storm wave. According to the video, the breakwater was relatively safe until the peak of the first tsunami wave.

Photo 7 Damaged caissons of Kamaishi Breakwater

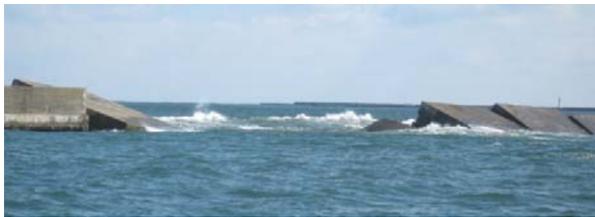
Many breakwaters and seawalls were also damaged by the tsunami. For example, the north breakwater of the Hattaro-district in Hachinohe Port (Photo 8), the marina breakwater of the Fujiwar-Kanbayashi district in Miyako Port and the offshore breakwater of Souma Port were damaged significantly. However, they were designed against severe storm waves and therefore relatively strong and tough against the huge tsunami. The

breakwaters damages due to the 1983 Nihonkai-Chubu Earthquake Tsunami and 1993 Hokkaido-Nansei-oki Earthquake and Tsunami were limited to inner breakwaters and the parts near breakwater mouths. The more than 10m tsunami caused extensive damage to offshore breakwaters but still was limited to those that have a relatively small width of the caisson.

Photo 8 Caisson sliding at Hattaro Breakwater in Hachinohe Photo 9 Seawall at Ryoishi in Kamaishi

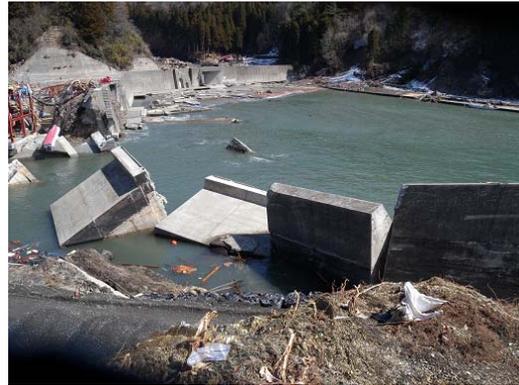
It should be noted that many seawalls and dykes were constructed to protect the coastal towns from tsunamis, using the 1896 Meiji-Sanriku Tsunamis for design conditions. The more than 10m tsunami overtopped the tsunami defenses and damaged them significantly (Photo 9). Even for huge tsunamis the tsunami defenses should exist and work to reduce the tsunami. The tough stability of the structures should be investigated further.

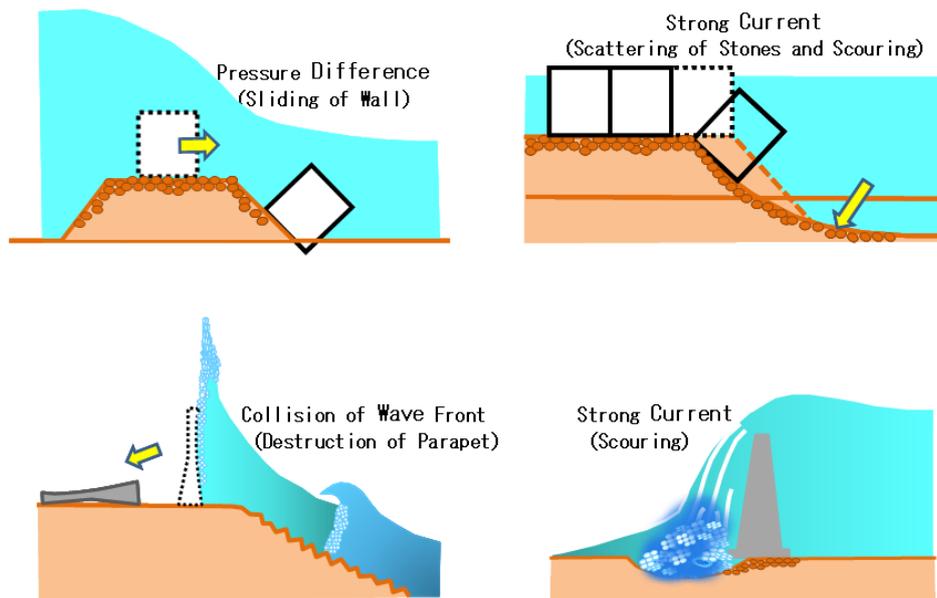
Figure 4 Typical Failures of Coastal Defenses

1. The force due to the pressure difference between the front and back walls broke the breakwaters and seawalls. The pressure is almost static especially when the water depth is large enough. Uplift forces should also be considered to check the stability.

2. Impulsive breaking wave forces hit the seawalls. Tsunami wave front breaks due to shallow water in the shore and collides into seawalls. Also rapid current due to breaking causes dynamic wave pressures on the seawalls.

3. Drag forces due to strong current causes the scattering of armor stones and blocks. However comparing the very rapid currents induced by tsunami the damages to concrete blocks for detached breakwaters to dissipate the wave energy are limited.

4. Strong current caused scouring damages in navigation channels, around seawalls and breakwaters in addition to beaches and rivers. Scouring is the most typical failure of coastal structures by tsunamis.
