Sugarloaf Key EF0 Tornado  
Friday Afternoon, June 1<sup>st</sup> 2007  
Survey Report

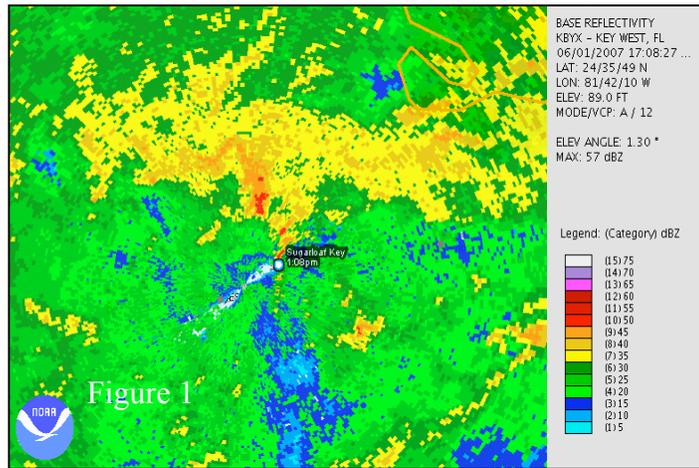
Tropical Storm Barry was forming in the east central Gulf of Mexico, and would be named a tropical storm at 5pm. Moderate to heavy rainfall was covering much of the Florida Keys (Fig 1). The Key West morning upper air sounding showed a saturated lower troposphere with low CAPE and high shear. The 0 to 3 km helicity was near 250 m<sup>2</sup>/s<sup>2</sup>. Base reflectivity data showed a family of cells oriented south to north in the vicinity of Sugarloaf Key. A small mesocyclone was evident in the SRM data at the time of the reported tornado.

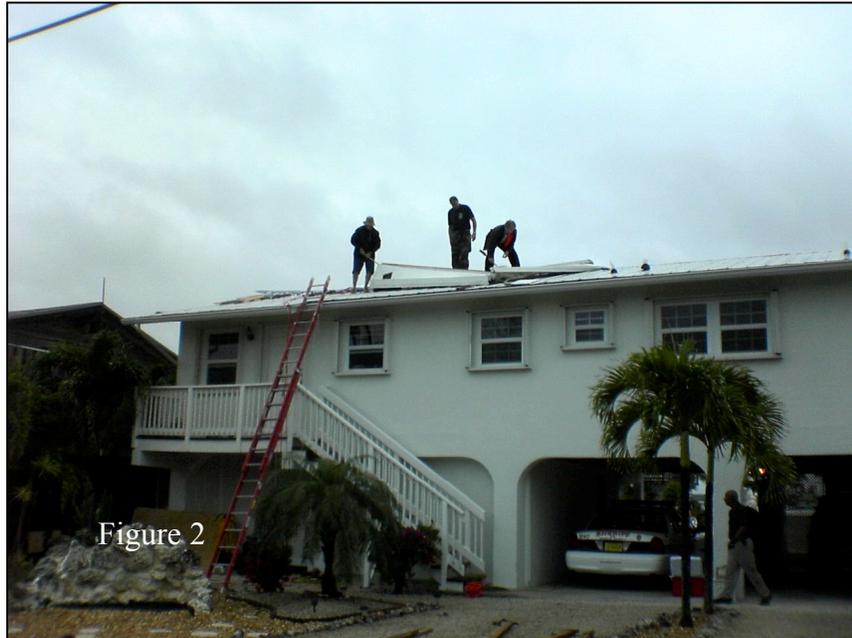
Figure 2

Upon arrival at the property on Hawksbill Lane, it was found that several Deputy Sheriffs, the property owners, as well as local residents were in the process of removing the debris and working towards securing the damaged roof (Fig 2). The damaged house is located on a canal that runs south to north, on the northern end of Sugarloaf Key. Given this orientation, the front of the house

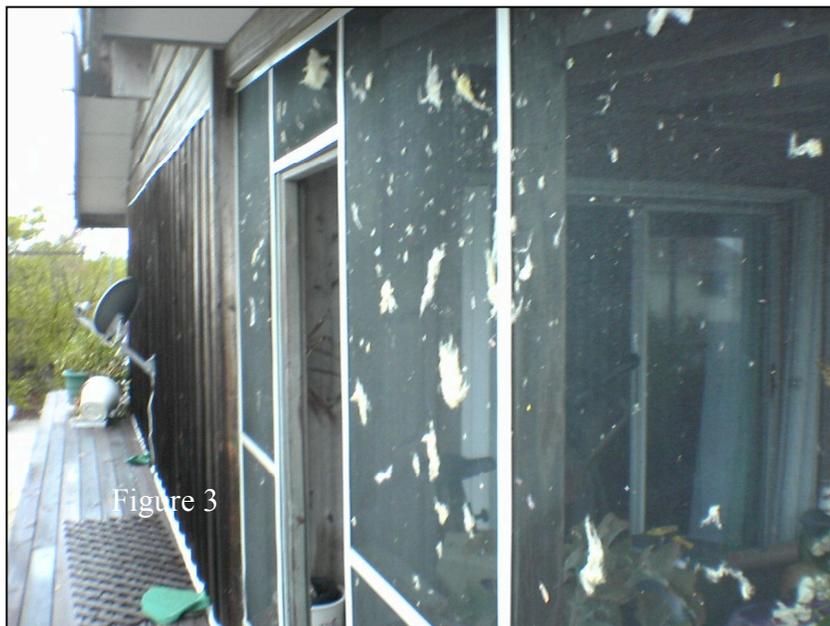
Figure 3

The damage done to the roof of the residence was substantial, and most likely the roof will need to be replaced. The roof was metal overlain on wood framing. Damage was heaviest on the

northeast corner of the house where the metal roofing had been peeled away and the underlying framing damaged, and a patio running the length of the back of the house was completely destroyed. Insulation from the roof was found embedded in the screen porch

of the house next door (Fig 3), but no damage was found to neighboring structures. Debris from the roof was found in a small area of mangroves on the other side of the canal just north of the empty lot. The owner of the house just north of the empty lot, across the canal and to the northeast of the affected structure on Hawksbill,

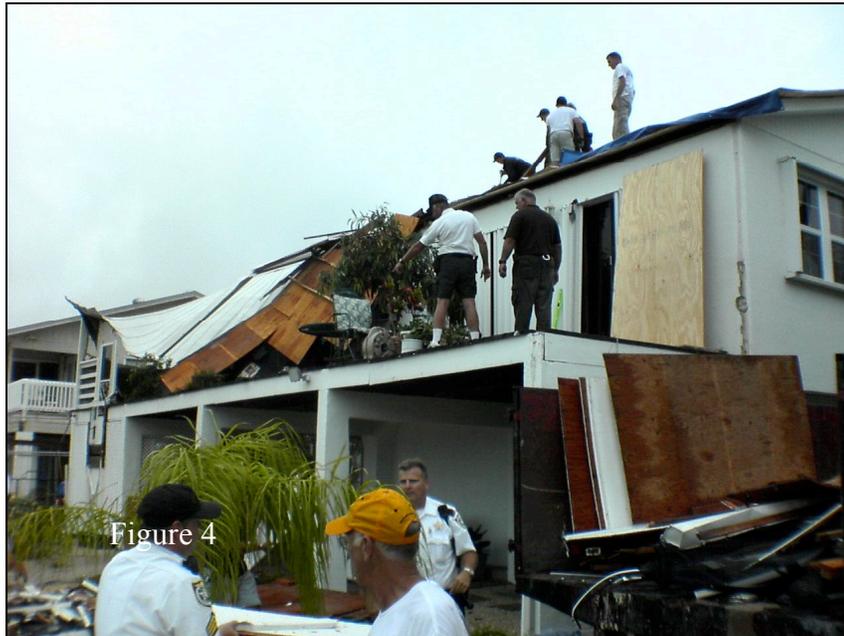
It is unclear how the aforementioned patio was attached to the roof, and whether the destruction of the patio leads to the roof damage (Fig 4). This may have occurred if the patio roof was improperly secured to the main roof structure. Since there was not access to the roof during this survey, it is not possible to make a determination on this matter.

**Addendum:** Discussion with the contractor that repaired the structure on Hawksbill (in November 2008) revealed that indeed the patio was improperly secured to the roof, and this contributed to the major damage done to the roof.

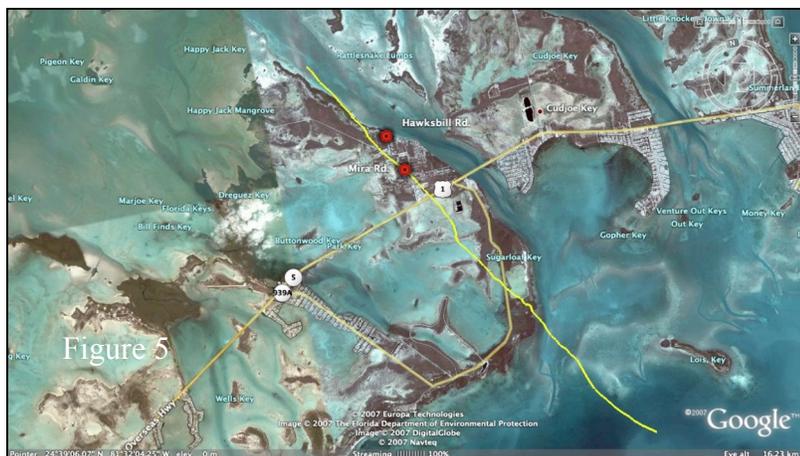
south side of the affected house received no damage, and the boats on the other side of the canal were not moved, a convective downburst event was ruled out as a cause of the damage. On Key West Doppler radar imagery, a shallow mesocyclone was detected moving from south to north over the eastern portion of Sugarloaf Key at the same time as the damage was reported to have occurred. Both Mira Rd. and Hawksbill Ln. were directly under the path of the mesocyclone. Therefore, the reported damage was most certainly caused by a tornado touchdown. The damage uncovered in the survey is consistent with an EF0 tornado. Thus, it is the conclusion of this survey that the structure at 1107 Hawksbill Ln., and likely the house at Mira Rd., was impacted by an EF0 tornado. It is entirely possible, and consistent with tropical cyclone induced tornados, that the tornado may not have been on the ground through the entire path of the mesocyclone over Sugarloaf Key, which would explain the relative lack of damage to neighboring structures. The distance between the affected structures on Mira and Hawksbill is 0.55 miles. Without further evidence, the track of the tornado must be assumed to be that length, with the possibility of having lifted at some point in that track. The diameter of the tornado, assuming the tornado could not have been larger than the distance from the patio at Hawksbill to the boats across the canal, and most likely was around half that length, could not have been more than 0.01 to 0.02 miles, or 50 to 100 feet (and possibly smaller). Figure five shows the estimated mesocyclone path over Sugarloaf Key, and the touchdown locations in red indicators.
