Lightning Damage at the LSU Agricultural Center

Lake Charles, LA
October 25, 2003

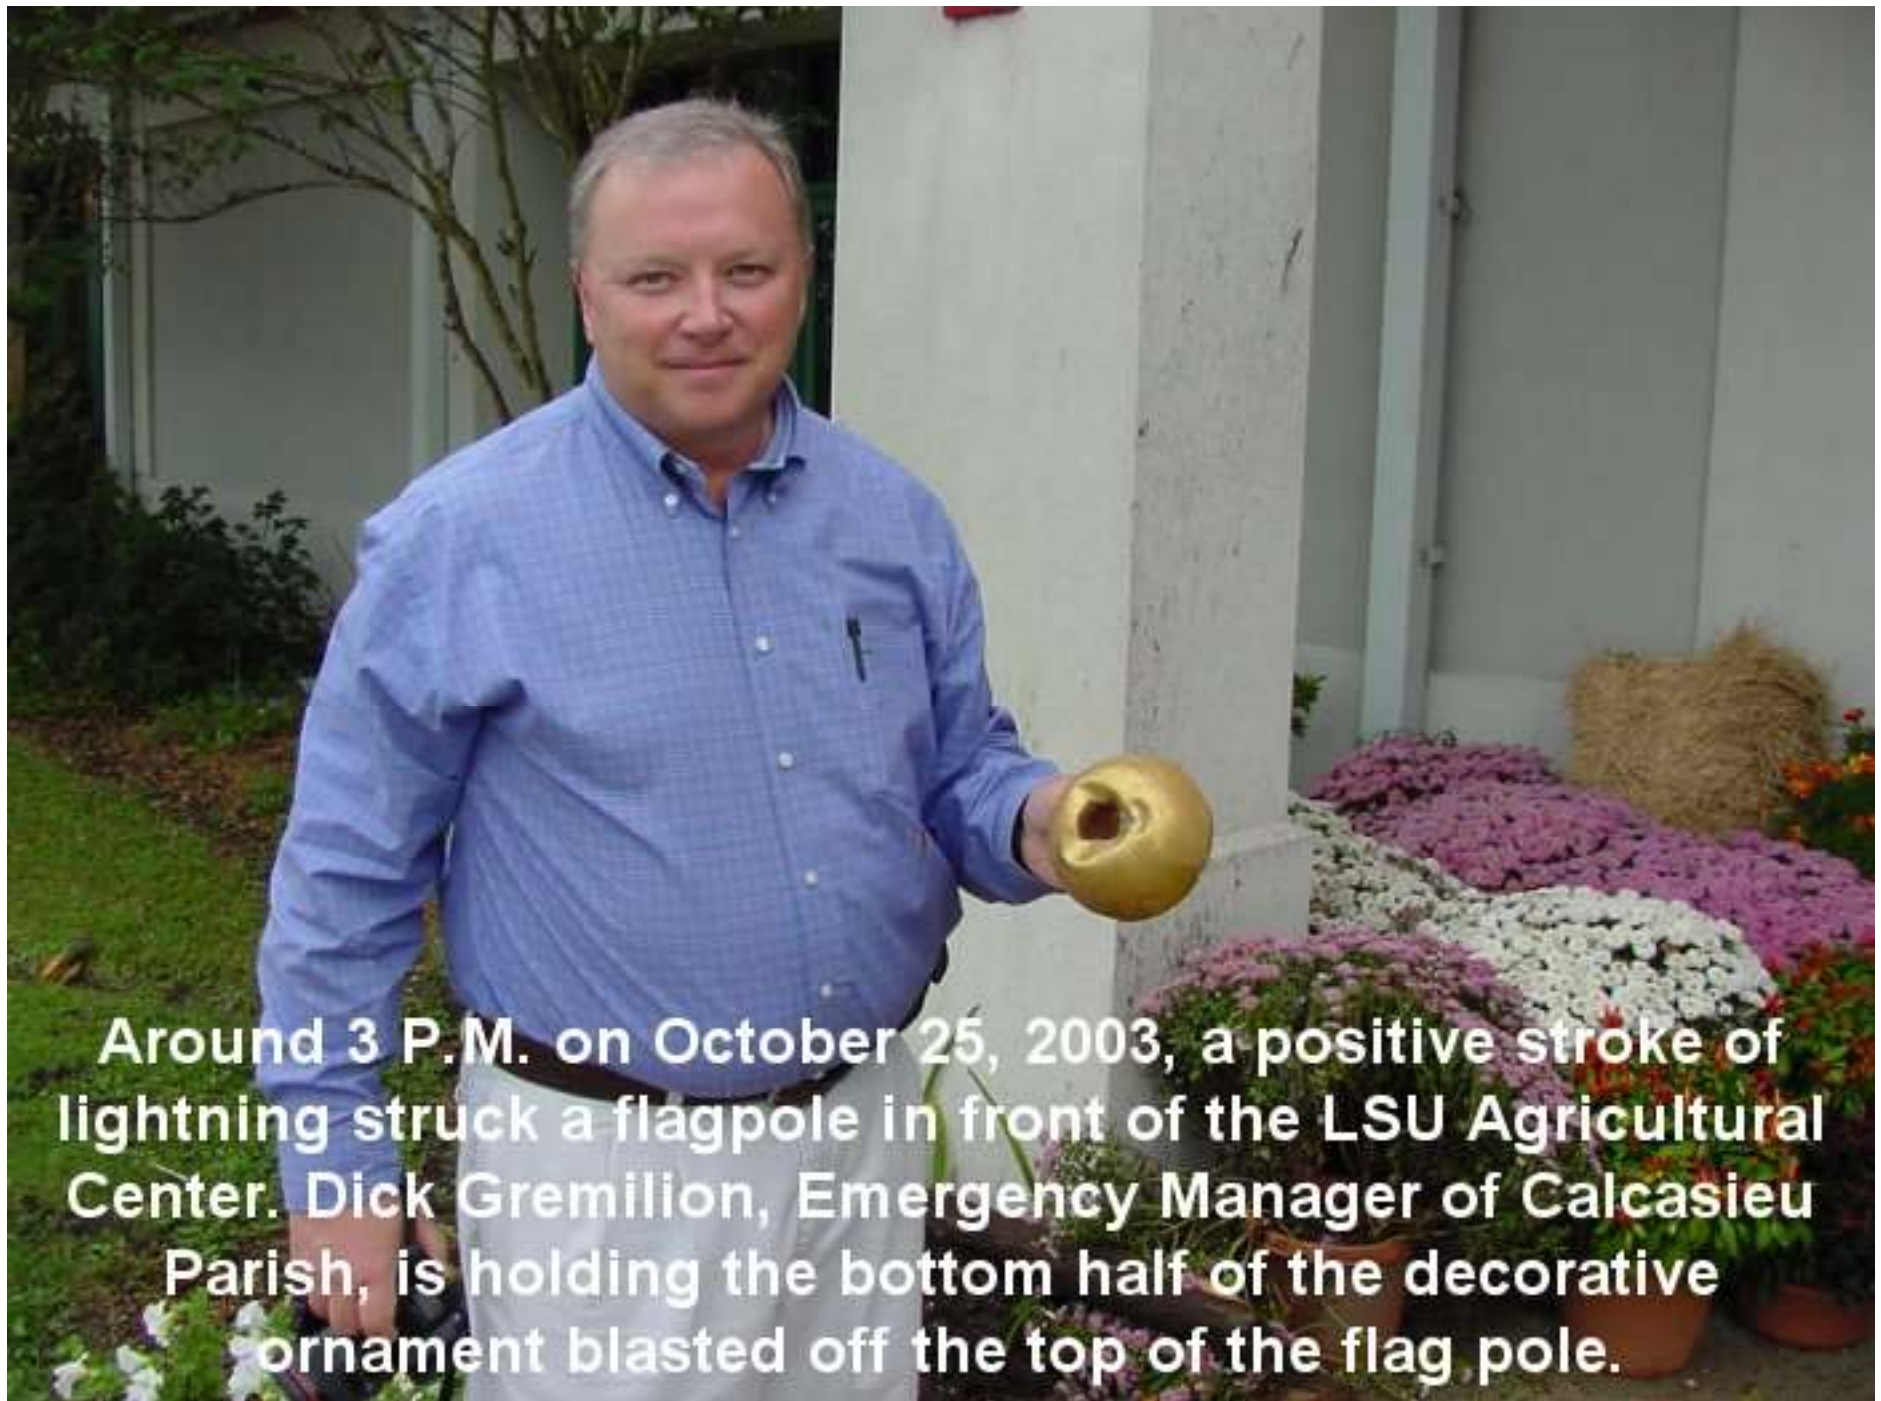
Around 3 P.M. on October 25, 2003, a positive stroke of lightning struck a flagpole in front of the LSU Agricultural Center. Dick Gremilion, Emergency Manager of Calcasieu Parish, is holding the bottom half of the decorative ornament blasted off the top of the flag pole.

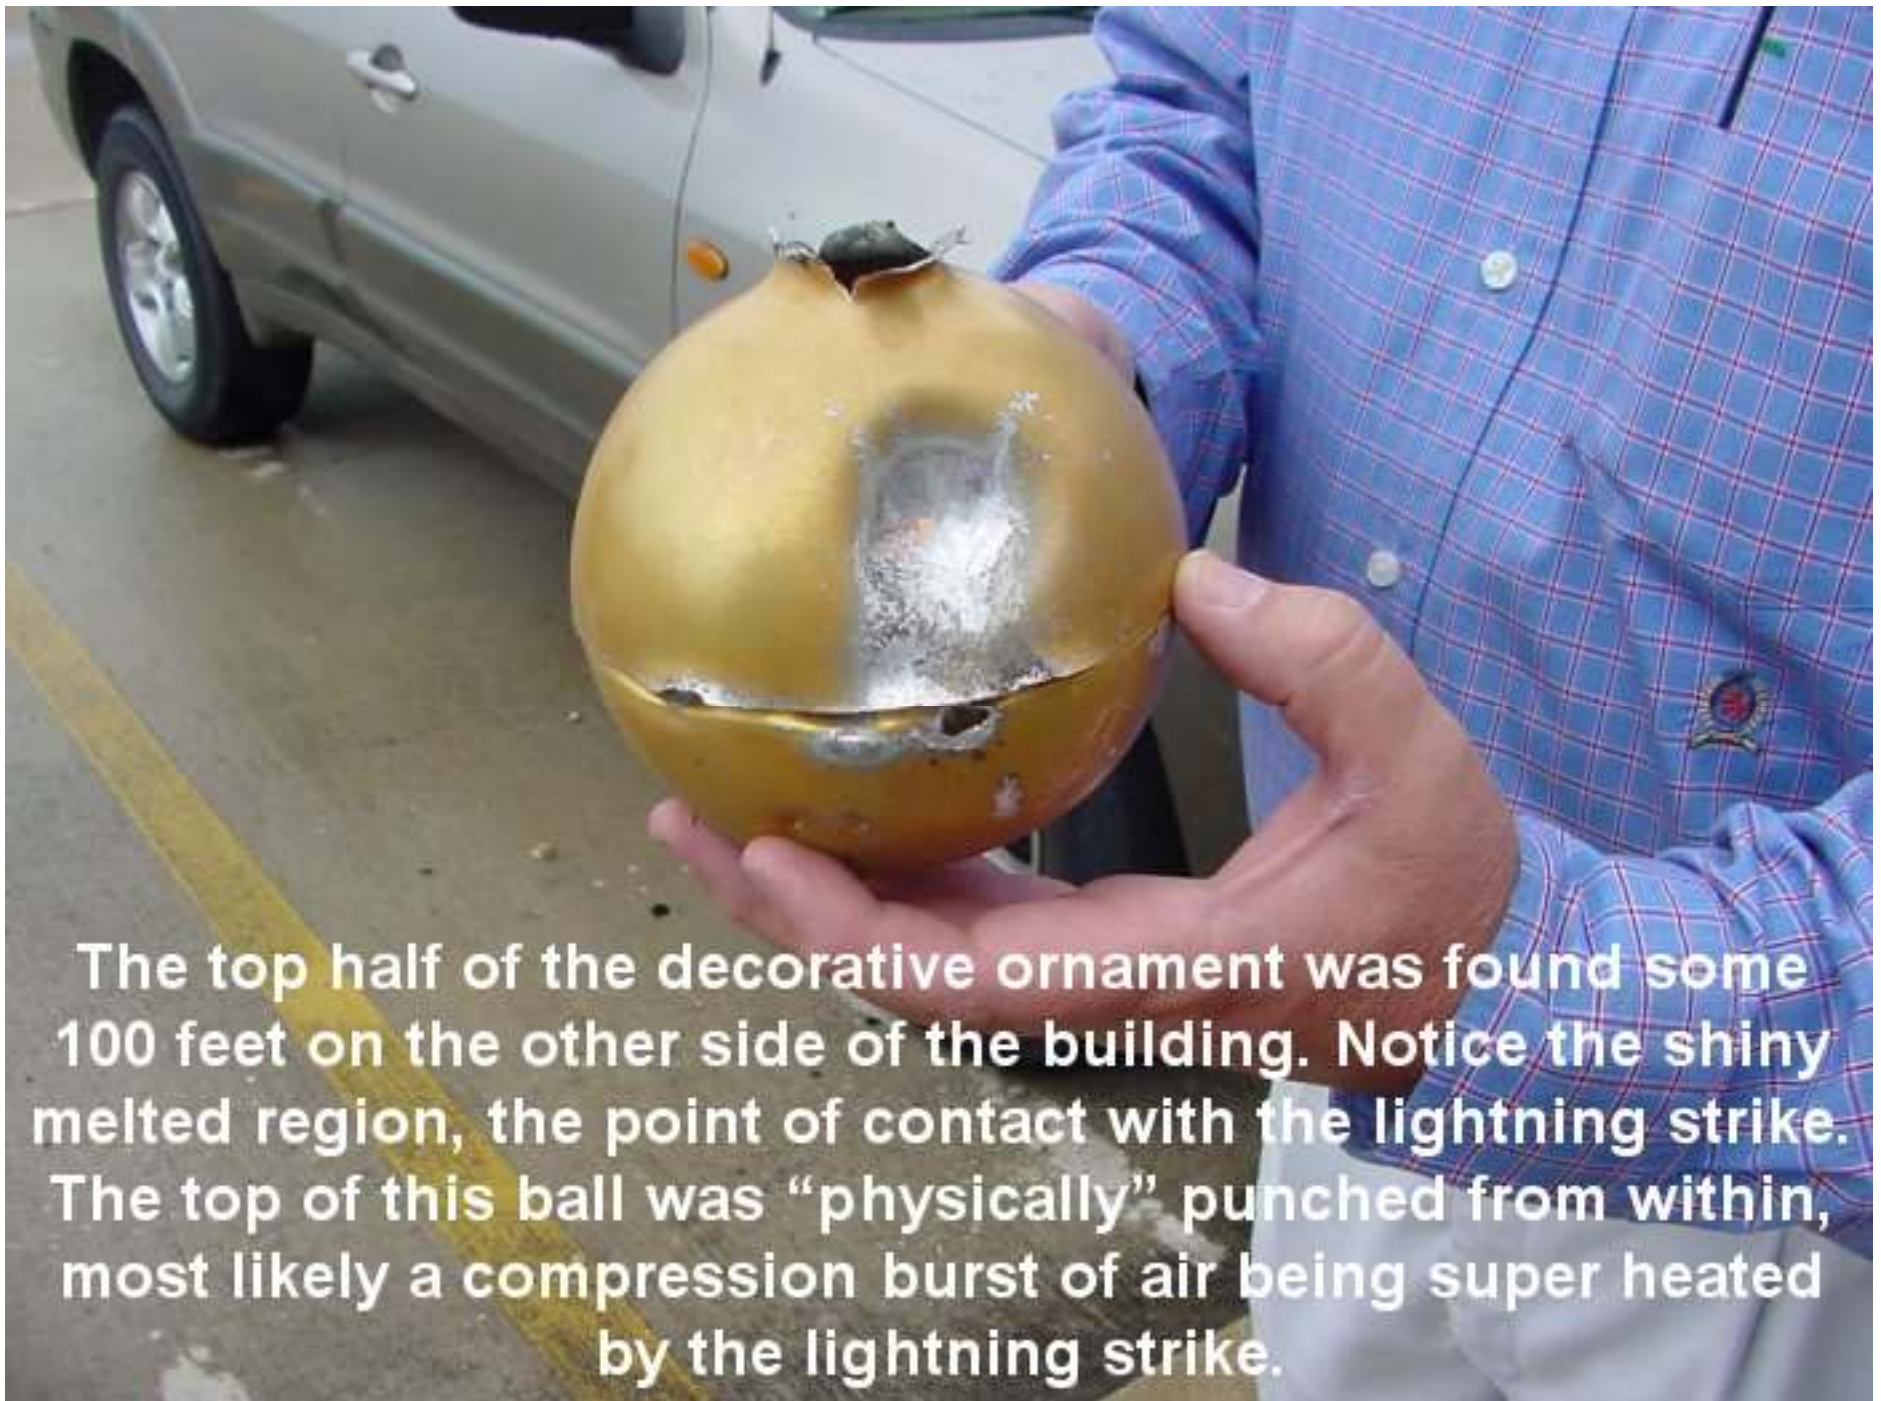
The top half of the decorative ornament was found some 100 feet on the other side of the building. Notice the shiny melted region, the point of contact with the lightning strike. The top of this ball was “physically” punched from within, most likely a compression burst of air being super heated by the lightning strike.

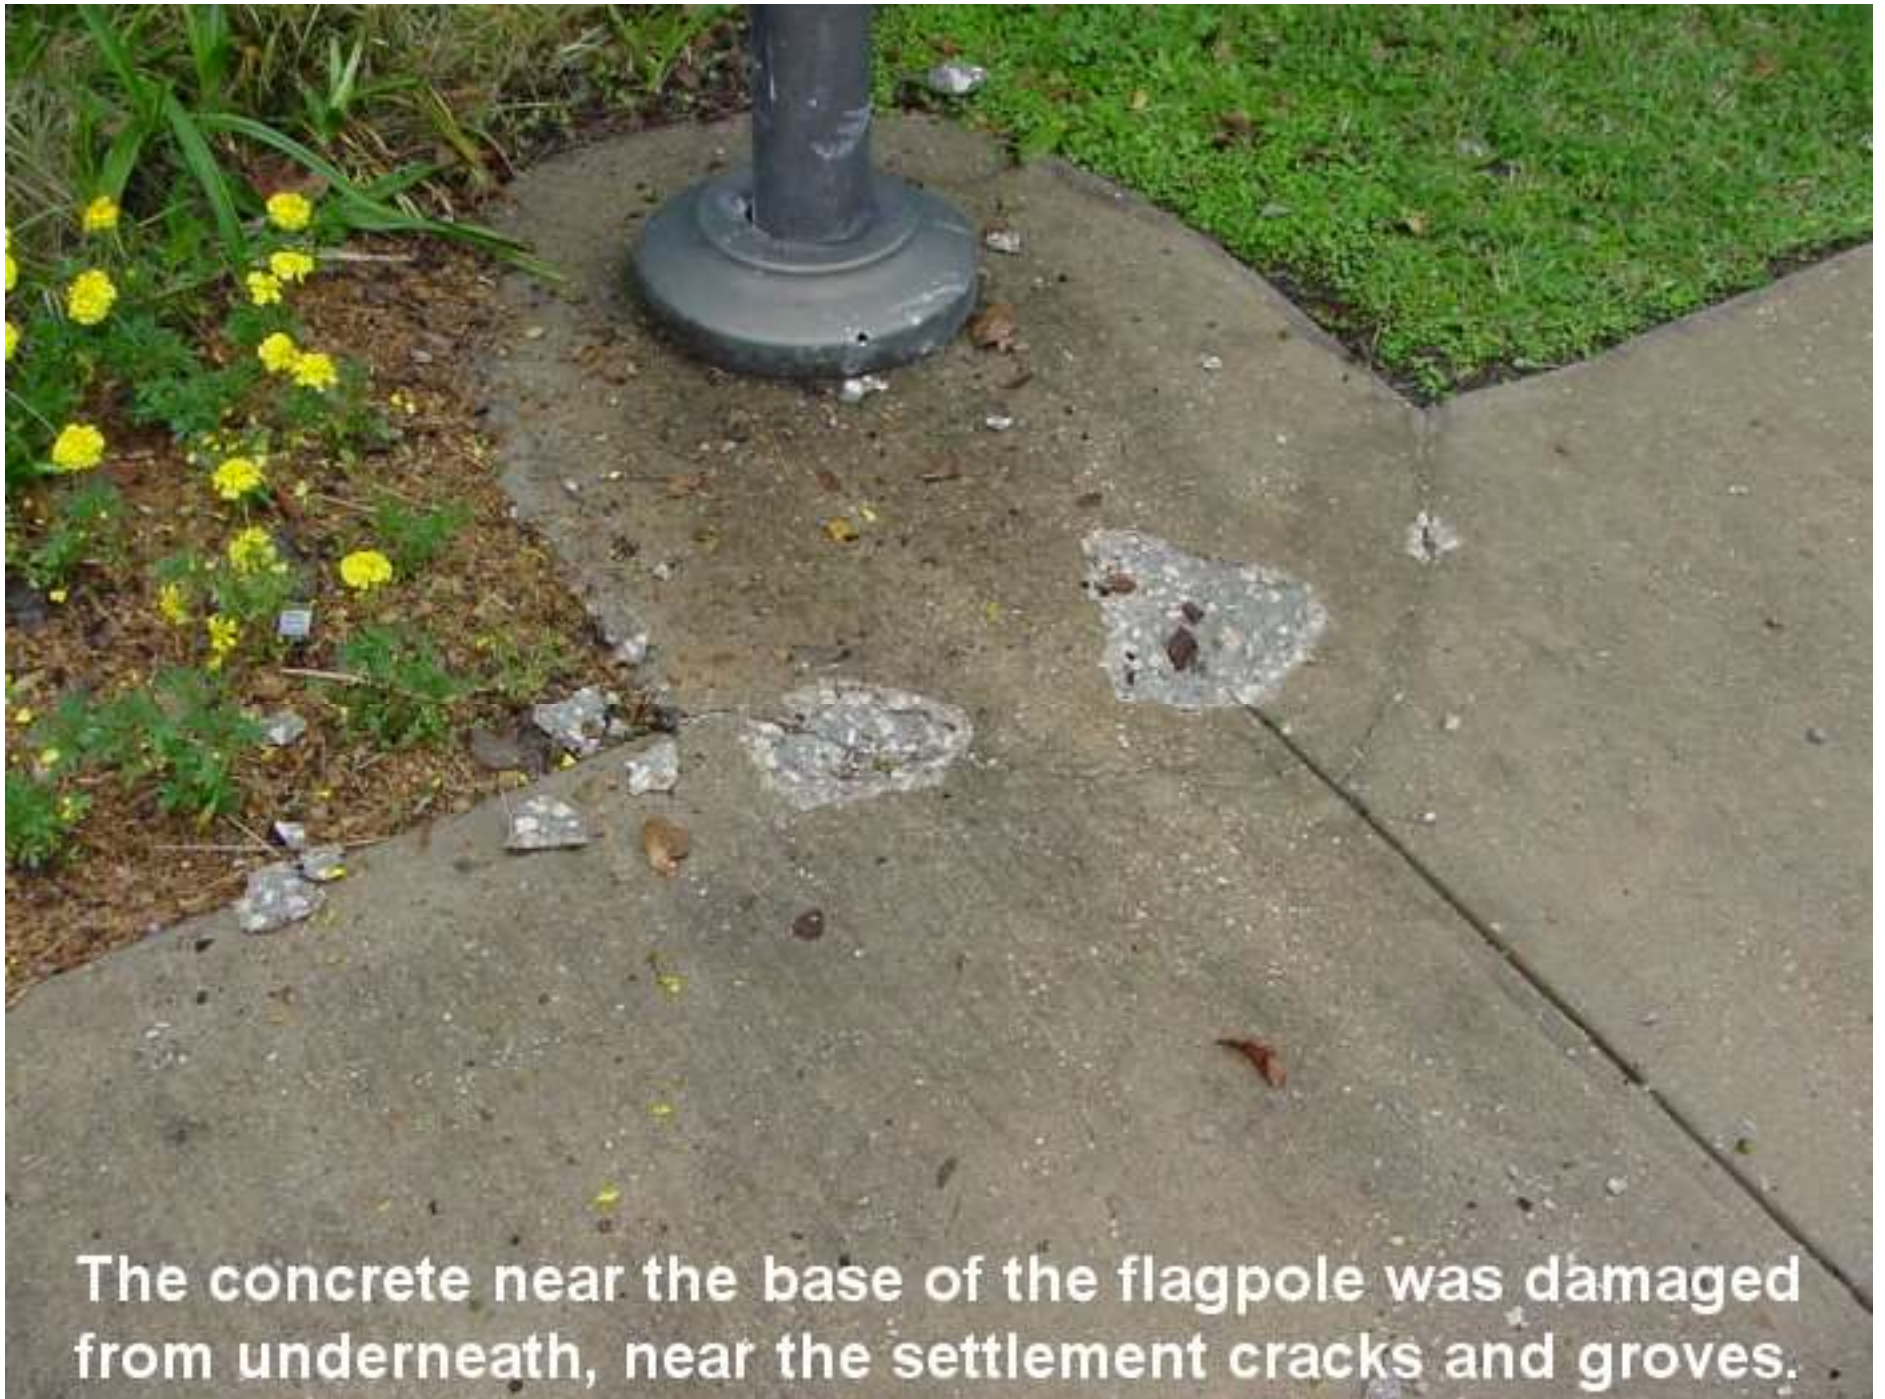
The concrete near the base of the flagpole was damaged from underneath, near the settlement cracks and groves.

The energy from the lightning strike caused several burn spots and melted holes in the metal base.

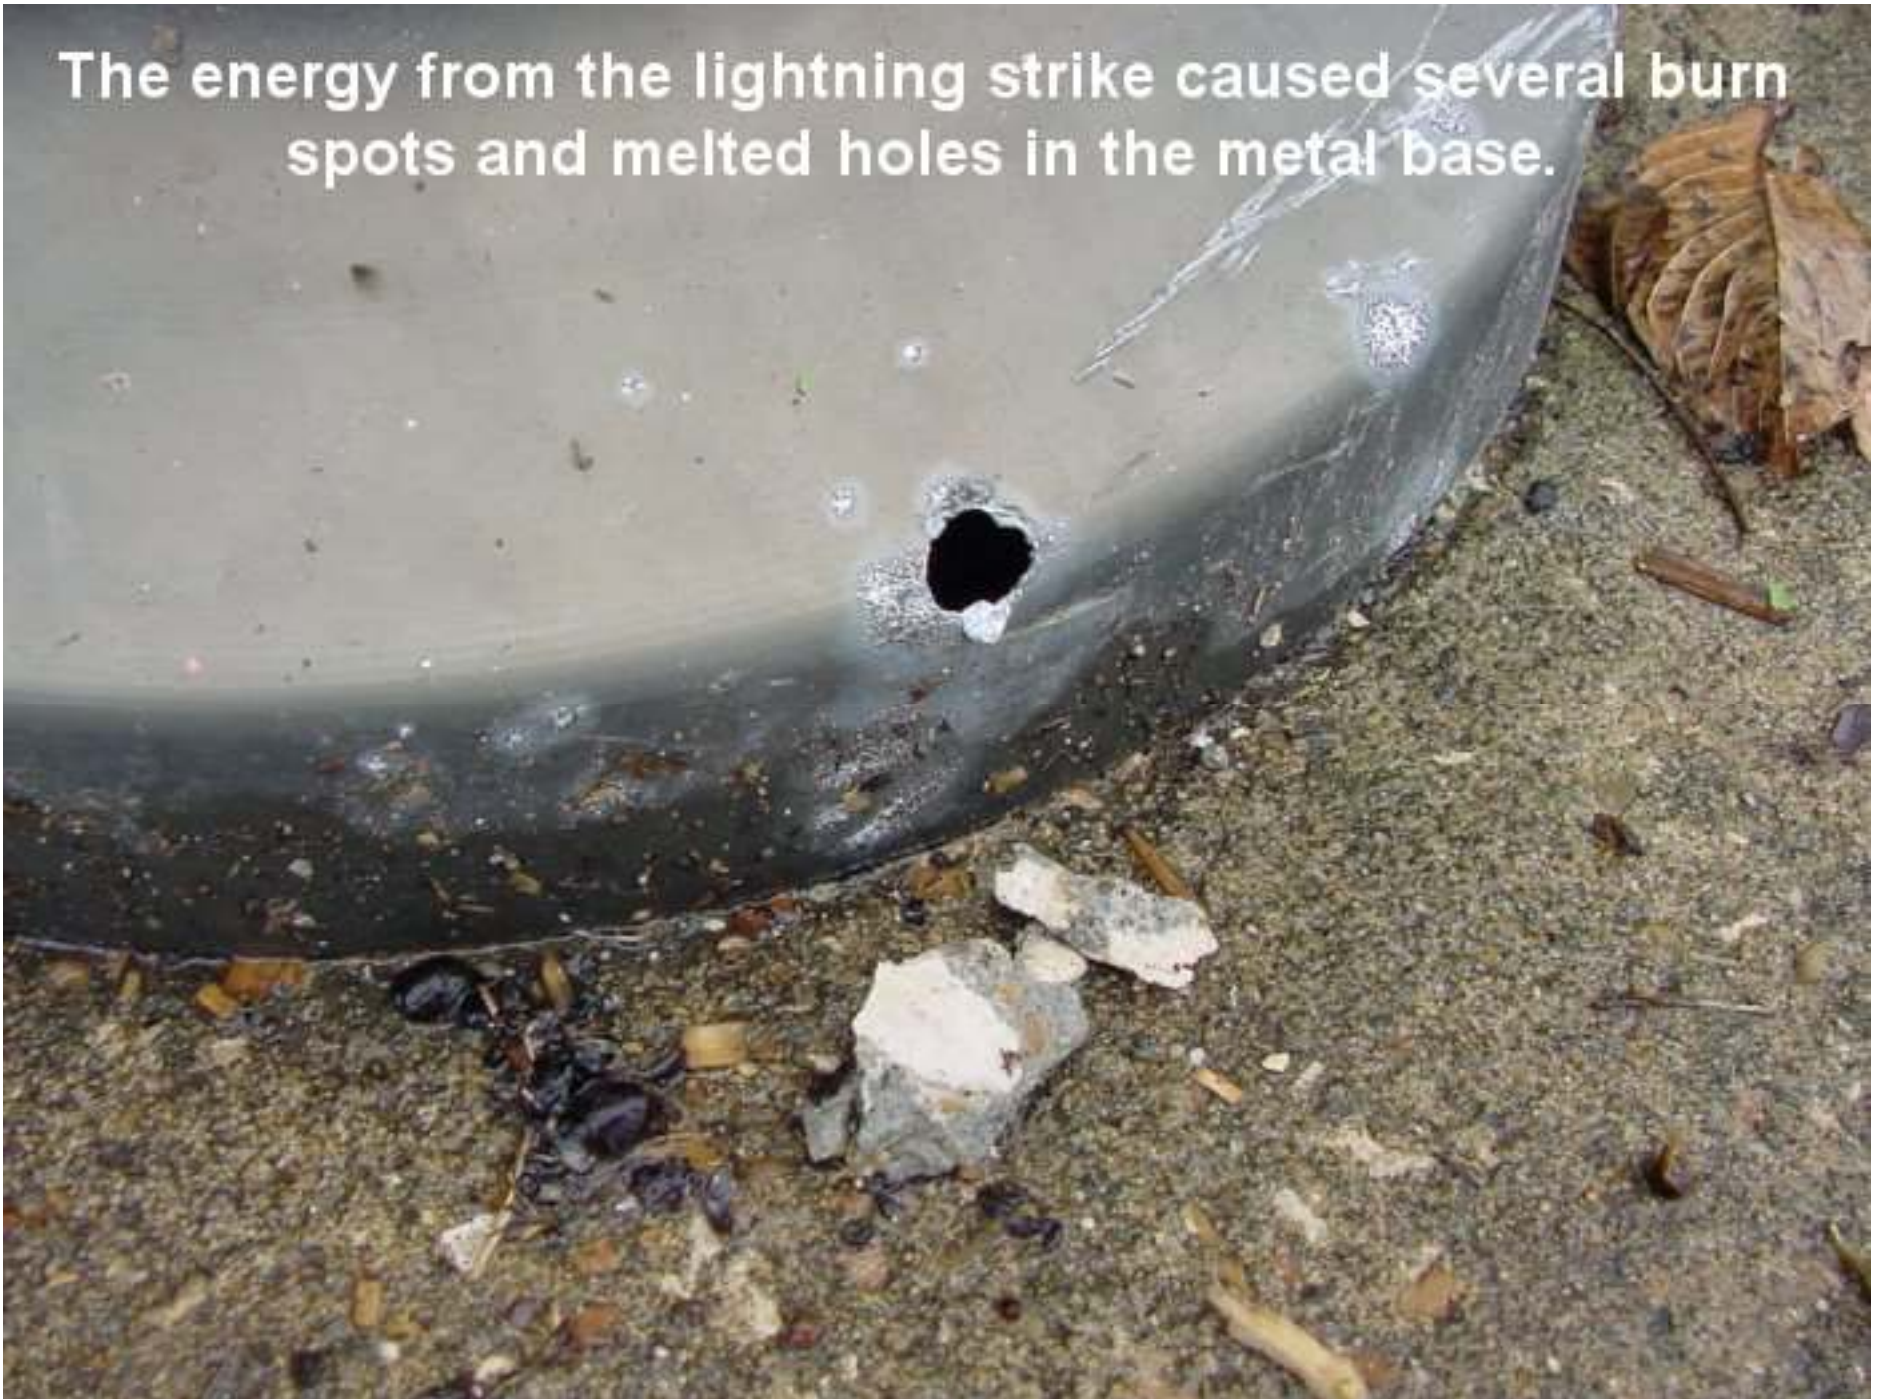
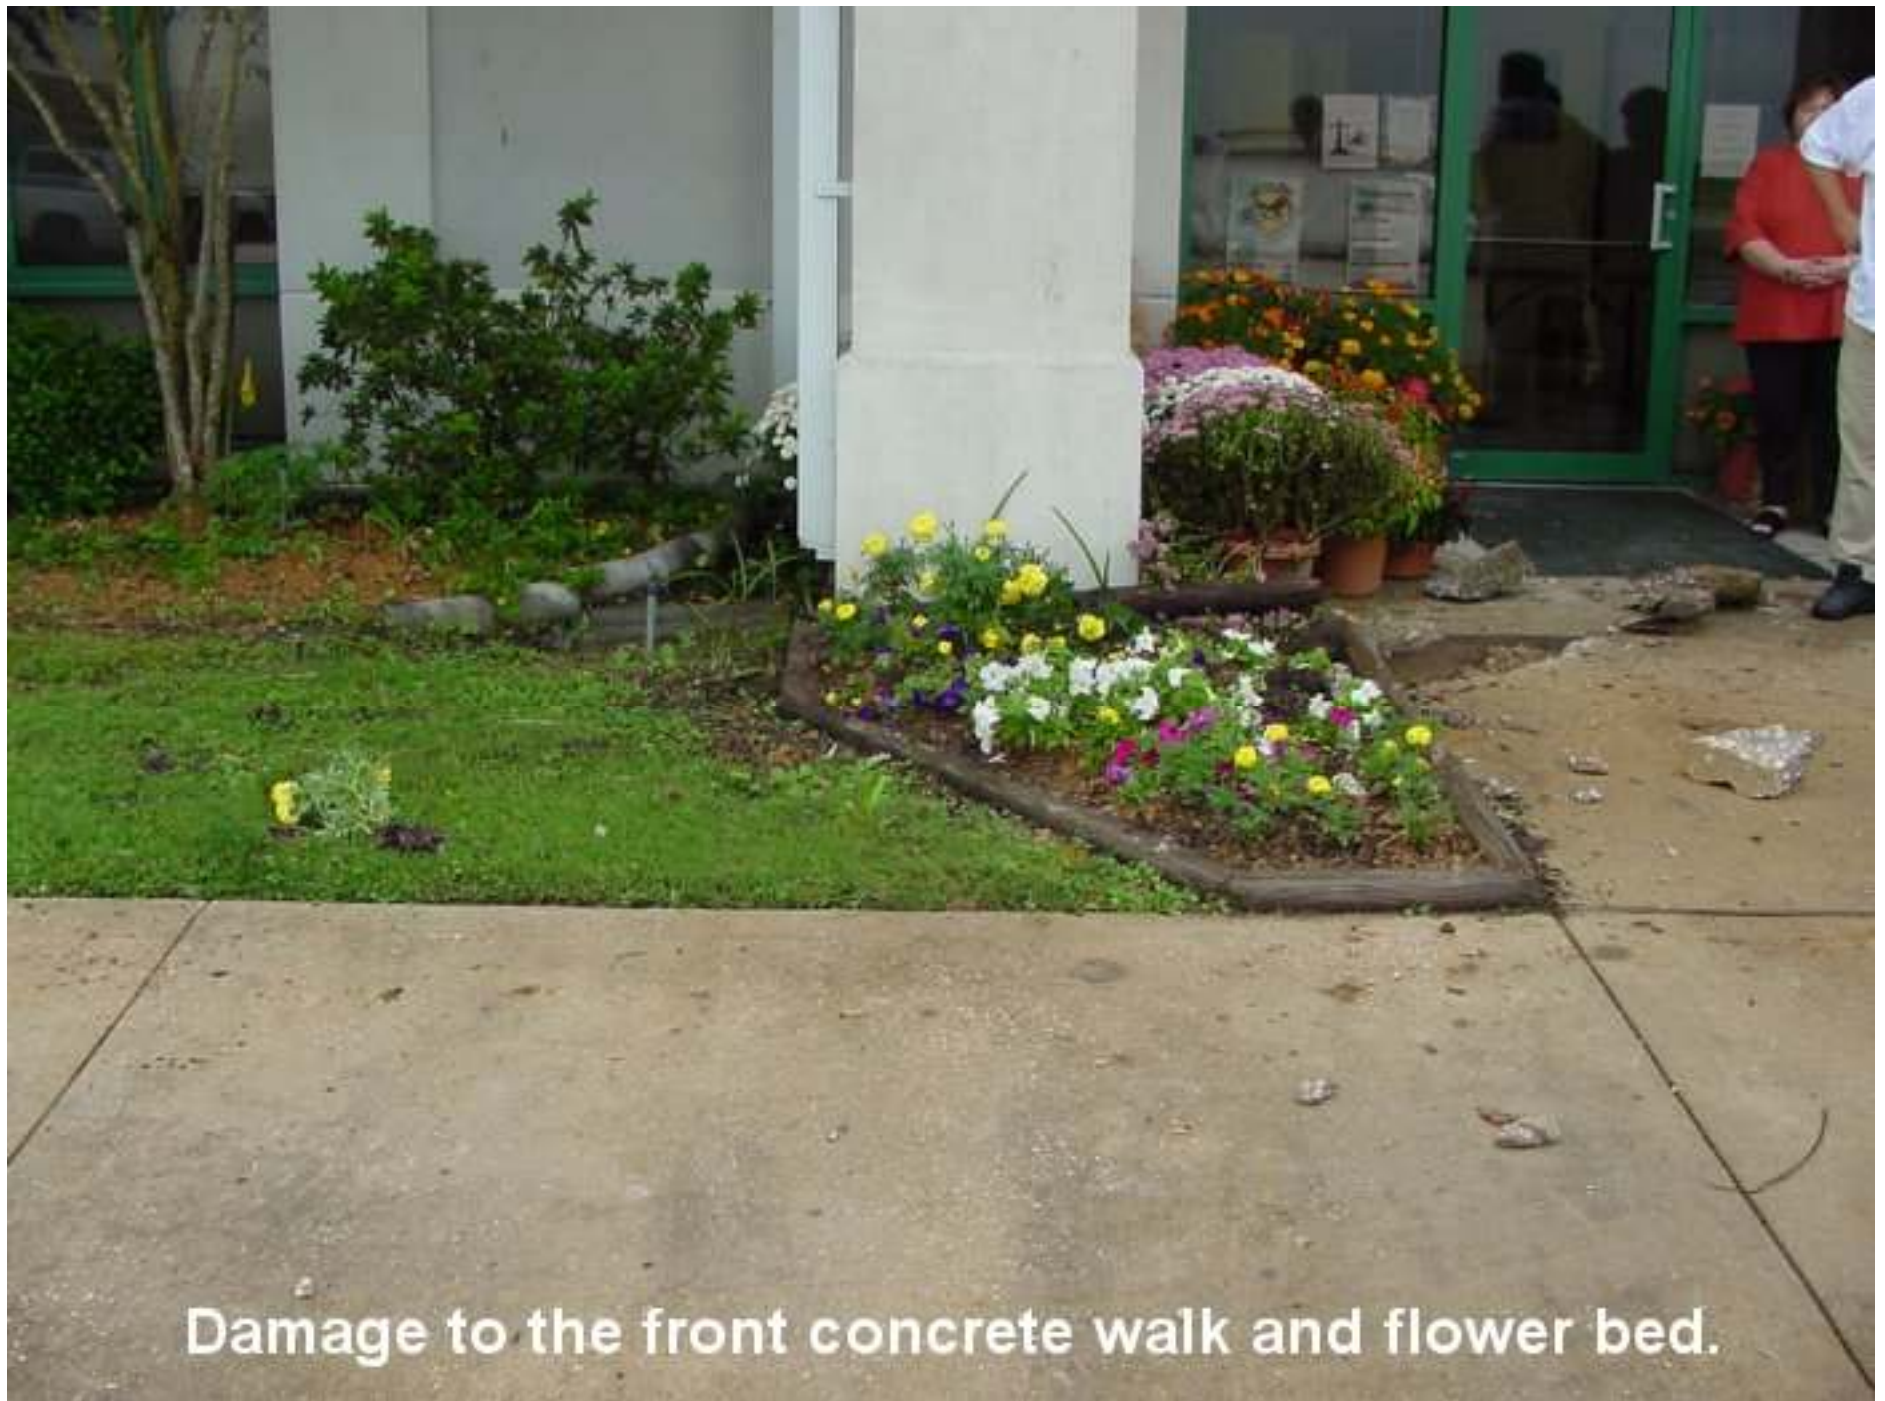
Damage to the front concrete walk and flower bed.

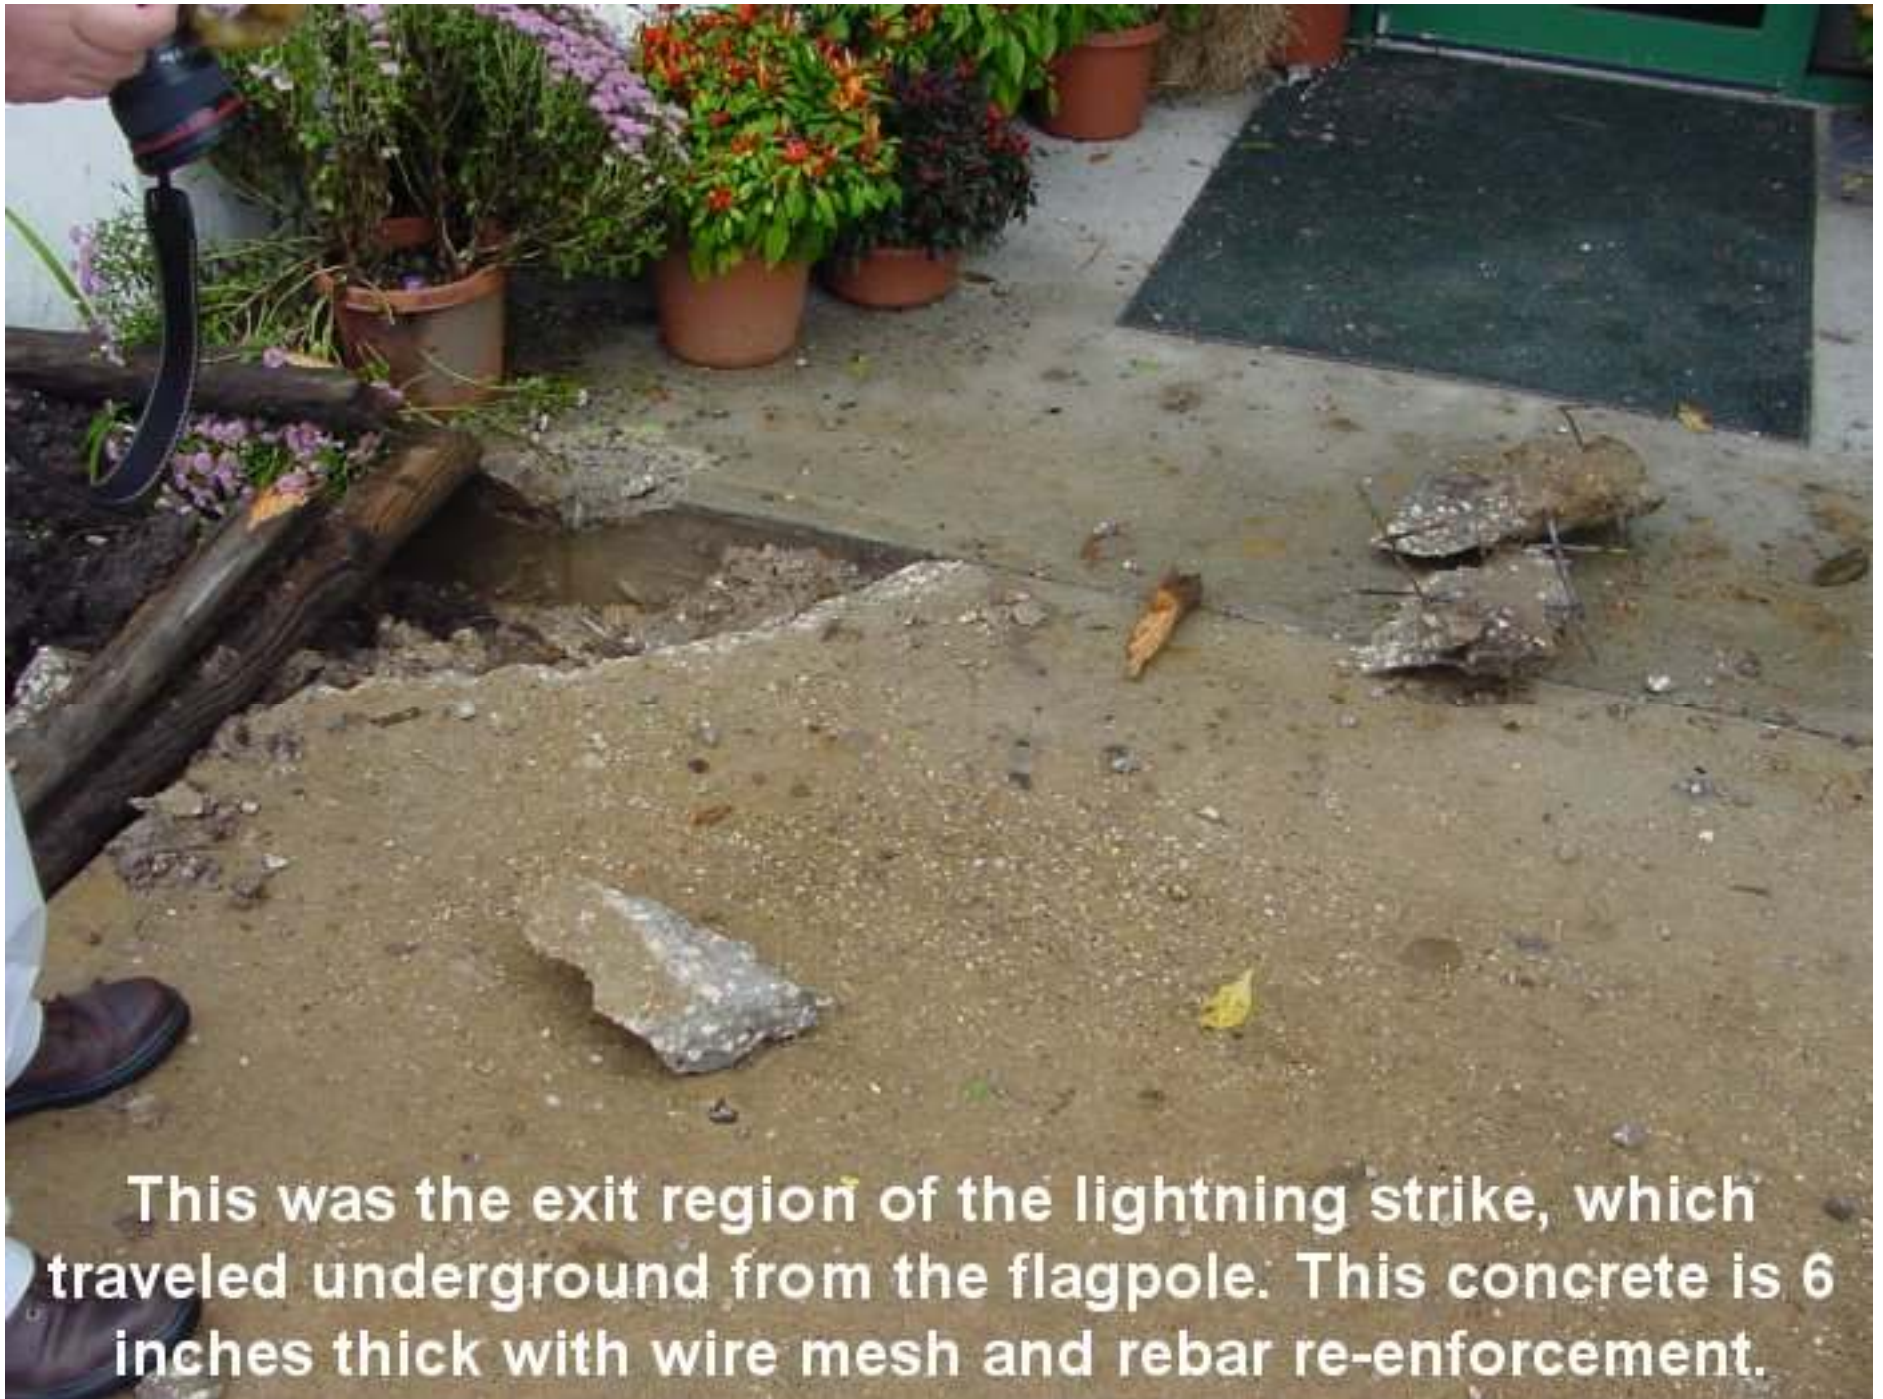
This was the exit region of the lightning strike, which traveled underground from the flagpole. This concrete is 6 inches thick with wire mesh and rebar re-enforcement.

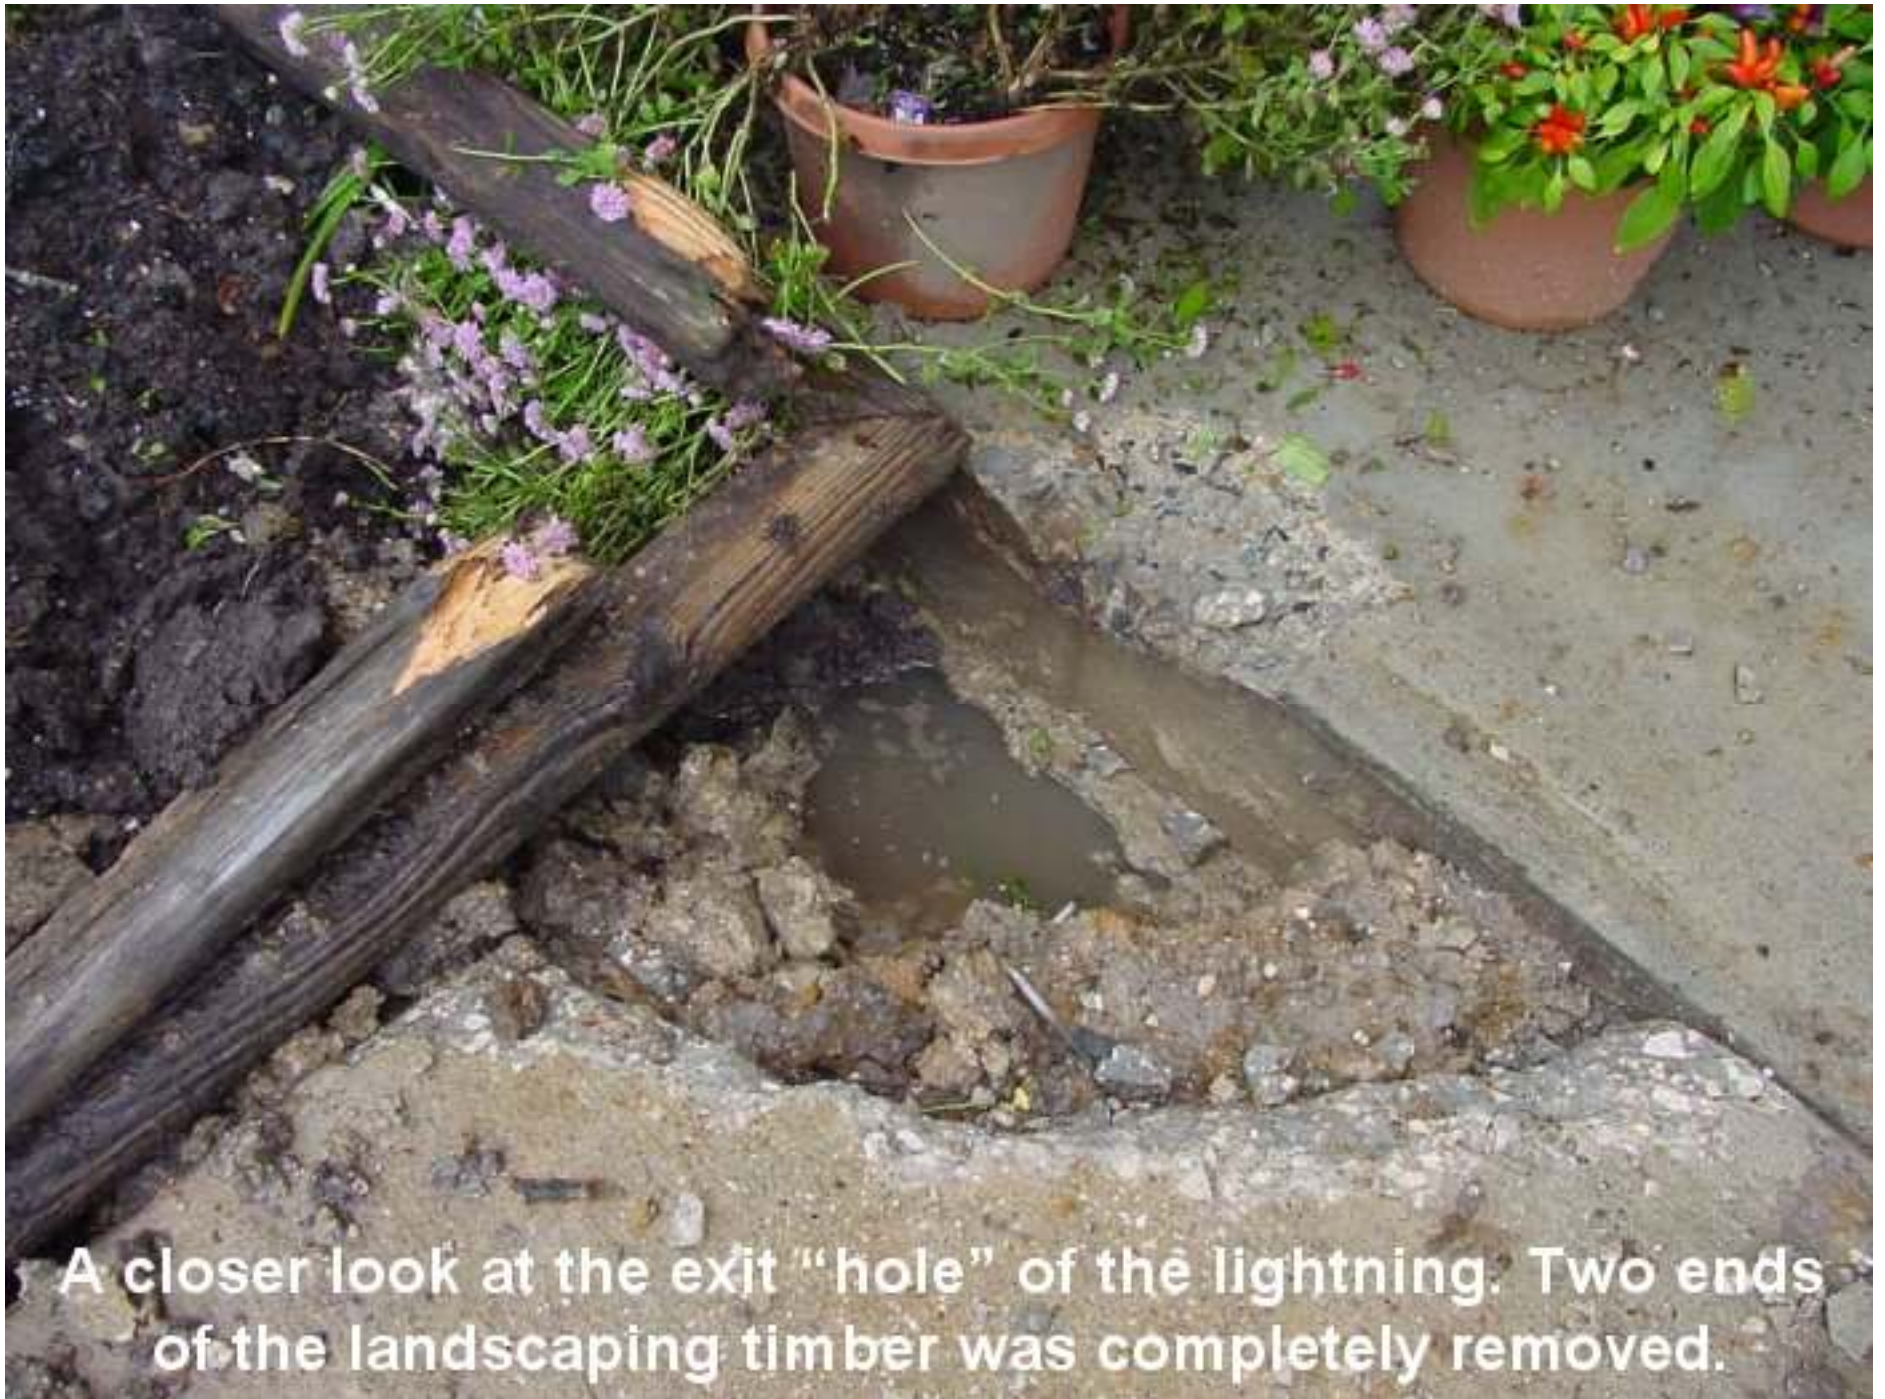
A closer look at the exit "hole" of the lightning. Two ends of the landscaping timber was completely removed.

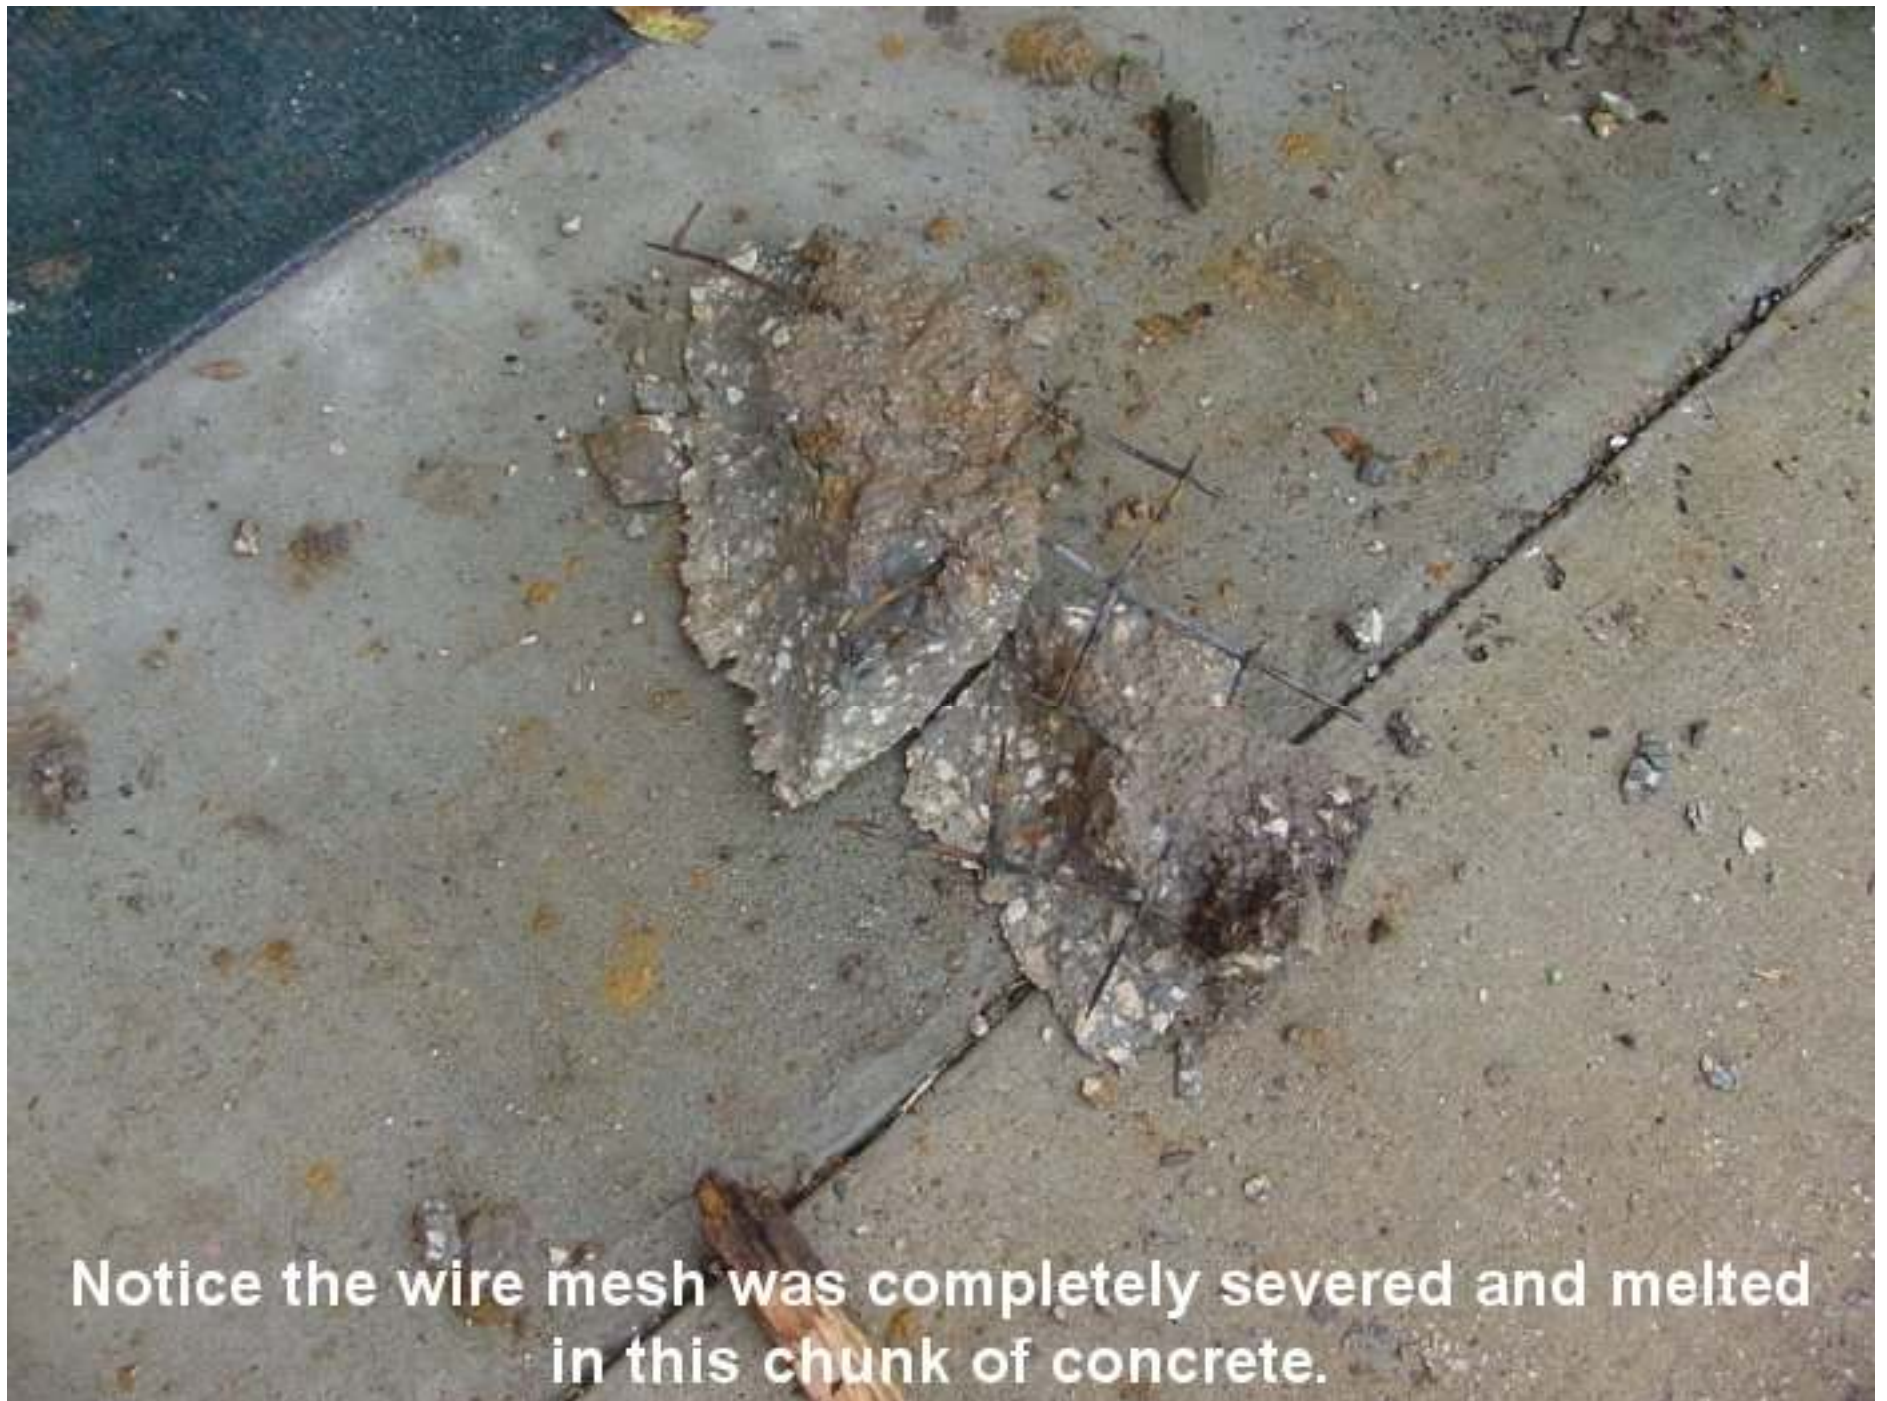
Notice the wire mesh was completely severed and melted in this chunk of concrete.
