Lightning Damage at the LSU Agricultural Center

Lake Charles, LA
October 25, 2003

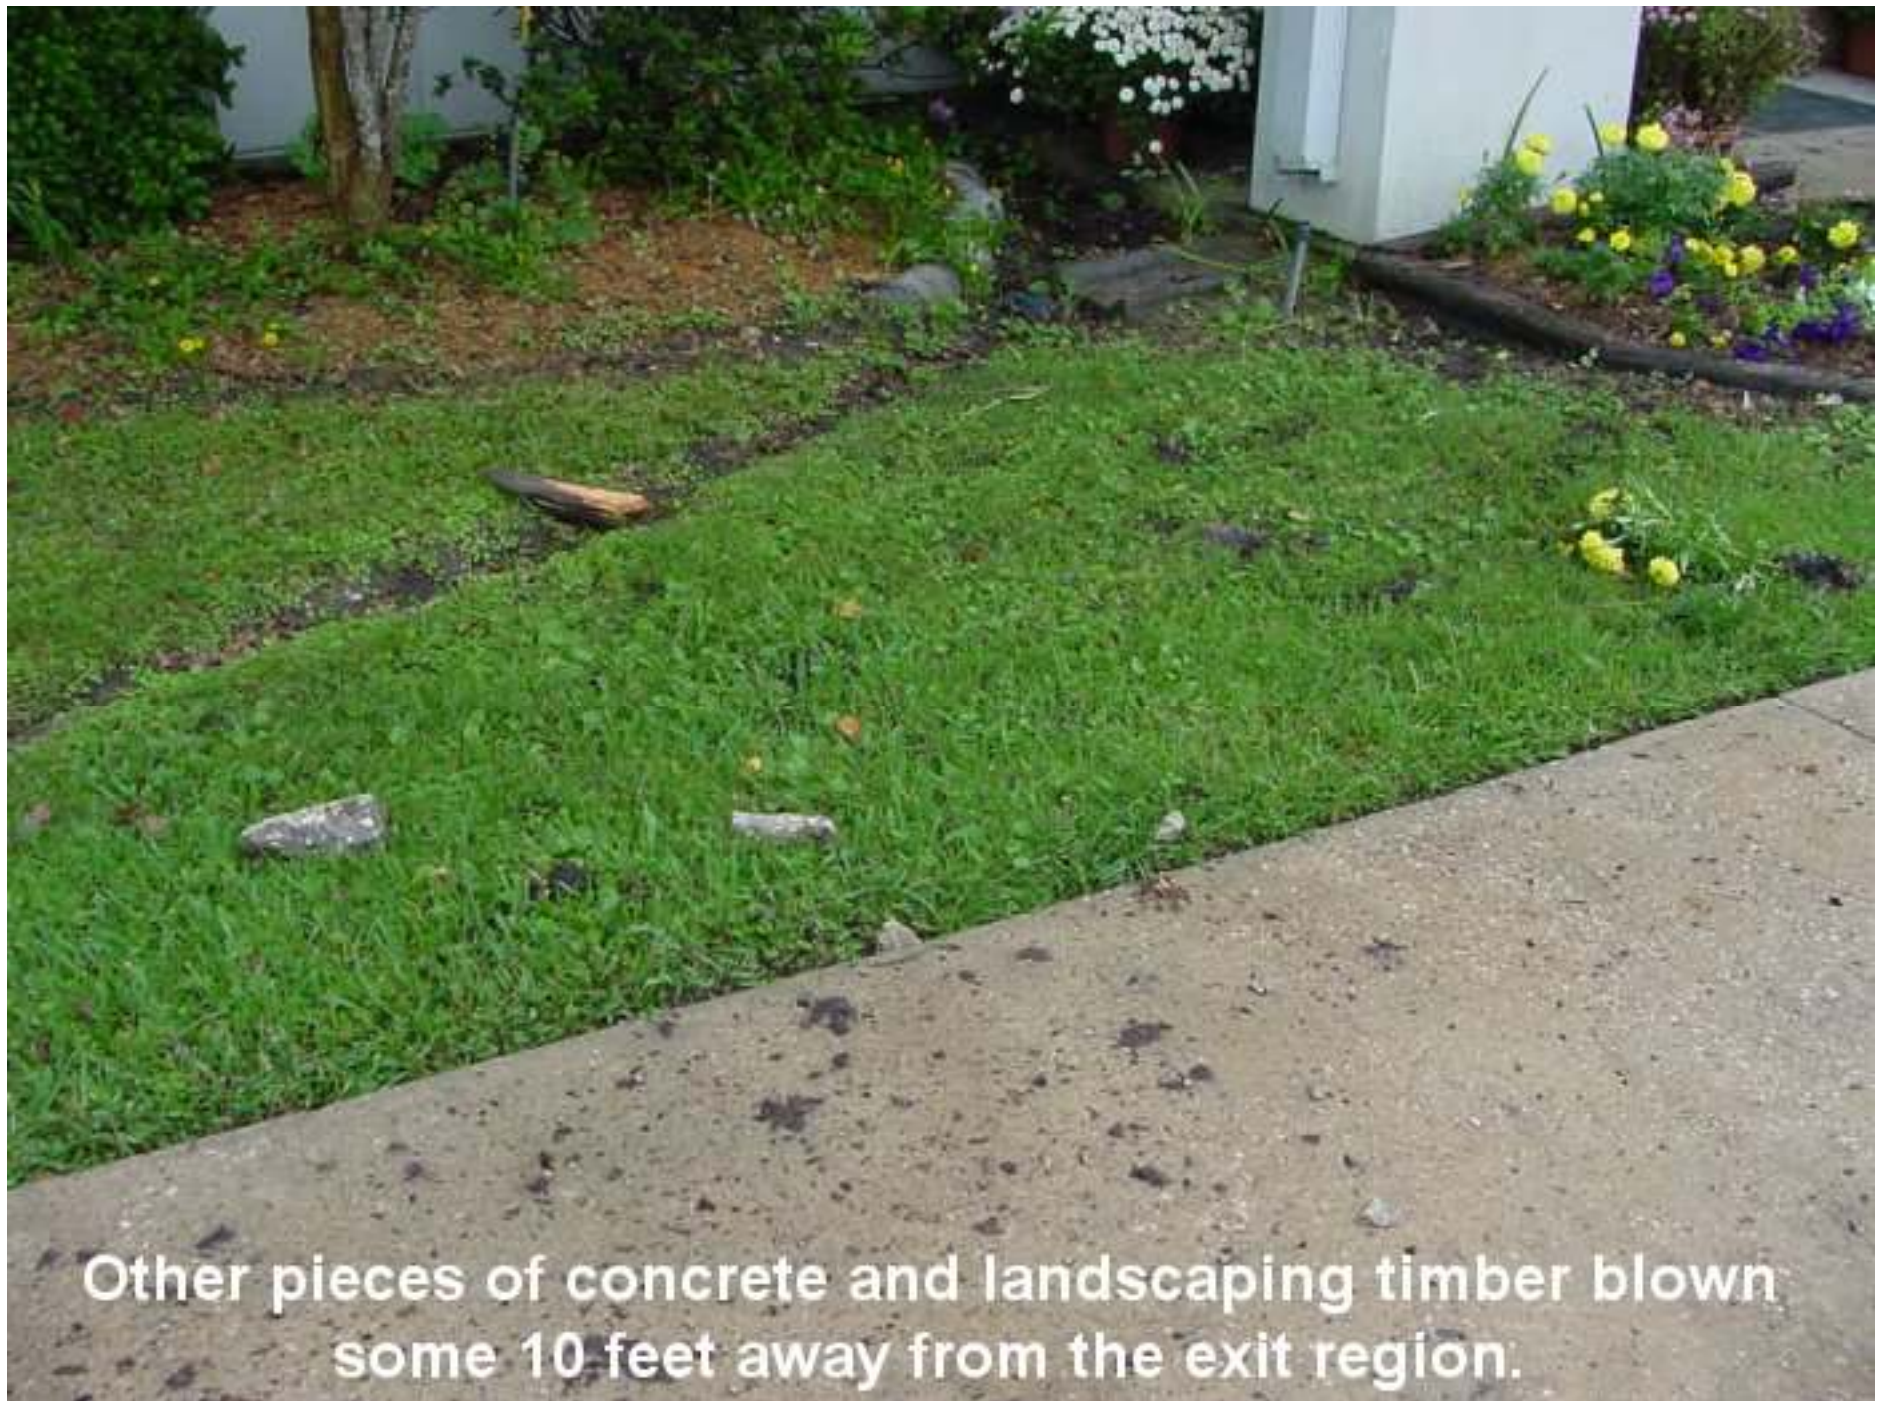
Other pieces of concrete and landscaping timber blown some 10 feet away from the exit region.

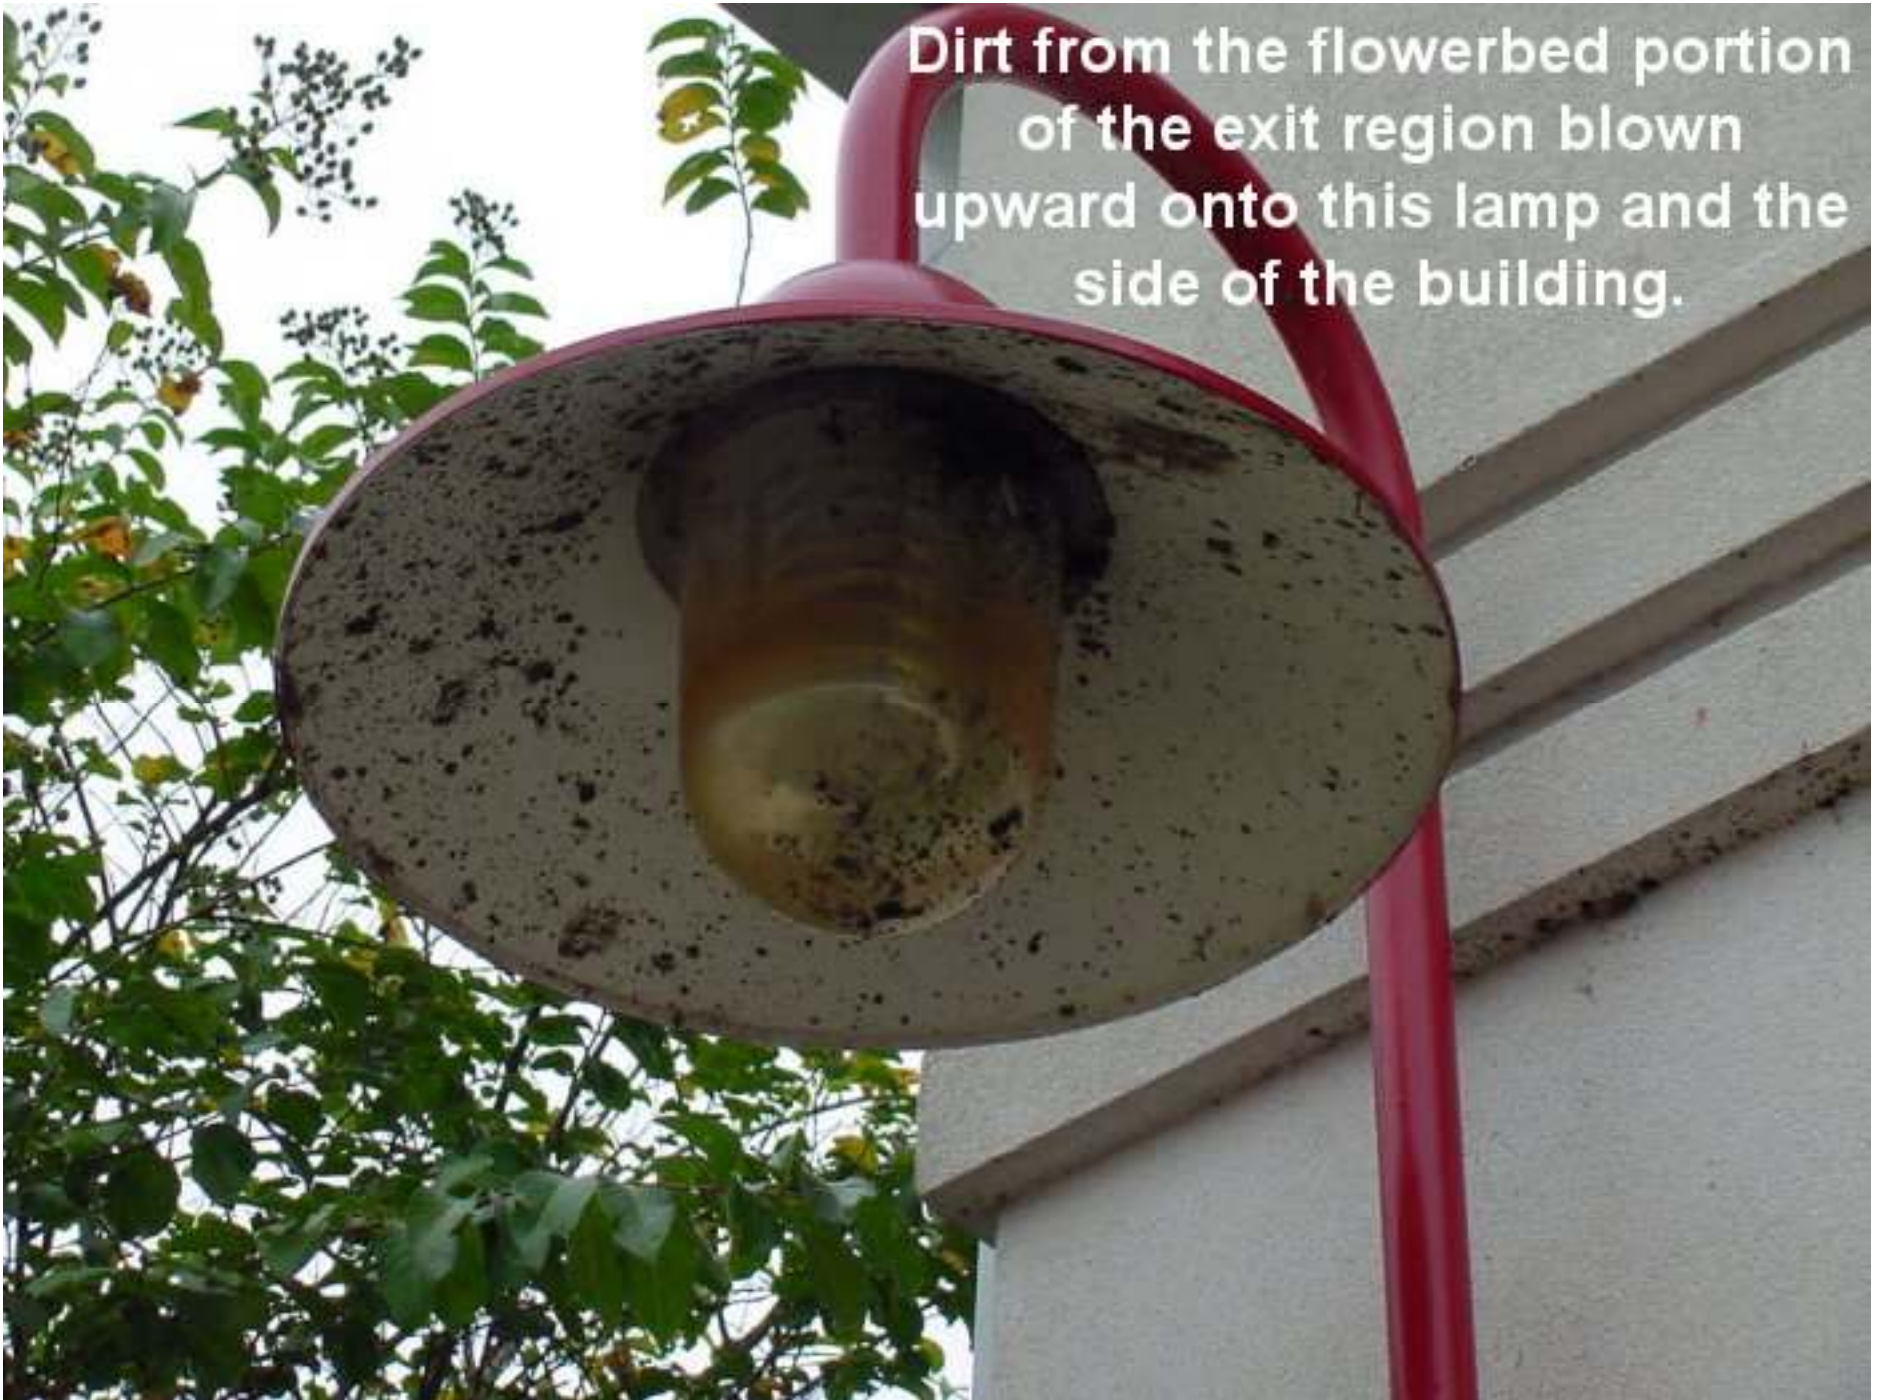
Dirt from the flowerbed portion of the exit region blown upward onto this lamp and the side of the building.

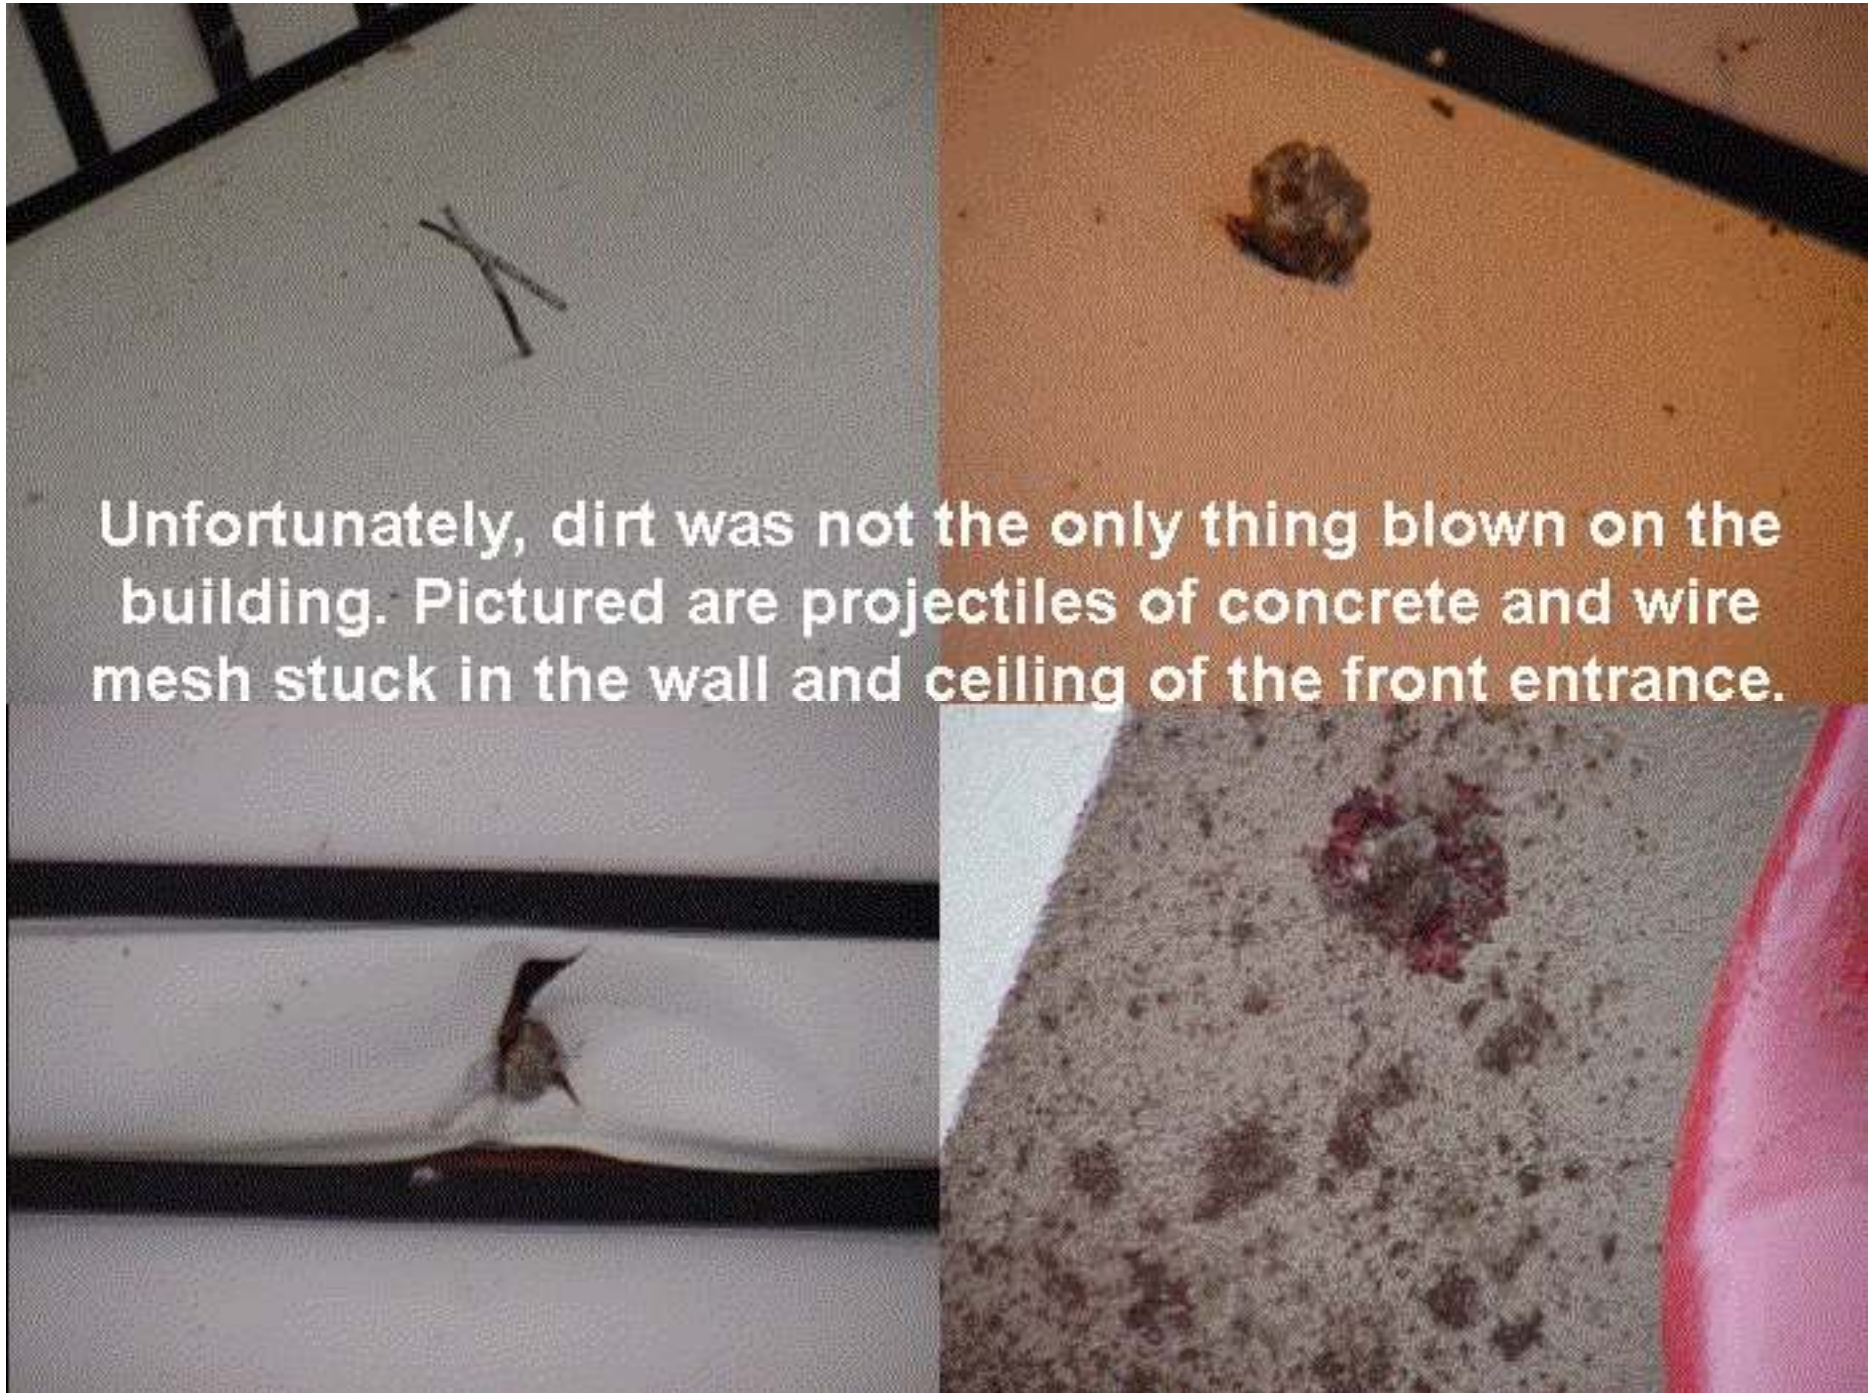
Unfortunately, dirt was not the only thing blown on the building. Pictured are projectiles of concrete and wire mesh stuck in the wall and ceiling of the front entrance.

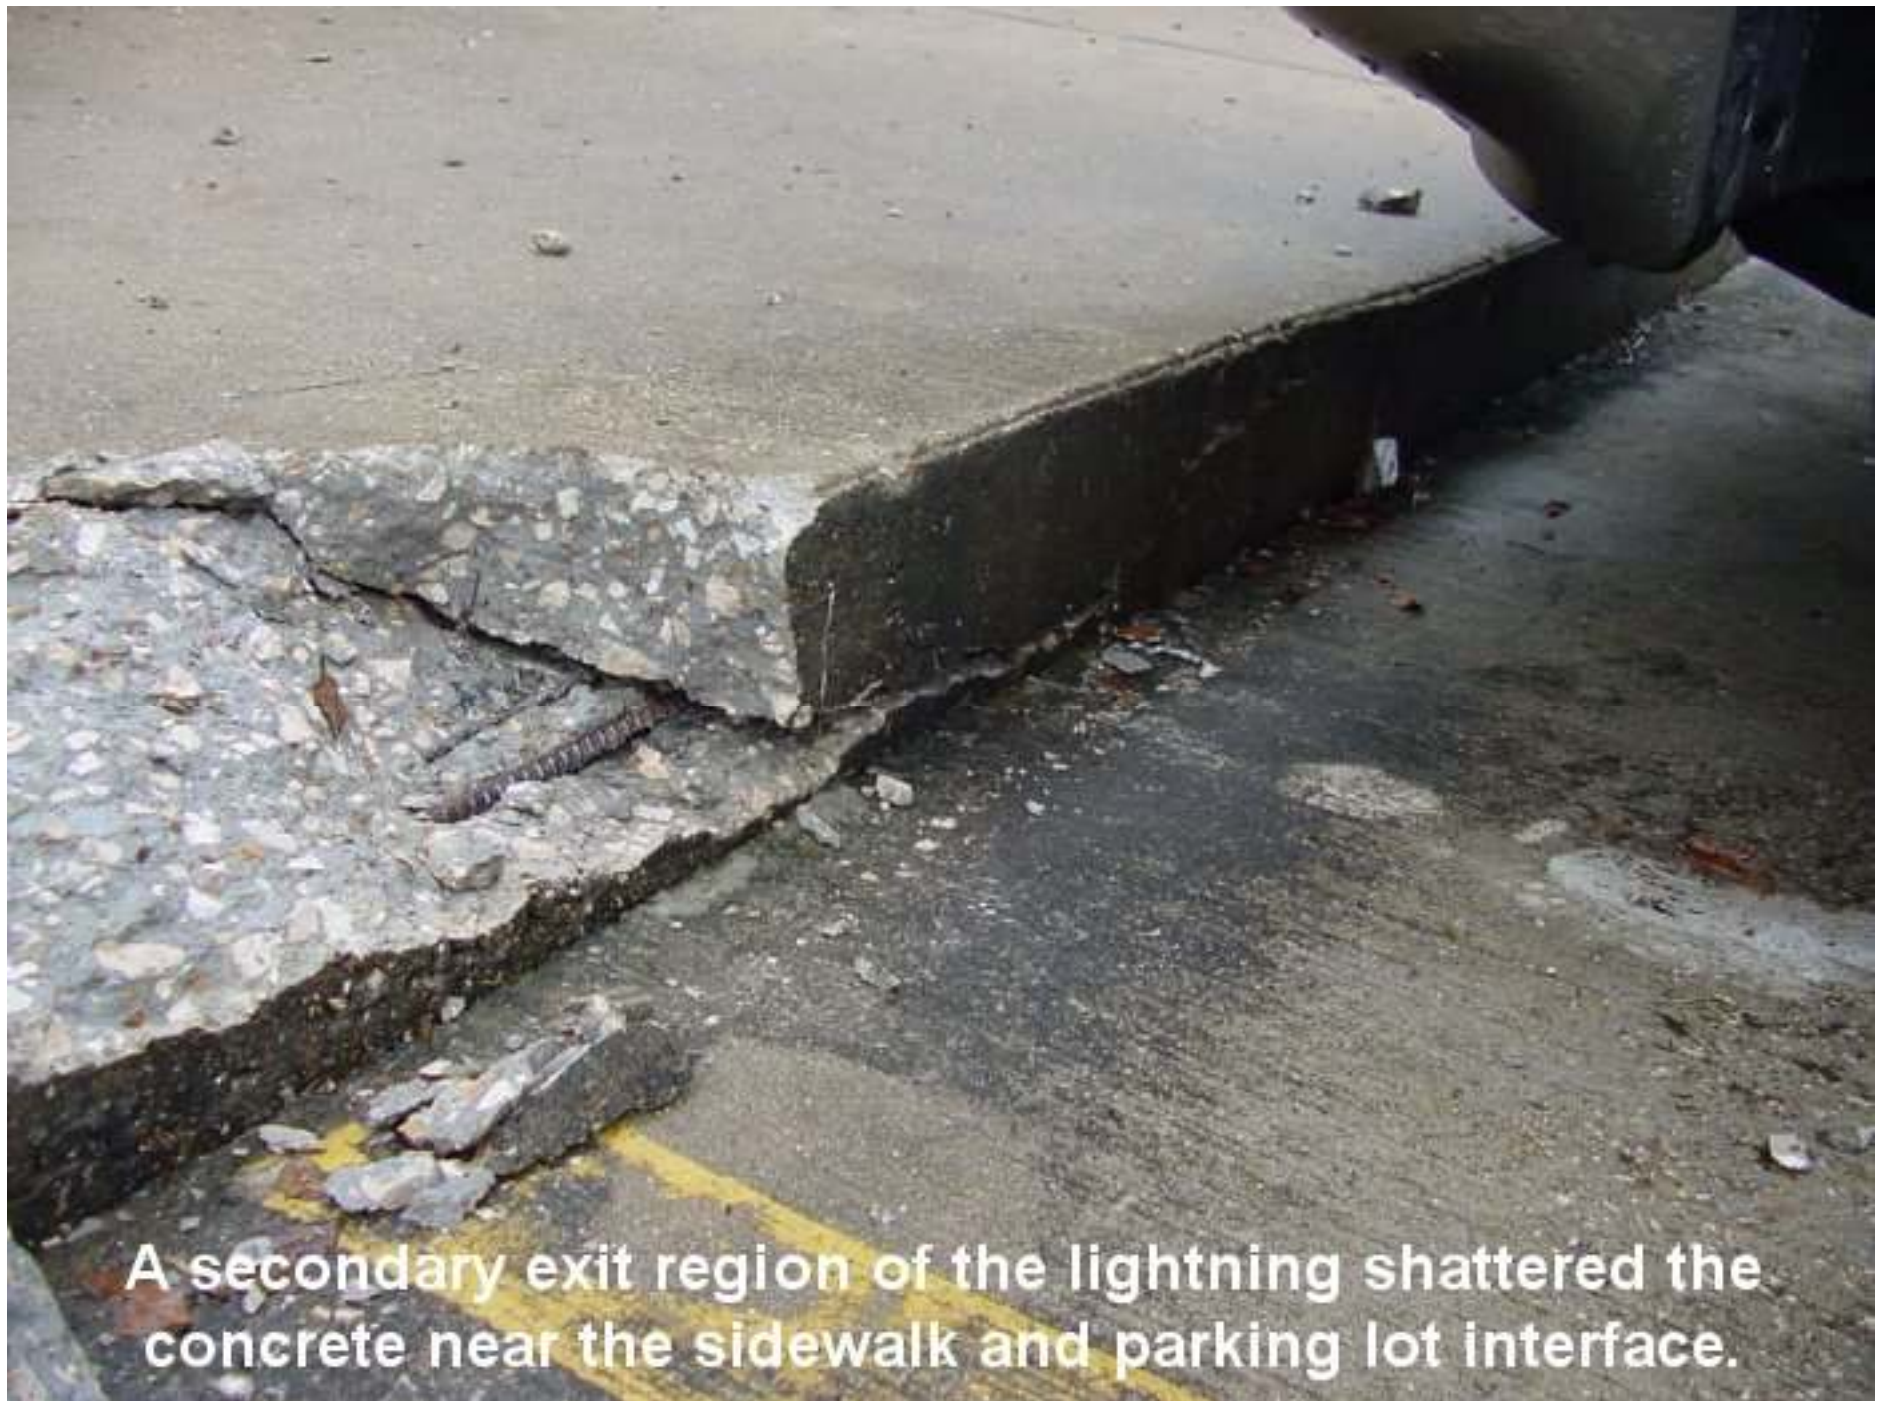
A secondary exit region of the lightning shattered the concrete near the sidewalk and parking lot interface.

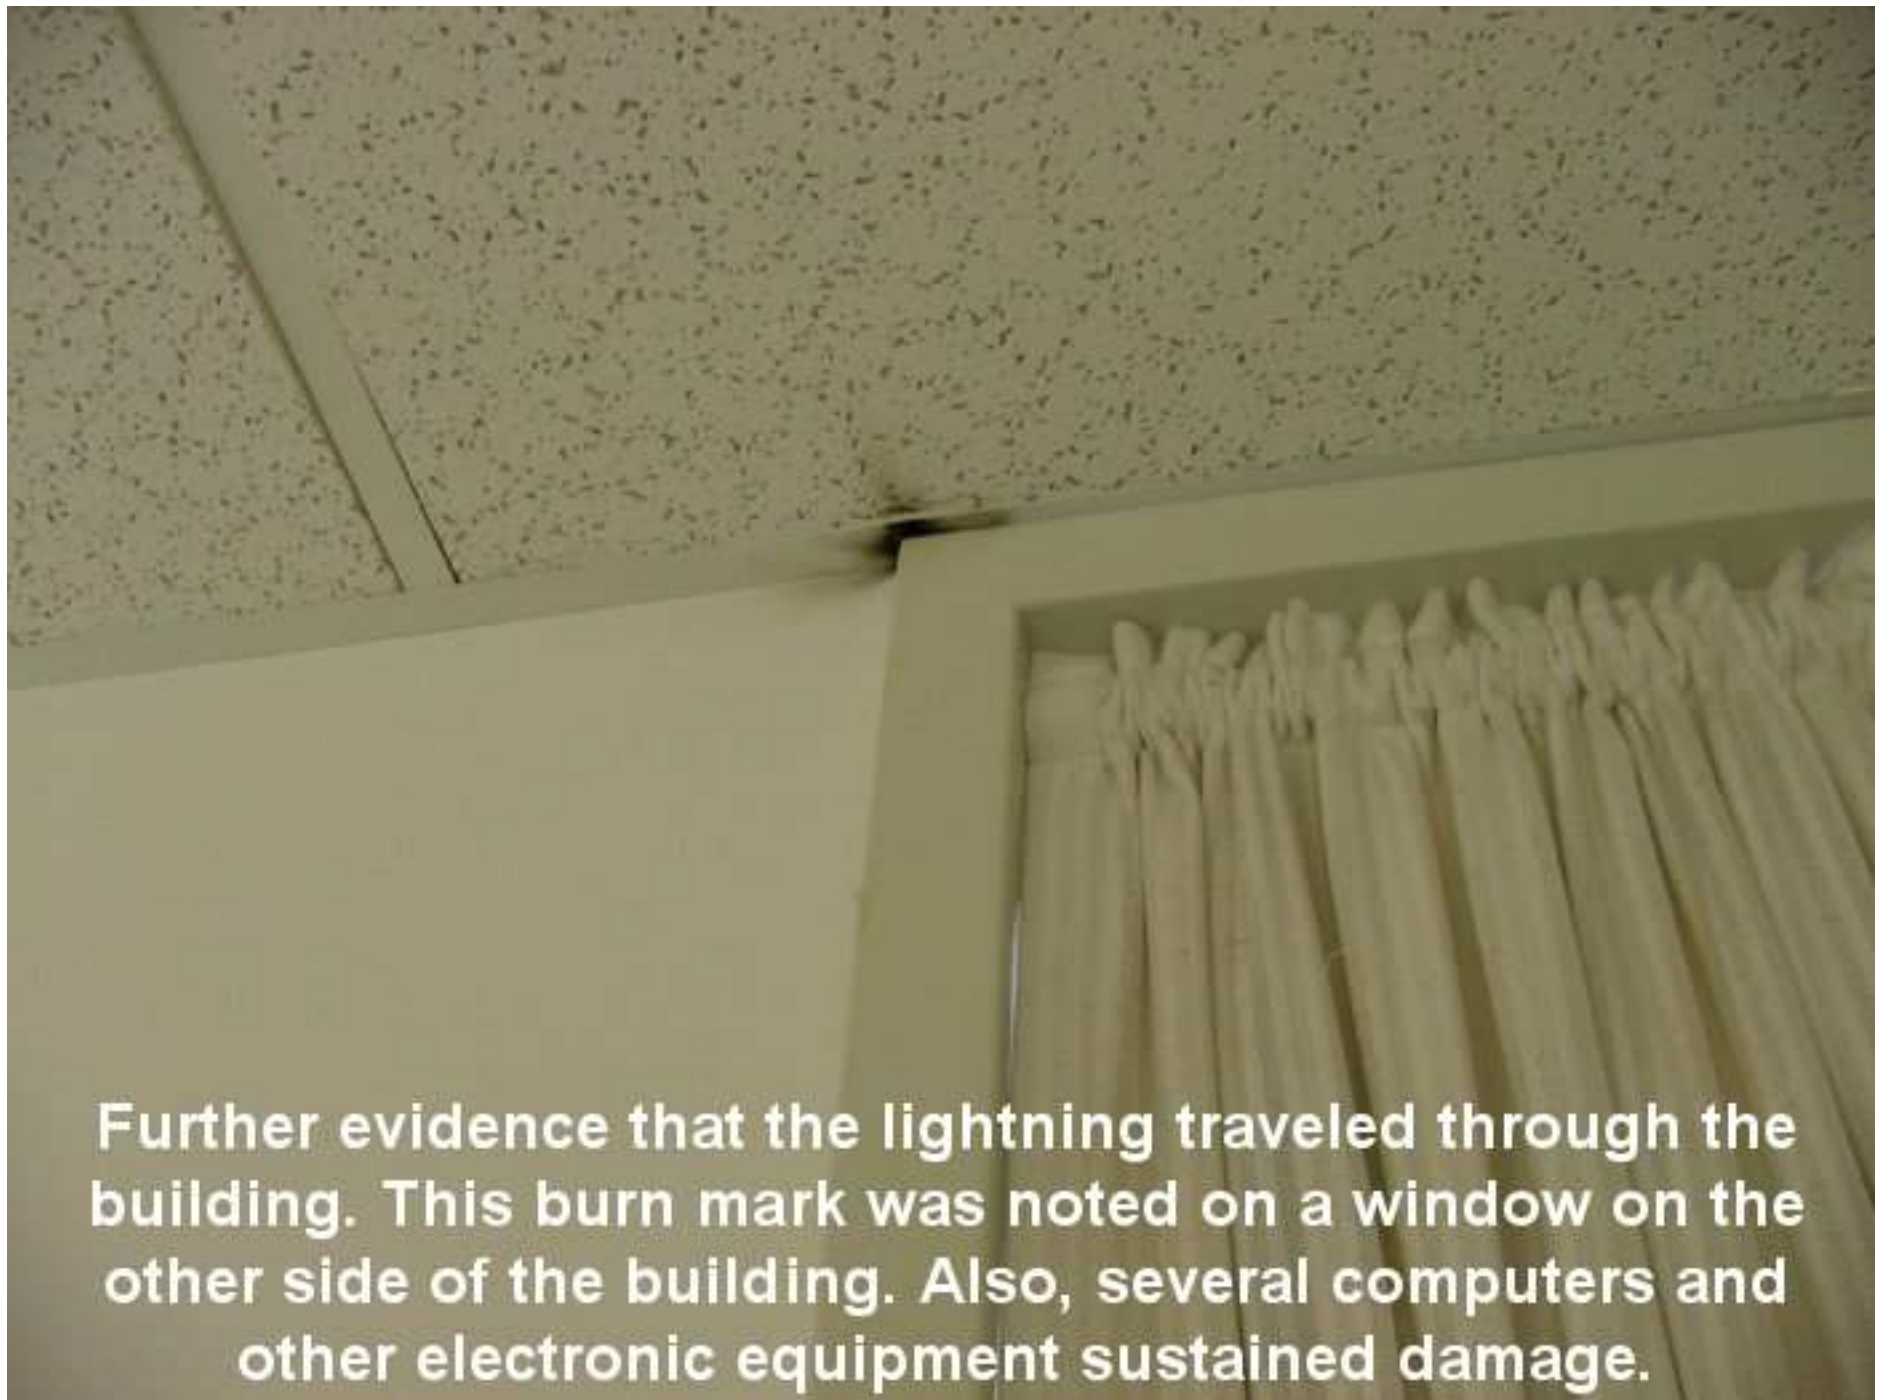
Further evidence that the lightning traveled through the building. This burn mark was noted on a window on the other side of the building. Also, several computers and other electronic equipment sustained damage.

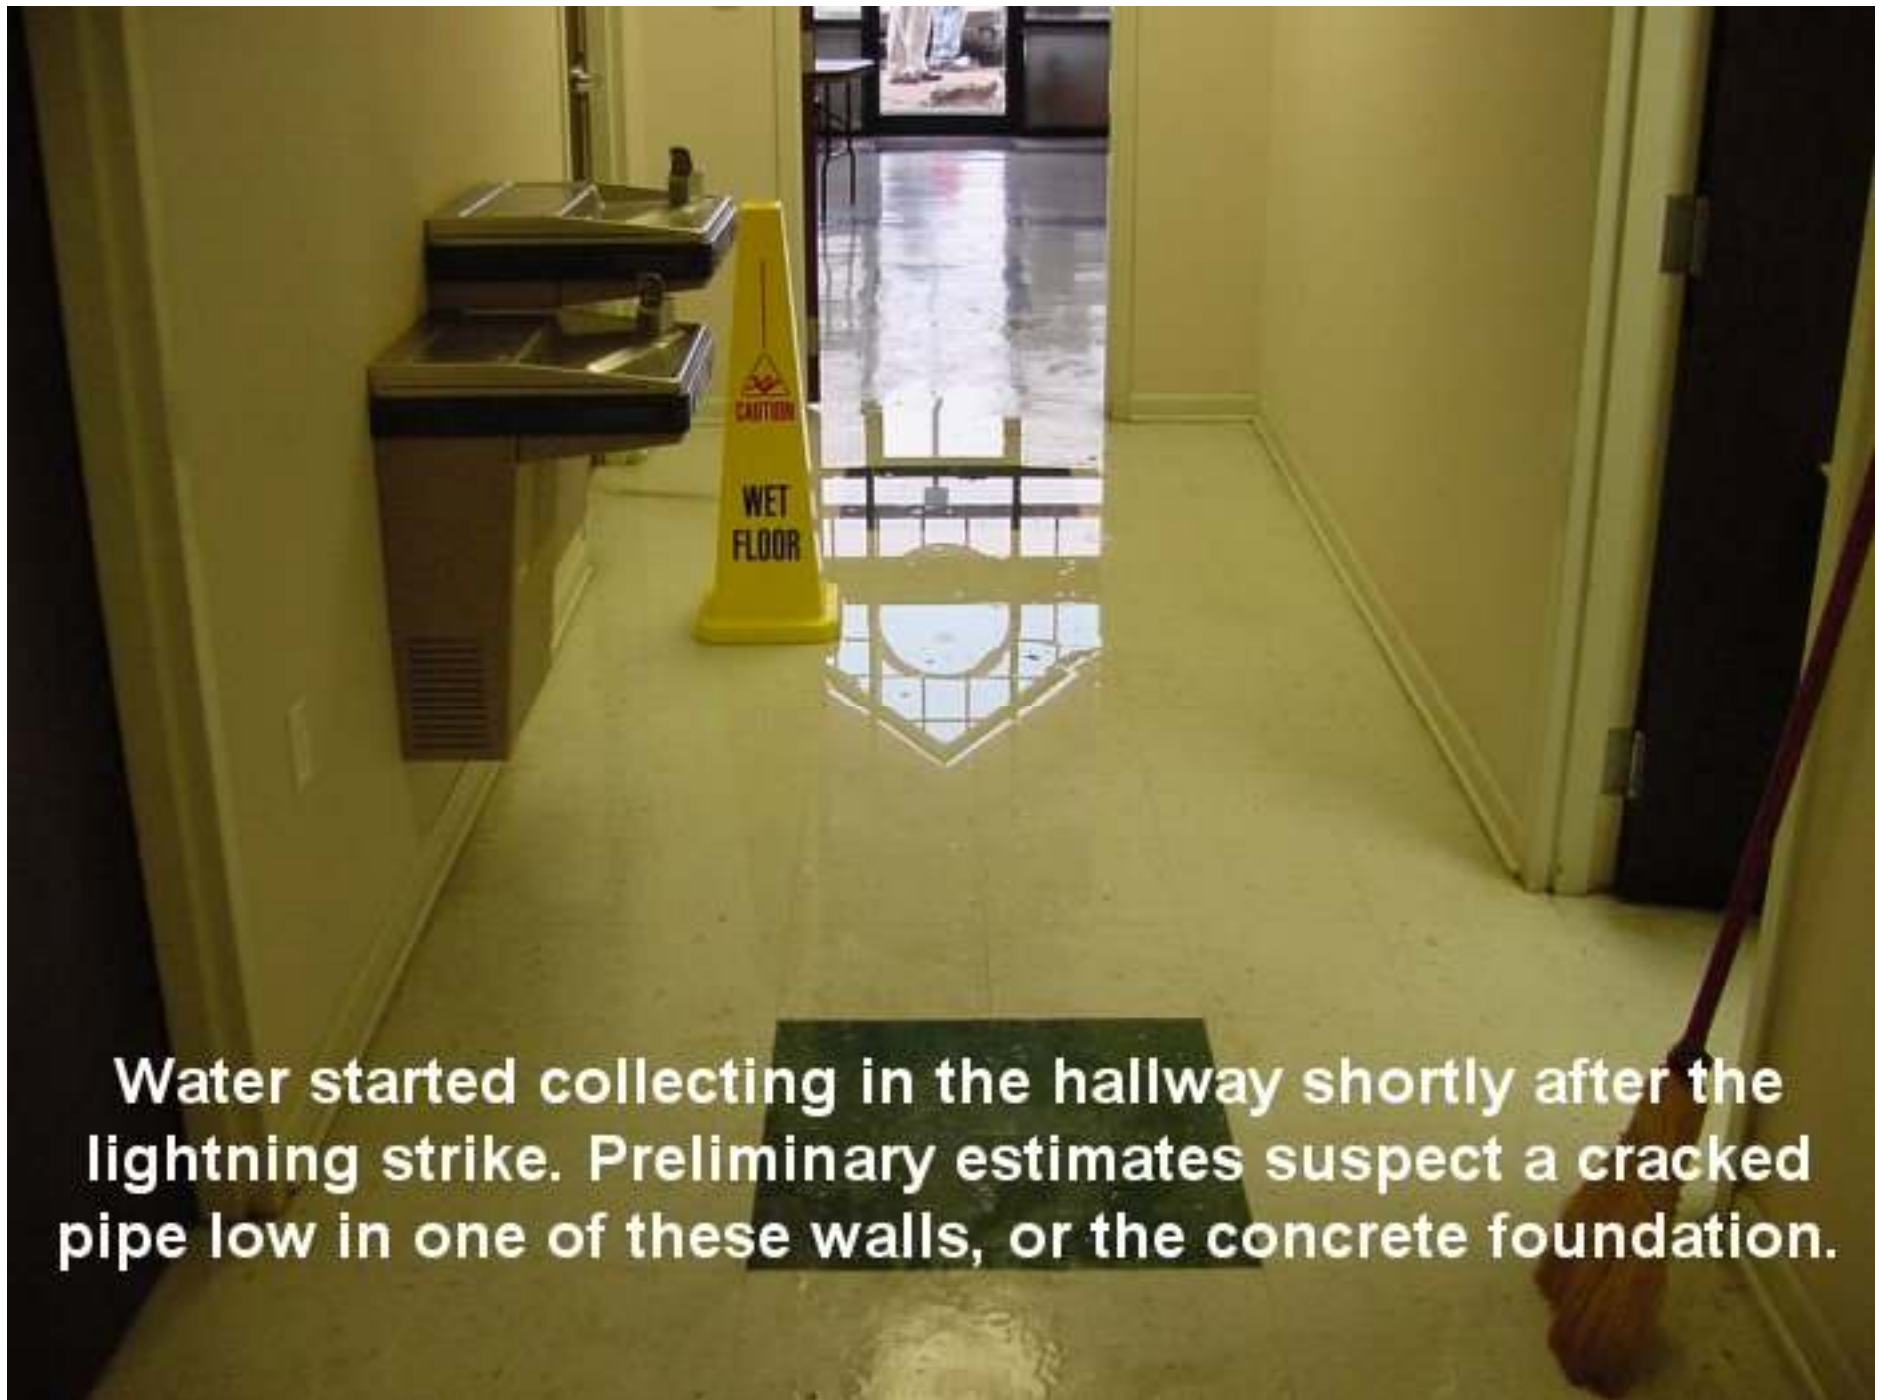
Water started collecting in the hallway shortly after the lightning strike. Preliminary estimates suspect a cracked pipe low in one of these walls, or the concrete foundation.
