**ENGINEERING
ASPECTS OF THE
TORNADOES OF
APRIL 3-4, 1974**

KISHOR C. MEHTA, JOSEPH E. MINOR, JAMES R. McDONALD

Committee on Natural Disasters
Commission on Sociotechnical Systems
NATIONAL RESEARCH COUNCIL

1975

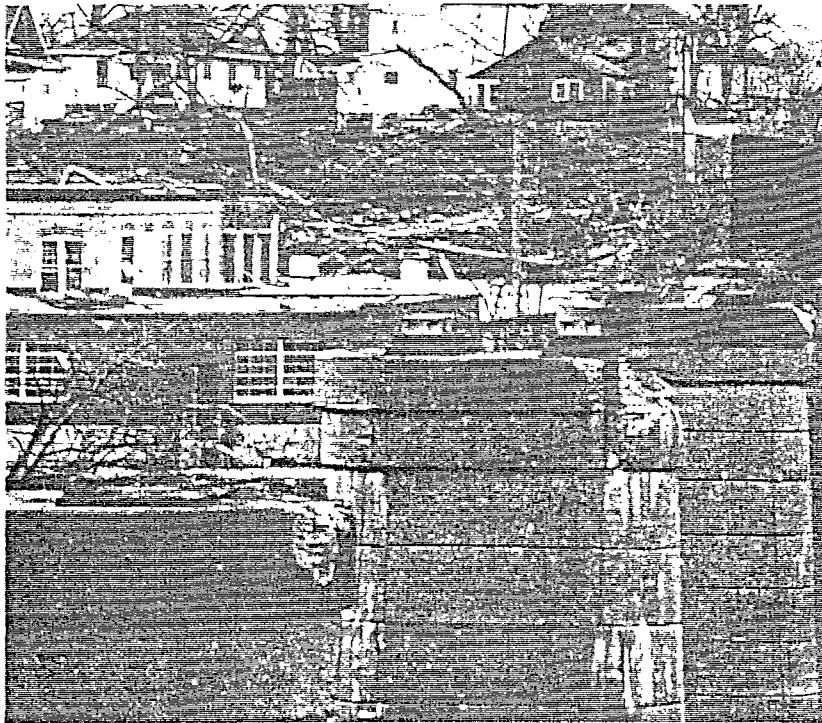
FIGURE 14. DAMAGED RAILROAD BRIDGE, MONTICELLO, INDIANA. Four spans, each with two 10 ft deep by 110 ft long girders, toppled into the river. (photograph courtesy J. J. Abernethy, University of Detroit-PASC)

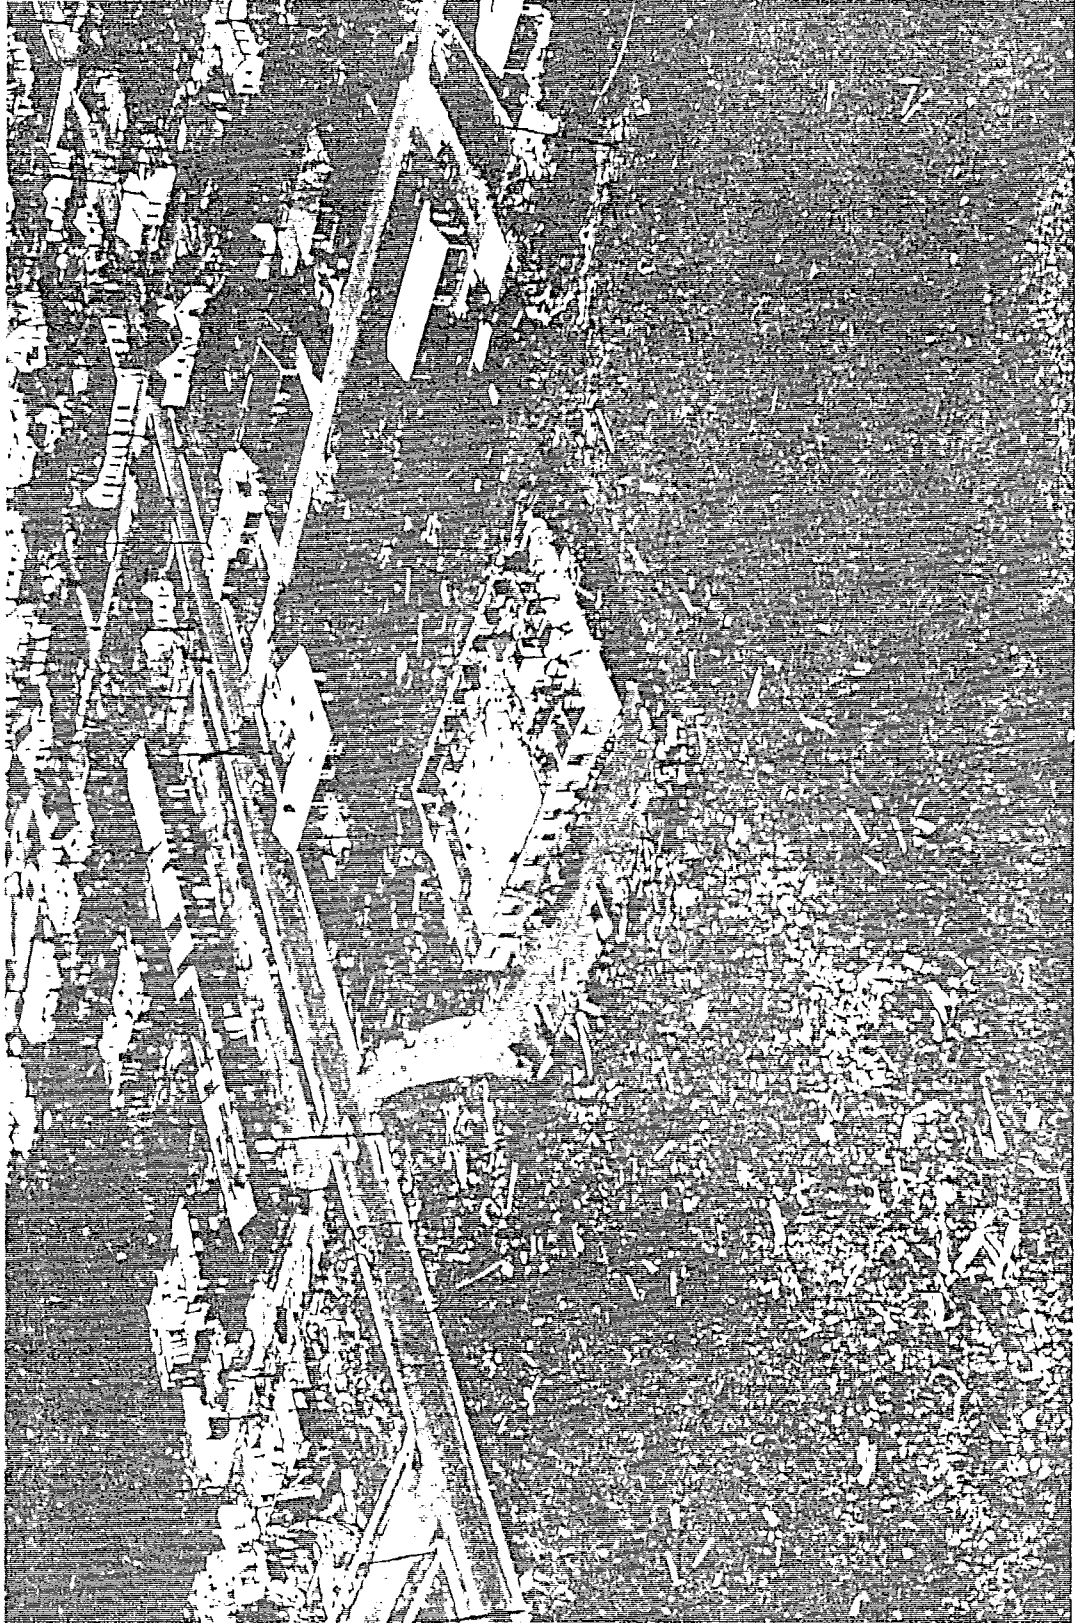
FIGURE 18. DAMAGED NURSING HOME IN MADISON, INDIANA. (photograph courtesy U. F. Koehler, Ball State University)

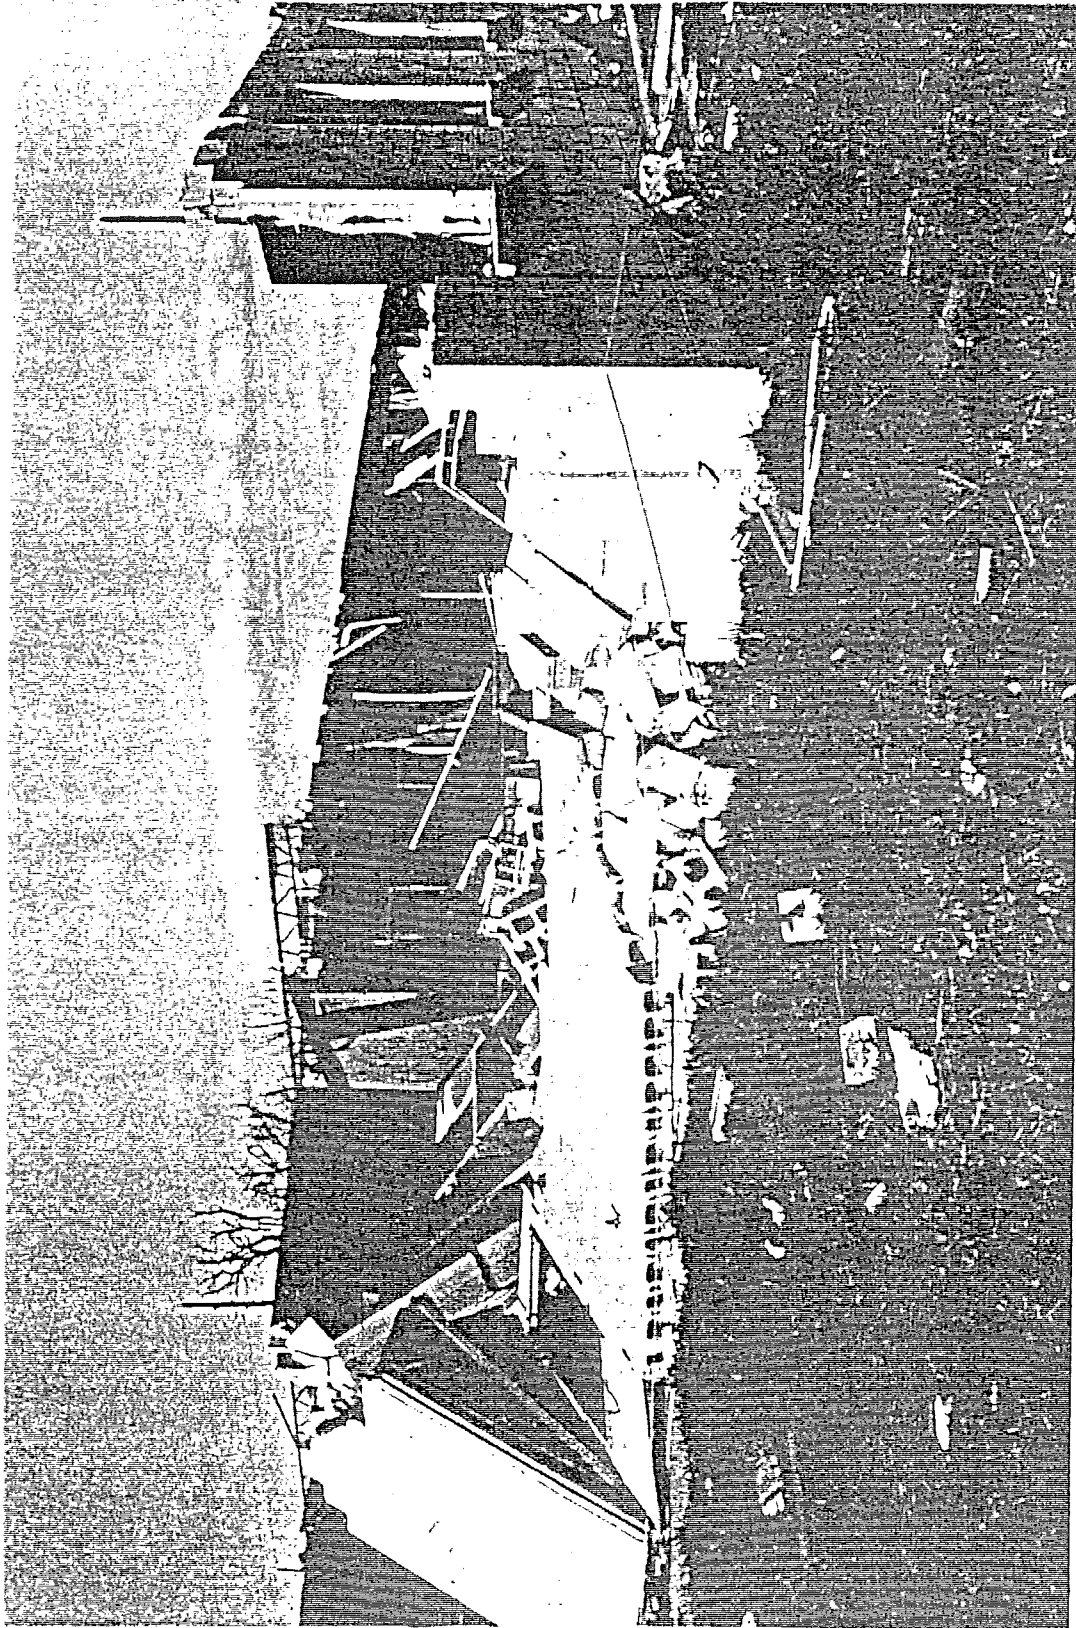
FIGURE 19. CONCRETE BLOCK WALL FAILURE IN NURSING HOME, MADISON, INDIANA. Note absence of vertical reinforcing steel and wall-foundation anchorage. (photograph courtesy U. F. Koehler, Ball State University)

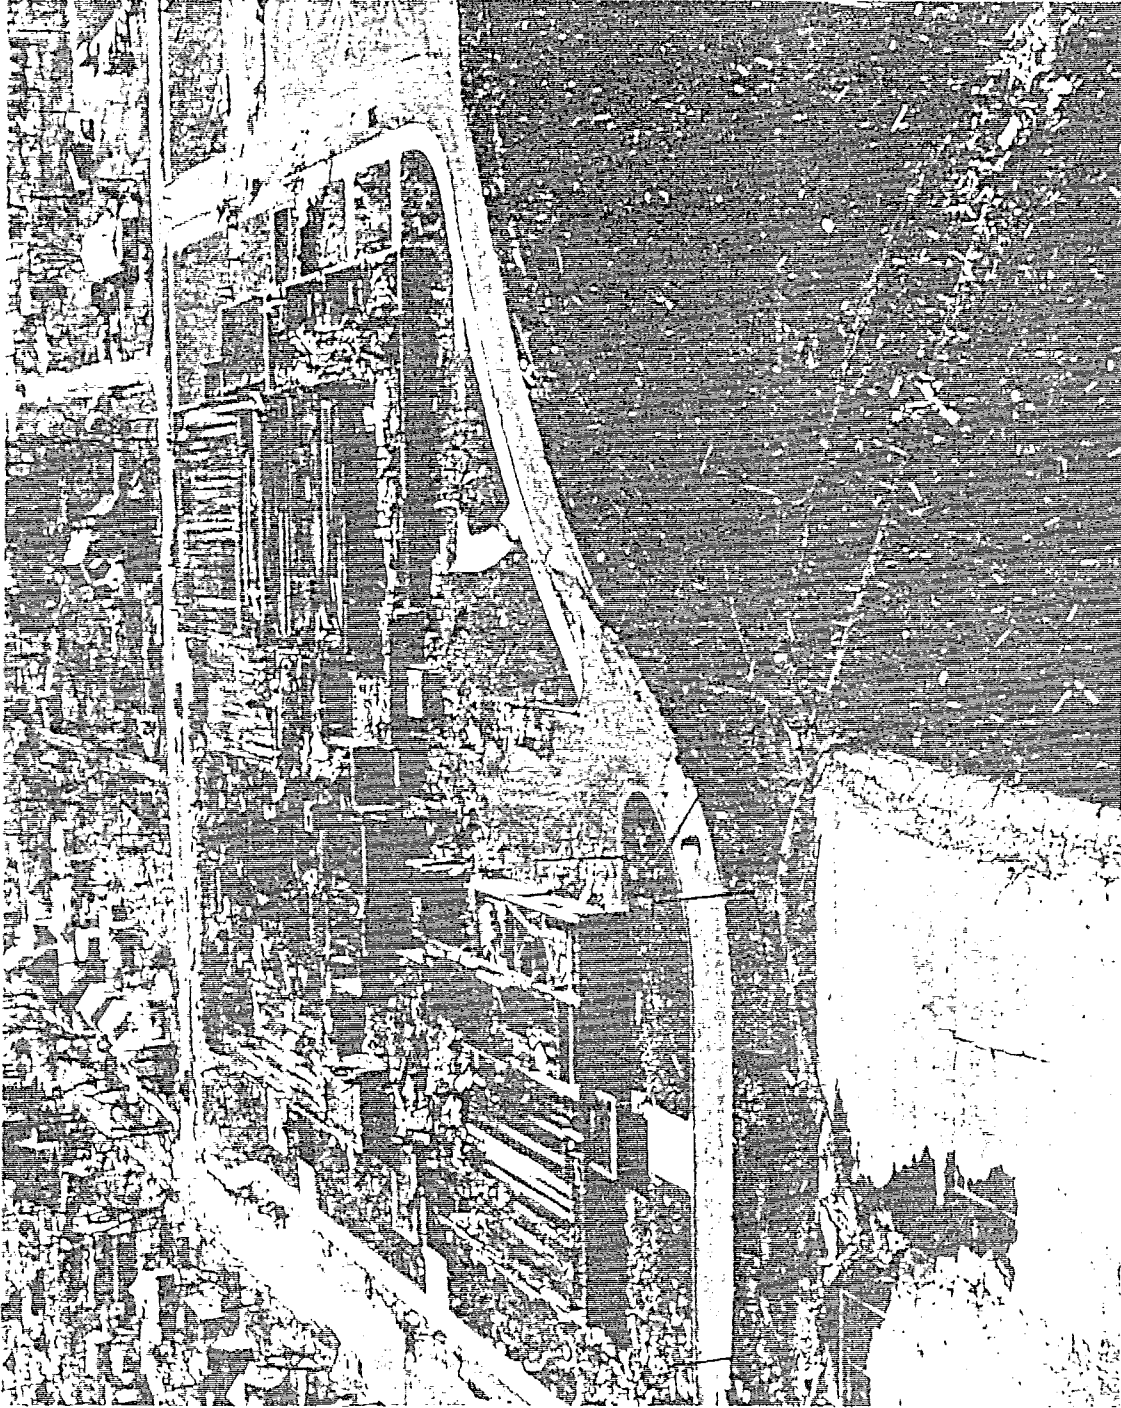
FIGURE 26. DAMAGE TO TWIN LAKES SENIOR HIGH SCHOOL, MONTICELLO, INDIANA. View is to east; gymnasium is right, center; beam which traveled over school was located originally atop exterior wall of classroom immediately left of gymnasium wall. (photograph courtesy U. F. Koehler, Ball State University)

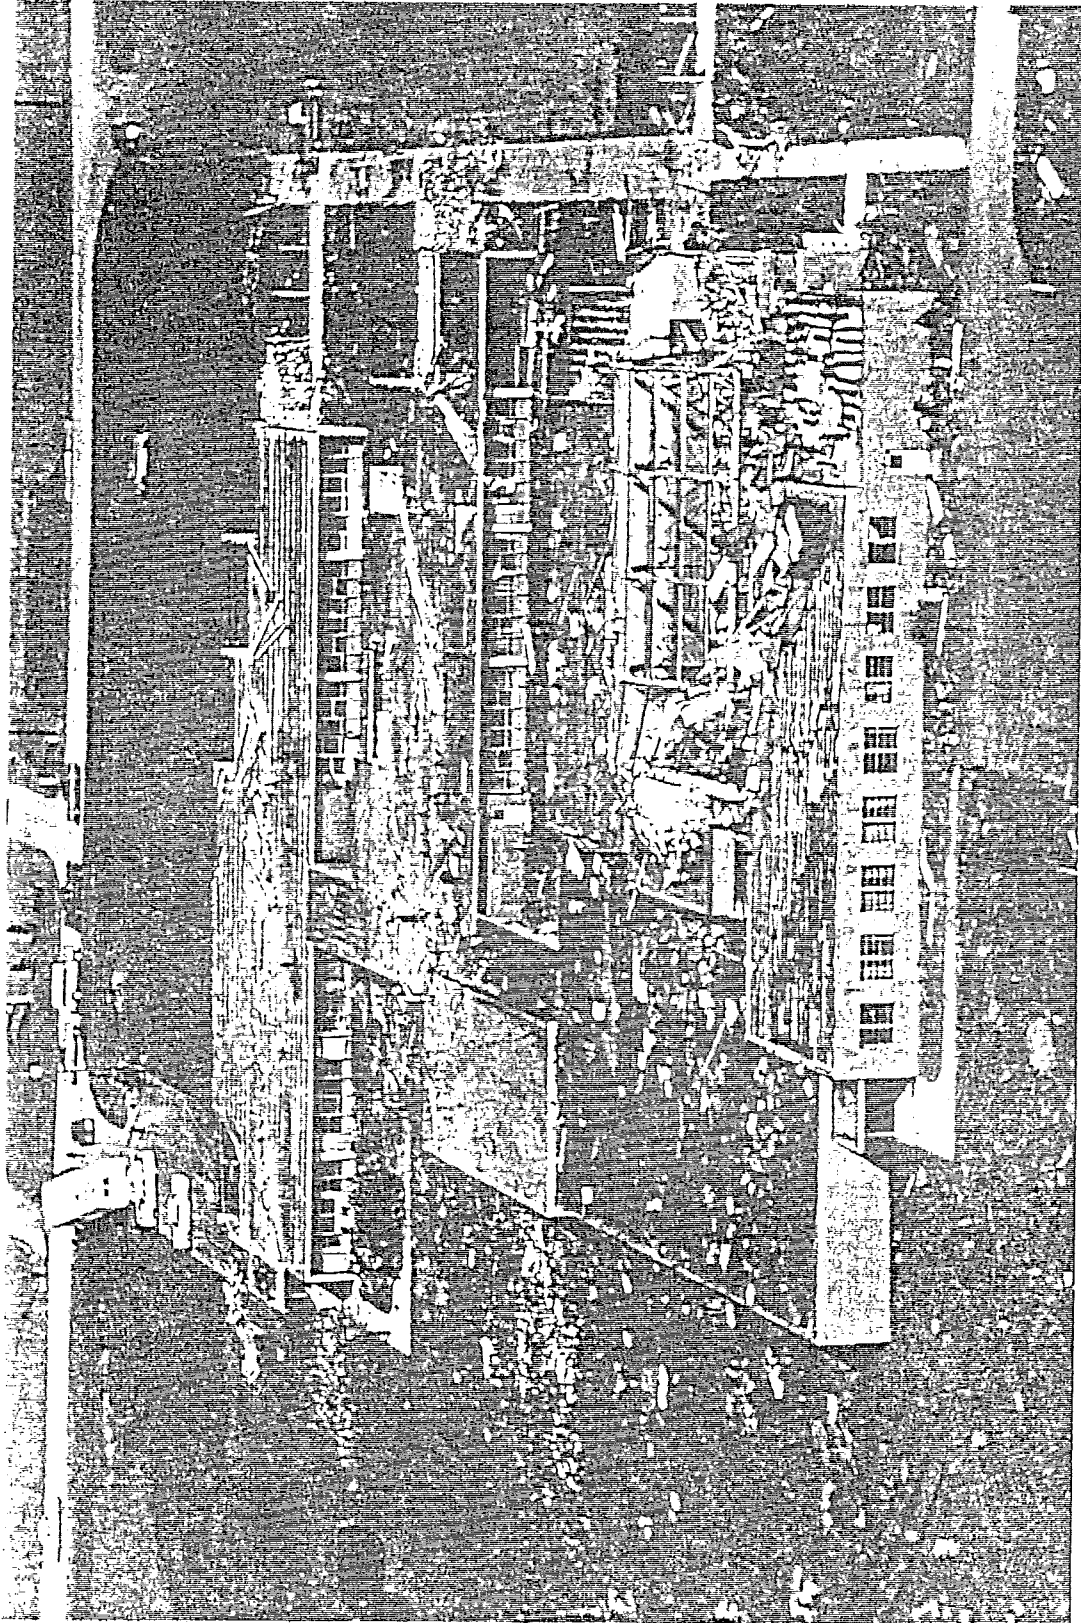
FIGURE 28. MONROE CENTRAL SCHOOL, PARKER/FARMLAND. Note intact structural frame of gymnasium and masonry wall failures. View is to east. Note precast roof planks missing and on roof on extreme east wing of building. (photograph courtesy U. F. Koehler, Ball State University)

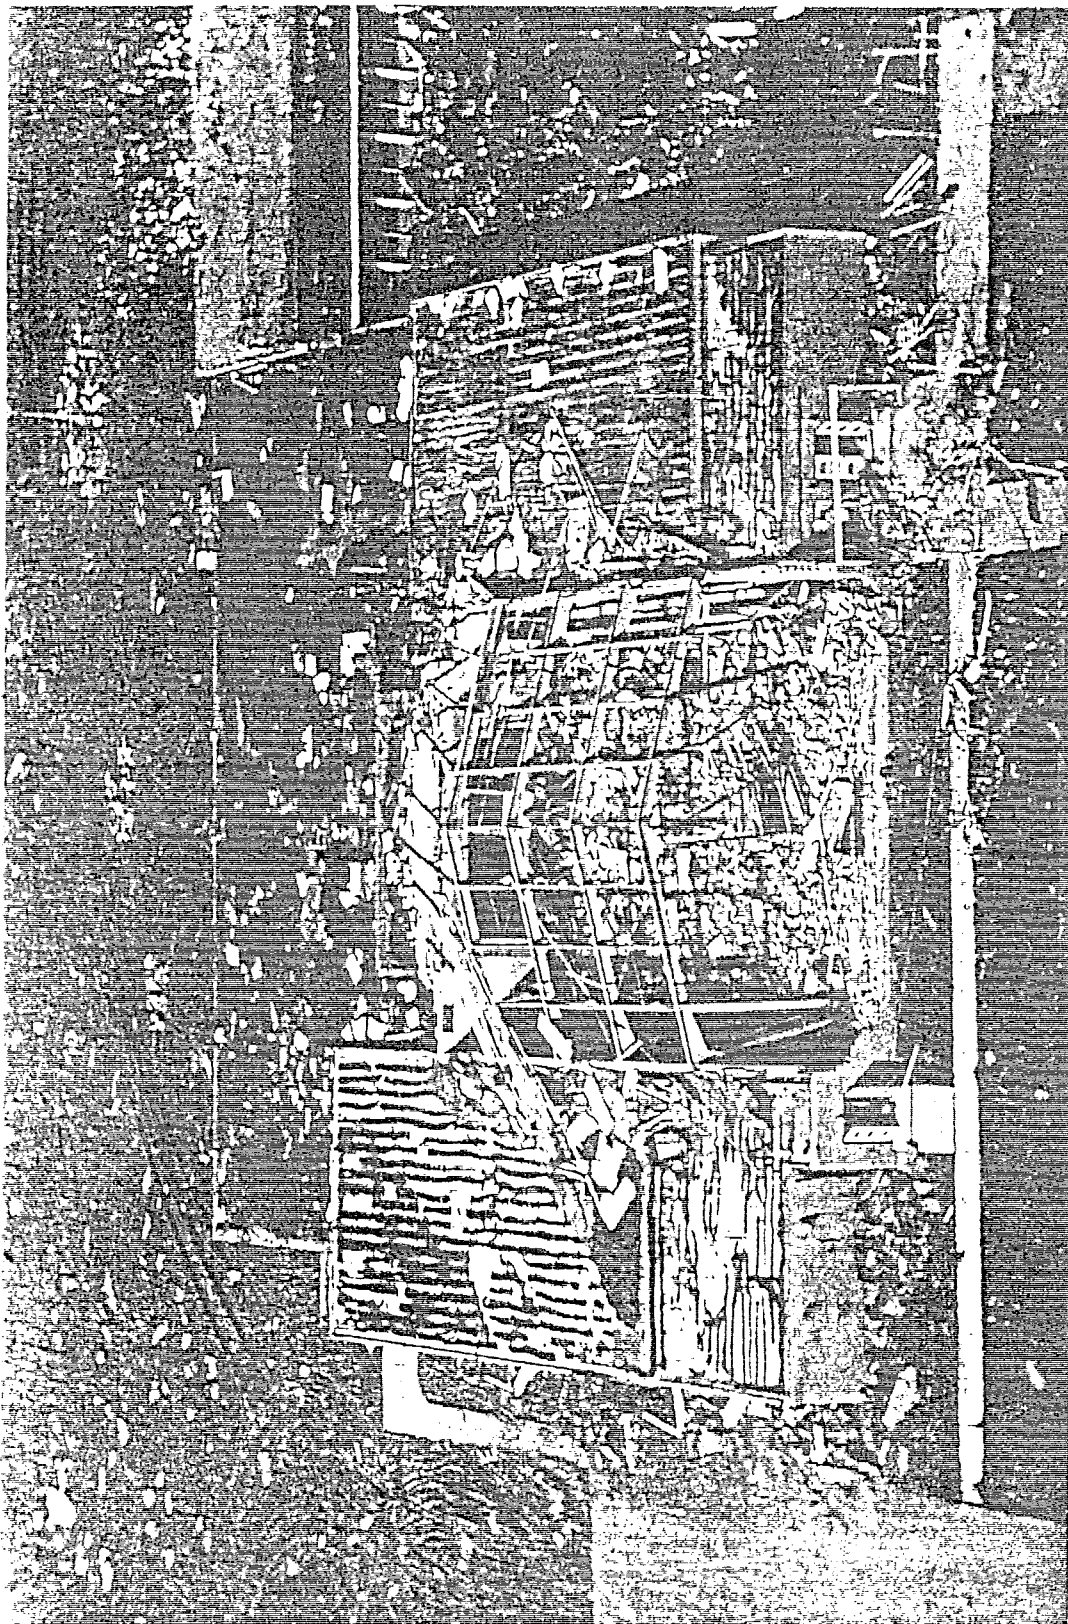
FIGURE 29. MONROE CENTRAL SCHOOL, PARKER/FARMLAND. Failures of gymnasium near wall (inward) and gabled portion of far wall (outward) was the basis for damage to this part of the structure. View is to north. (photograph courtesy U. F. Koehler, Ball State University)

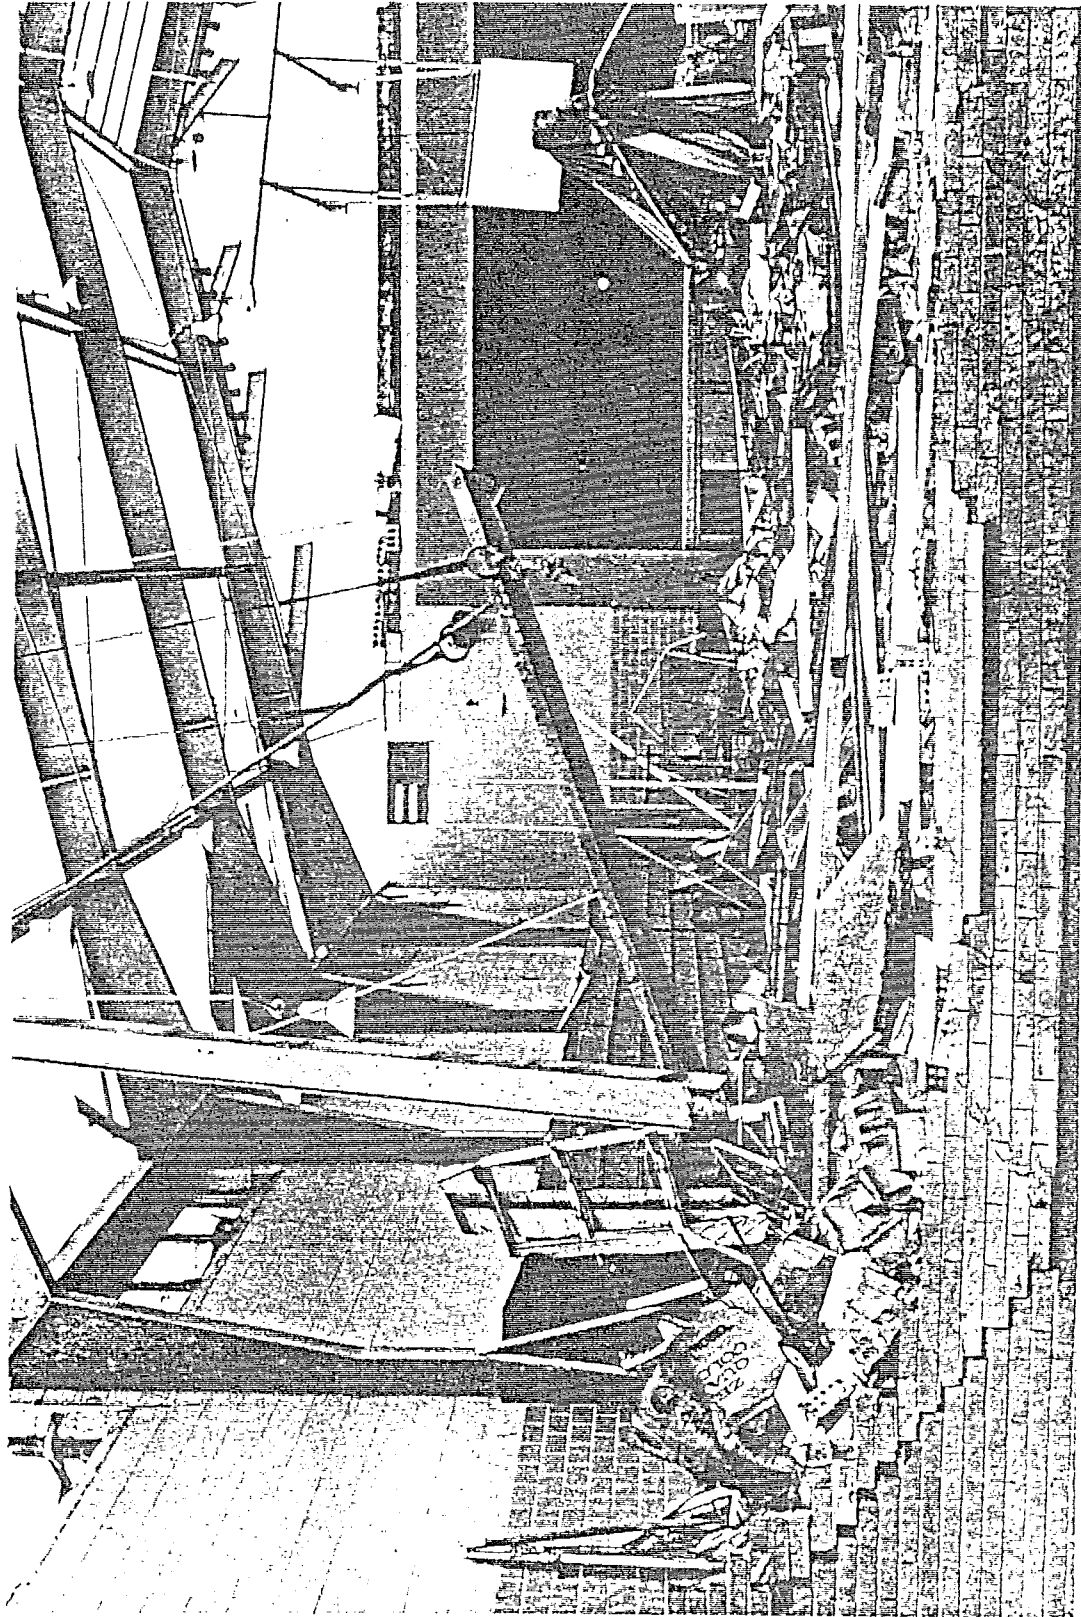
FIGURE 30. INTERIOR OF GYMNASIUM, MONROE CENTRAL SCHOOL. Note lack of damage to structural frame. View is to north. (photograph courtesy U. F. Koehler, Ball State University)

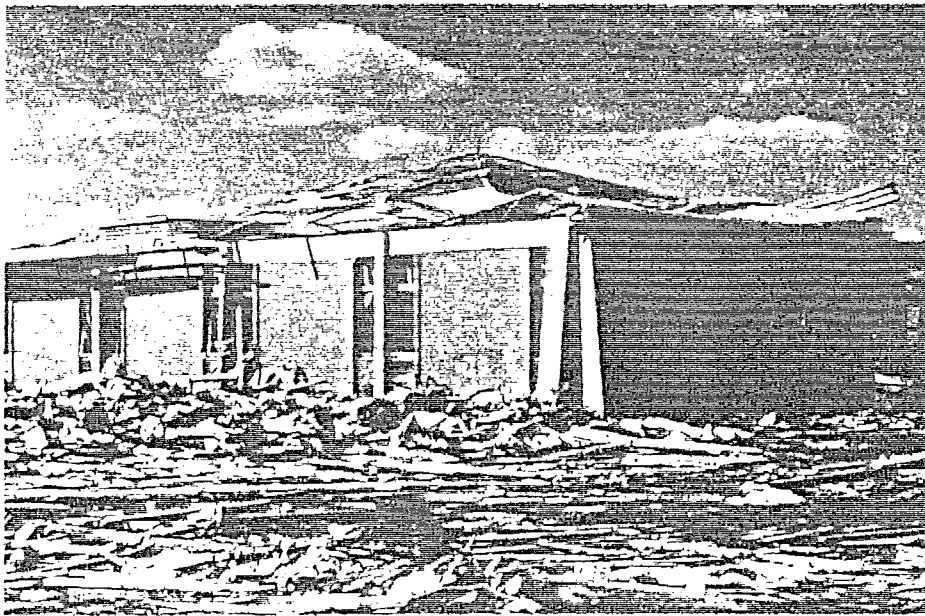
FIGURE 37. ARROWOOD ELEMENTARY SCHOOL, SOUTHEAST CORNER. The roof corner is uplifted and the windows to the classroom are broken. There was no damage to structural frame. Note the amount of debris that has collected outside of school.

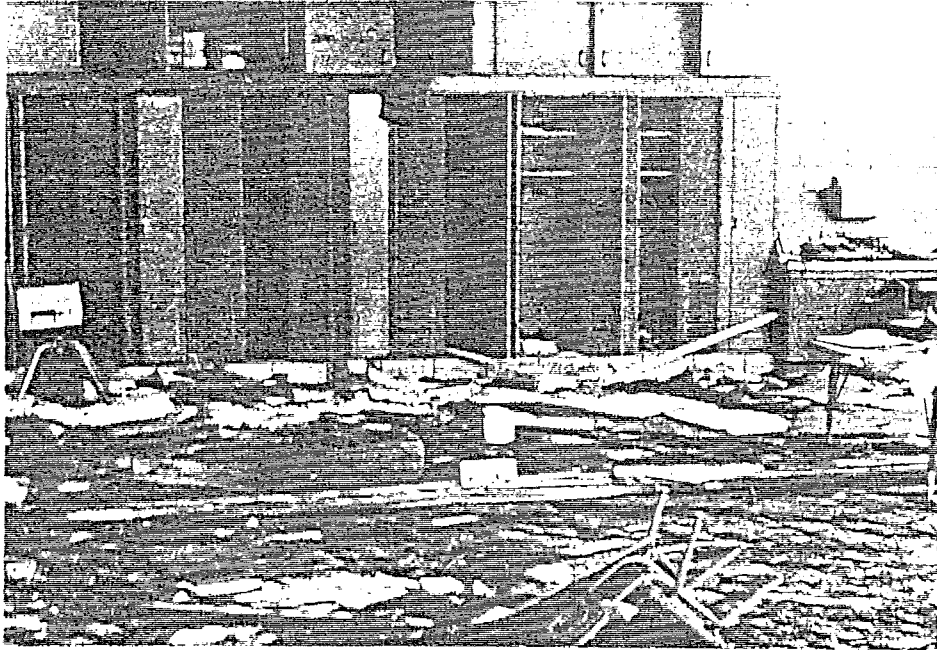
FIGURE 38. ARROWOOD ELEMENTARY SCHOOL, EXTERIOR CLASSROOM. A 2 x 8 in., 14 ft long piece of wood and an automobile tire had entered through windows.

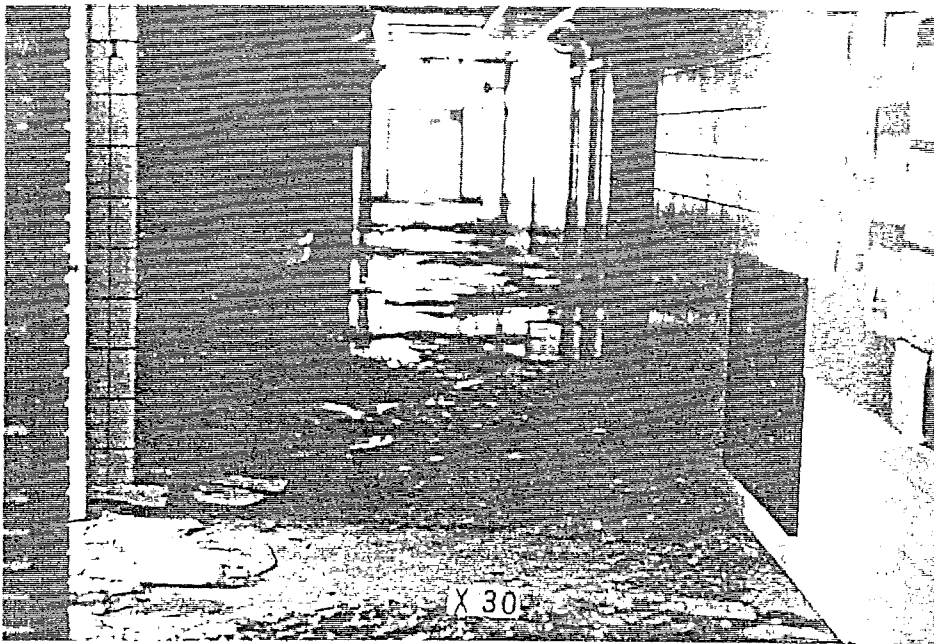
FIGURE 39. ARROWOOD ELEMENTARY SCHOOL, INTERIOR HALLWAY. The hallway sustained no damage and is free of flying debris. Pieces on the floor are acoustic panels of the hallway ceiling which became loose.

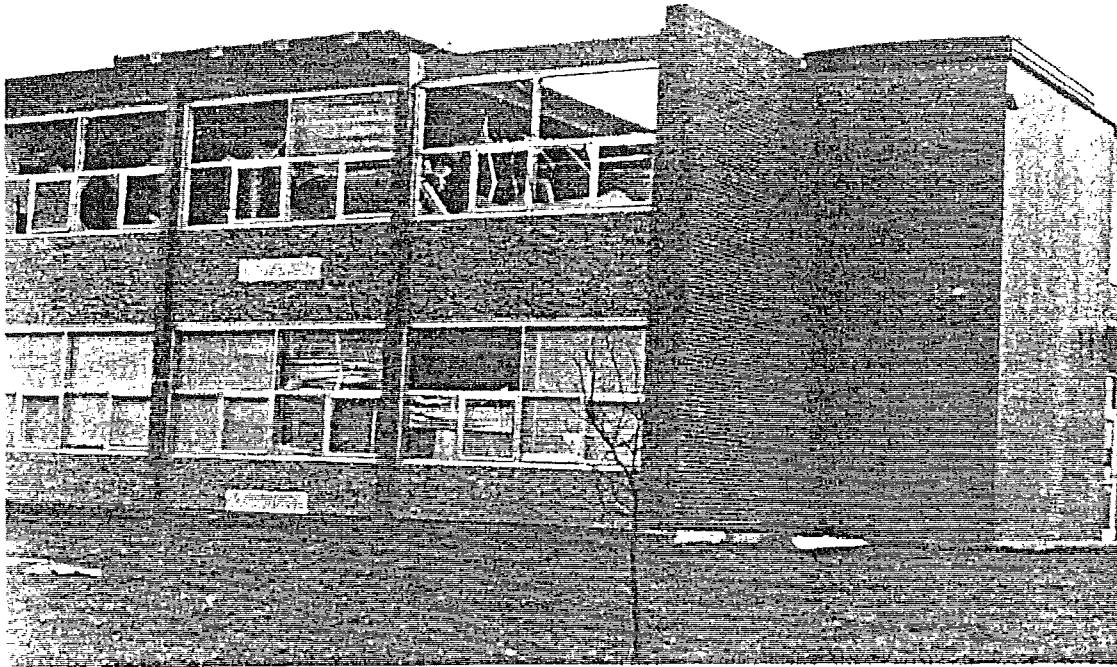
FIGURE 40. WEST JUNIOR HIGH SCHOOL, ROOF CORNER. Precast double-tee beams were uplifted. The two-story building did not sustain any other structural damage.

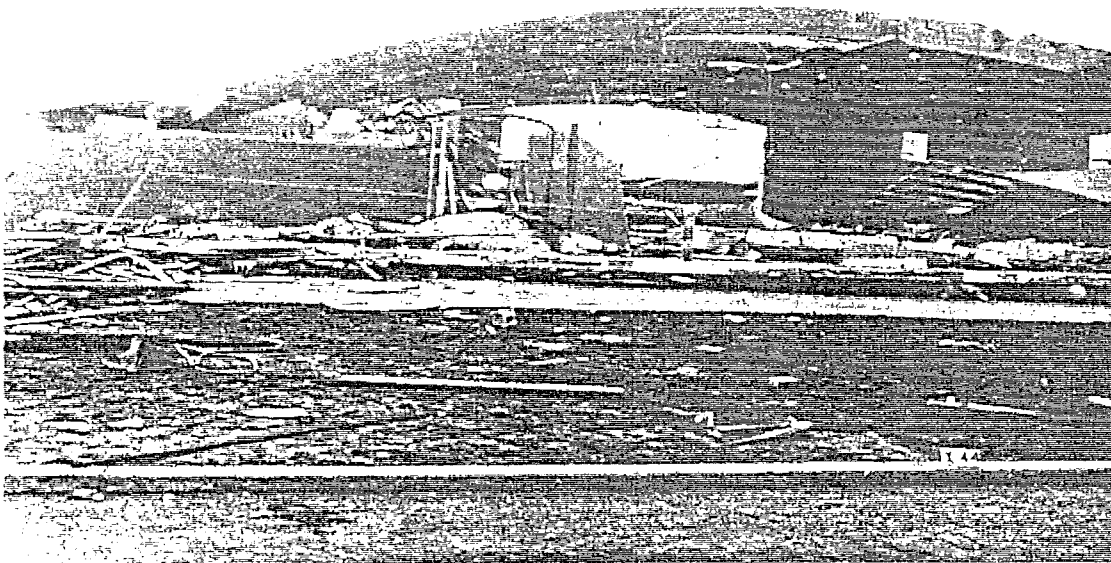
FIGURE 41. WEST JUNIOR HIGH SCHOOL, GYMNASIUM. The end walls collapsed and fifty percent of the roof was gone.

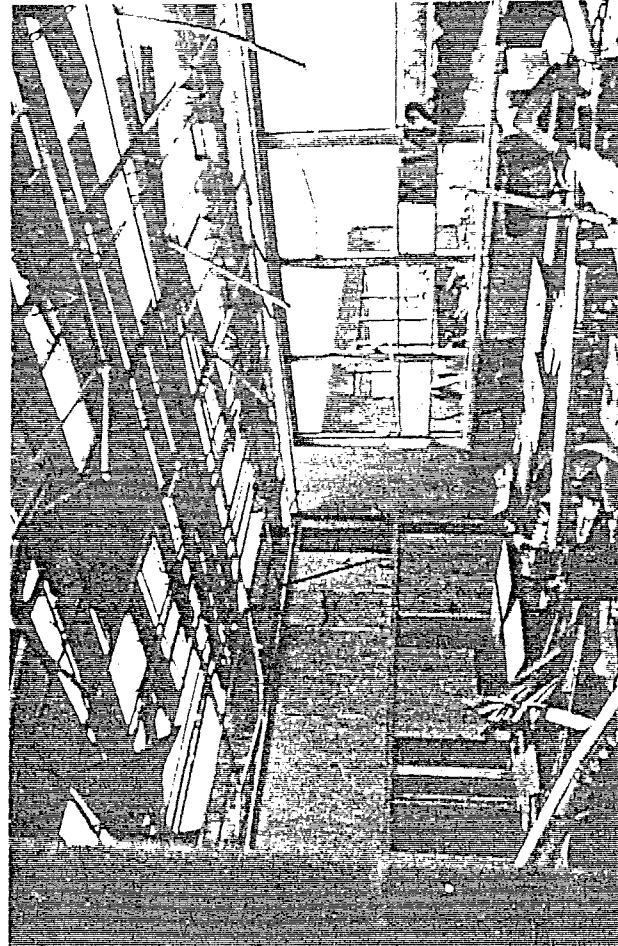
FIGURE 44. SIMON KENTON ELEMENTARY SCHOOL, CLASSROOM. Severe damage was due to wind and flying debris entering the classroom.

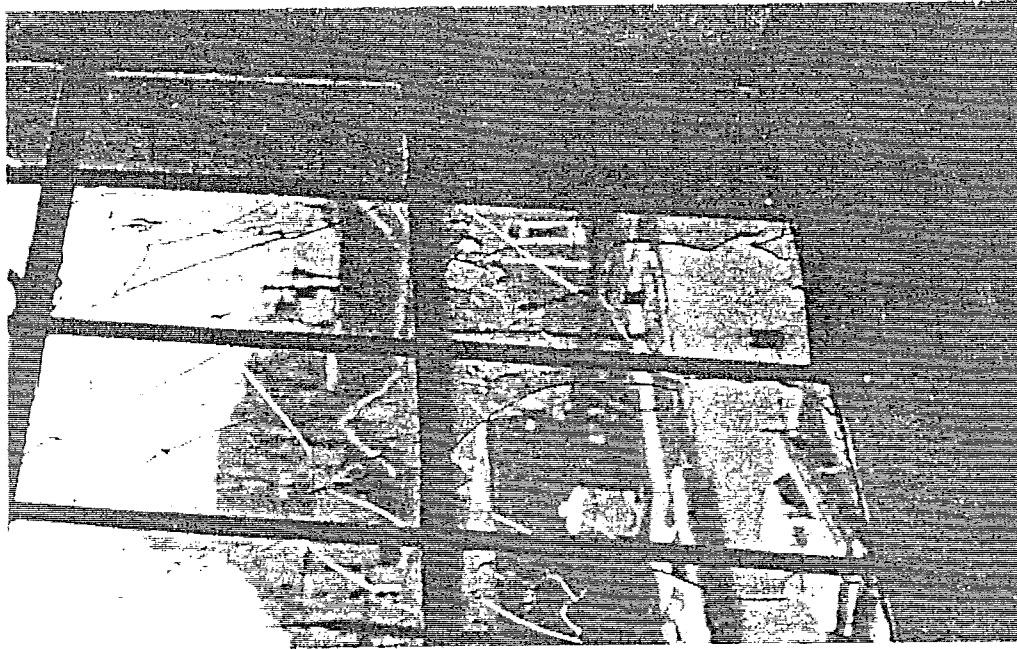
FIGURE 47. CENTRAL JUNIOR HIGH SCHOOL, WINDOWS. Windows were broken by roof gravel. The roof gravel came from one story building across the street.

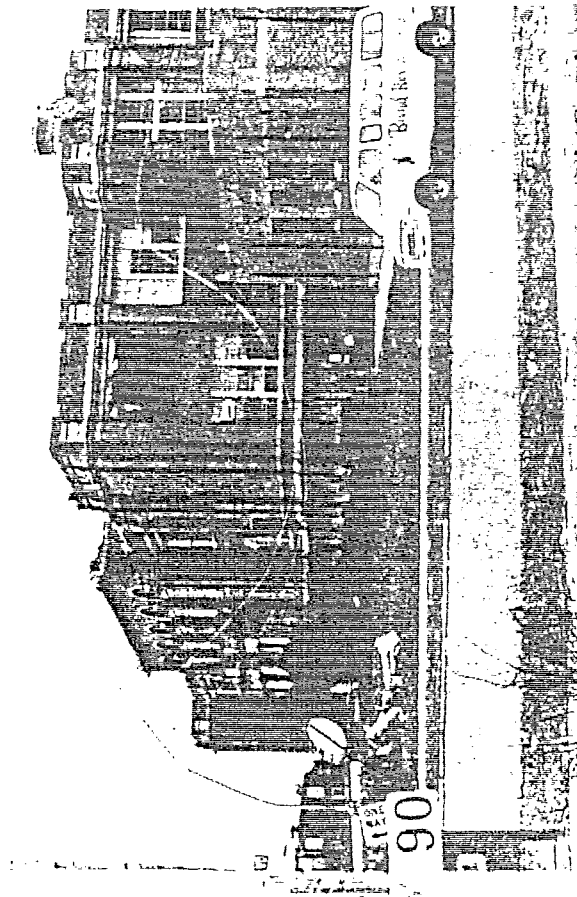
FIGURE 46. CENTRAL JUNIOR HIGH SCHOOL. Window frames on second floor were damaged by flying debris. The building sustained very little structural damage.

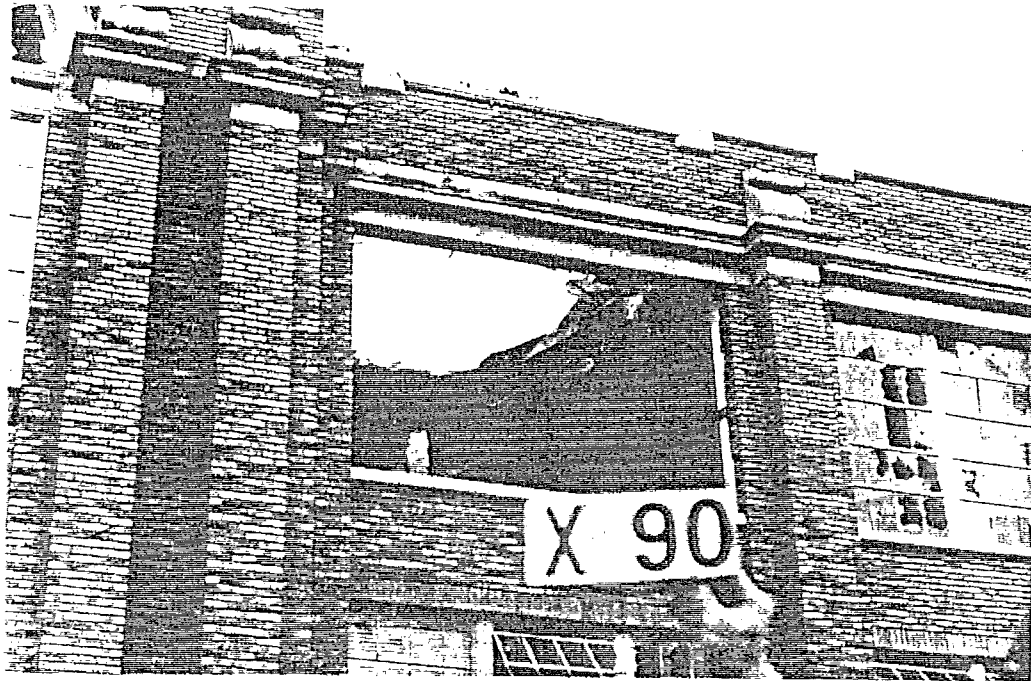
FIGURE 48. CENTRAL JUNIOR HIGH SCHOOL, ROOF SLAB. The slab collapsed under the weight of brick masonry parapet and cast stone coping material.

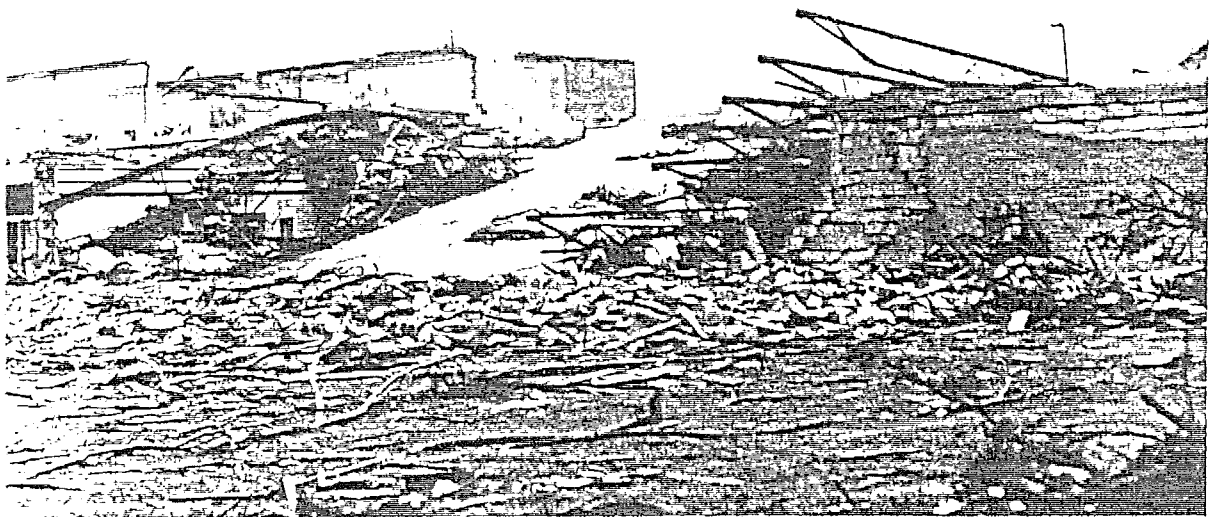
FIGURE 53. XENIA HIGH SCHOOL, CAFETERIA. Roof collapsed when loadbearing masonry walls failed.

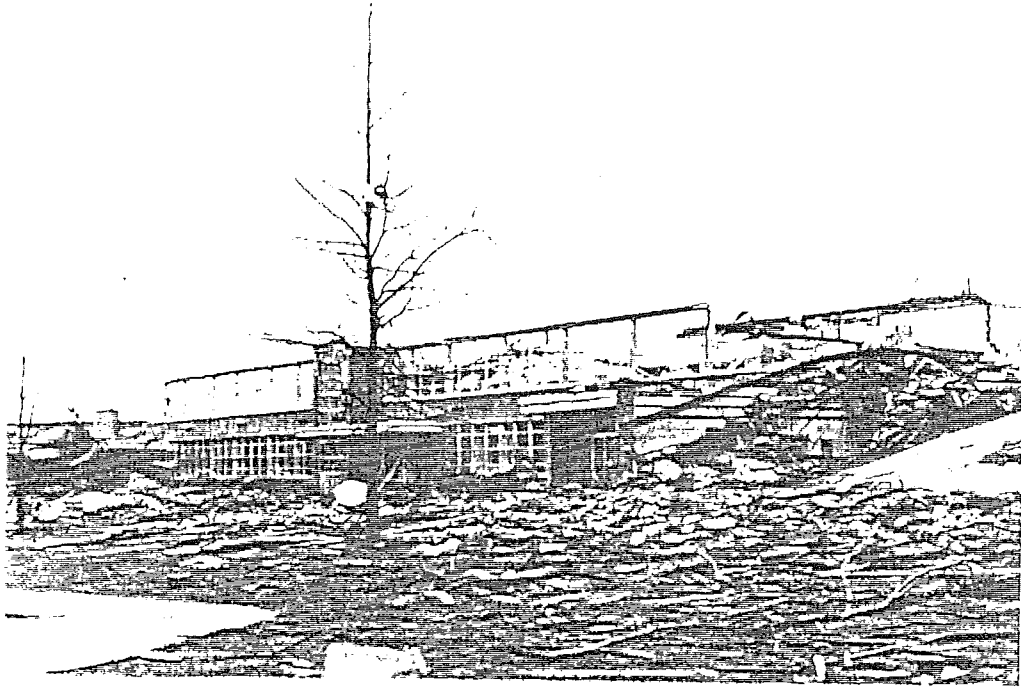
FIGURE 54. XENIA HIGH SCHOOL, TWO STORY BUILDING. The second story was totally gone. The roof system consisted of open web steel joists.

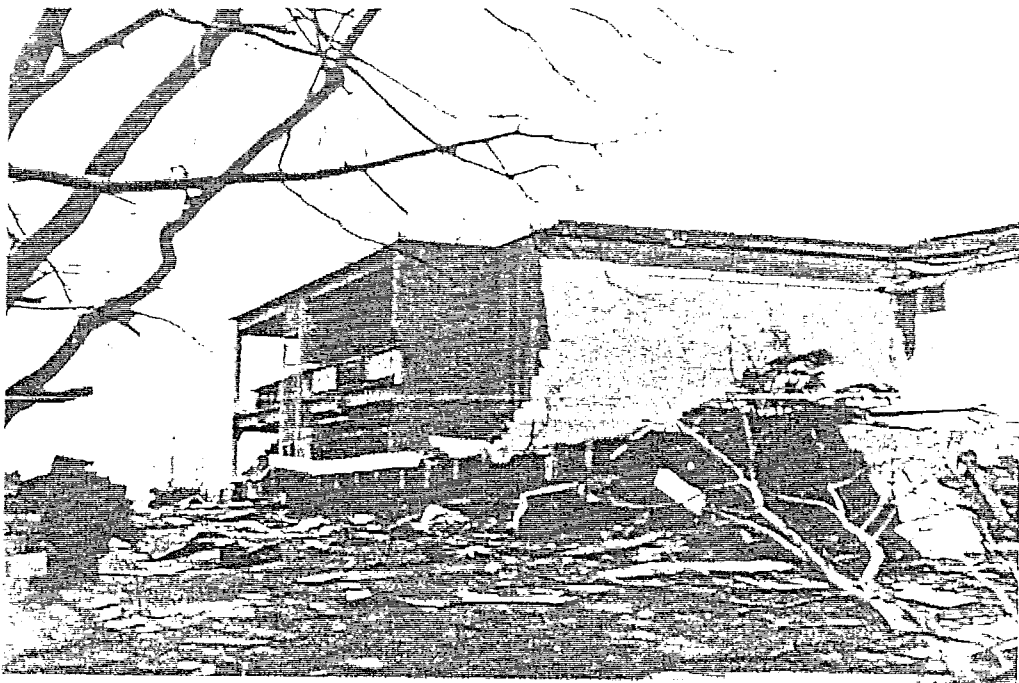
FIGURE 55. XENIA HIGH SCHOOL GYMNASIUM. The precast concrete roof of the gymnasium (foreground) collapsed when the loadbearing walls failed. In the background, precast concrete framing survived, but wall panels are gone.

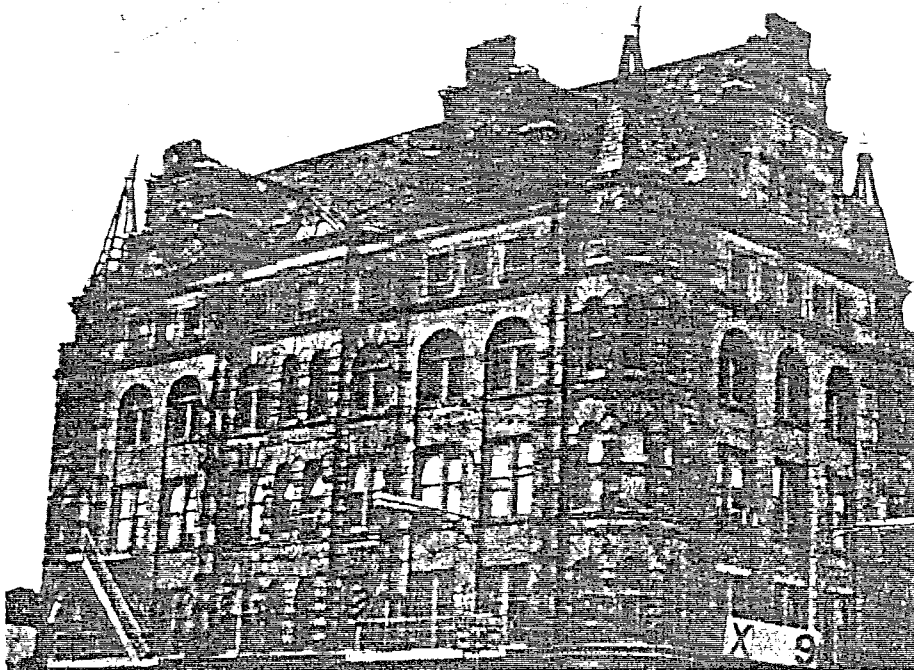
FIGURE 60. COMMERCIAL BUILDING: AN OLD FIVE STORY OFFICE BUILDING. Damage was restricted to the roof and to window glass.

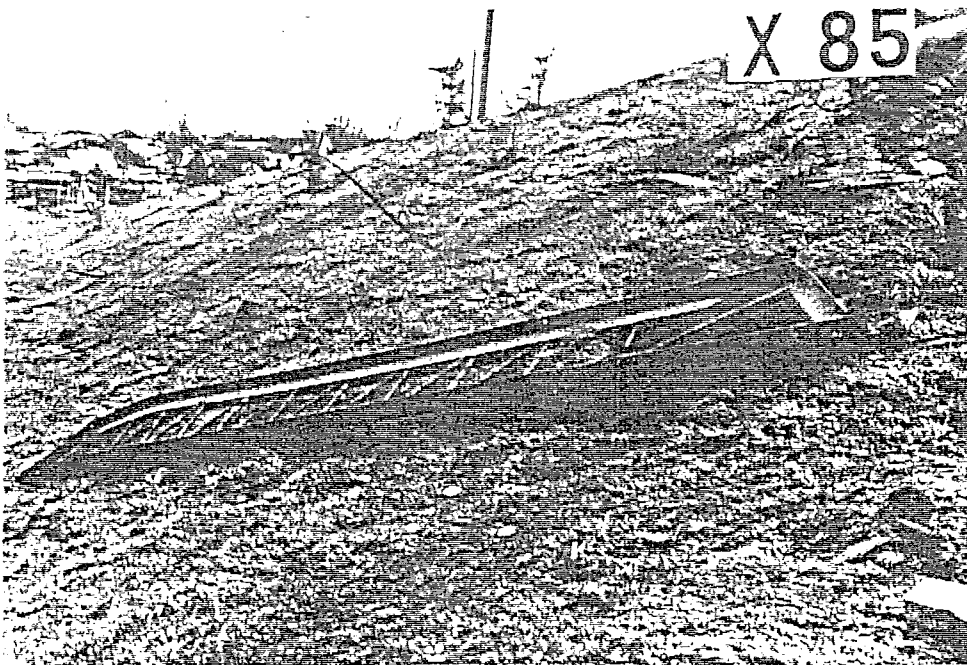
FIGURE 68. OPEN WEB STEEL JOIST. The joist, 20 ft long, was found at the location marked on Fig. 58. The original location of this joist was not found within a 300 ft radius area.

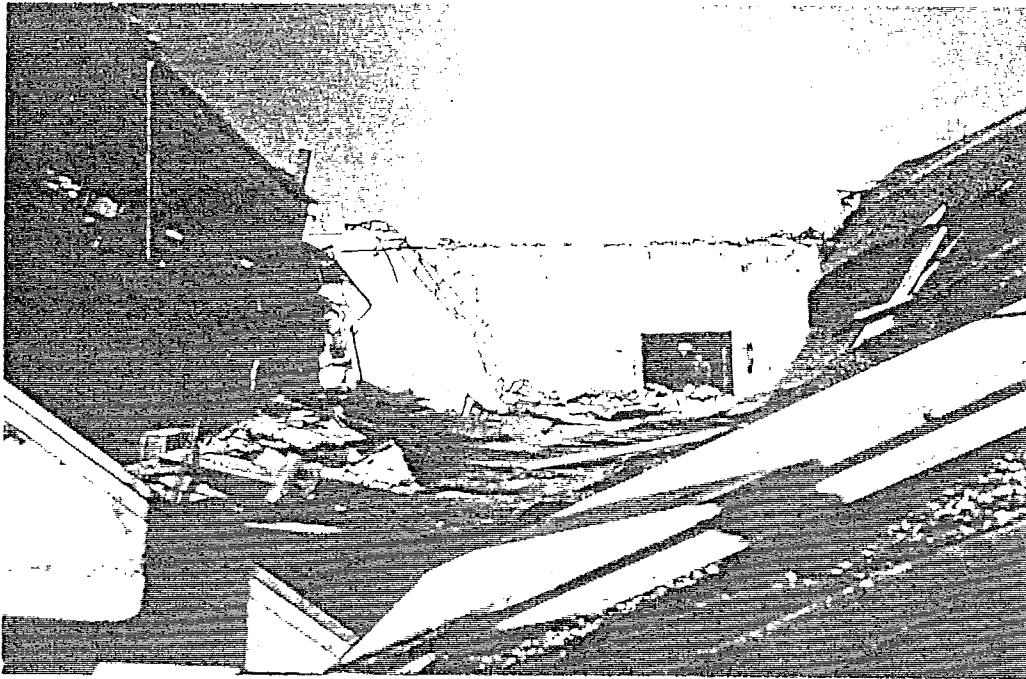
FIGURE 73. CHENOWETH ELEMENTARY SCHOOL. Progressive collapse of roof was precipitated by the toppling of an 8 ft incinerator chimney. Debris from chimney can be seen in background near wall.

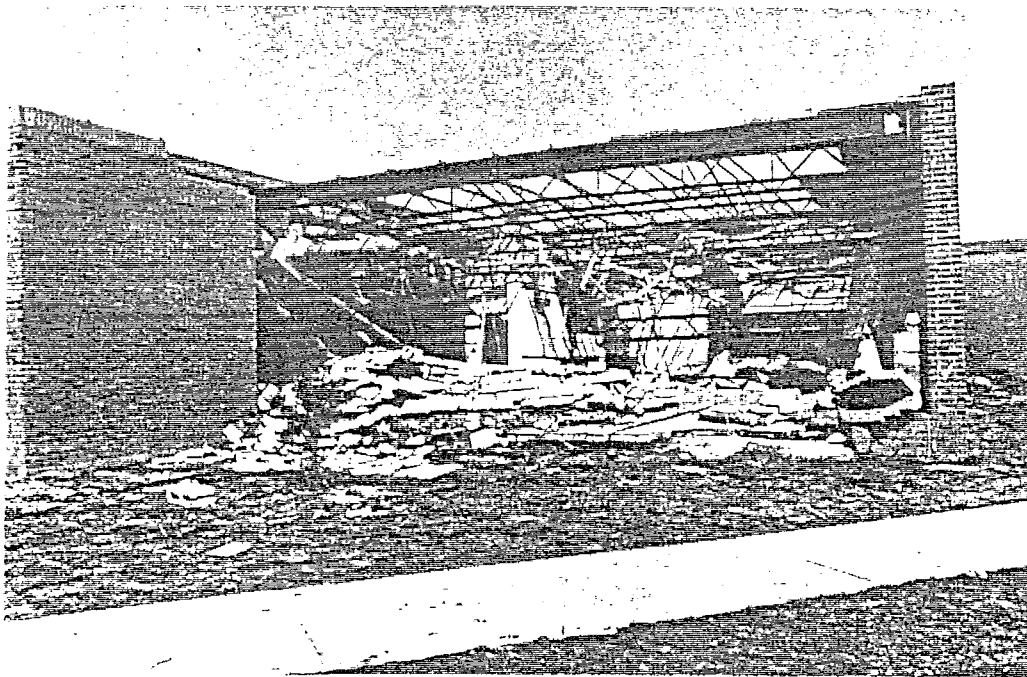
FIGURE 74. WINDWARD WALL FAILURE AT DUNN ELEMENTARY SCHOOL. Note the lack of anchorage at the roof level and across the masonry control joint.

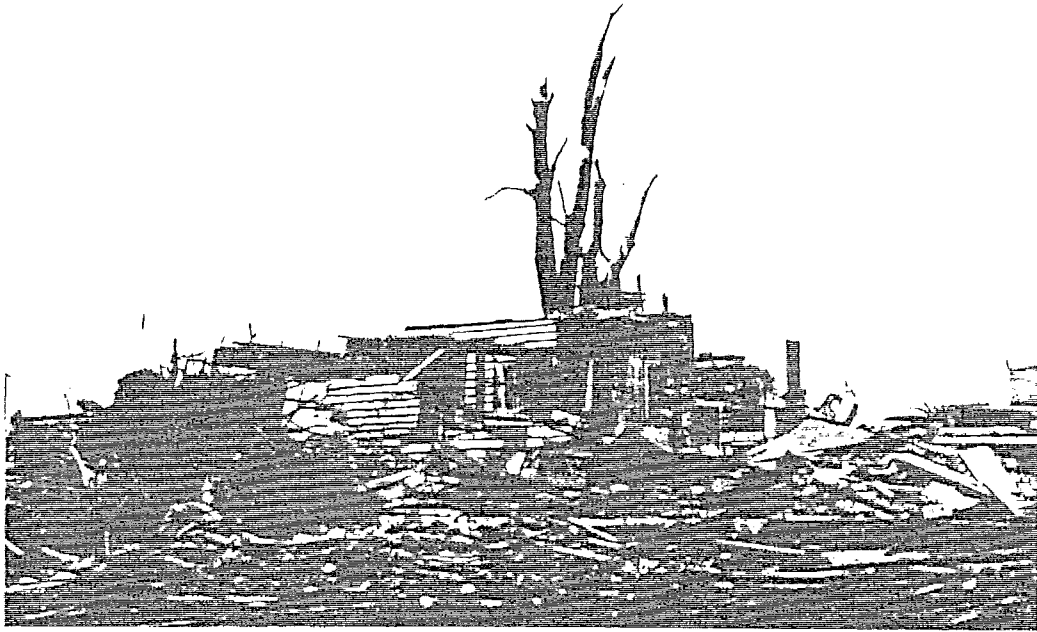
FIGURE 76. DAMAGED RESIDENCE IN BRANDENBURG. The damage shown here is typical of that to a well-constructed residence. Note the uprooted tree in the foreground and the tree stripped of its branches in the back-ground.
