**ENGINEERING
ASPECTS OF THE
TORNADOES OF
APRIL 3-4, 1974**

KISHOR C. MEHTA, JOSEPH E. MINOR, JAMES R. McDONALD

Committee on Natural Disasters
Commission on Sociotechnical Systems
NATIONAL RESEARCH COUNCIL

1975

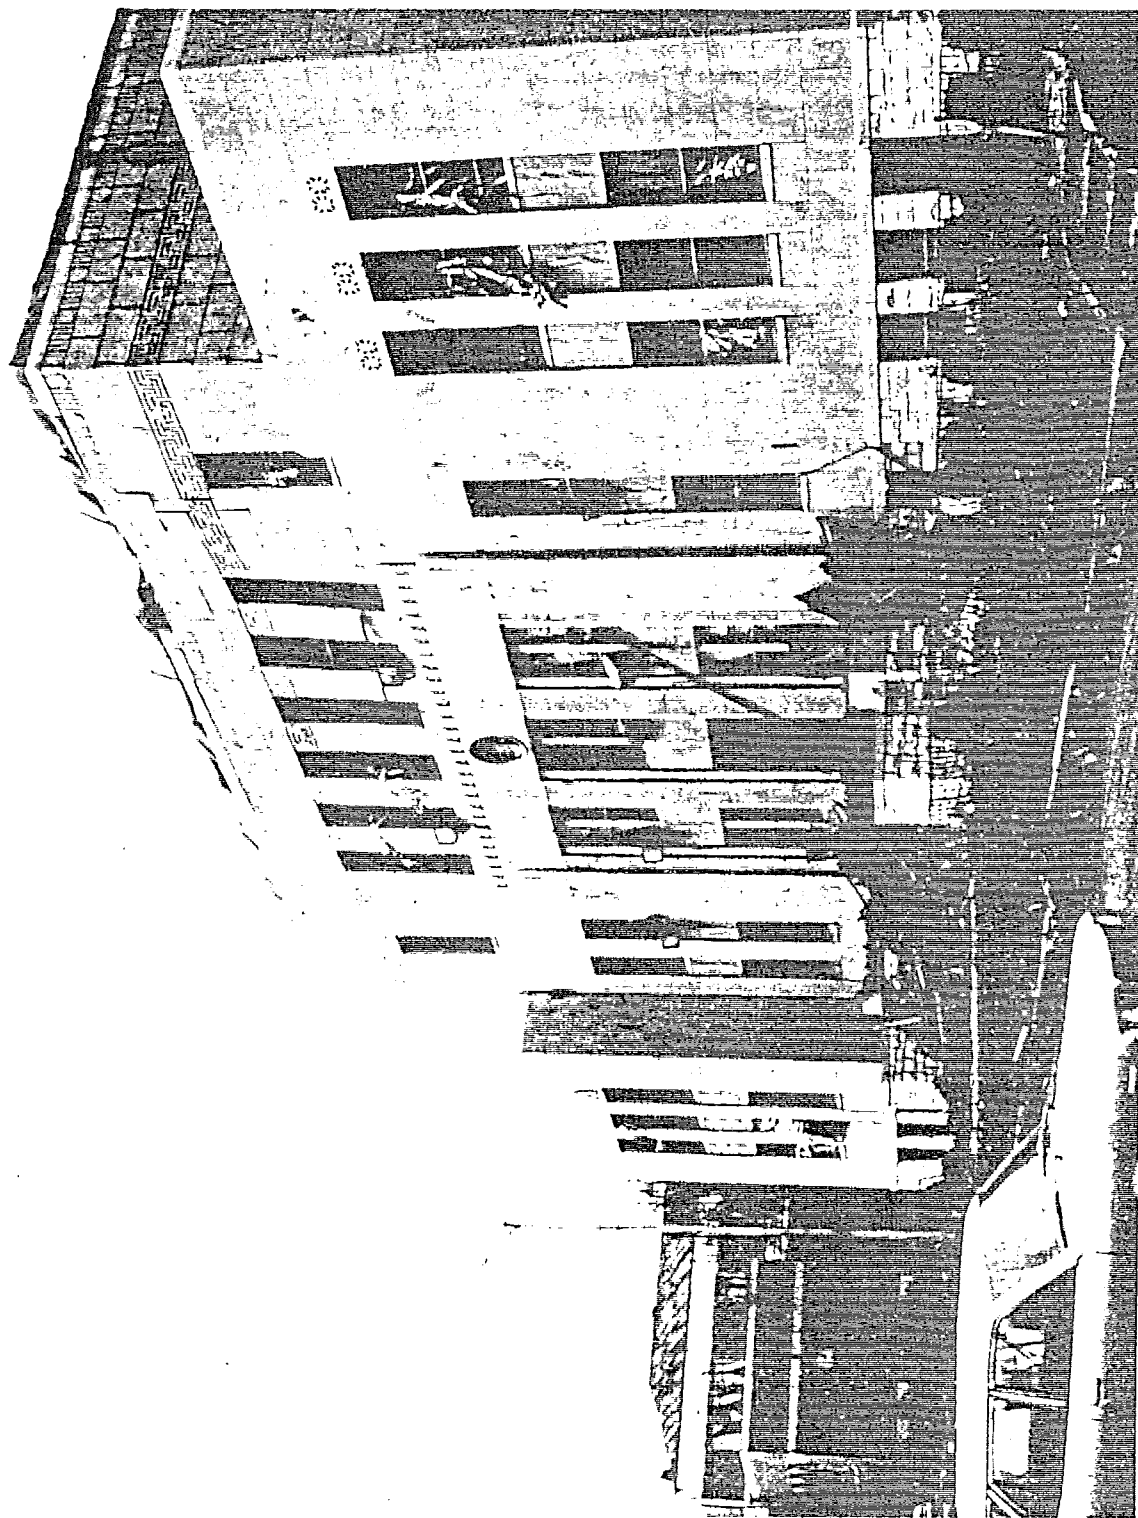
FIGURE 82. WALKER COUNTY COURT HOUSE, JASPER, ALABAMA. Force of winds caused an 11 in. permanent deformation of the steel frame at the third floor. (photograph courtesy B. R. Manning, Auburn University-PASC)

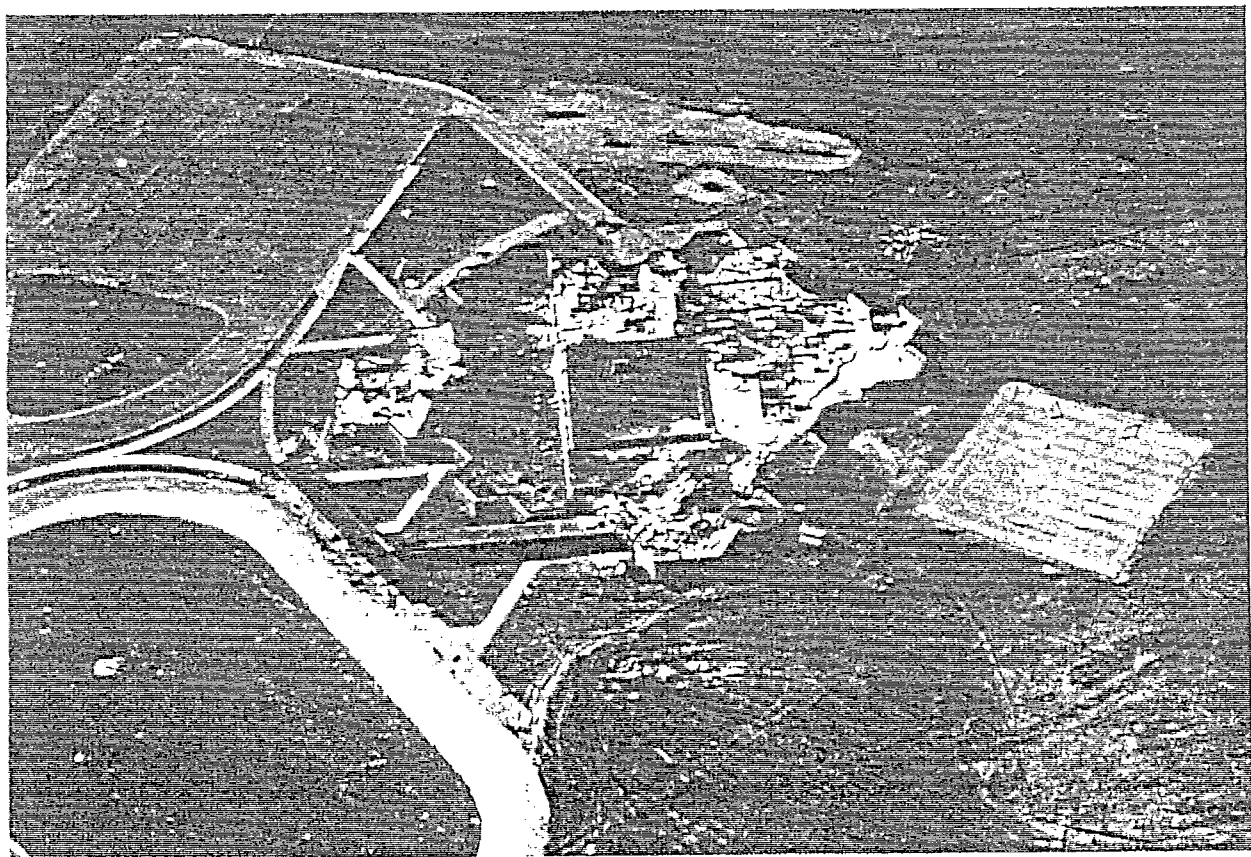
FIGURE 83. MCDONNELL ELEMENTARY SCHOOL, HUNTSVILLE, ALABAMA. Short exterior wall segments, cast in place bond beams and vertical reinforcement in the walls contributed to favorable performance of this structure. Damage was restricted to the roof. (photograph courtesy City of Huntsville Police Department)

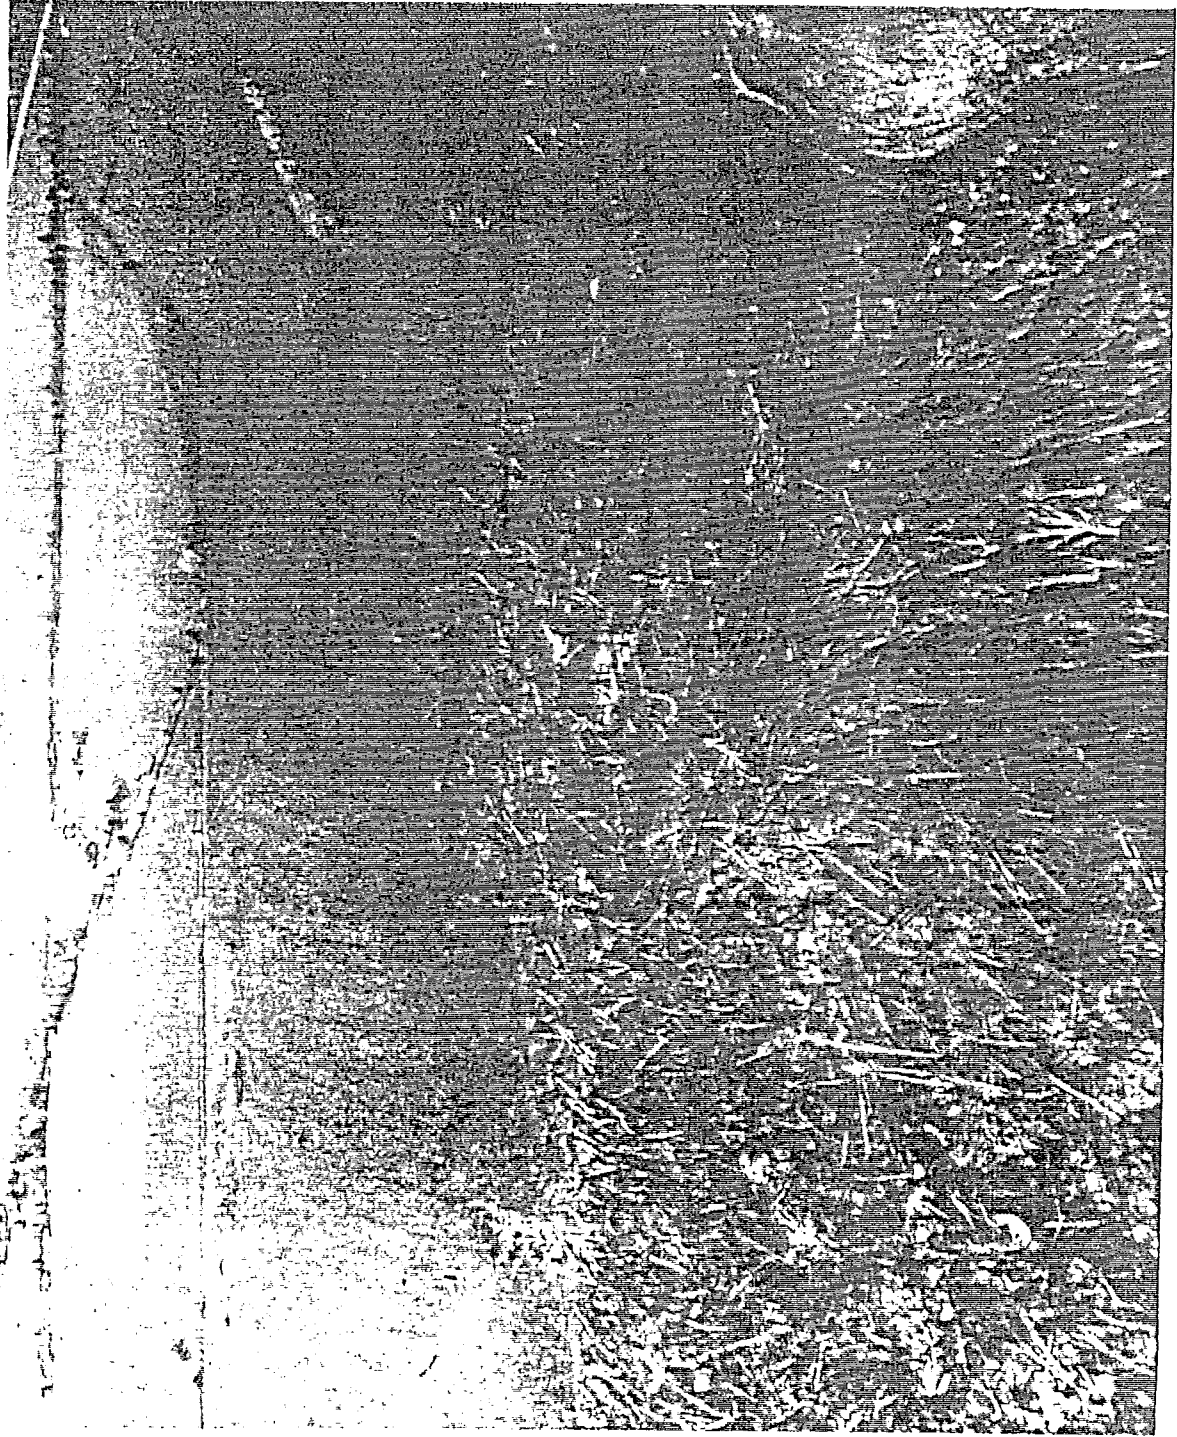
FIGURE 84. TREE DAMAGE NORTHEAST OF MOULTON, ALABAMA (TORNADO NO. 2). Note that some trees are snapped off while others are uprooted. (photograph courtesy B. R. Manning, Auburn University-PASC)

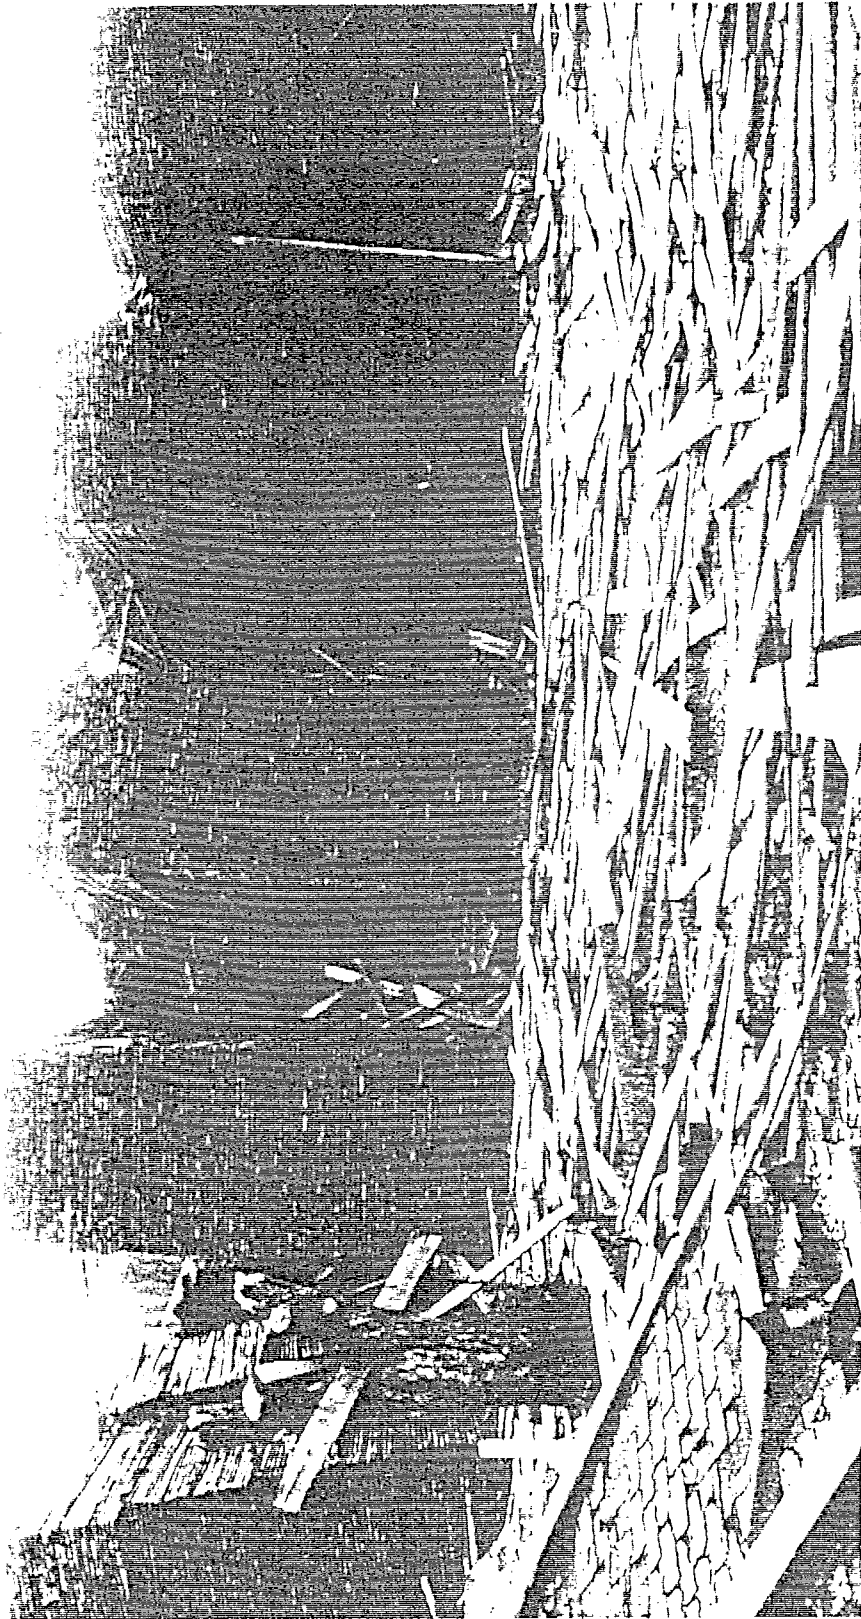
FIGURE 85. LUMBER STORAGE YARD, GUIN, ALABAMA. Although some bundles were broken, individual pieces of lumber did not travel more than 100 ft. (photograph courtesy B. R. Manning, Auburn University-PASC)

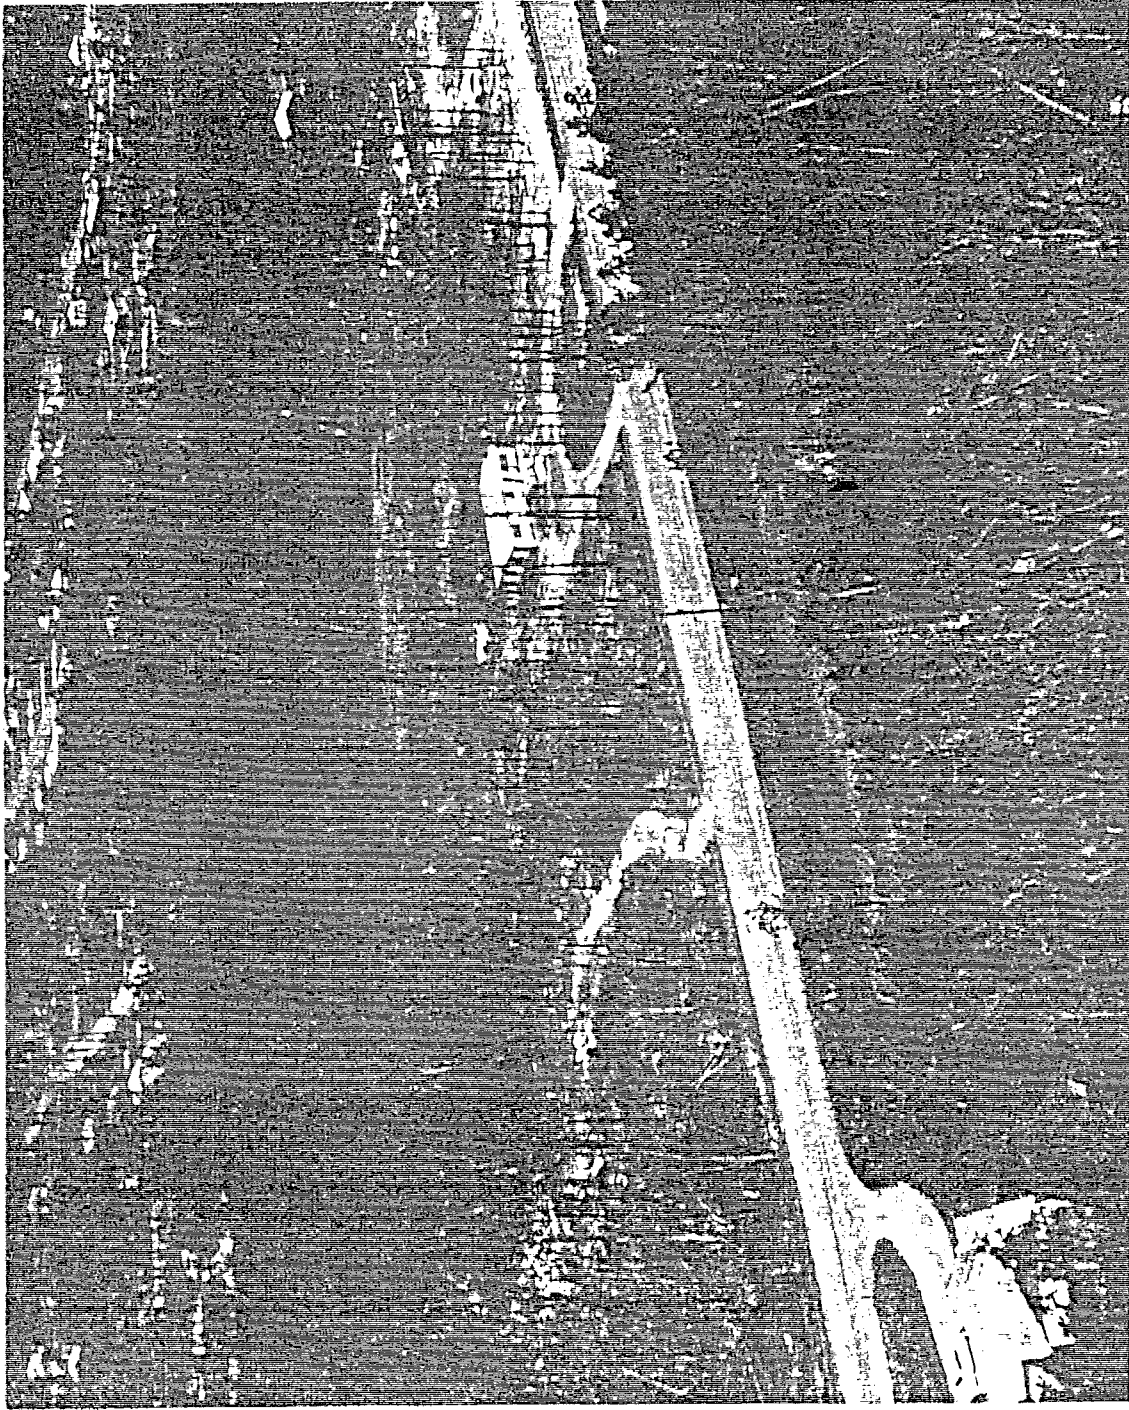
FIGURE 87. MOBILE HOME IN CHATSWORTH. This mobile home was double-wide and anchored to the ground. It did not sustain damage. There was considerable tree damage in the surrounding area. (photograph courtesy B. R. Manning, Auburn University-PASC)
