## **Squall Line Produces Two Tornadoes** April 24<sup>th</sup>, 2010

## **Overview**

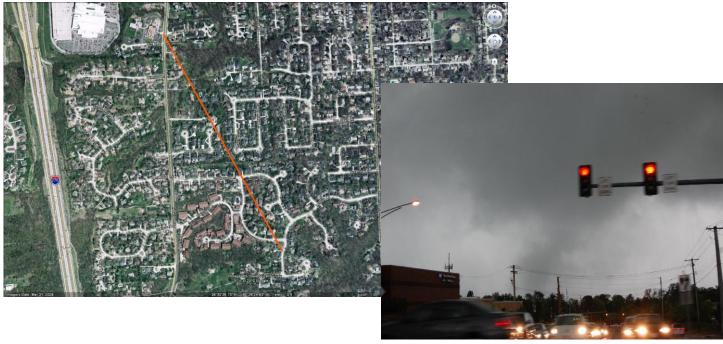
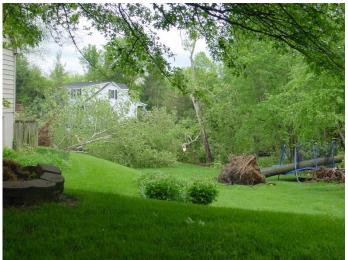
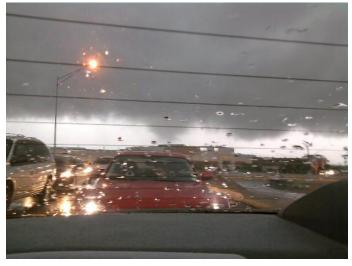
The path was approximately 0.6 miles long with a maximum width around 300 yards across part of the subdivision and an average width of less than 200 yards elsewhere. Widespread tree damage and minor roof damage was observed across the subdivision but the overall lack of structural damage suggests winds did not exceed 70-80 mph. In the subdivision, several large healthy trees were uprooted and some roofs had missing or damage shingles. At least one healthy tree was snapped several feet above its base. More extensive tree damage was observed with the second touchdown near Ballas Road and Kirk Place Drive where several healthy pine trees were snapped at the midpoint and the debris pattern indicated a convergent circulation. Tree damage in this area also downed several power lines along Ballas Road.

Below are a few photos of the tornado and damage that occurred, along with a preliminary damage survey map.

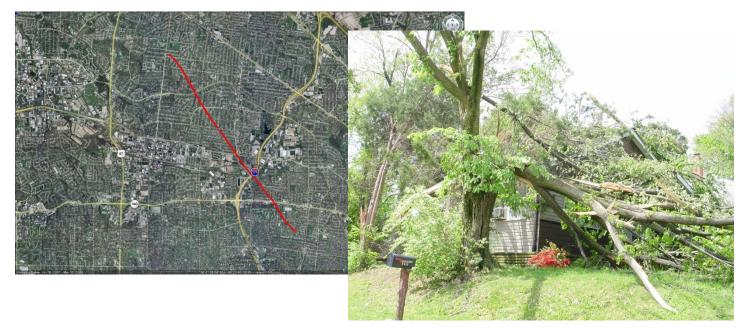
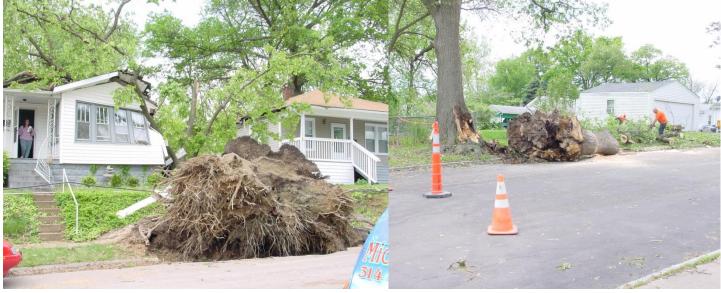
The vast majority of the damage along the path consisted of varying degrees of tree damage which included numerous tree branches broken, trees uprooted, and tree trunks snapped well above their base. The most significant structural damage occurred on Wallis Avenue just north of Trescott Avenue where a three foot diameter tree caved in the corner of a home. The tornado reached a maximum width of 325 yards as it crossed Trescott Avenue. This is also where the damage was most intense with wind speeds estimated at 85 mph. Other notable damage was located near the intersection of Woodson Road and Harney Road where there was roof damage to a storage facility. Minor structural damage was noted at other locations along the path caused by tree limbs or trees falling on homes. Any direct tornadic damage to homes and businesses was minor superficial damage which consisted of siding, soffit and shingles.

Below are a few photos of the tornado damage that occurred.
