Derecho May 8th, 2009

Overview

Damage Surveys

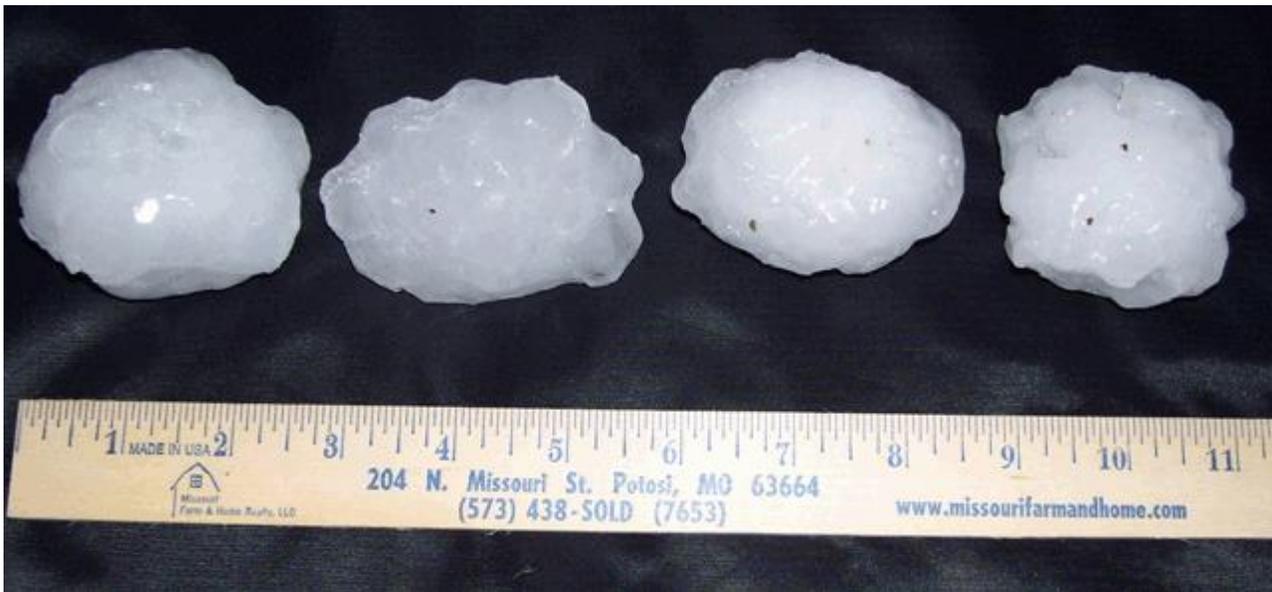
Baseball-sized hail From
Potosi, Missouri

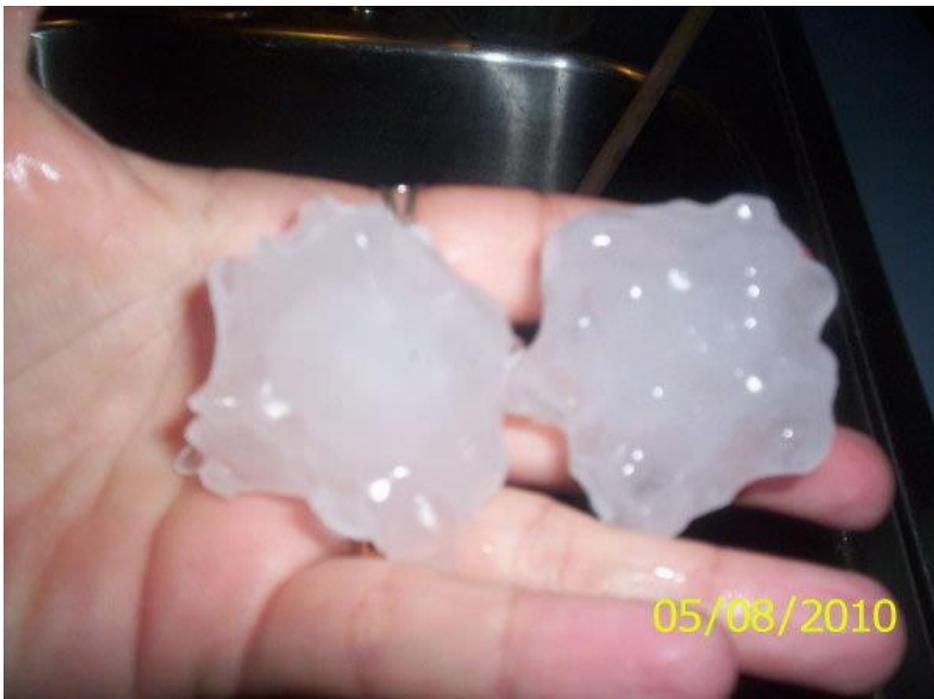
Cuba, Missouri Severe Hail
