Severe Thunderstorms

June 27th, 2010

Overview

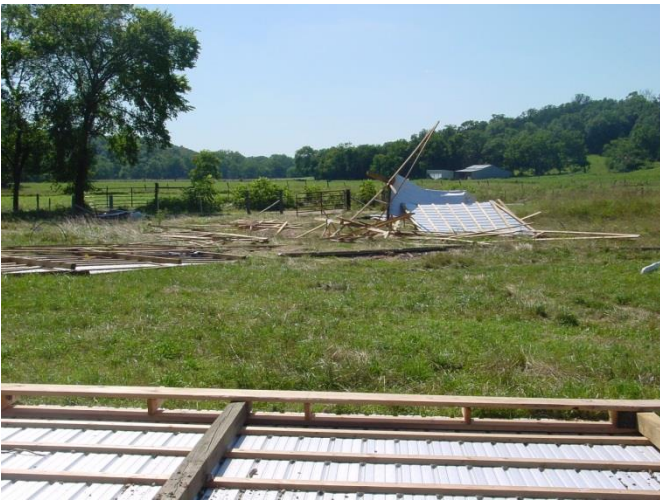
Further east towards the south end of County Road 603, near Brush Creek, a second machine shed was completely destroyed with debris from the machine shed laid to the west southwest. As the machine shed started to lift to the west, five occupants moved inside a large pickup truck within the machine shed. None of the occupants were injured. A nearby house approximately 50 yards to the south was not damaged. Approximately 100 to 150 yards northeast and east of the location, several large hardwood trees were uprooted and were also lying to the west and southwest. This is an interesting area in which the tree and machine shed damage laid to the west and southwest and occurred immediately on the back side (west side) of the severe thunderstorm. This is an uncommon type of damage pattern. Surface winds were estimated between 70 and 90 mph. The final area of tree damage occurred 2.2 miles southeast of the town of Loose Creek along County Road 602. This road was along a ridge axis and several very large oak trees were uprooted to the northeast. The total tree and structural damage area extended 5 miles in length and 1 mile in width.

Machine Shed Destroyed South of Country Road 603

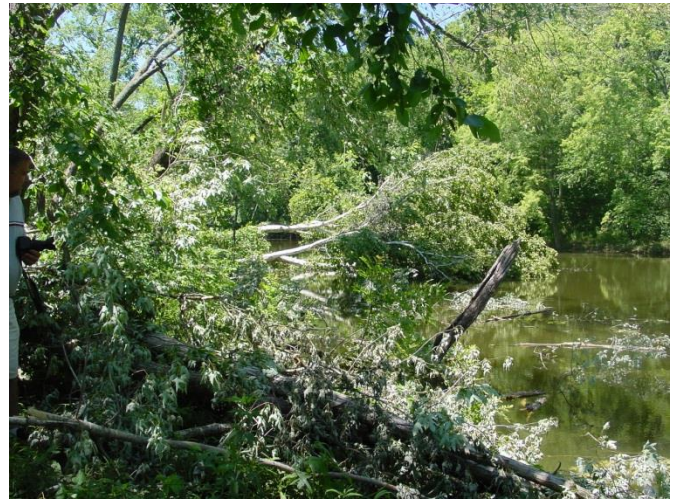
The damage area started one quarter mile east of County Road 608 near the Maries River or about 2.5 miles south southwest of Loose Creek, Missouri. The roof of one machine shed was uplifted to the southeast on a farmstead near County Road 608. Tree damage was confined at three locations along the Maries River. One area of tree damage extended from the river up to the ridge axis across the river. Several large oak and pecan trees were damaged along the Maries River.

Hardwood Tree Damage at Maries River

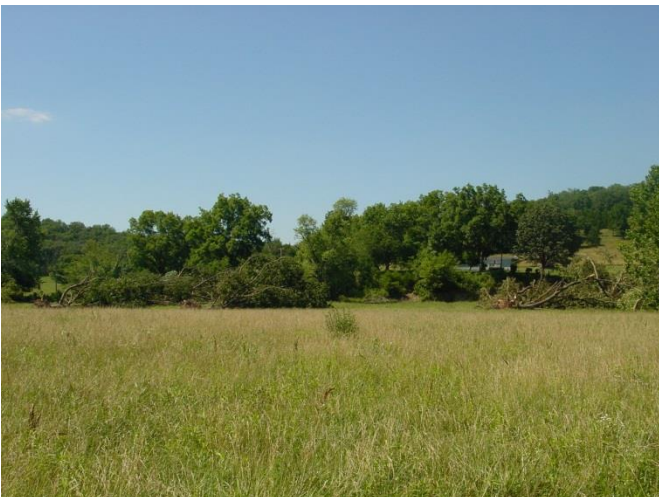
Other nearby tree damage due to downbursts and microbursts occurred along Brush Creek Hollow about 2 miles south-southwest of Loose Creek. Several large oak trees over 100 years old were uprooted due to an intense microburst. Surface wind gusts were estimated between 85 and 95 mph.

100 Year-Old Oak Trees Uprooted

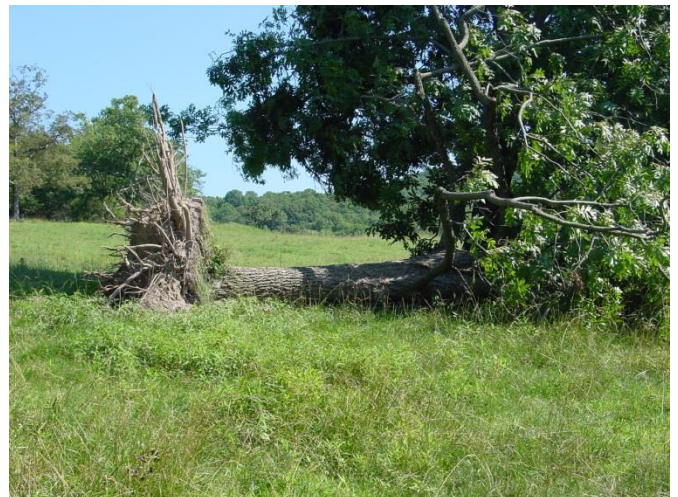
Large Hardwood Tree Uprooted
