# Tornado and Wind Event Over Northeast Missouri and South Central Illinois

October 2<sup>nd</sup>, 2007

## Overview

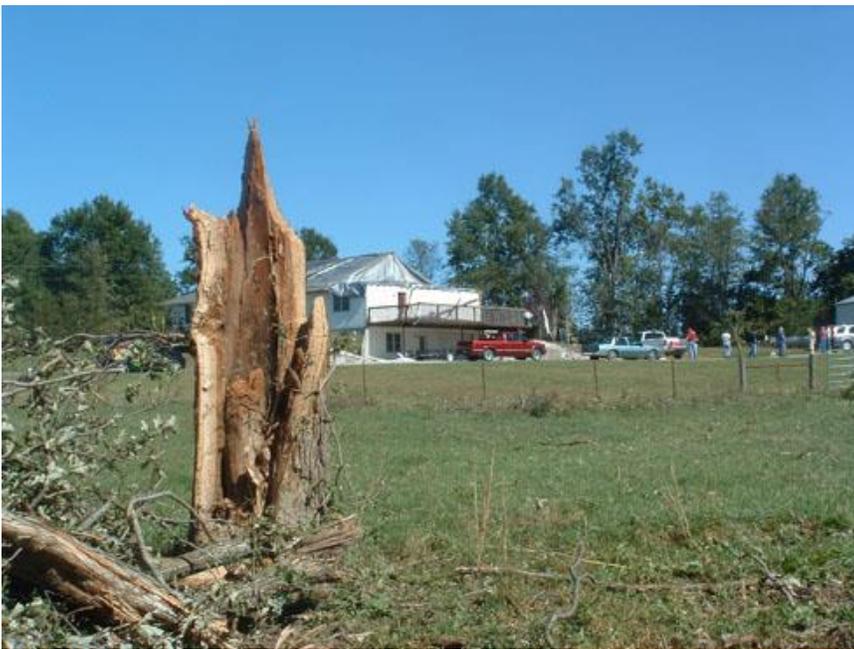
**EF1 Tornado damage near the intersection of Highways CC and 15 in Monroe County.**

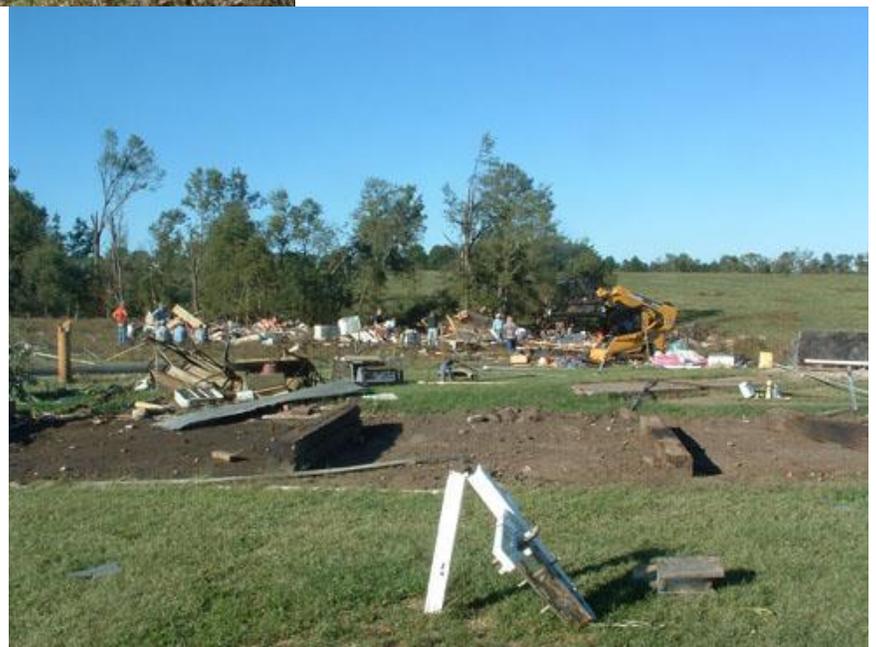
**EF2 Tornado damage on Highway PP in Monroe County. Single wide mobile home completely destroyed.**

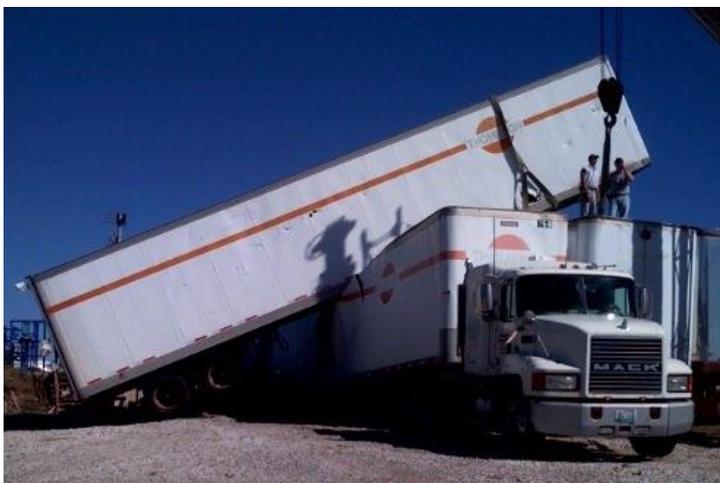
**Additional tornado damage in same location, south of Palmyra, Missouri.**

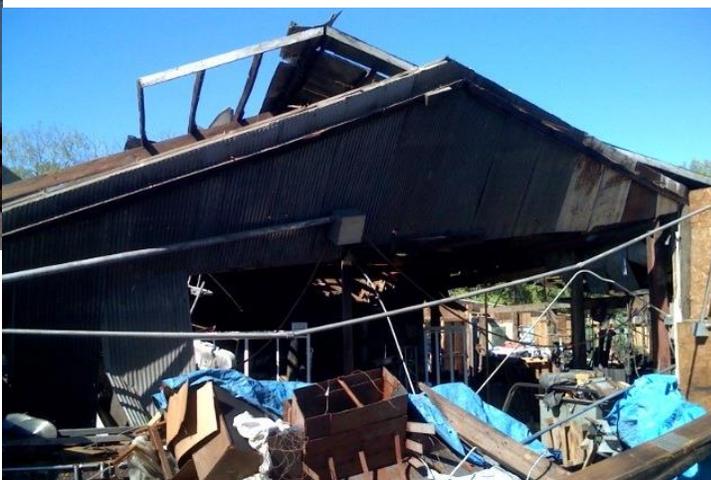
**Tornado damage just south of Palmyra, Missouri (Marion County), near Business 61 and U.S. Highway 61.**

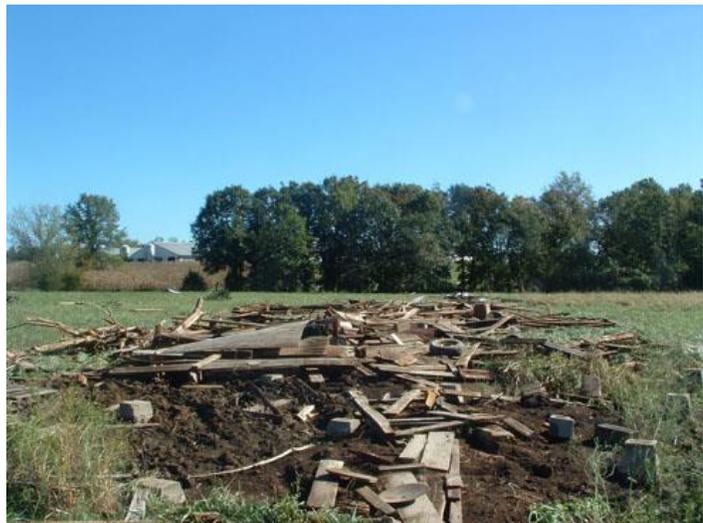
The tornado touched down near the intersection of County Roads 165 and 168. It travelled to the northeast destroying one outbuilding and damaging or destroying numerous trees. Also, the southeast corner of a hog confinement building was damaged, leading to a partial roof collapse. Some of the debris was thrown a third of a mile to the northeast. An unoccupied car was also damaged. The tornado lifted and dissipated on County Road 160 about a quarter of a mile south of County Road 164. The path length of the tornado was 2.1 miles and the max path width was 40 yards. The tornado was rated as an EF0.

**Large outbuilding completely destroyed by EF0 tornado in Montgomery County.**
