Four Weak Tornadoes

April 27th , 2016

Storm damage surveys indicate that four weak tornadoes occurred during the evening hours of 4/27/2016.

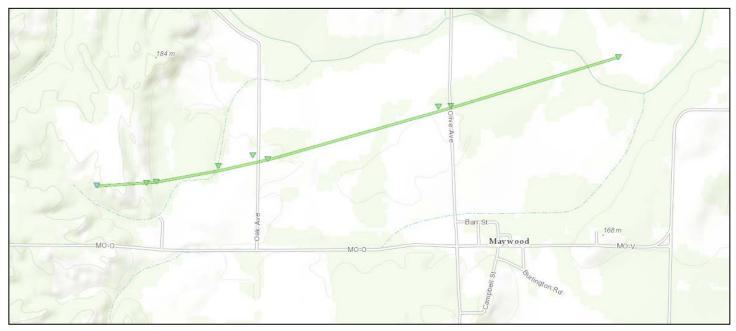
Damage Survey Map for EF1 Maywood, MO Tornado.

A tornado touched down in a farm field north of Highway O and west of Oak Ave, which is west-northwest of Maywood. The tornado moved east directly hitting a home in its path, causing EF1 damage by lifting a large portion of the roof from the house (top right photograph). Roofing materials were deposited up to a half mile to the east of the building. The tornado continued east toward Oak Ave. causing significant tree damage. At Oak Ave. the tornado rolled a full size tanker truck on its side and destroyed two grain bins (middle right photograph). The tornado continued east across Olive Ave. causing significant tree damage. The tornado dissipated a few hundred yards to the east of Olive Ave in a farm field.

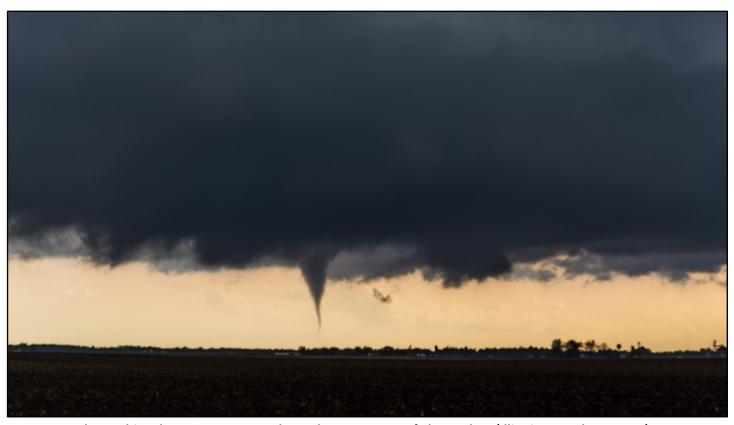
EFO tornado touching down near Raymond, IL. Photo courtesy of Shae Cohan (Illinoisstormchaser.com).
