## Severe Thunderstorm Winds Affect Borden County on June 4th, 2020

## Wind Damage in Gail, TX

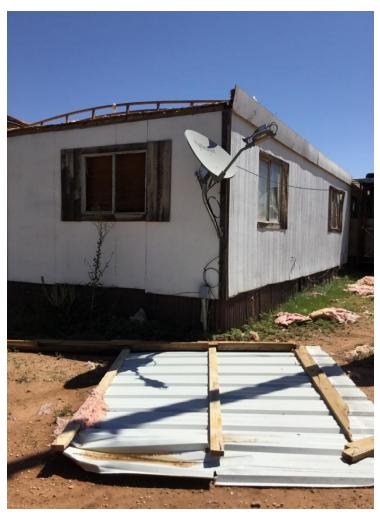
**Figure 3:** A mobile home on the southeast side of Gail, TX, had their entire roof blown off when the storm passed through. The roof was thrown 100+ feet away into a field across the road, snapping a powerline in the process. No injuries were reported.

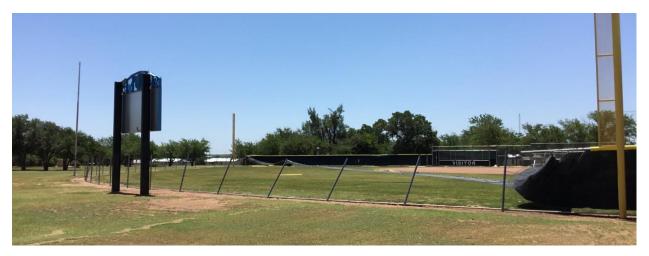
**Figure 4:** This is a photo of the softball field at Borden County School. The metal poles were all bent towards the southeast, and the fencing along the poles was ripped off.

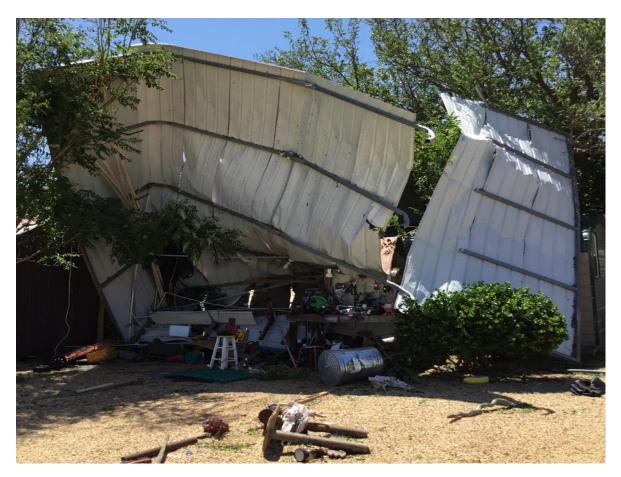
**Figure 5:** A large metal shed also located on the southeast side of Gail, TX, was overturned and ripped in half.

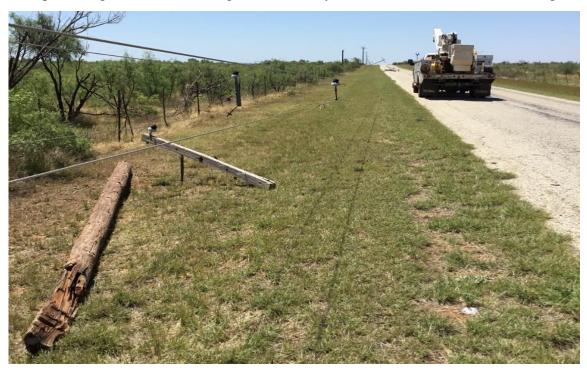
Shortly after these storms moved southeast of Gail, around 11:30 PM CDT, a localized microburst occurred roughly 5 miles southeast of the city. Damage found in the area included 3 broken powerline poles (Figures 6 and 7), along Willow Valley Road, oriented WSW. This damage was

Figure 6: Downed powerline poles along Willow Valley Road. All of the poles were snapped in half.

consistent with winds of 100-120 mph, similar to that of a weak EF-2 tornado. The damage observed indicated that a microburst had occurred, and examination of radar data helped to solidify this conclusion. The velocity imagery shown in Figure 8 illustrates strong convergence in the upper portions of the storm (outbound connecting with inbound velocity) which lead to a strong downdraft and air rushing outwards at ground level where the damage occurred. The localized microburst was determined to have a width of 255 yards.

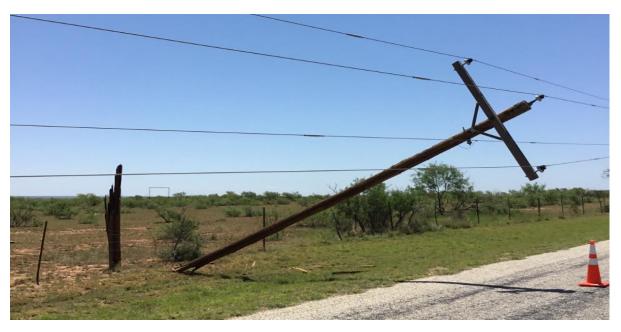
**Figure 7:** This pole was the furthest south on Willow Valley Road and was snapped near the base of the pole.
