June 22nd- 23rd, 2020 Midland and Snyder Texas Straight-Line Wind Events

Midland, TX Snapped Powerline Poles

Snyder, TX Damaged Radio Tower

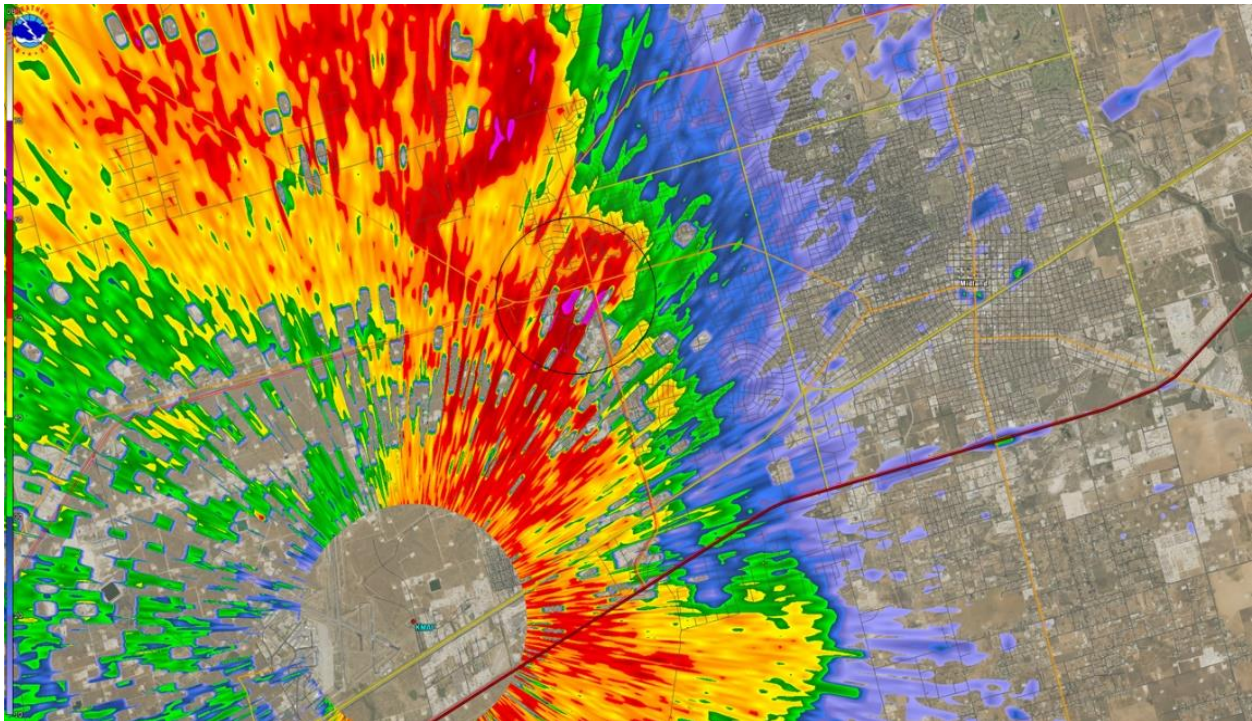
Figure 1. KMAF 0.5 deg Z at 10:46 PM CDT, June 22nd. Highest reflectivity values are shown over the location of damaged powerline poles.

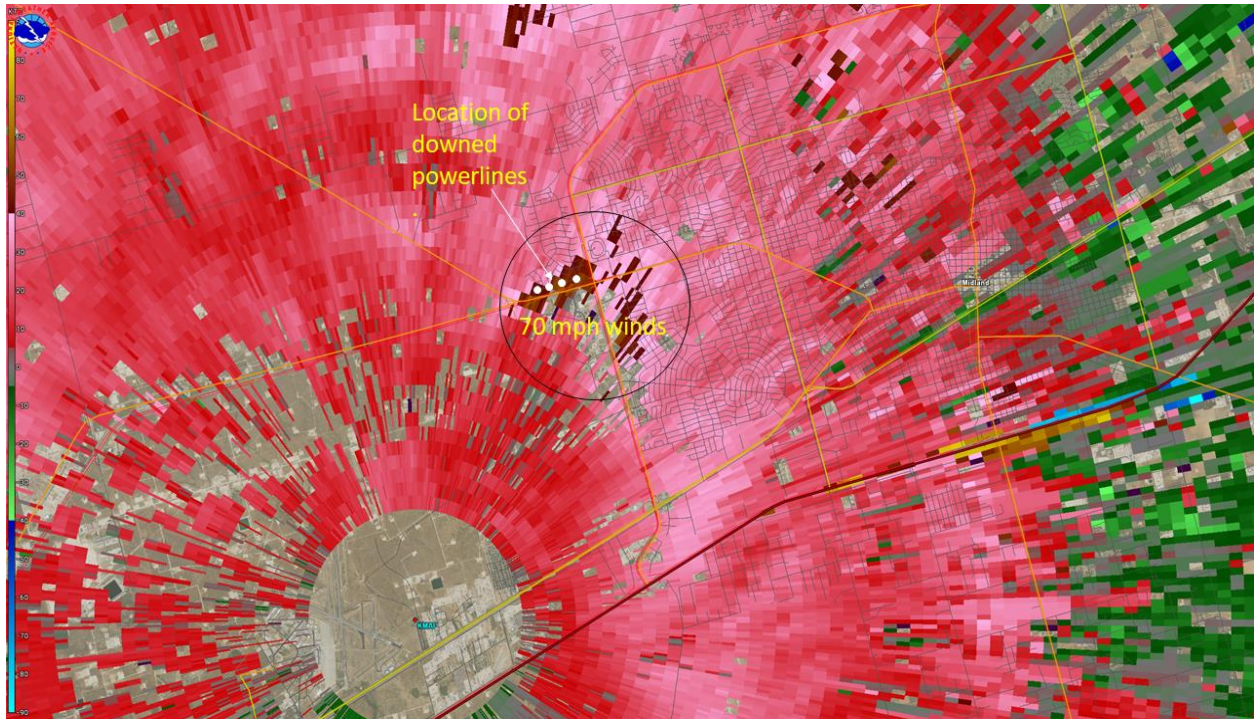
Figure 2. KMAF 0.5 deg V at 10:46 PM CDT, June 22nd. The red and pink colors indicate winds moving away from the radar site. Wind speeds up to 70 mph are indicated by the darker red colors in the circled area.

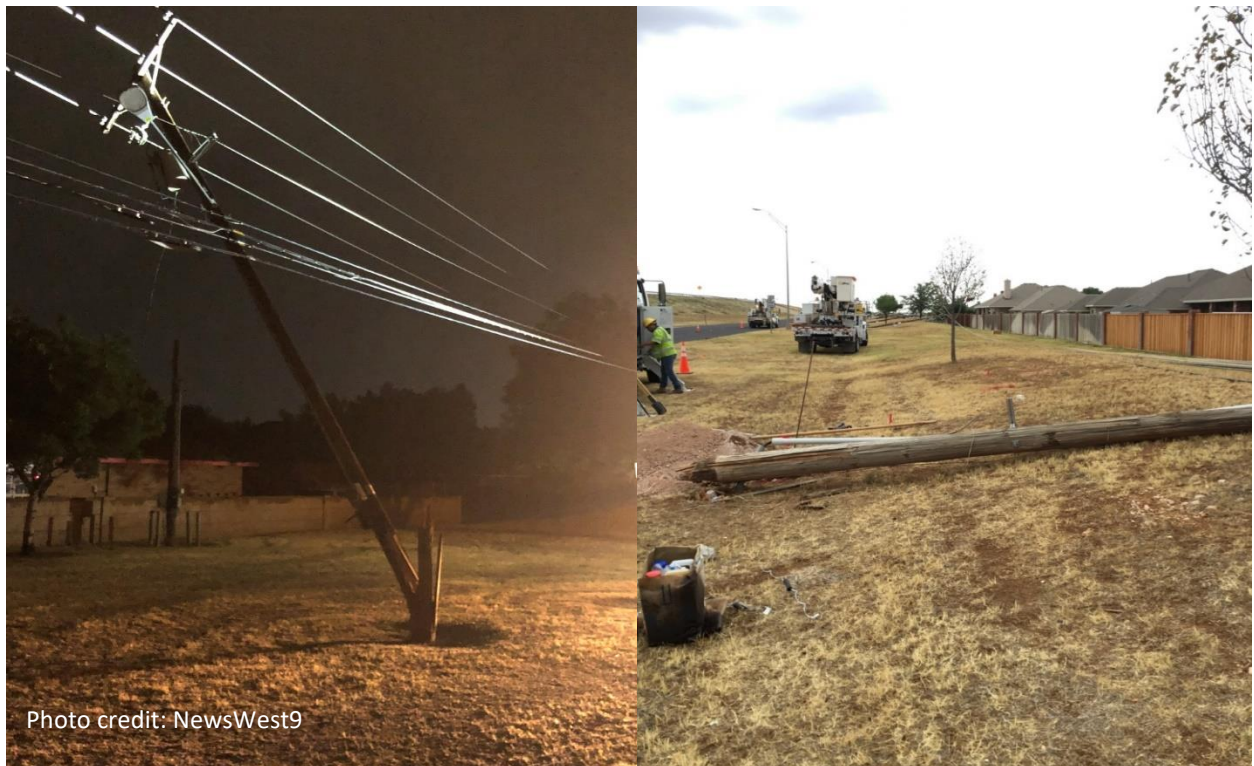
On the evening of June 22nd, a line of thunderstorms developed along two intersecting outflow boundaries in Andrews and Ector Counties. The line quickly progressed eastward and picked up speed as it moved into Midland County and over Midland International Air and Space Port (MAF). At 10:44 PM CDT, a 60mph wind gust was reported at MAF. The storms continued to push eastward, reaching the west side of Midland between 10:45-10:50 PM CDT. Heavy precipitation is denoted by the red and purple shaded areas in radar reflectivity (Figure 1). A pocket of strong outbound winds, indicated by the darker red shades in base velocity (figure 2), led to a localized area of damage near West Loop 250 and Andrews Highway just outside the Grasslands Estates neighborhood. Six powerline poles snapped near their base and toppled over causing most of the neighborhood to lose power (Figure 3). This damage was indicative of powerful straight-line winds estimated to be up to 70 mph. As the storm continued through Midland, winds up to 60 mph were still possible, but no other major damage was reported.

Figure 3. Wood powerline poles snapped at their base and leaning over along the westbound frontage road of Andrews Highway.

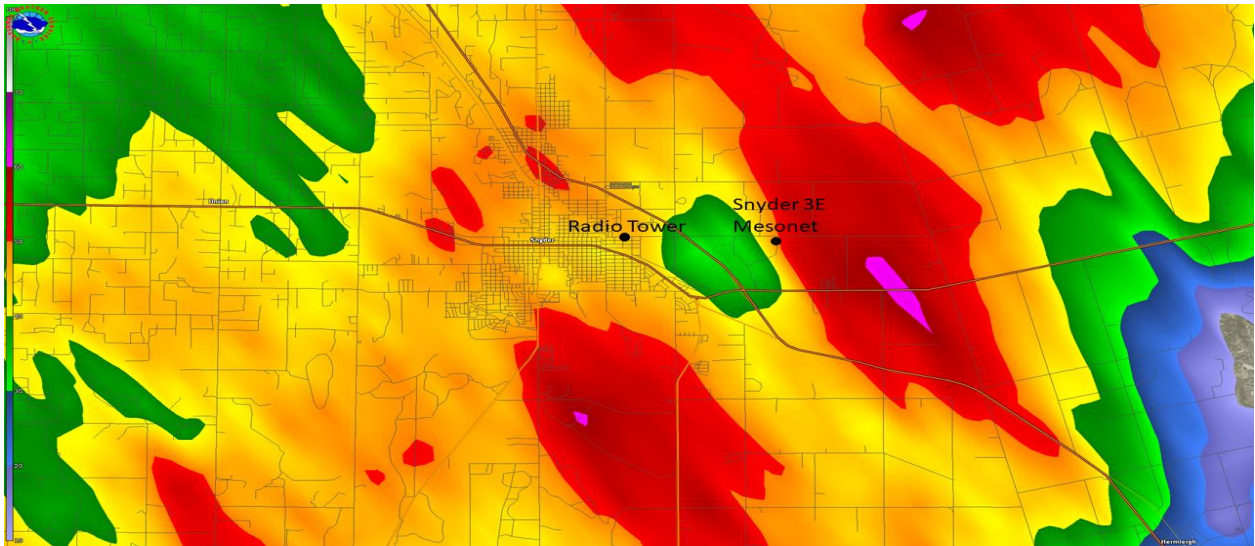
Figure 4. KMAF 0.5 deg Z at 2:11AM CDT, June 23rd. Highest reflectivity values are depicted over the Snyder 3E Mesonet where a 72 mph wind gust occurred.

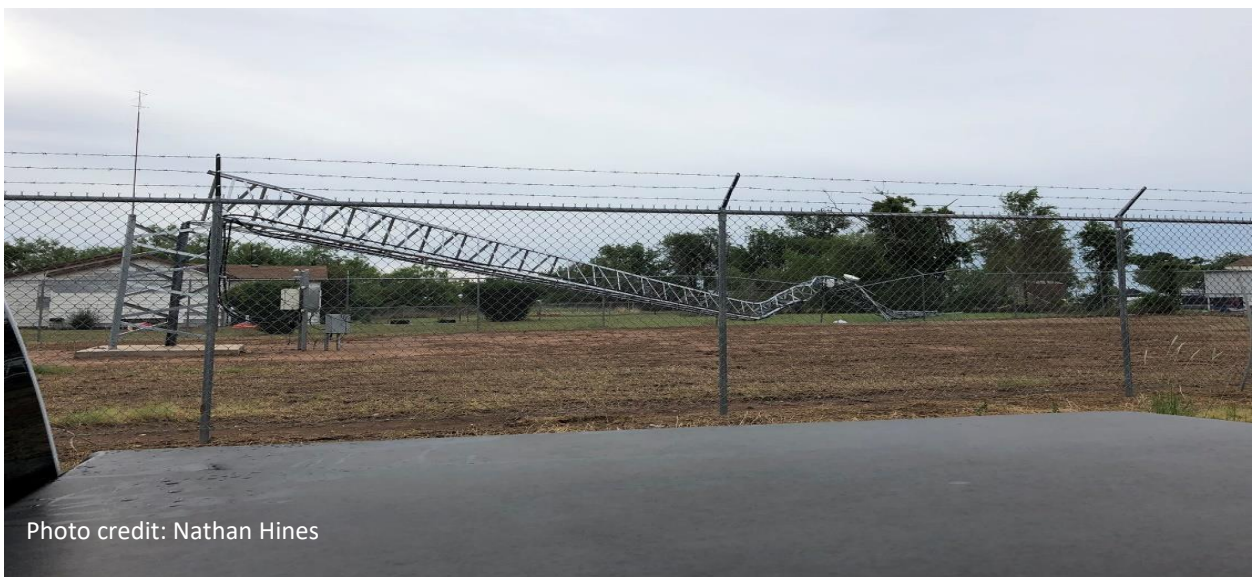
Around 2:00 AM CDT on June 23rd, multiple thunderstorms formed along an outflow boundary in northern Scurry County and moved south over the city of Snyder, TX. One storm strengthened over the east side of the city as noted by the higher radar reflectivity (Figure 4). A West Texas Mesonet recorded a 72 mph wind gust at 2:10 AM CDT. At around the same time, a 100 ft radio tower located at the intersection of Ave B and 24th St was blown over by the strong winds. The tower appeared to break near the base where it was connected by several bolts (Figure 5). This damage was determined by local emergency management to be caused by straight-line with wind speeds estimated between 70-75 mph. Special thanks to Nathan Hines, Deputy EMC with the Snyder Fire Department, for conducting this damage survey.

Figure 5. 100 ft tall radio tower in Snyder, TX broken near its base due to strong straight-line winds.
