# Culberson County Microburst

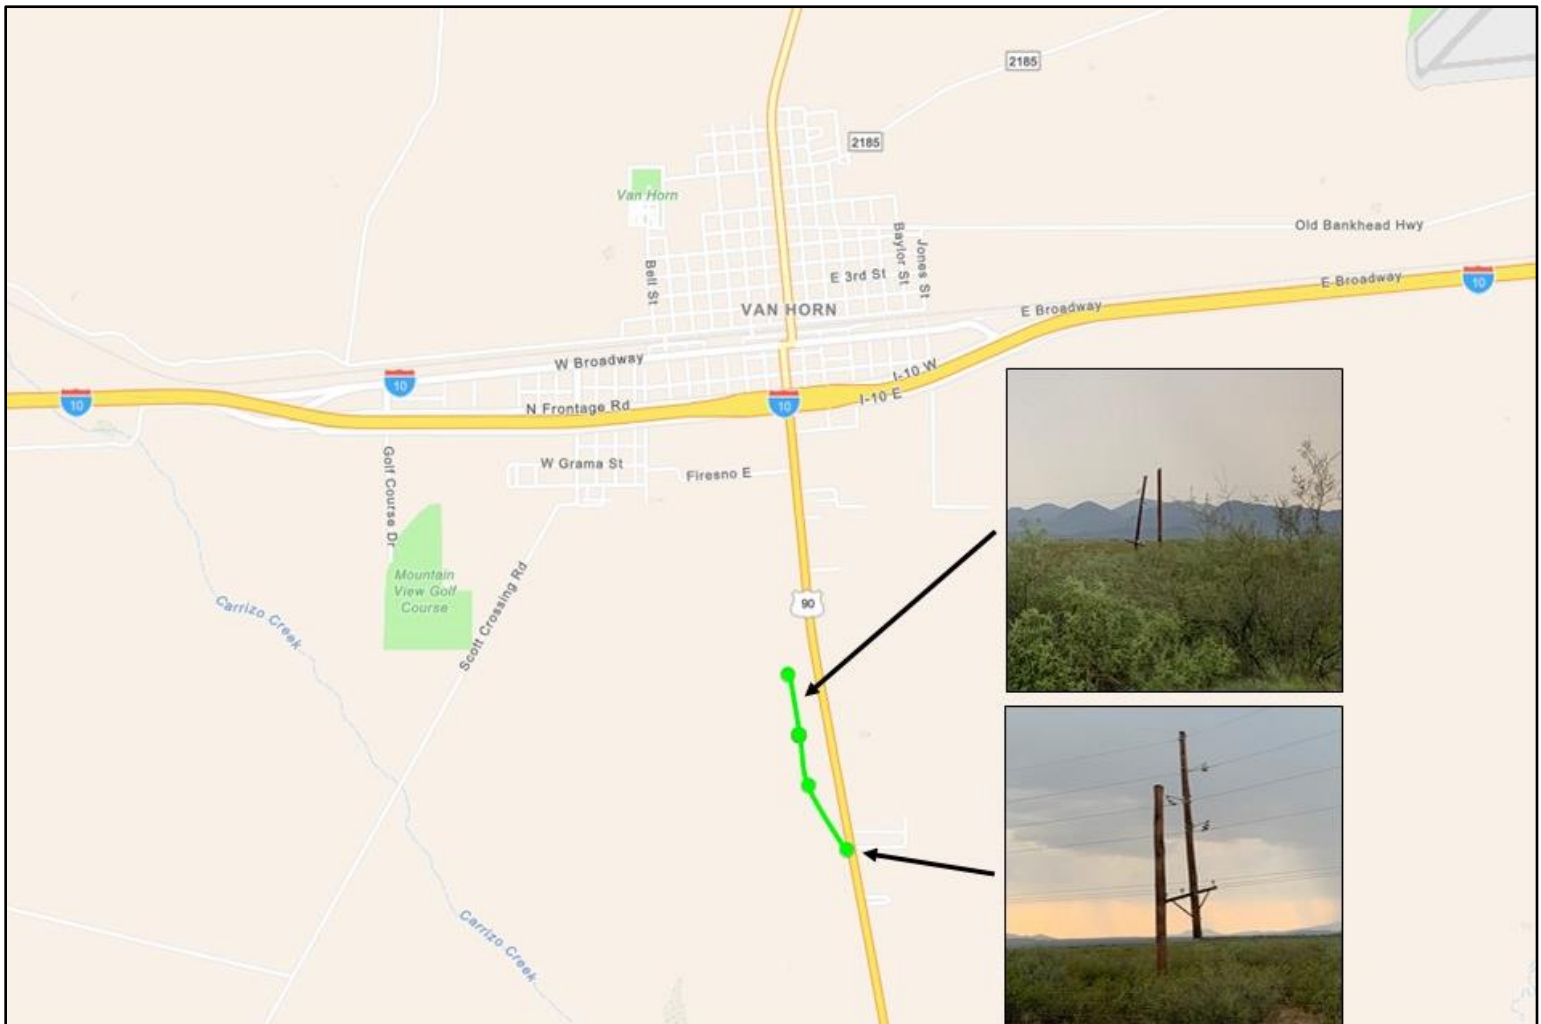
Scattered showers and thunderstorms developed across portions of West Texas and southeastern New Mexico during the afternoon hours of August 17, 2020. Most of this activity remained sub severe through the evening hours, producing some lightning and brief periods of heavy rainfall. However, one particular storm that moved over the city of Van Horn, TX produced a localized area of damaging straight-line winds as the core of this storm collapsed just south of the city around 6:30pm CDT. By 7pm CDT, Culberson County Office of Emergency Management (OEM) reported 10 snapped powerline poles 1-2 miles south of Van Horn along Highway 90 that resulted in a city-wide power outage. After re-evaluating radar data and assessing the damage remotely using photos sent in by Culberson County OEM, the National Weather Service determined that the damage was caused by a microburst (definition is provided below) with estimated wind speeds near 100 mph, which is equivalent to an EF-1 tornado!
