June 2nd, 2024 Lower Trans Pecos Severe Weather

Sanderson Tornado #1

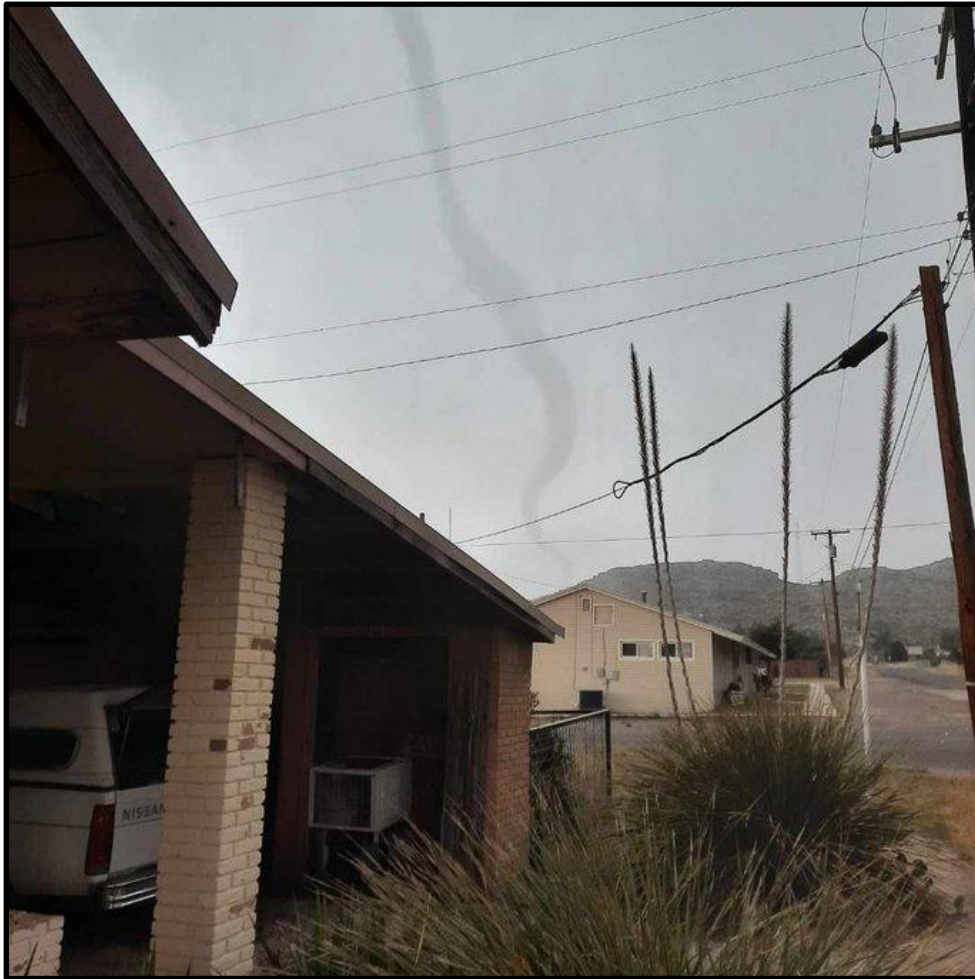
Tornado entering the town of Sanderson. Photo Courtesy of Jubal Lane.
