## May 4<sup>th</sup> 2024 Severe Weather

### Pecos County Straight-Line Winds and Hail

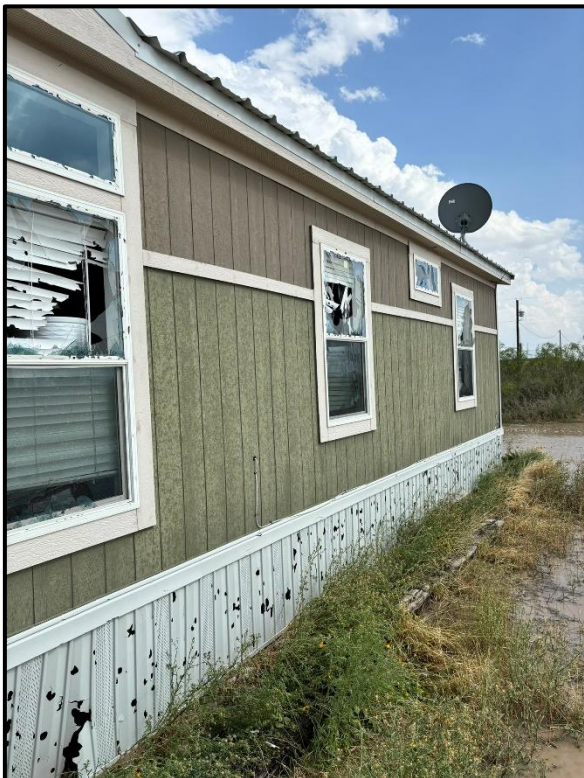
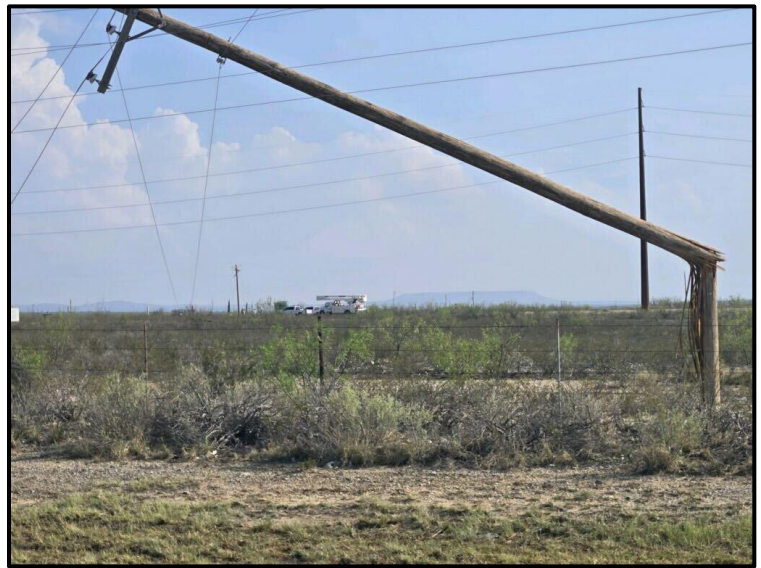
A supercell thunderstorm developed and strengthened west of Fort Stockton, TX along I-10. This thunderstorm would slowly move east before impacting parts of the Fort Stockton area. Straight-line winds and wind driven hail along US Highway 285 near the Pecos County Airport caused extensive damage to a home. Windows were broken, two power poles were snapped near the base, and there was exterior wall damage due to wind and hail at this location. Wind speeds were estimated to have reached up to 100 mph with this thunderstorm.

**Photos of hail damage to a home and a snapped power pole due to straight-line winds. Photos are courtesy of Kendra Reed and Pecos County EM.**

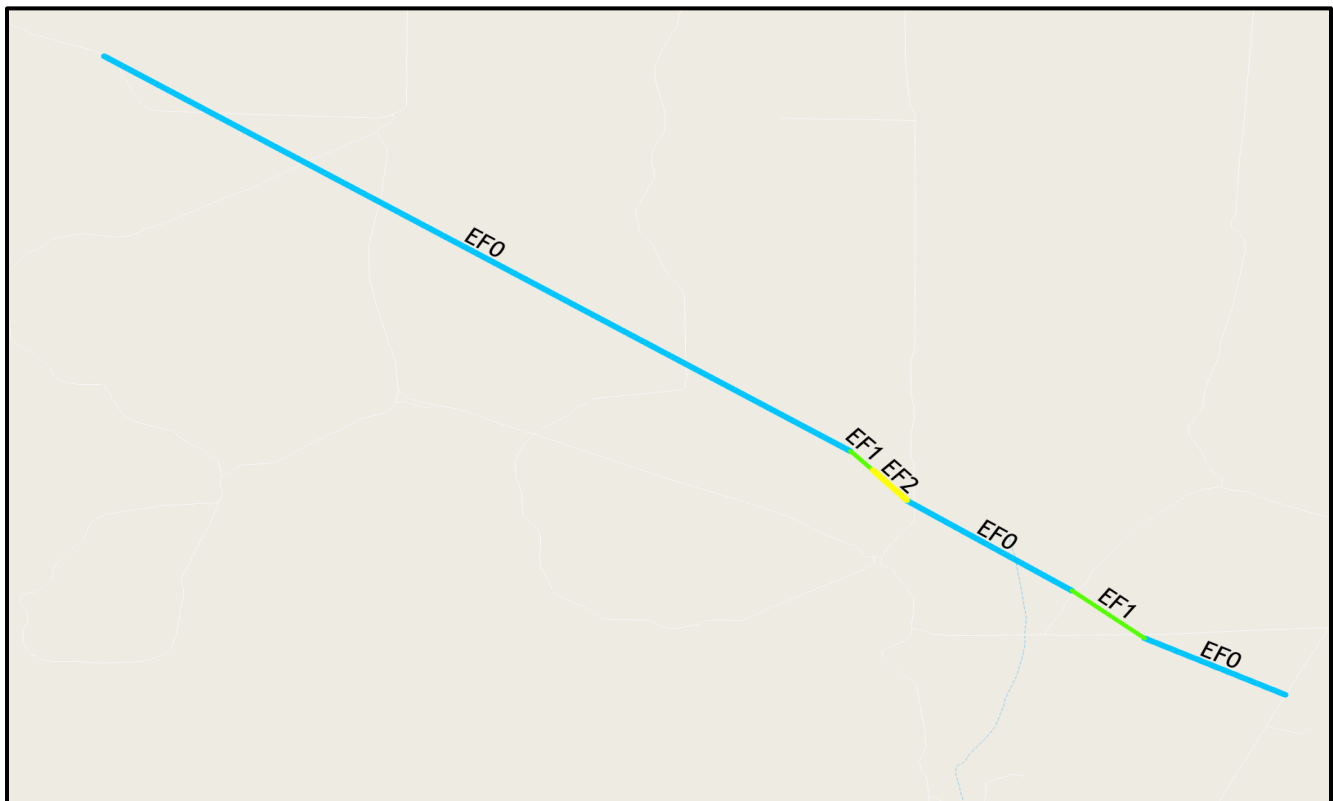
The same supercell thunderstorms that produced the very large hail spawned several tornadoes as well. The first tornado began just east of US Highway 385 south of Fort Stockton in rural central Pecos County. This tornado was documented by numerous observers and an NWS employee, quickly developing into a photogenic stovepipe before becoming increasingly wrapped in rain. The tornado slowly moved southeast, before completely wrapping in rain and likely dissipating. This tornado occurred over mainly open terrain only causing damage to vegetation and a few wooden electrical power poles in the area. This tornado was rated as a mid-range EF-2 given the degree of damage to these wooden power poles which were snapped cleanly from near the base.

**Zoomed in photo of the track of the EF-2 tornado that occurred south of Fort Stockton.**
