The Indialantic Tornado - 2/17/98

Overview of Indialantic Tornado - the tornado first touched down around 7:07 AM on February 17th, 1998 in the 500 block of South River Oaks Drive on the barrier island near Indialantic. The tornado knocked down some fencing in the backyard and tore the porch roof off of one house and damaged portions of the main roof. A car in the driveway was spun around and damaged by flying debris ([photo 2](#)). The neighboring house was damaged by flying debris from the first house, including a roof beam that completely penetrated the wall of the house ([photo 1](#)). The tornado was rated F1 (73-112 mph at this point FUJITA DAMAGE SCALE). The tornado immediately lifted to near treetop level and continued to do minor (F0 damage - winds less than 73mph) further along South River Oaks Drive and North River Oaks Drive. Trees were topped off and one concrete light pole was broken off ([Photo 3](#)) near the top indicating winds speeds were much higher than F0 just 20 or 30 feet off the ground. The tornado then lifted for about 1/4 mile and touched down again just north of the Hoover Junior High School on Riviera Blvd and produced damage consistent with an F1 torn

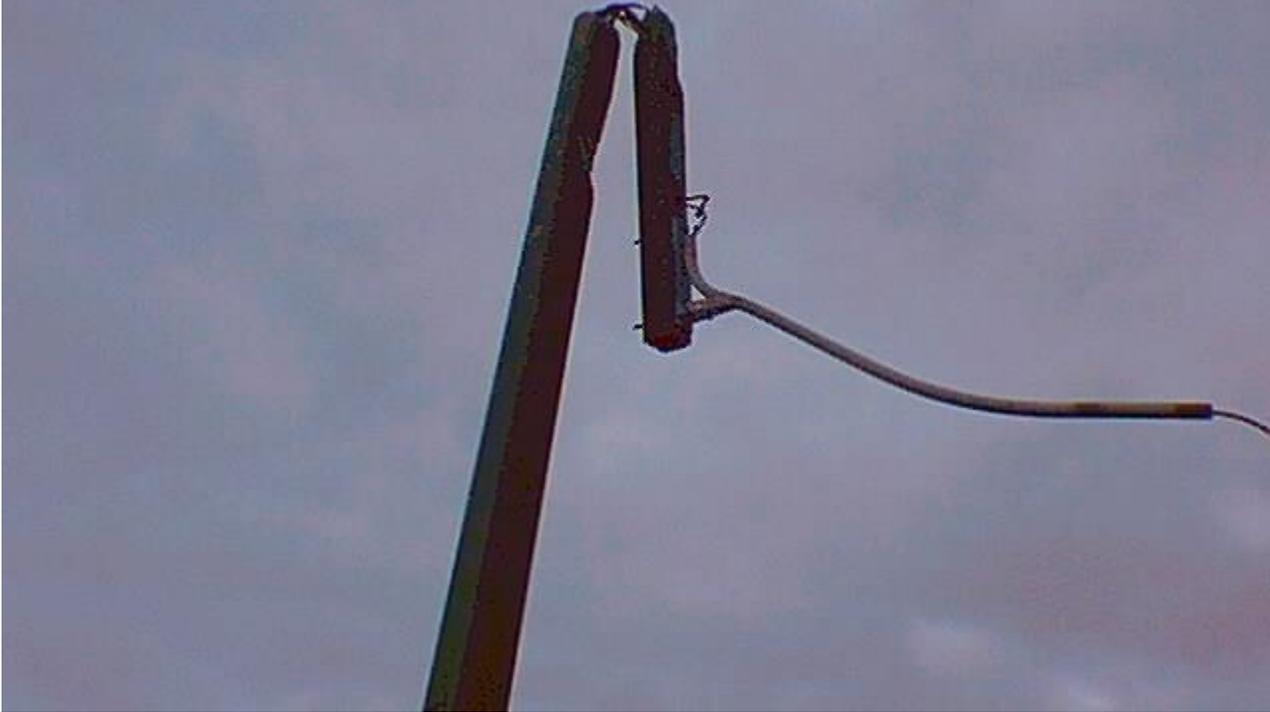
Damage photo at location 3.

A cement power-pole snapped and hanging by its embedded reinforcing bar.

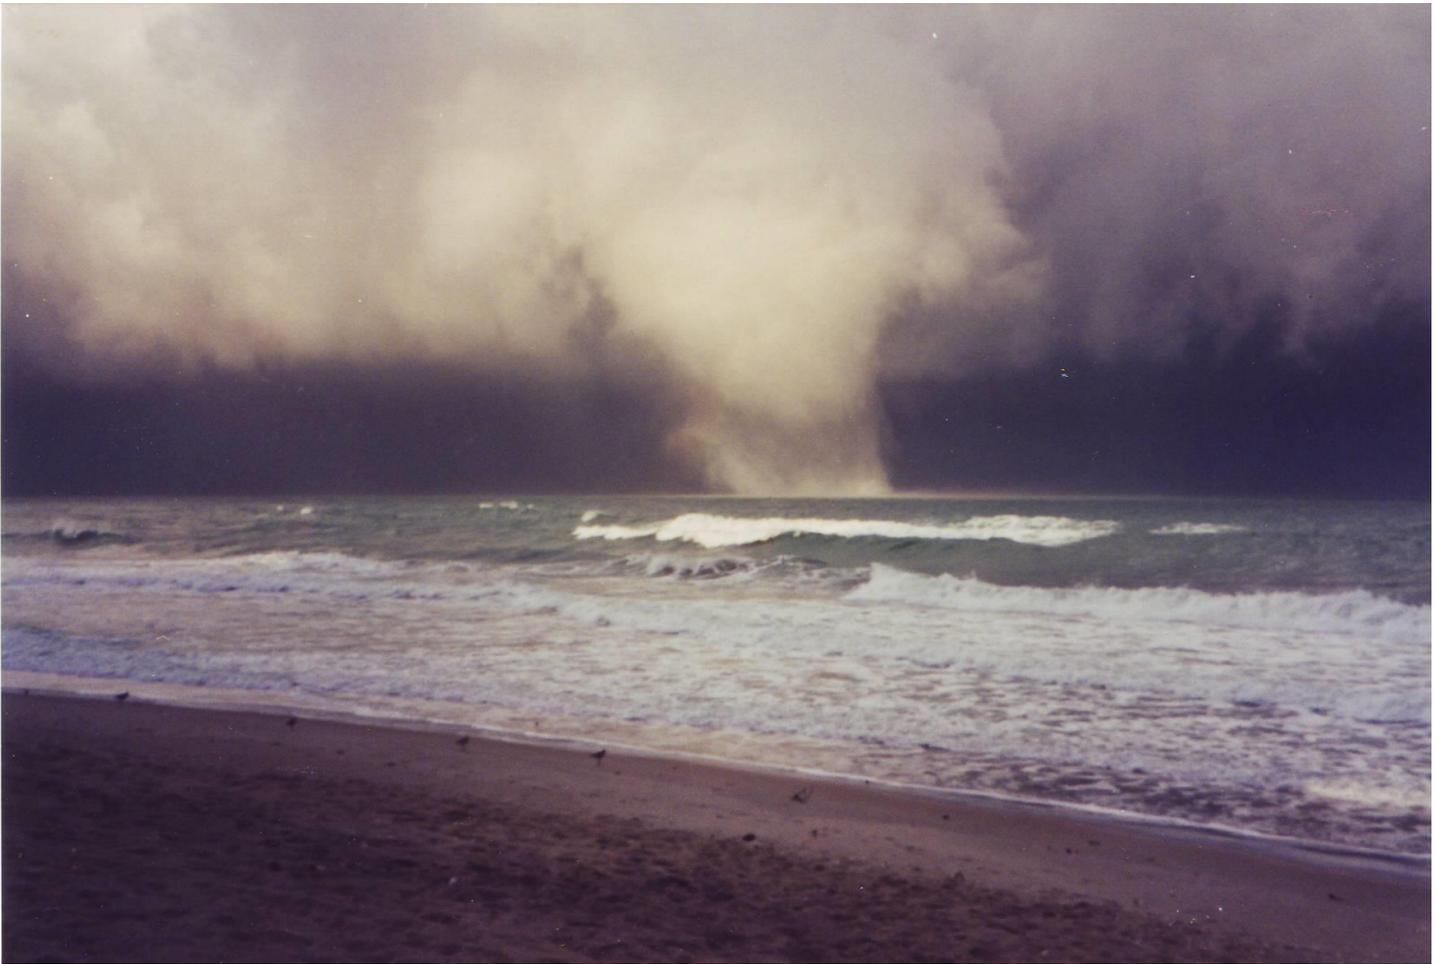
Photo 5. Tornado that moved offshore on 2/22/98 near the same path of the 2/17/98 tornado!

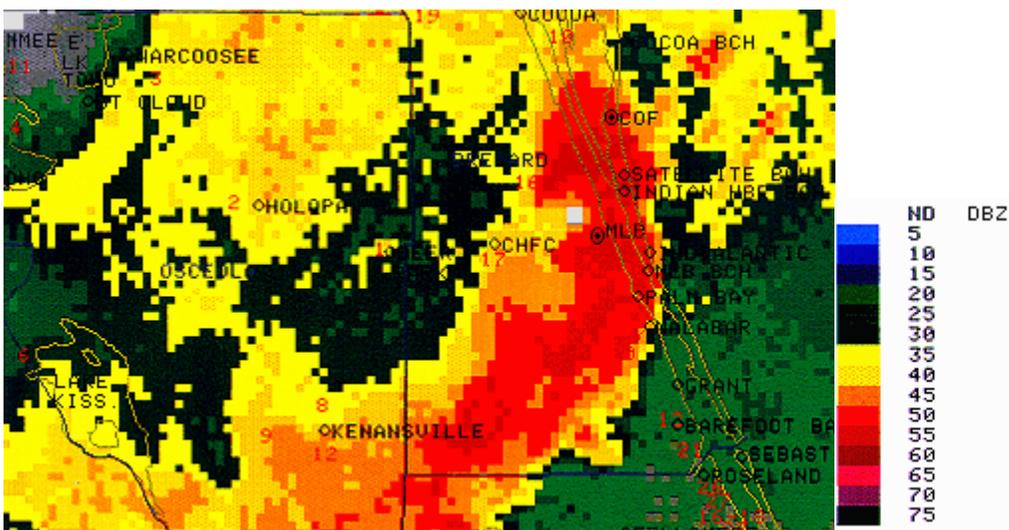
Composite Reflectivity 7:09 AM EST 2/17/98

This radar reflectivity image from the NWS Melbourne WSR-88D shows an intense "Bow Echo" approaching Indialantic and the barrier islands. Typically, this type of feature is associated with damaging straight line winds, however short-lived tornadoes can spin up rapidly along the leading edge of the bow echo.

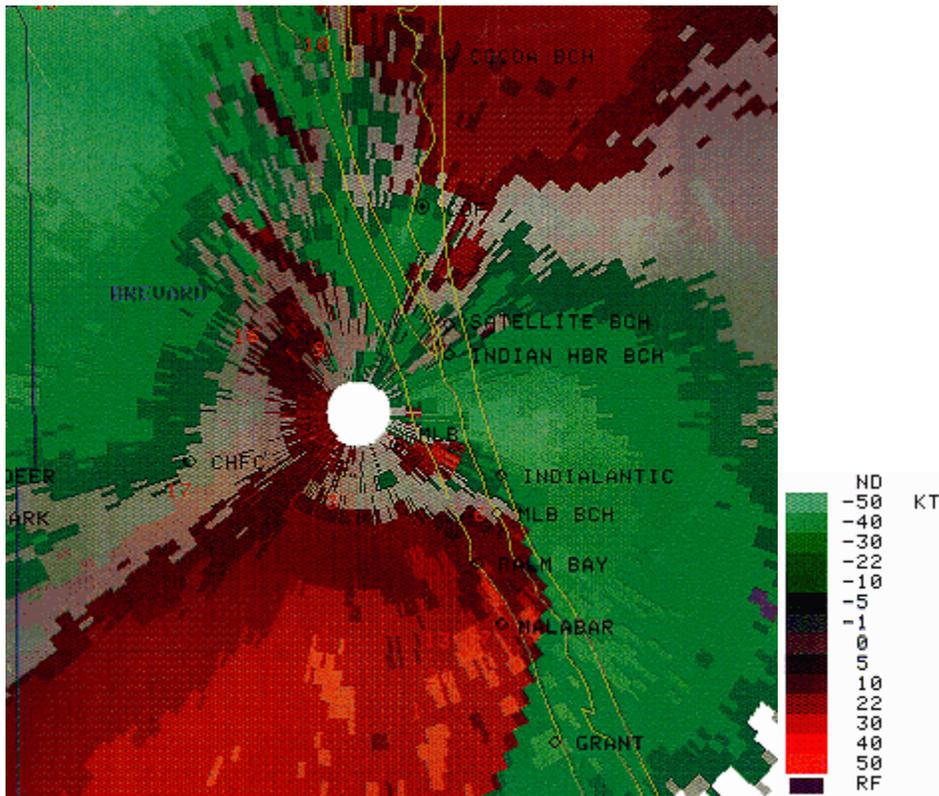
Velocity 7:09 AM EST 2/17/98

This Doppler velocity image from the NWS Melbourne WSR-88D shows the small circulation associated with the Indialantic tornado between the Melbourne radar site (the white circle in the middle of the image) and the town of Indialantic. The circulation is located near the letters "MLB" on the image. Green indicates air moving toward the radar site and red indicates winds moving away from the radar and reveals the classic counterclockwise circulation around the great majority of tornadoes.
