# Tornado Outbreak November 17, 2013

A major severe weather outbreak unfolded on Sunday as numerous tornadoes were spawned from supercell thunderstorms that formed in an unstable and highly sheared atmosphere. Provided below are results of several damage surveys conducted by the National Weather Service in Paducah over the past few days. Additional damage assessments are scheduled to take place in Scott County of southeast Missouri today.

**...DAMAGE SURVEY RESULTS FOR MCCRACKEN, MASSAC, POPE, LIVINGSTON, AND LYON COUNTIES...**

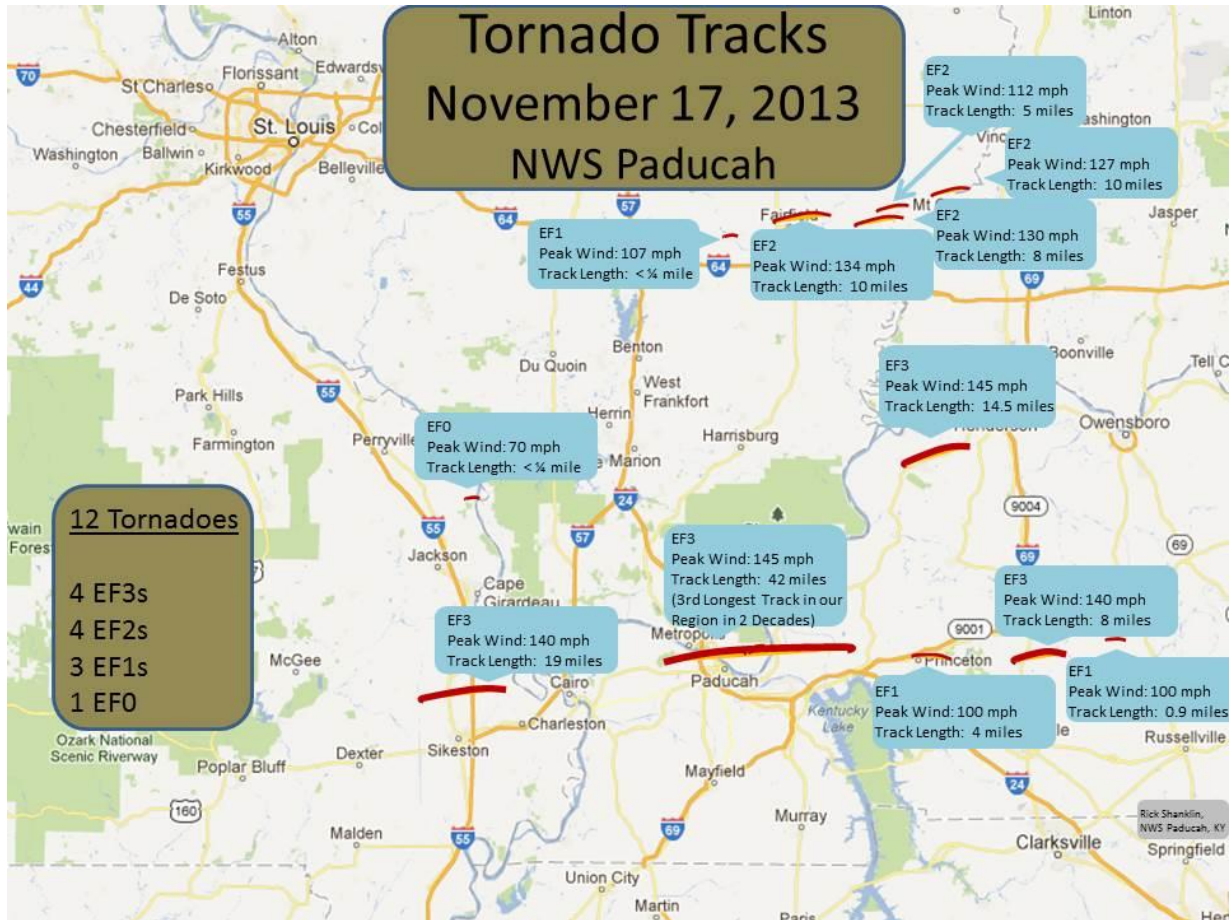
Damage in Brookport, IL from Brookport Tornado.

IN MASSAC COUNTY: DOZENS OF MOBILE HOMES DESTROYED, MANY BLOWN 100 FEET OR MORE. ONE HOME LEVELLED WITH DOZENS OF HOMES, GARAGES, STORAGE BUILDINGS, BUSINESSES AND OTHER BUILDINGS STRUCTURALLY DAMAGED. SEVERAL CARS AND A SCHOOL BUS TOSSED AROUND. AT LEAST HUNDREDS OF TREES SNAPPED AND UPROOTED. DAMAGE WAS IN BROOKPORT AND ALONG AND NORTH OF UNIONVILLE ROAD TO THE OHIO RIVER SOUTHWEST OF HAMLETSBURG, AND RATED EF-3.
