Irwin / Ben Hill County Tornado

Preliminary Report

NWS Tallahassee
Wednesday Dec. 18, 2019

Preliminary Damage Survey Results

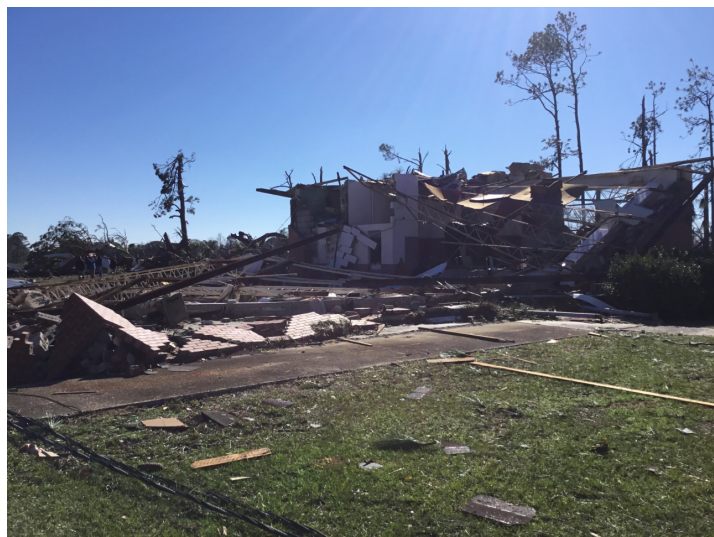
Near Mystic, GA

Damage was significant in Mystic. Several homes suffered serious roof loss and a couple brick buildings were nearly destroyed. Debris including concrete chunks was thrown hundreds of yards into a nearby field. There were hundreds of snapped and uprooted trees of all kinds in the area. Damage was well into the EF-2 range here.

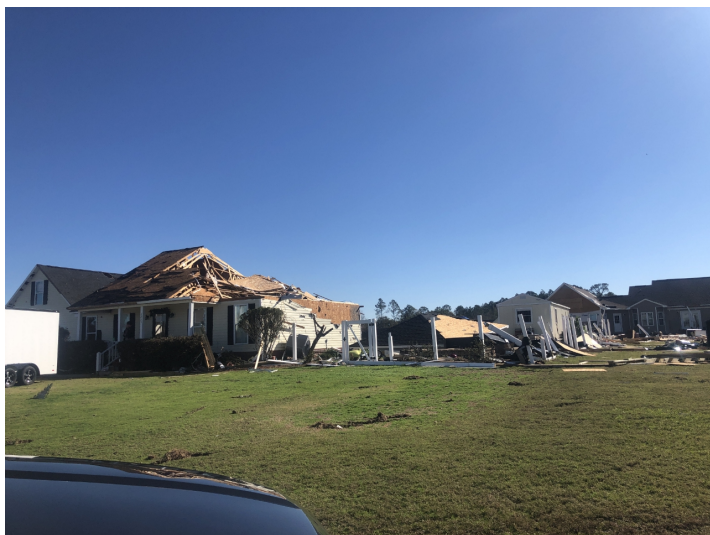
Near Irwin/Ben Hill line

The tornado continued moving northeast eventually crossing into Ben Hill county along Highway 319. Several more homes suffered roof damage, many barns were destroyed and hundreds of trees were snapped. The last evidence of damage was to a barn and trees along Partridge Road approximately 2.5 miles east of the Ashton community.
