StEER: Structural Extreme Event Reconnaissance Network

HURRICANE MICHAEL: FIELD ASSESSMENT TEAM 1 (FAT-1) EARLY ACCESS RECONNAISSANCE REPORT (EARR)

Released: October 25, 2018
NHERI DesignSafe Project ID: PRJ-2111

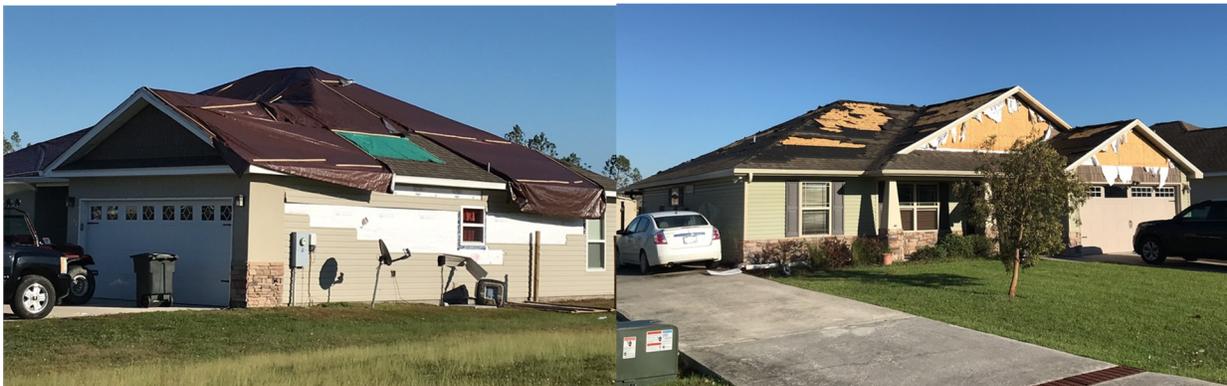
Figure 10: Damage to roof cover and building wall envelope observed in Southport

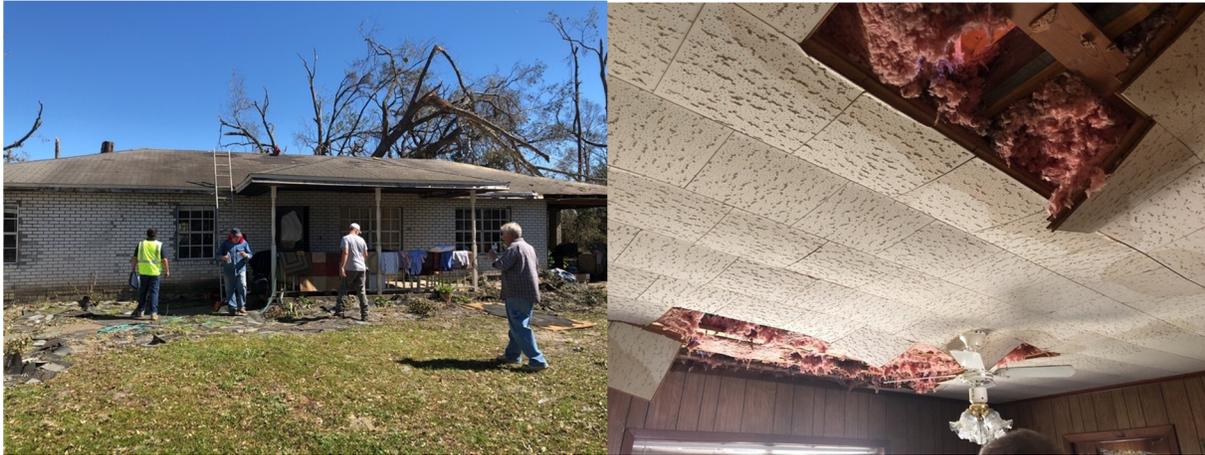
Figure 11: Example of tree damage observed in Southport

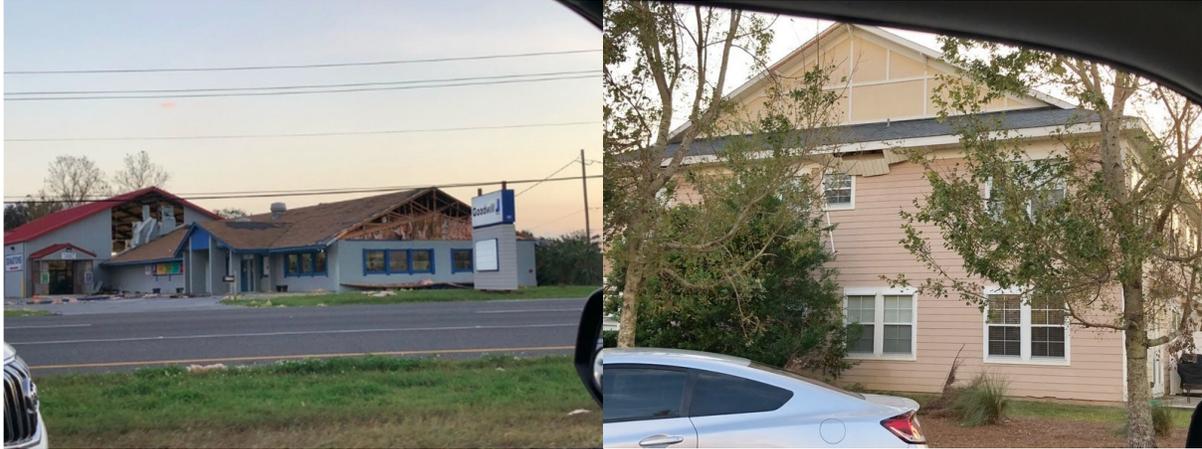
Figure 12: (left) Commercial building in Panama City Beach sustaining severe wind damage. (Right) Multifamily building under construction sustaining minor wind damage in Panama City Beach.

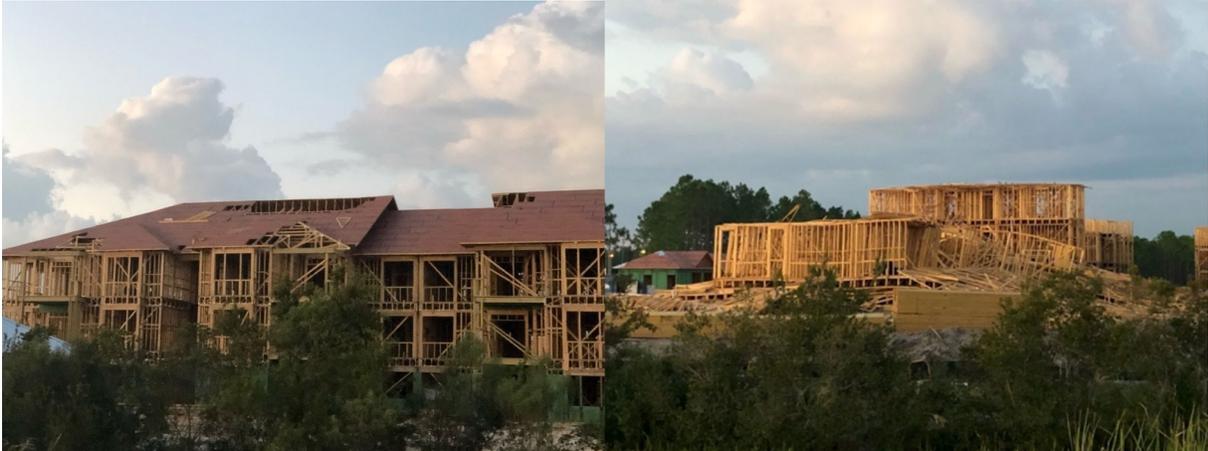
Figure 13: Construction sites in Panama City Beach sustaining moderate wind damage.

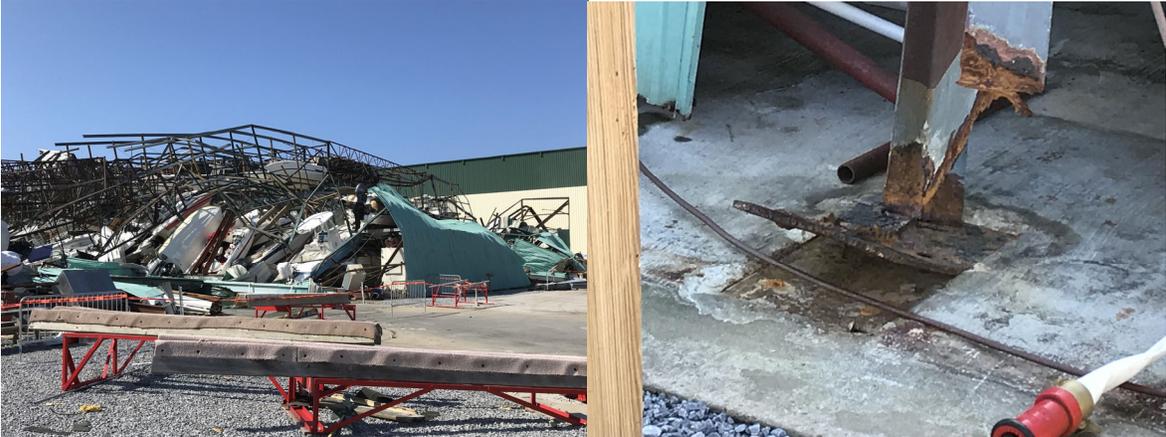
Collapse of three metal buildings associated with marinas were assessed in Panama City Beach (Figs. 14-15). While there is no doubt of the intensity of the wind speeds in Panama City Beach, forensic investigation revealed many connections of steel framing to their footings that were corroded to be point of significant loss of section and strength. In particular these conditions are likely to occur where the structures are located along the water and exposed to the environmental conditions salt air in marine locations.

Figure 14: Collapse of a storage building (left) with corrosion and material loss in columns and baseplates (right).

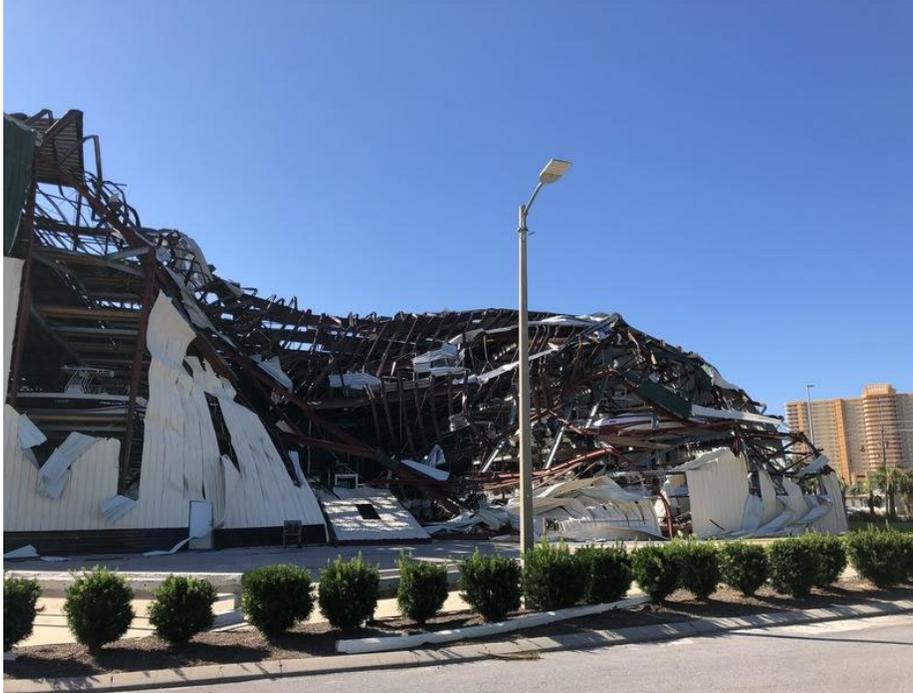
Figure 15: Partial collapse of a metal building marina in Panama City Beach.

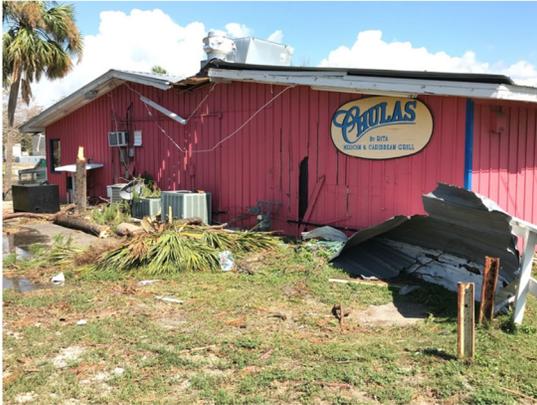
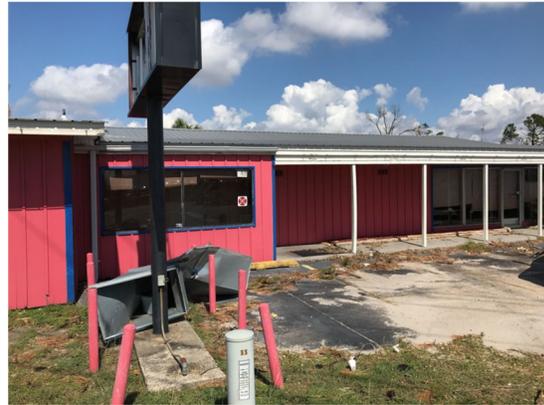
Figure 16: Commercial structure in Interior Panama City Sustaining minor wind damage.

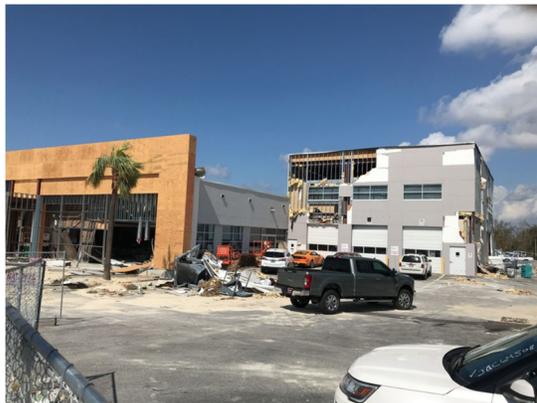
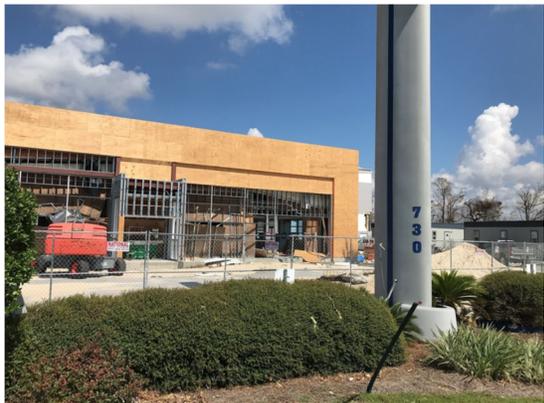
Figure 17: Commercial structure in Interior Panama City Sustaining moderate wind damage.

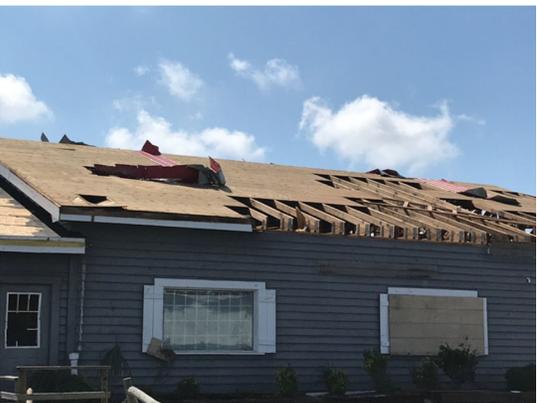
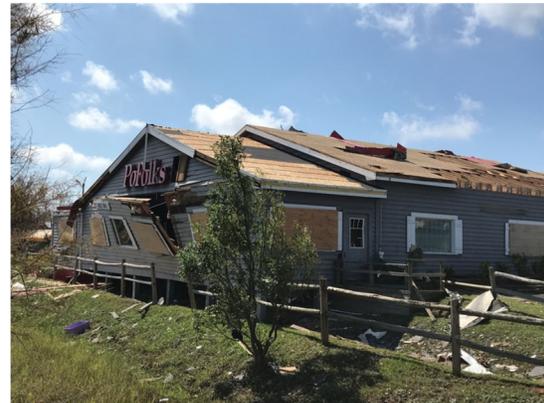
Figure 18: Commercial structure in Interior Panama City Sustaining severe wind damage.

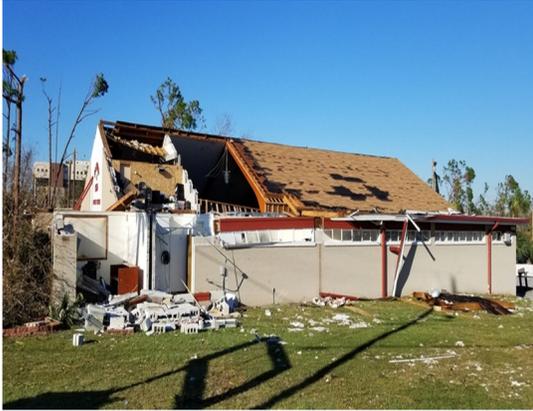
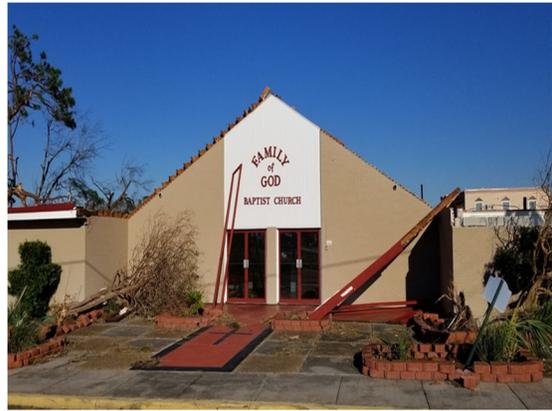
Figure 19: Severely damaged roof at Family of God Baptist Church at 901 US-98 BUS, Panama City (Captured by: Tim Johnson)

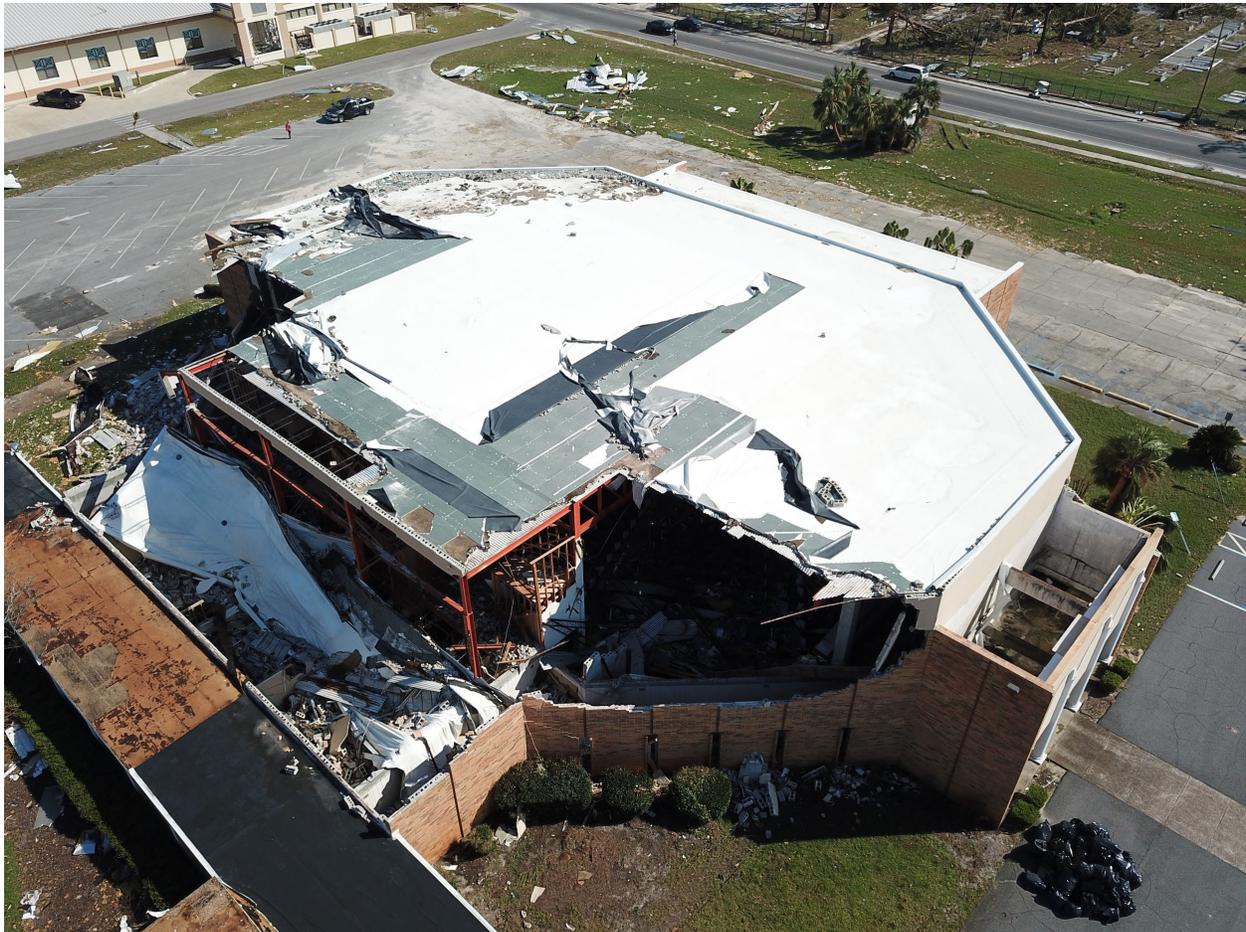
Figure 20: Failure of roof cover and exterior wall of a gymnasium at the Bay County Prep Academy (Lat: 30.16902, Long: -85.67445).

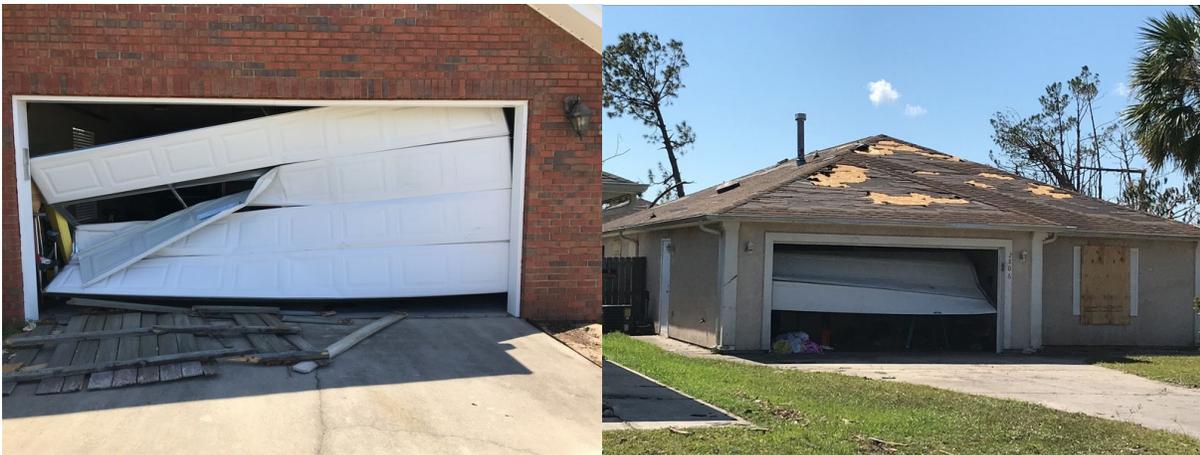
Figure 21: Garage door failures in residential homes in Cedar's Crossing.

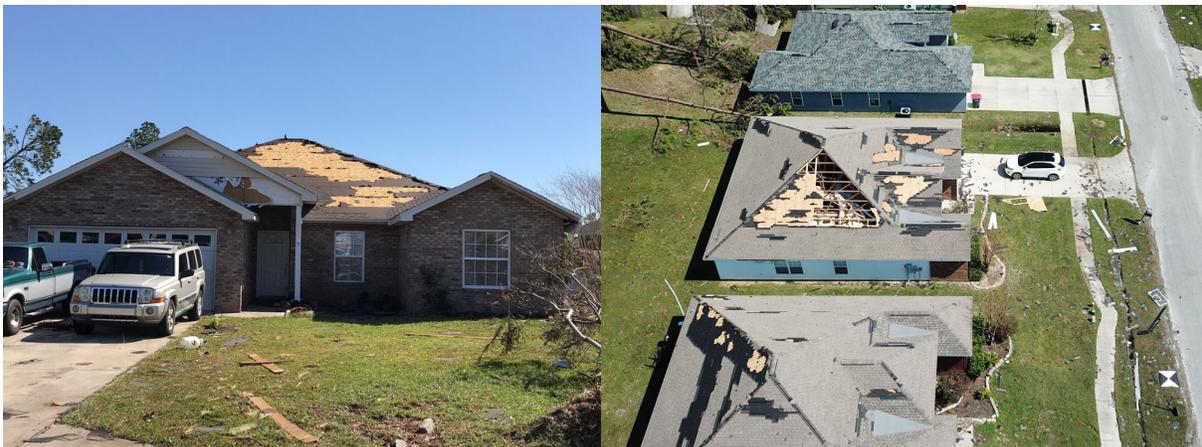
Figure 22: Damage to roof cover and roof sheathing in residential homes in Cedar's Crossing.

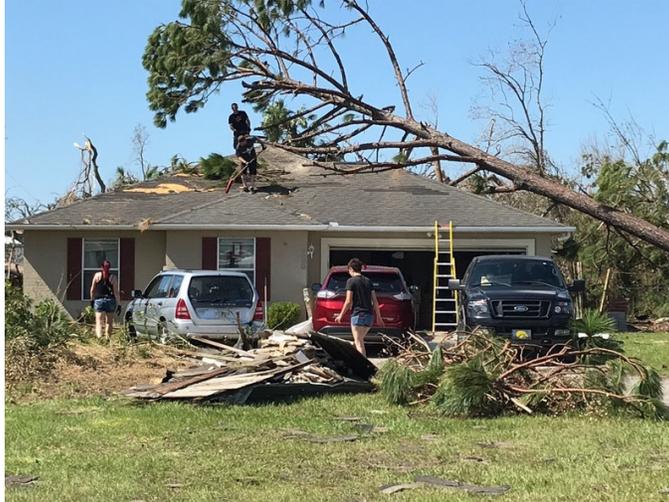
Figure 23: Example of tree damage in Cedar's Crossing.

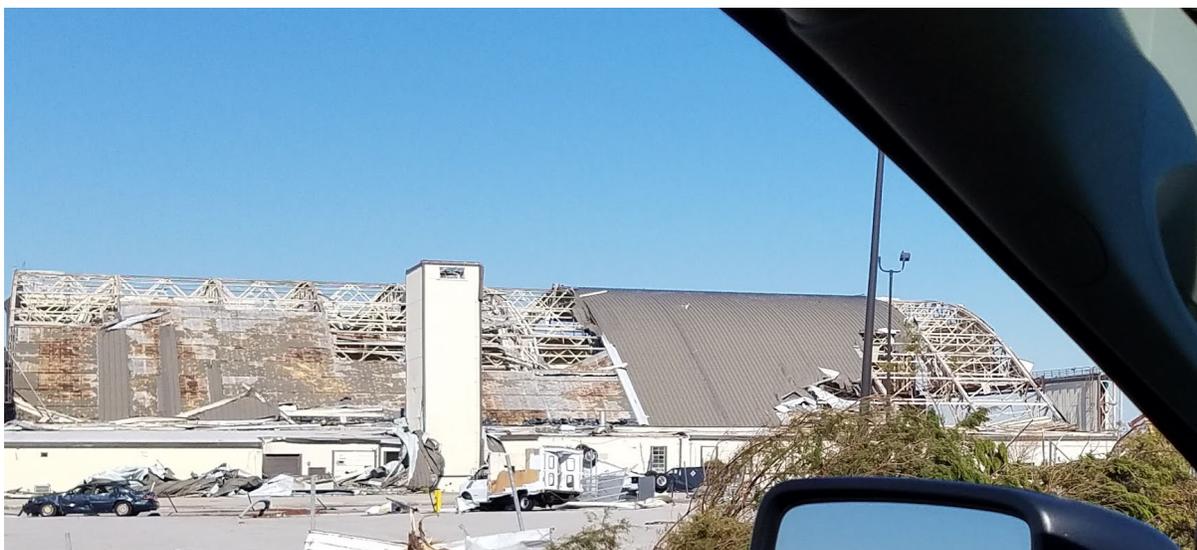
StEER did not attempt to access Tyndall Air Force Base, but significant damage to a number of buildings was observed from US-98, including several large aircraft hangars (Fig. 24), on-base housing, and experimental laboratories.

Figure 24: Severe wind damage observed to a large aircraft hangar on the Tyndall Air Force base, with almost complete failure of the corrugated metal roof cladding system.

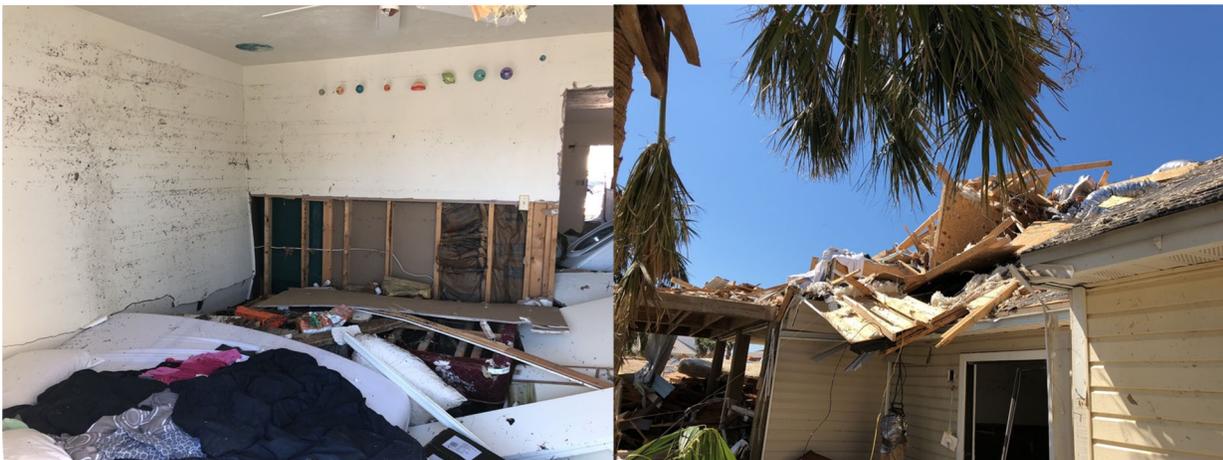
Figure 25: Example of storm surge damage in Mexico Beach. High water mark, 8" short of the 8 ft ceiling, slab is elevated 5" above ground level so surge height estimated 93" AGL.

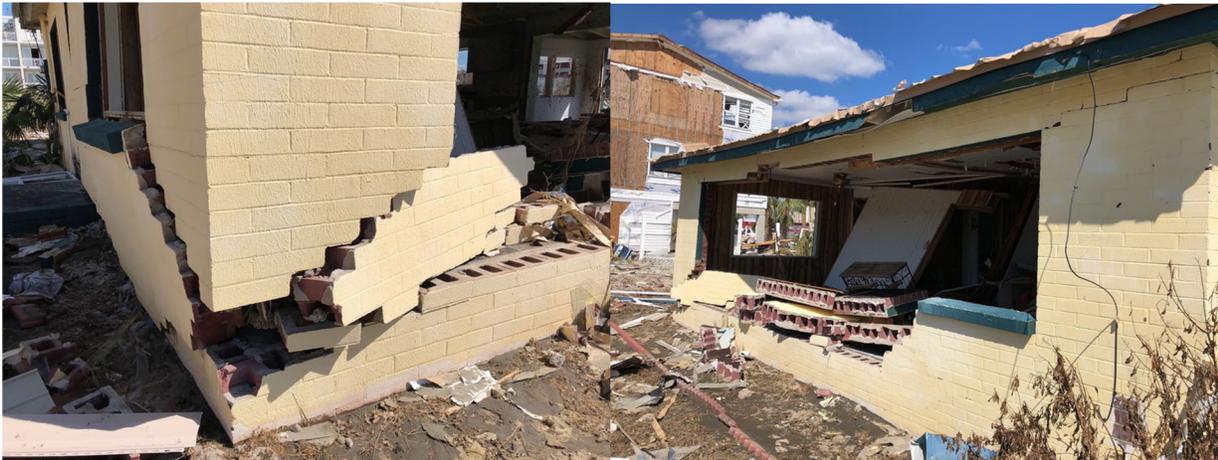
Figure 26: Severe damage to a masonry building observed in Mexico Beach (likely due to storm surge).

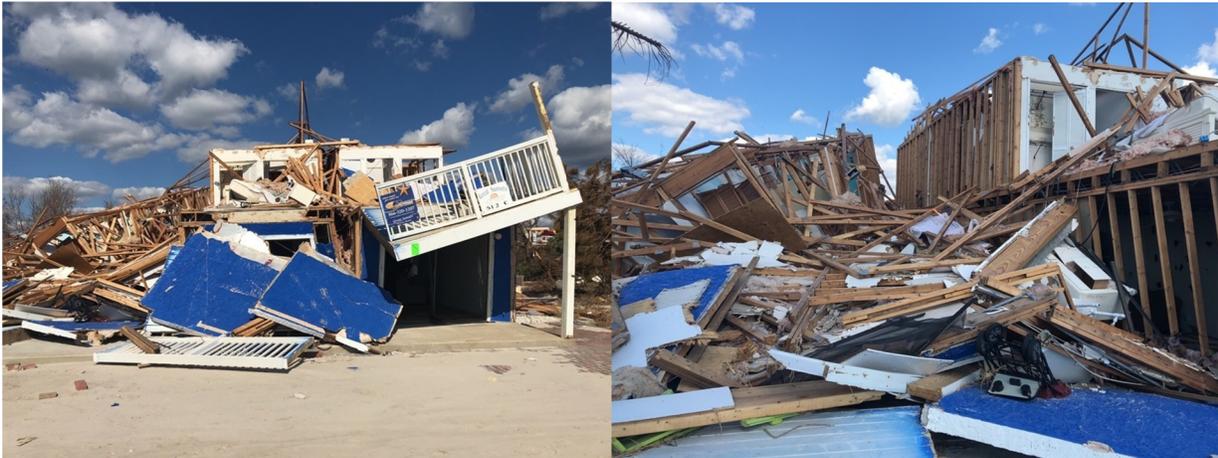
Figure 27: Example of total destruction of residential construction in Mexico Beach.

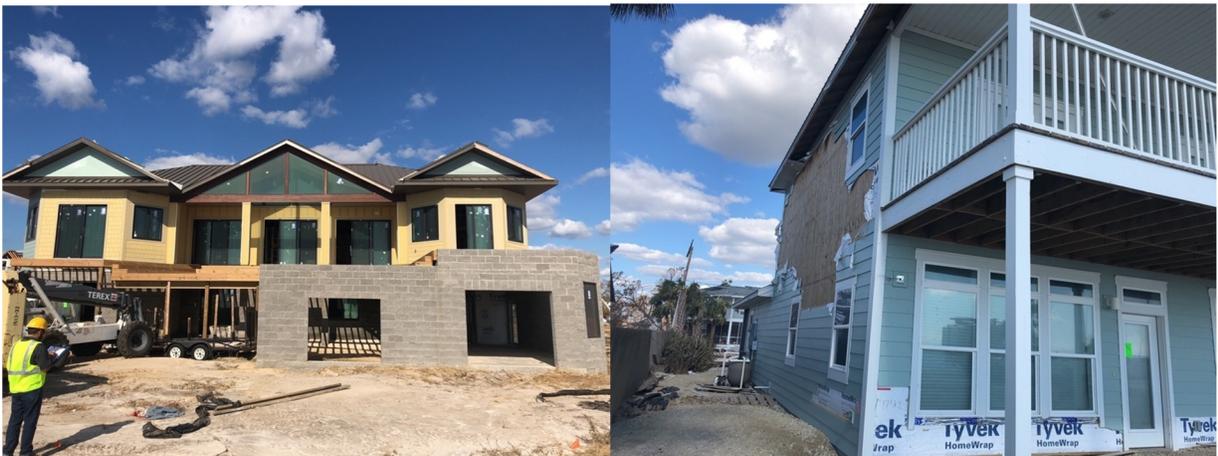
Figure 28: Newer buildings with minor damage in Mexico Beach.

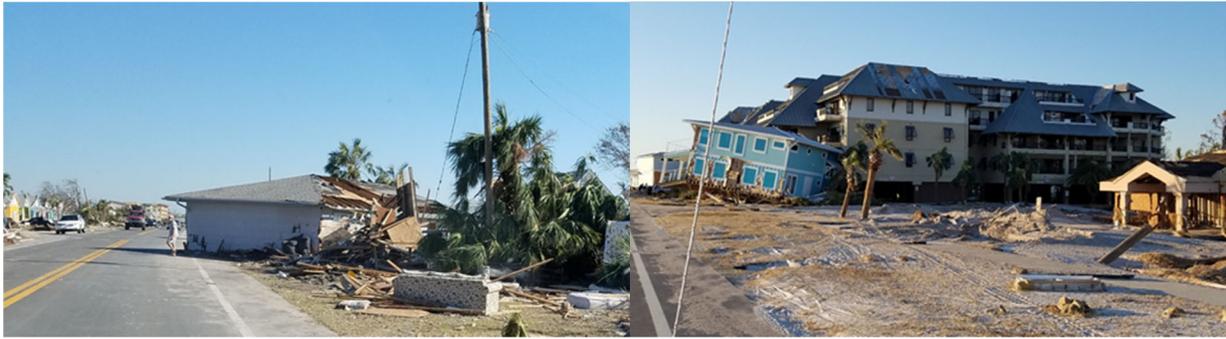
Figure 29: (left) Home pushed on to US-98 by storm surge; (right) Home pushed into multi-family residential complex by storm surge in Mexico Beach.

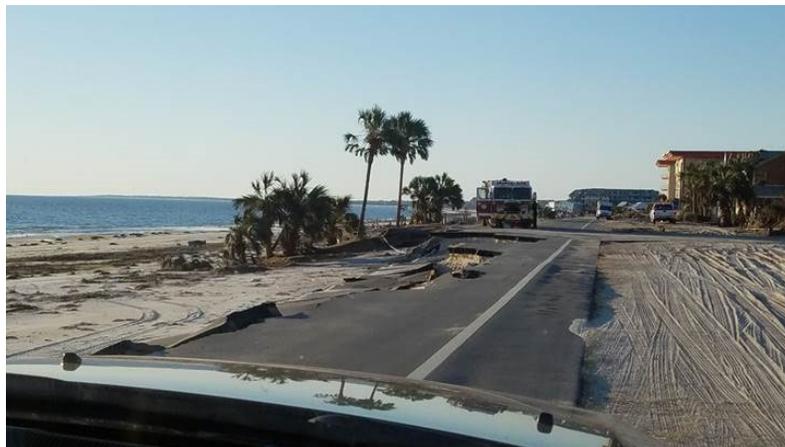
Figure 30: Road washout near US Hwy 98 in Mexico Beach (Latitude: 29.935440, Longitude: -85.400476).

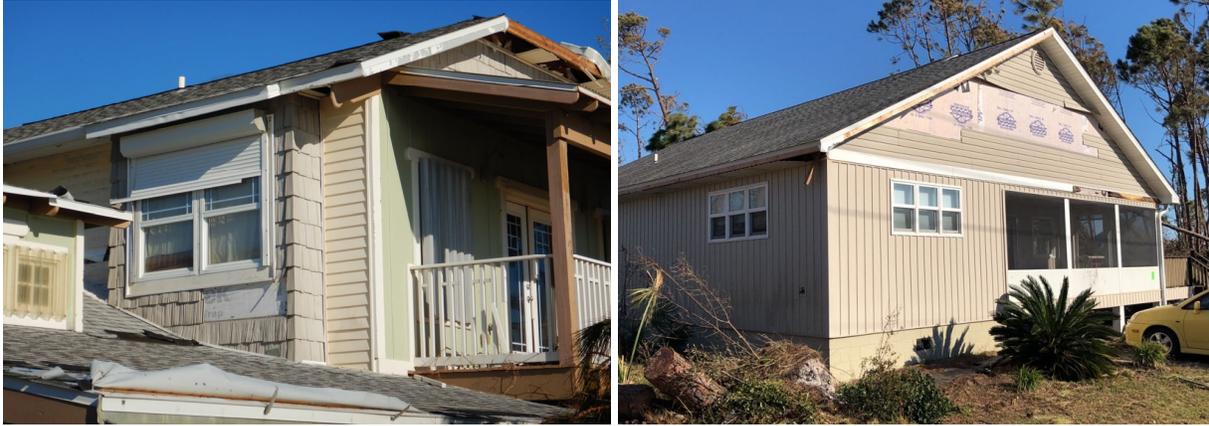
Figure 31: Examples of minor damage to homes assessed near the intersection of Highways 98 and 386 in Mexico Beach.

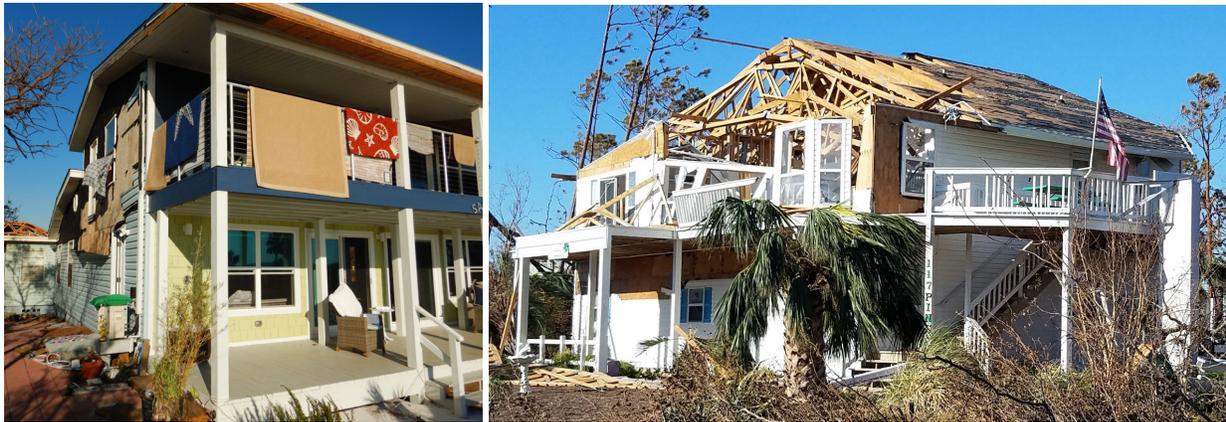
Figure 32: Examples of moderate (left) and severe (right) damage to homes assessed near the intersection of Highways 98 and 386 in Mexico Beach.

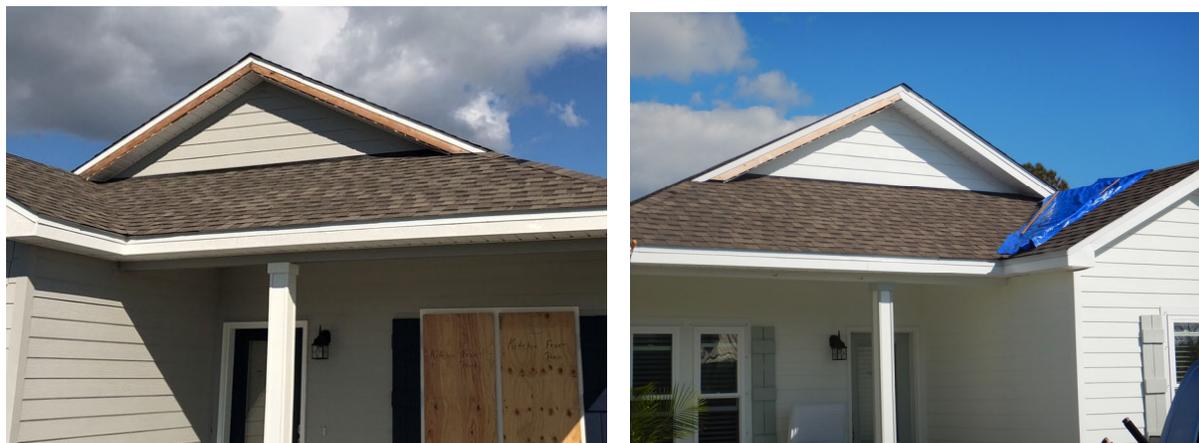
Based on discussions with the residents who were available, the homes have been built within the last five years, with some of the houses less than two years old. The primary forms of damage to these houses were loss of fascia boards and soffit damage, both under the eaves and under the entryways. There were also cases of minor shingle loss. Figure 33 shows examples of the

Figure 33: Typical fascia damage of homes in the Beacon by the Sea Community.

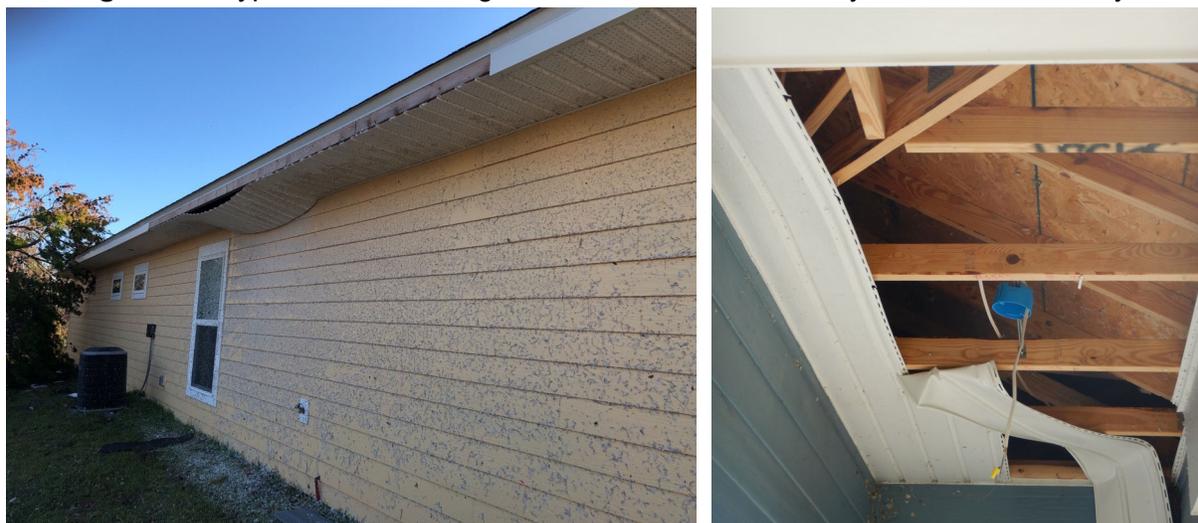
Figure 34: Typical soffit damage to homes in the Beacon by the Sea community.

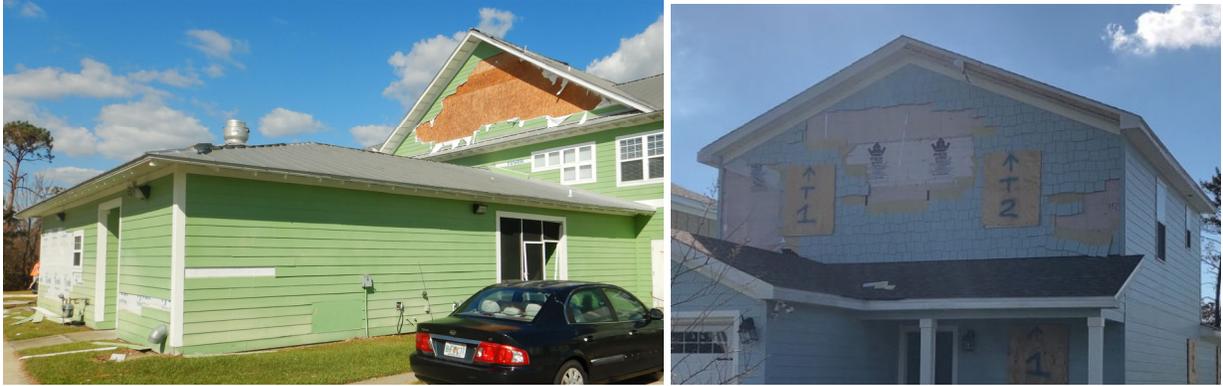
Figure 35: Examples of siding loss in an assisted living facility (left) and single family residence (right) in the Beacon by the Sea community.

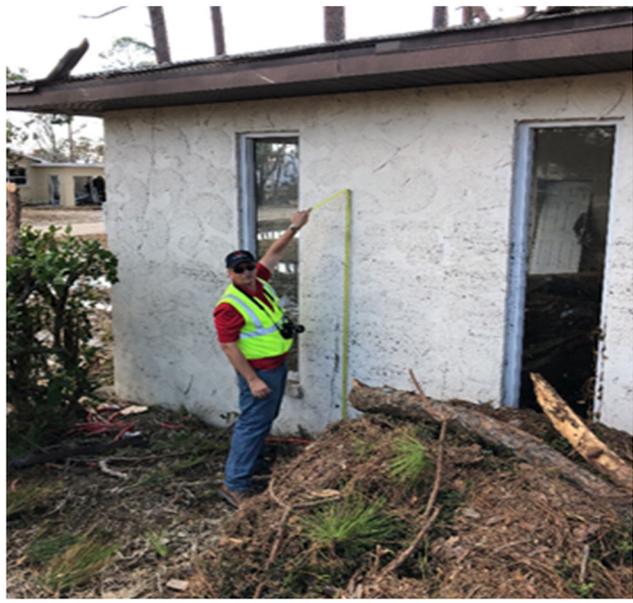
Surge high water mark of 72" was measured at Port St. Joe as shown in Figure 36. Wind damage was also severe in Port St. Joe, generally trending toward moderate and minor moving farther South. In general, it was seen that the surge footprint extended much farther south than the high-wind footprint. A surge-induced bridge failure (Fig. 37) was observed on 30A just South of Country Club road. New homes (less than 5 years old) along Four J's Rd. and Kaelyn Ln., less than a mile northeast of FCMP T2, performed very well. All were single-story, most with gable roofs, and with a mix of wall cladding and roof cover materials. Most had engineered wood panels installed to protect glazed openings. Isolated roof cover and wall cladding damage was observed. Vinyl siding failed more frequently, typically in small lengths. Fascia damage was common. Conversations with multiple homeowners revealed no significant water ingress through the building envelope, even to homes with soffit damage (Fig. 38).

Figure 36: Surge high water mark (72") in Port St. Joe.

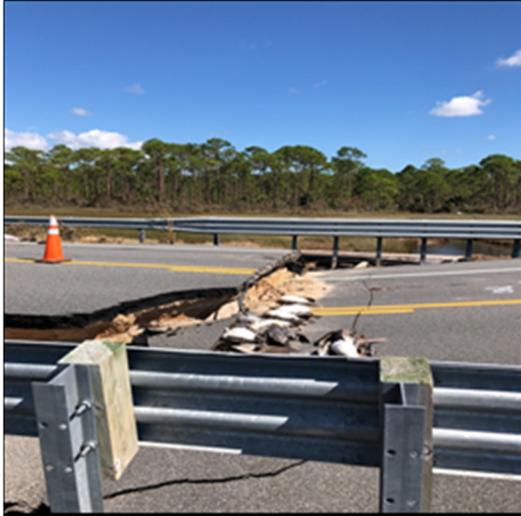
Figure 37: Surge-induced bridge failure on 30A South of Port St. Joe: (a) buckled road surface; (b) scour at abutment support.

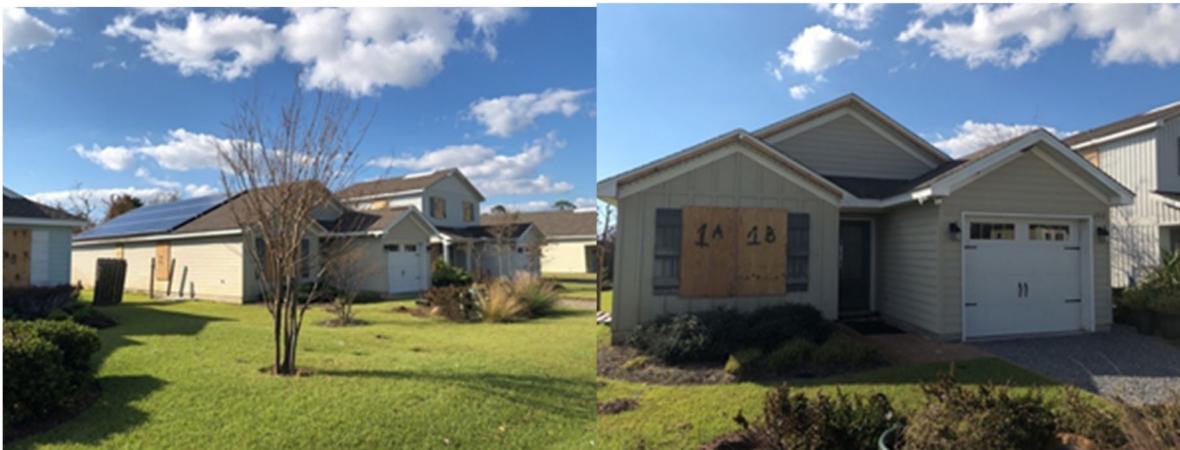
Figure 38: Residential structure in Port. St. Joe with solar panels intact (left) and minor vinyl soffit damage to front elevation (right), windows were covered with plywood.

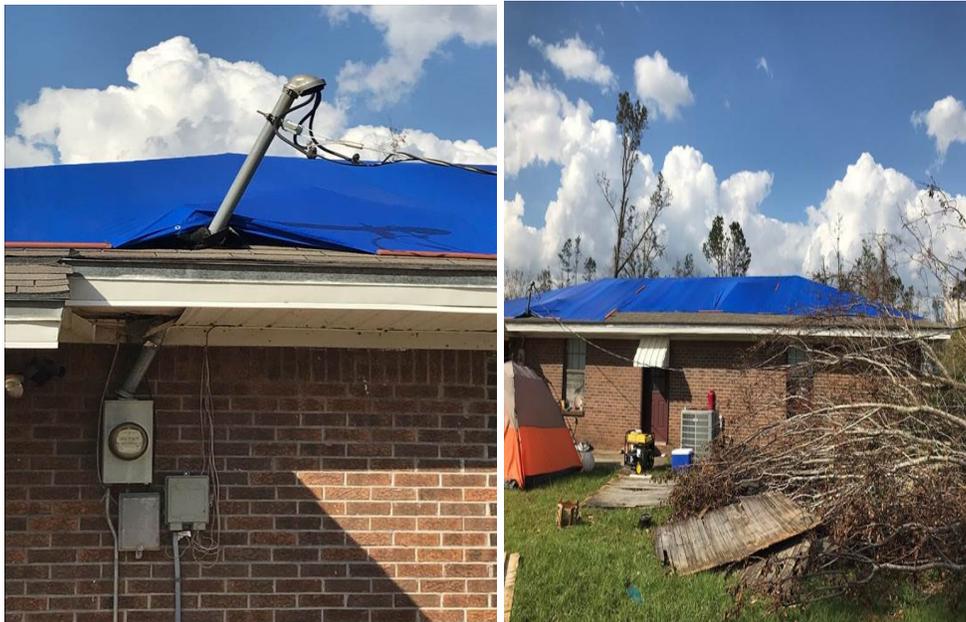
Figure 39: Damaged electricity conductor present in a building near Lambert Ave. in Blountstown.

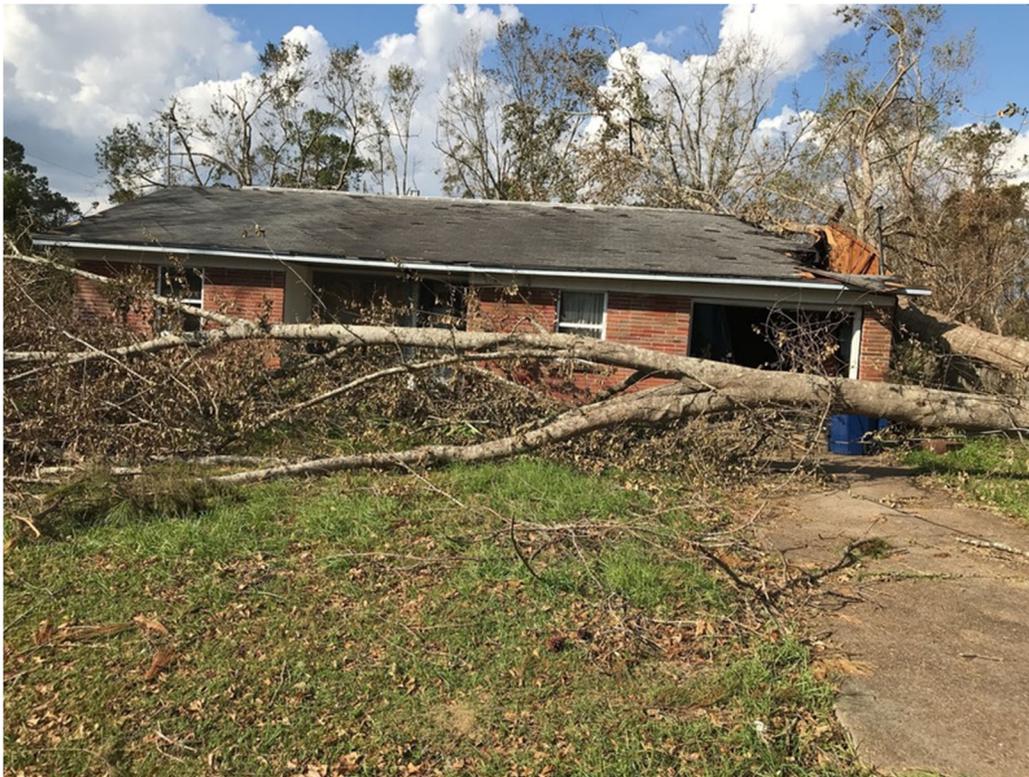
Figure 40: Residential building sustaining severe damage due to tree fall at NE Lambert St. in Blountstown.

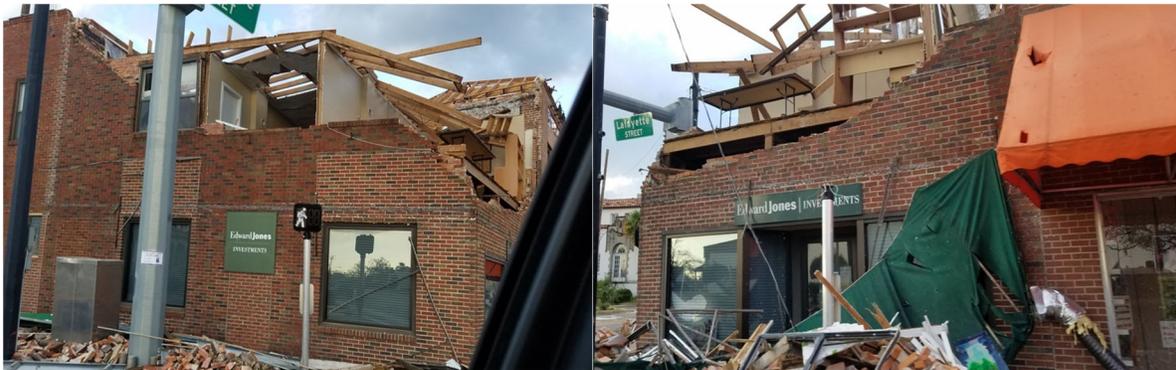
Figure 41: Commercial building (Edward Jones investments) with wall collapsed and roof structure damaged on Lafayette St. in Marianna.

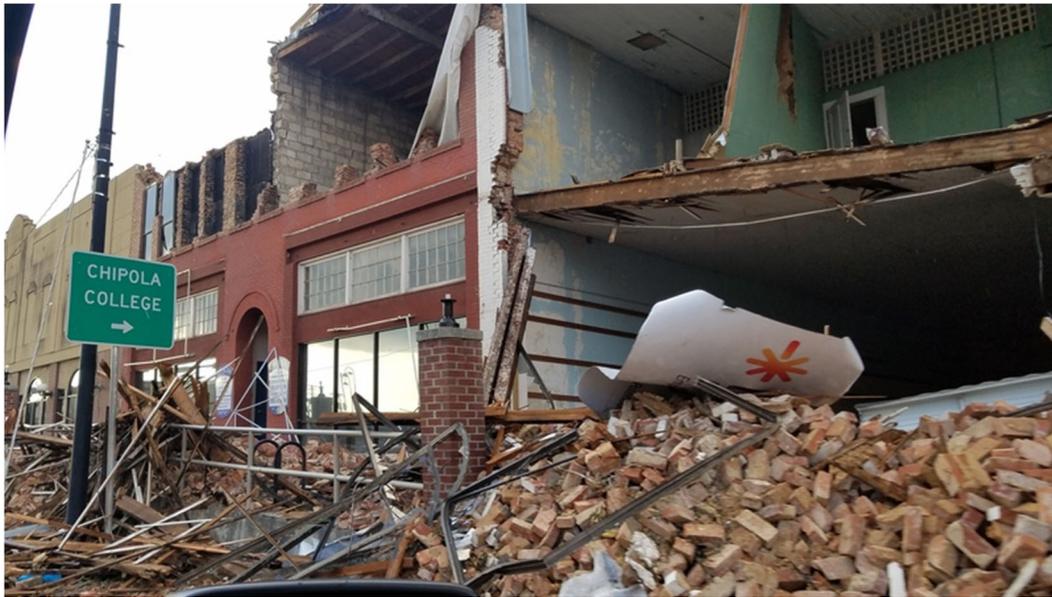
Figure 42: Commercial buildings with masonry walls collapsed and roof structure damage on Lafayette St. in Marianna.

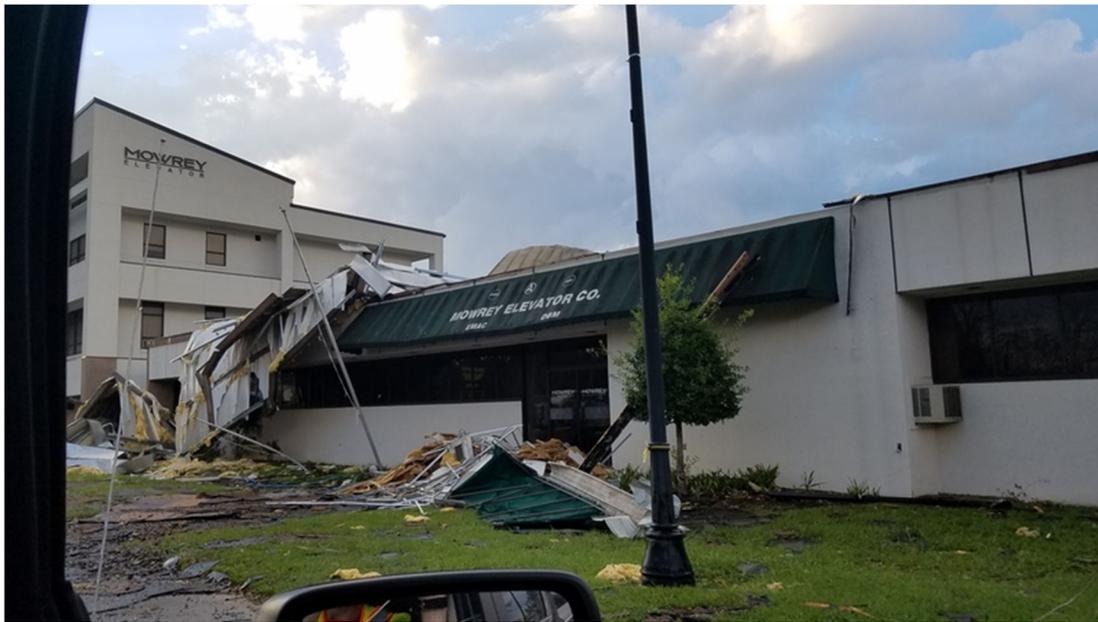
Figure 43. Commercial building (Mowrey Elevators) sustaining severe roof damage on Lafayette St. in Marianna.

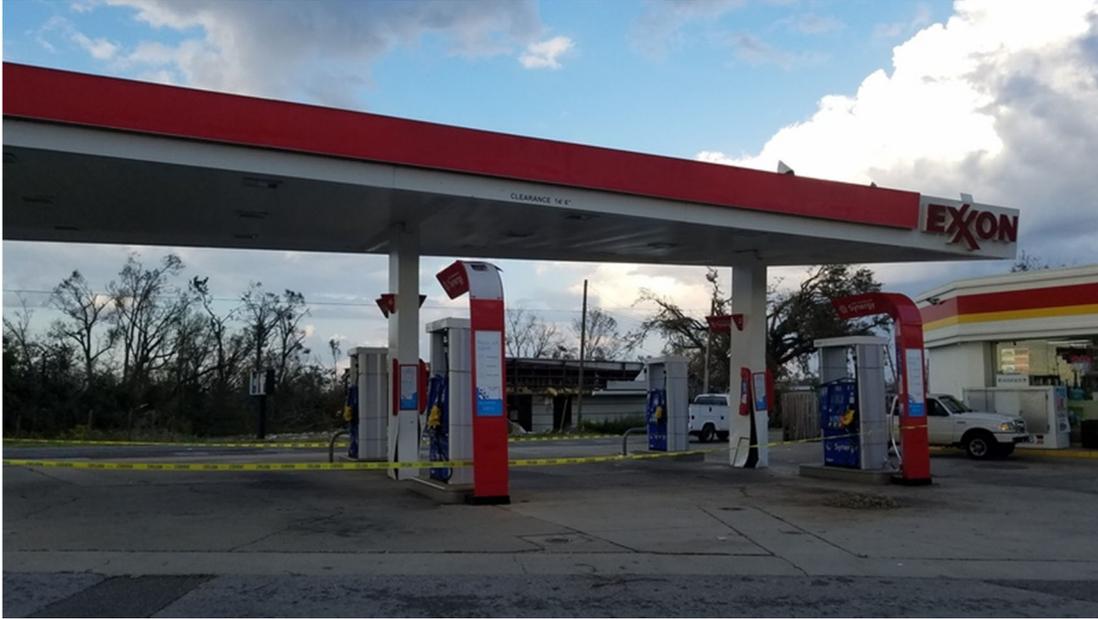
Figure 44: Exxon station sustaining column and roof damage at US 90 in Marianna.

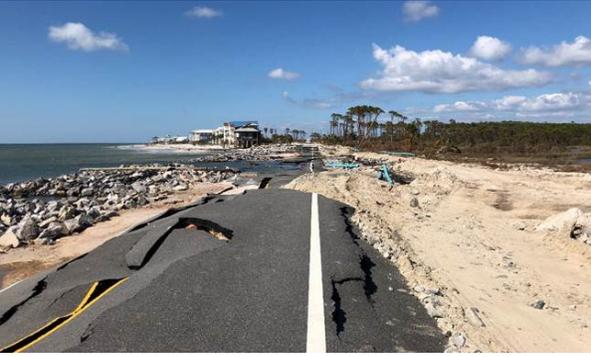
Figure 45: Road washout on Highway 30E (Cape San Blas Rd) on Saint Joseph Barrier Island (Latitude: 29.680619, Longitude: -85.366115).

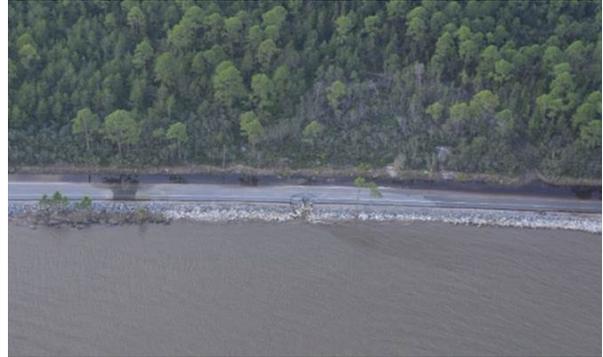
Figure 46: Road wash out US Hwy 98 (Big Bend Scenic Byway Coastal Trail) (Latitude: 29.772736, Longitude: -84.793465) (Source: [ESRI StoryMap](#)).

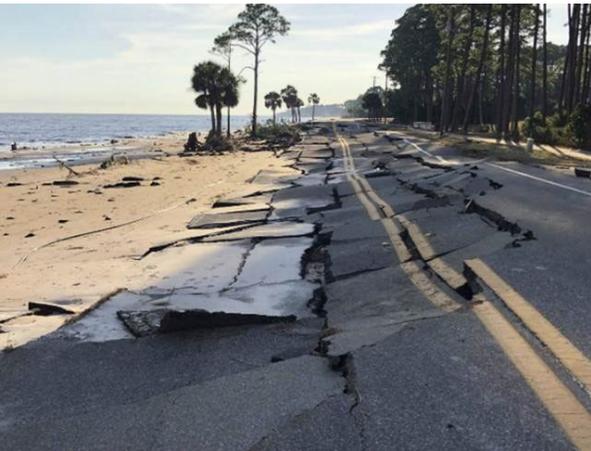
Figure 47: Road washout US Hwy 98 near Carrabelle (Latitude: 29.827057, Longitude: -84.696981) (Source: [ESRI StoryMap](#)).

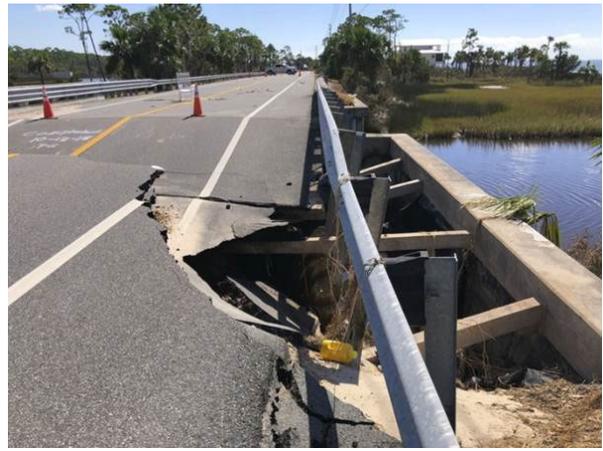
A majority of closures that were reported in the P-VAT report have been lifted as they constituted cautionary closures due to high winds or water or debris over the roadways/bridges. The remaining closures or loss of access are mostly due to sustained damage. The damage could be categorized as follows: damage to roadways due to raised water levels that resulted in washing out the subgrade (Figs. 45-47) or those due to high levels of storm surge (and potentially waves in some locations) that resulted in failure of bridges spans, approaches, and abutments (Fig. 48).

Figure 48: Bridge approach washout on Highway 30A Bridge near Saint Joseph Bay (Latitude: 29.754006, Longitude: -85.303750).

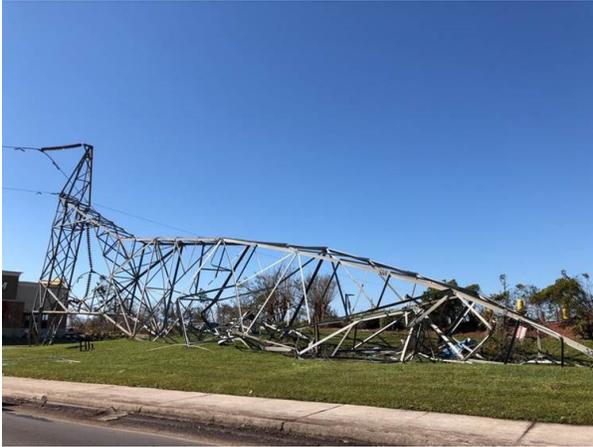
Most of the areas remain without the power, but utility crews are working to restore the power. The damage to the power infrastructure is observed at the level of transmission (high voltage) (Fig. 49), distribution poles (lower voltage), and also access points at individual housing locations. The damages observed seem to be a combination of the bending and shear failure at the base of the poles (Fig. 50), or snapping of the tip of the pole where the attachments are connected (Fig. 51). There are cases of one pole failure leading to a domino effect in multiple poles. Some of the failures may be as a result of not only the high winds but also the impact from flying debris from adjacent structures or fallen trees or branches of trees (Fig. 52). The damage to the transmission

Figure 49: Destroyed transmission tower near North Tyndall Parkway, Springfield (Latitude: 30.160519, Longitude: -85.591164).

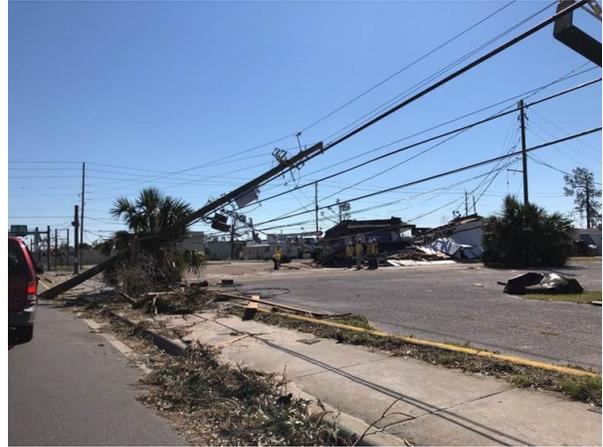
Figure 50: Damaged electric pole near West 15th St., Panama City (Latitude: 30.175136, Longitude: -85.663061).

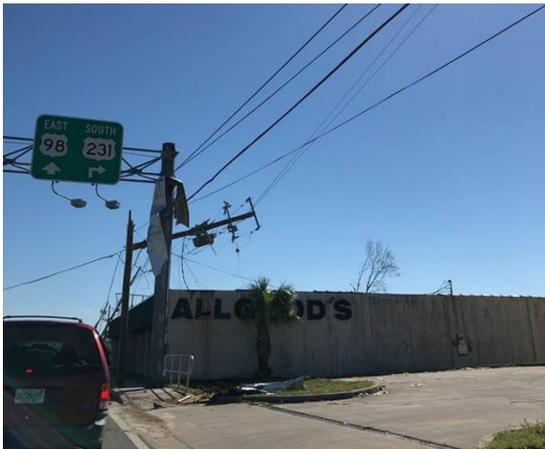
Figure 51: Damaged electric pole near West 15th St., Panama City (Latitude: 30.175136, Longitude: -85.663061).
