StEER: Structural Extreme Event Reconnaissance Network

HURRICANE MICHAEL: FIELD ASSESSMENT TEAM 1 (FAT-1) EARLY ACCESS RECONNAISSANCE REPORT (EARR)

Released: October 25, 2018
NHERI DesignSafe Project ID: PRJ-2111

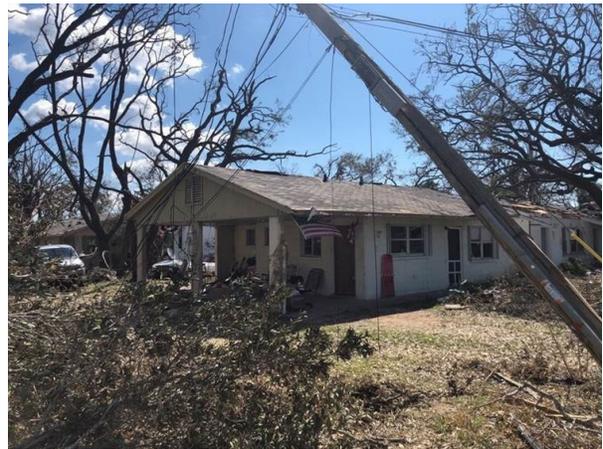
Figure 52: Damaged electric pole near Oakshore Dr., Parker (Latitude: 30.110311, Longitude: -85.60216) (Credit: Dean Ruark)
