Tornado Outbreak

May 10th, 2003

Damage Surveys

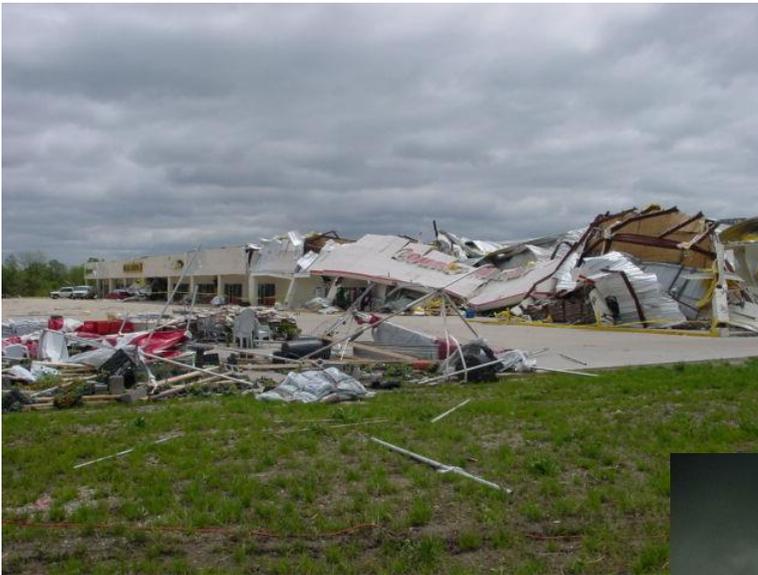
A strong tornado struck Canton, MO during the early evening hours on May 10, 2003. After leaving a path of destruction from near Ewing northeast to the intersection of Highway 61 and Highway P, the tornado entered the Canton area about 6:25 pm CDT. The area hit first was the County Market complex along the South Outer Road, McRoberts Road, and Oak Street. The tornado, at this point reaching high end F2 strength, collapsed the roof of the County Market, and severely damaged the roof and walls of the Comfort Inn. Virtually all the windows on the west and south side of the motel were also broken. Across Oak St. a home suffered serious damage losing its roof and one exterior wall. The tornado traveled northeast and moved across the campus of Culver-Stockton College. The College Field House roof was flattened by the tornado as it continued at F2 intensity. Just hours earlier, the Field House had been full of people attending the graduation ceremony, but no one was there when the tornado hit. The entire roof and a small portion of an upper wall was blown off a brick fraternity house on the campus near the Field House. Other campus buildings suffered roof damage and broken windows. Numerous very large trees on campus were uprooted or mangled by the tornado. The tornado moved northeast into the main residential area of Canton next, where it weakened a bit to F1 intensity. Numerous trees were topped by the tornado, power lines downed, roofs damaged, and garages seriously damaged. Near the intersection of College St. and N 8th St., the tornado turned more north-northeast. Near Henderson and N 8th St., the tornado again reached F2 intensity. At least 8 homes suffered major roof damage and some wall damage. The tornado did its final damage in the mobile home park on the north end of town near Kimberly Drive and Business 61. Two mobile homes were smashed by the tornado and with about 6 others suffering major damage.

Tornado Damage to County Market in Canton, MO

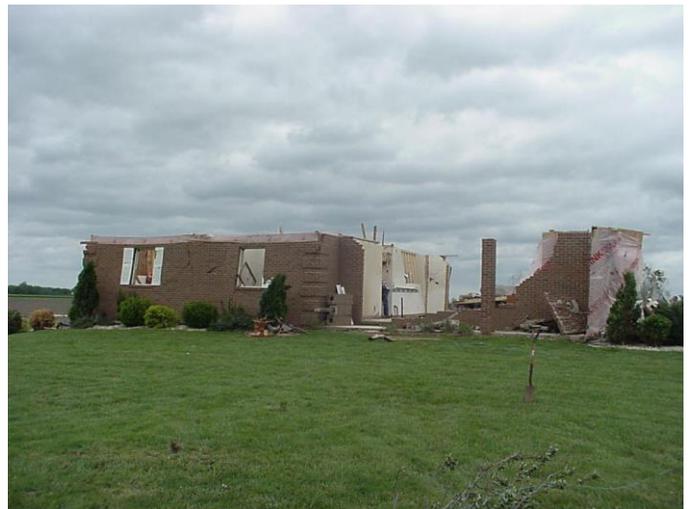
The tornado traveled northeast into far southern Marion County approximately one mile north of the small community of Ely Missouri (or 8 mile northeast of Monroe City). Three farmsteads sustained varying degrees of damage including damage or destroyed machine sheds, grain bins, and barns. The garage attached to a home one mile north of Ely was completely destroyed while the farm house sustained roof and side damage and was moved off its foundation. A relatively new home 200 yards to the east experienced severe damage with the roof of the home tossed over 1/3 mile to the northeast. Much of the south, and parts of the east and west walls of the home were destroyed. A nearby barn located 30 yards to the northwest was completely destroyed with debris tossed 1/4 mile to the north-northeast. Several two-by-four wood planks were driven into the ground at 45 to 60 degree angles into the ground and located 50 to as much as 150 yards downwind from the home. The damage intensity over these areas were rated high-end F2 and low-end F3. The width of the damage area was over 200 yards.

Tornado Damage to brick home in Ely, Missouri
