Burlington VT

MONTHLY REPORT OF HYDROLOGIC CONDITIONS

REPORT FOR:
MONTH YEAR
May 2013

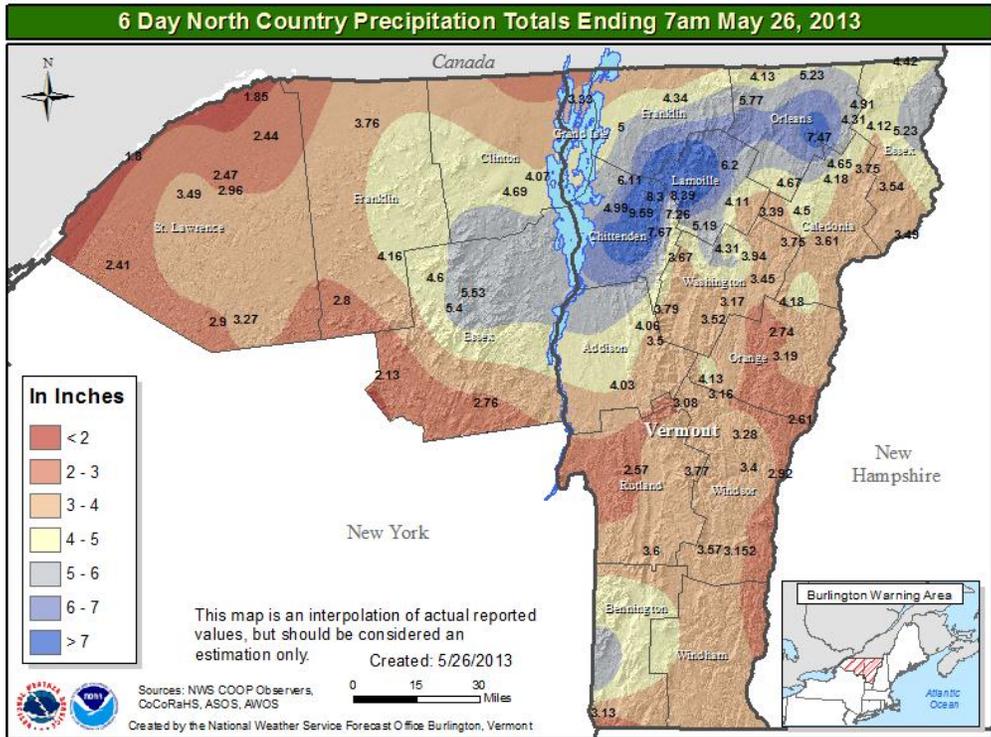
Figure 1. 6-day precipitation totals ending 7am, 26 May, 2013. Note the excessive totals across portions of Chittenden, Lamoille and Orleans counties in Vermont. Nearly half of this rainfall occurred during a 3 to 5 hour period on the evening of 23 May, 2013.

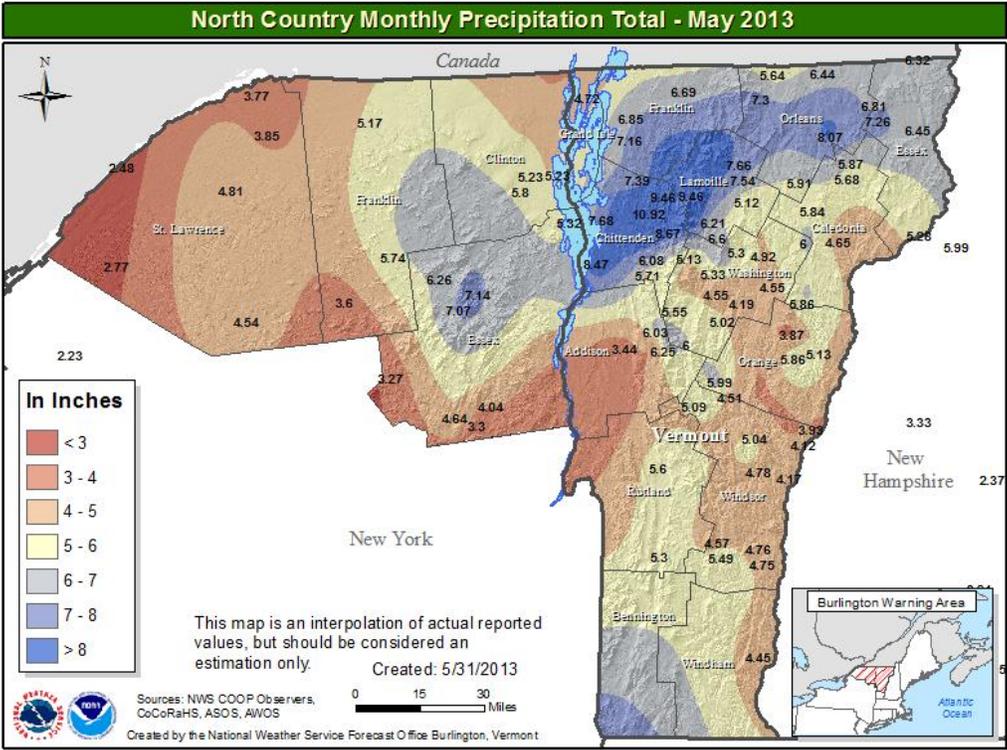
Figure 2. Precipitation totals for the Burlington HSA for May 2013. Most of this rainfall occurred during the last 10 days of the month as the existent long-term dry pattern was quickly erased.

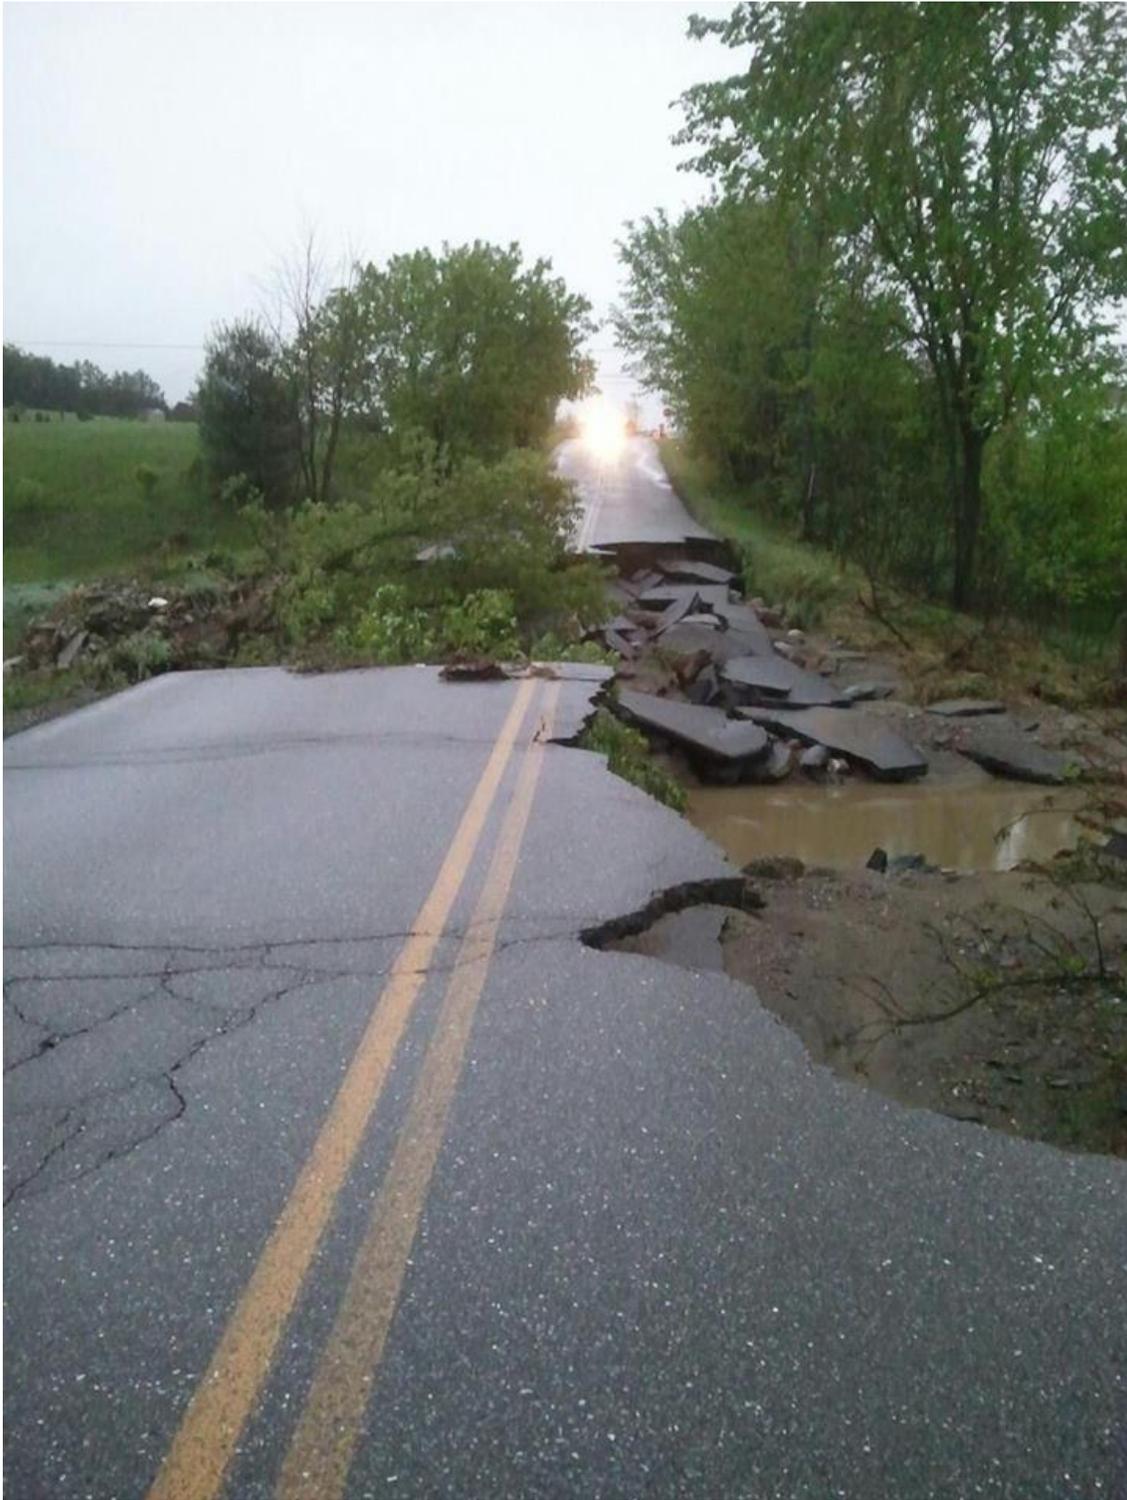
Figure 3. One of the numerous road washouts (approx. 20-30) across eastern Chittenden and western Lamoille counties during flash flooding on the evening of 23 May, 2013.

By the 18th into the 20th signs of a major pattern change became evident as synoptic flow trended more southerly allowing moisture-laden air to push northward into the region. At the same time a semi-stationary frontal boundary became established in the area providing the focus for widespread convective rainfall. While moderate to locally heavy totals of 1 to 3 inches on the 21st and 22nd were initially beneficial given the antecedent dry conditions, the potential for additional heavy rainfall continued to exist. As a result, a Flash Flood Watch was issued on the morning of the 23rd. This proved the correct decision as during the evening of the 23rd training thunderstorms dropped excessive totals across portions of Chittenden and Lamoille counties in Vermont. Flash flood warnings were promptly issued for these areas where additional amounts of 2 to as much as 4 inches fell leading to numerous reports of road washouts along with local evacuations and isolated home damage.

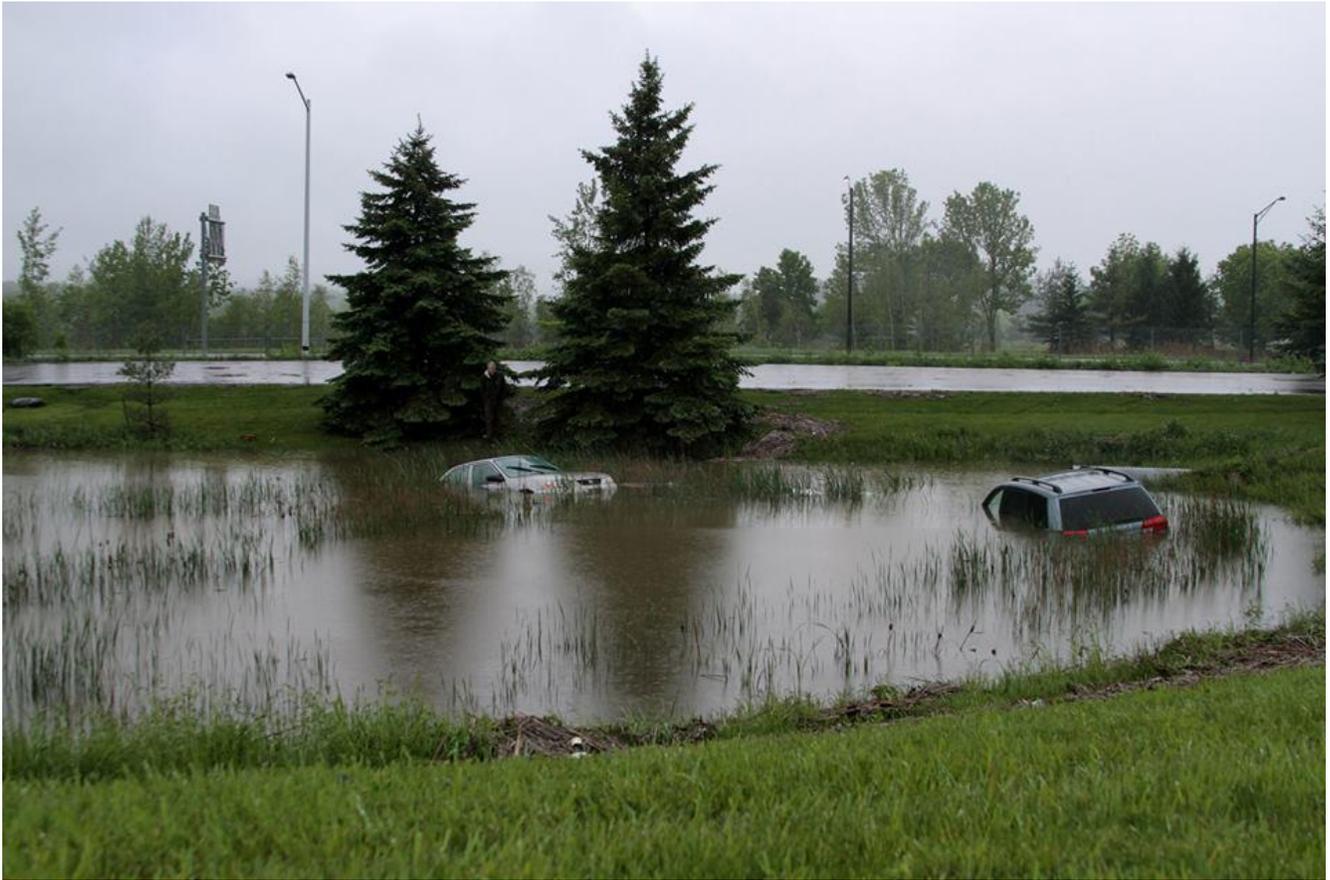
Figure 4. Two vehicles which drove into a small drainage pond in Essex, VT during the flash flooding event of 23 May, 2013. The pond had been concealed by high water. An elderly woman was rescued from the vehicle on the left.
