<b>NWS Form E-5</b> (04-2006) (PRES. BY NWS Instruction 10-924)	U.S. DEPARTMENT OF COMMERCE NATIONAL OCEANIC AND ATMOSPHERIC ADMINISTRATION NATIONAL WEATHER SERVICE HYDROLOGIC SERVICE AREA (HSA) Burlington VT
<b>MONTHLY REPORT OF HYDROLOGIC CONDITIONS</b>	REPORT FOR: MONTH                      YEAR August                      2023
TO: Hydrologic Information Center, W/OS31 NOAA's National Weather Service 1325 East West Highway Silver Spring, MD 20910-3283	SIGNATURE /s/ John Goff, Senior Service Hydrologist DATE October 9, 2023

### **Addison/Rutland County flash flooding of August 3-4, 2023**

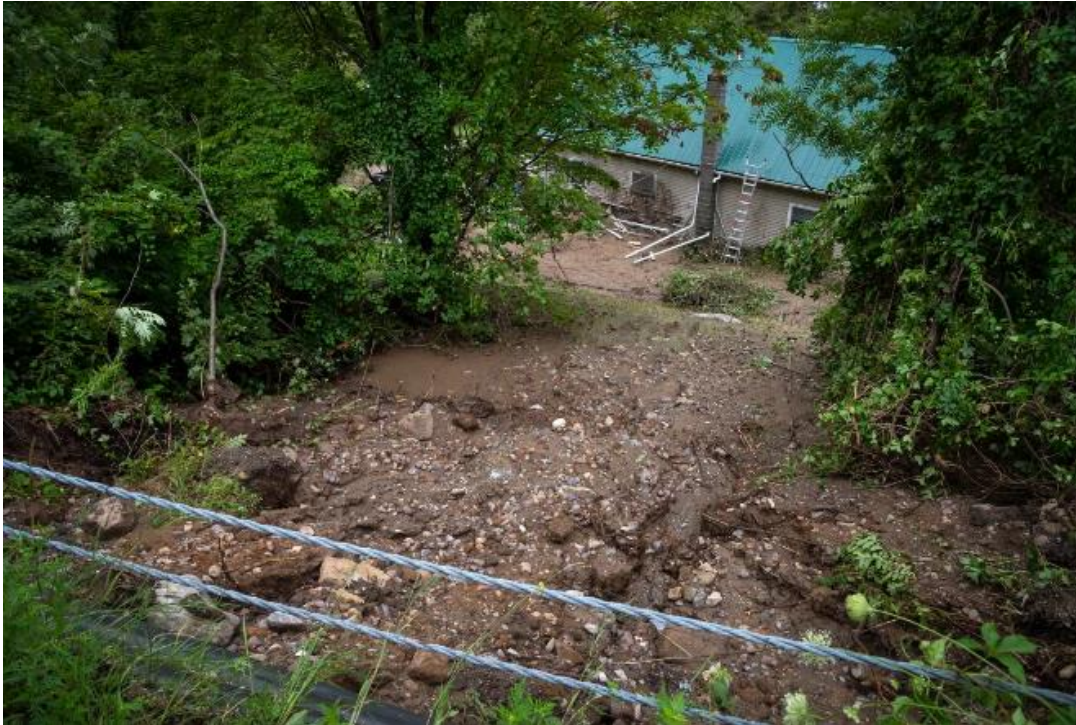
Figure 6: A landslide affects the backyard of a home in Middlebury, VT on the evening of August 3, 2023. Photo courtesy VT Digger.

During the late afternoon and evening hours of August 3, 2023 a training band of showers and thunderstorms evolved across portions of Essex County, NY eastward into central Addison County, VT. The storms formed in a weak wind flow regime and deep moisture pooling well south of any significant synoptic scale weather features. Over a period of 3 to 4 hours, tremendous amounts of rain fell from this band on the order of three to six inches. The heaviest totals were unfortunately centered over Middlebury, VT, the county seat and largest town within the county. This led to severe flash flooding in the town and immediate surrounding countryside, with numerous road washouts, damage to infrastructure and several swift water rescues reported (Figs. 4-6).

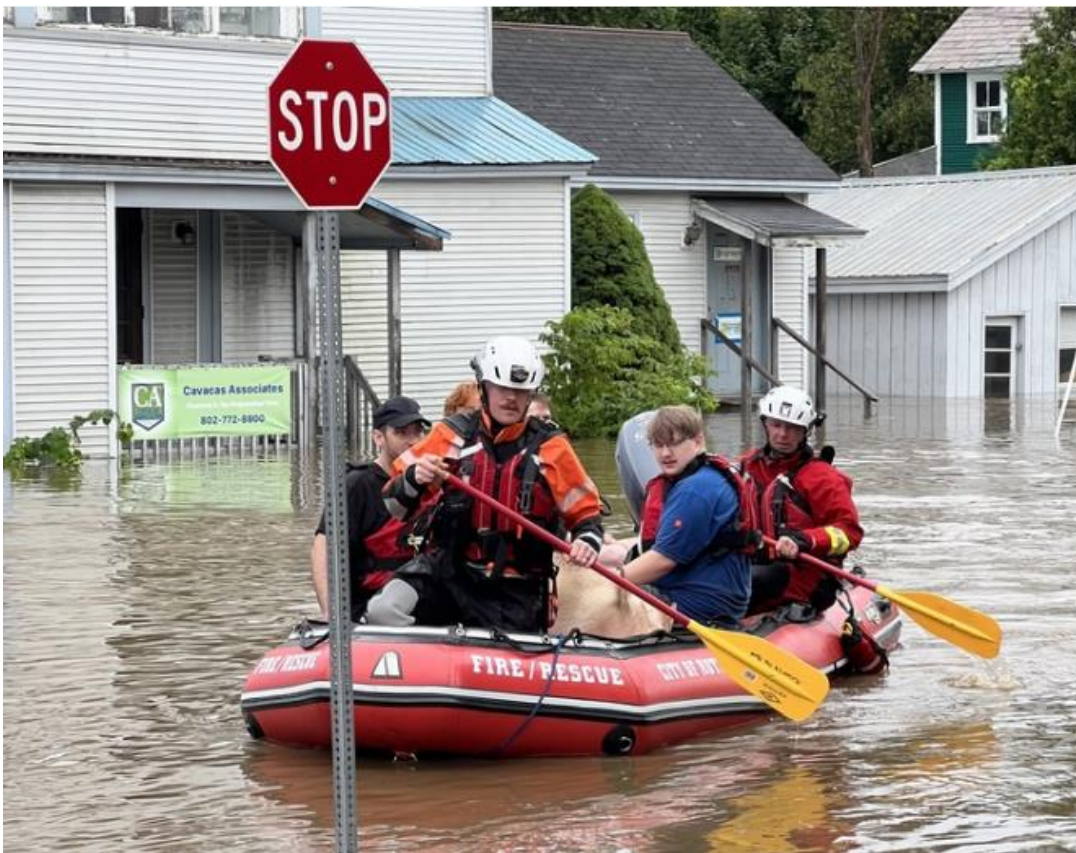
Figure 7: A swift water rescue team evacuates affected homeowners on Clover St. in the City of Rutland on the evening of August 4, 2023. Photo courtesy Michael Talbott.

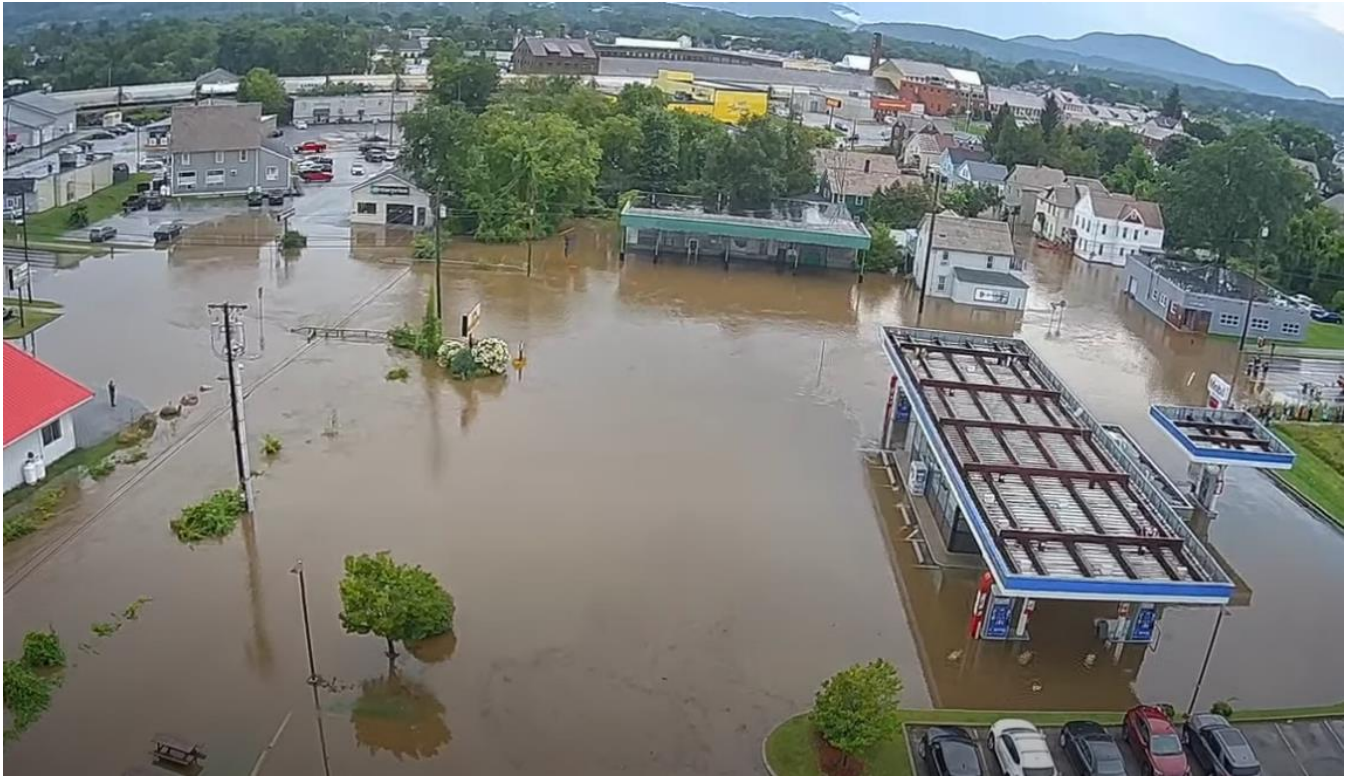
**Figure 8: Aerial imagery from Rutland, VT on the evening of August 4, 2023 showing flash flooding affecting areas near Clover St. in the southern portions of the city.**

By the next evening, a similar rinse-and repeat of training storms developed across Rutland County, immediately south of Addison County. These storms uncannily were focused on the City of Rutland, Vermont's third largest city with numerous reports of flash flooding received. While the severity of the flash floods were slightly lesser in magnitude than in Addison County the prior evening, numerous road closures occurred. The area along Clover St. near the Moon Brook was particularly hard hit with homes impacted by high water leading to several swift water rescues (Figs. 7-8).
