Tornado Outbreak Over Southwest Illinois

May 24th, 2006

Overview

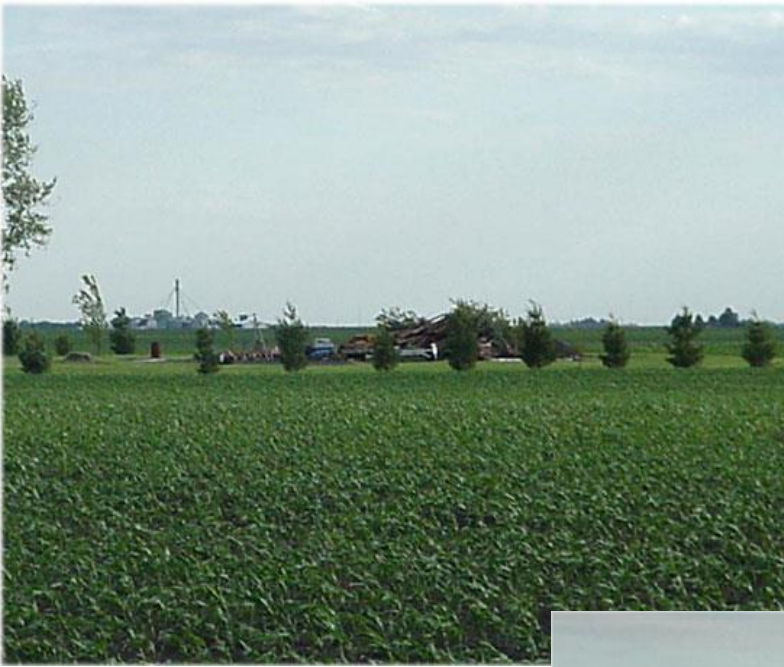
Machine shed destroyed near the intersection of county roads 3100N & 800E in northern Montgomery County IL. Viewing southwest.

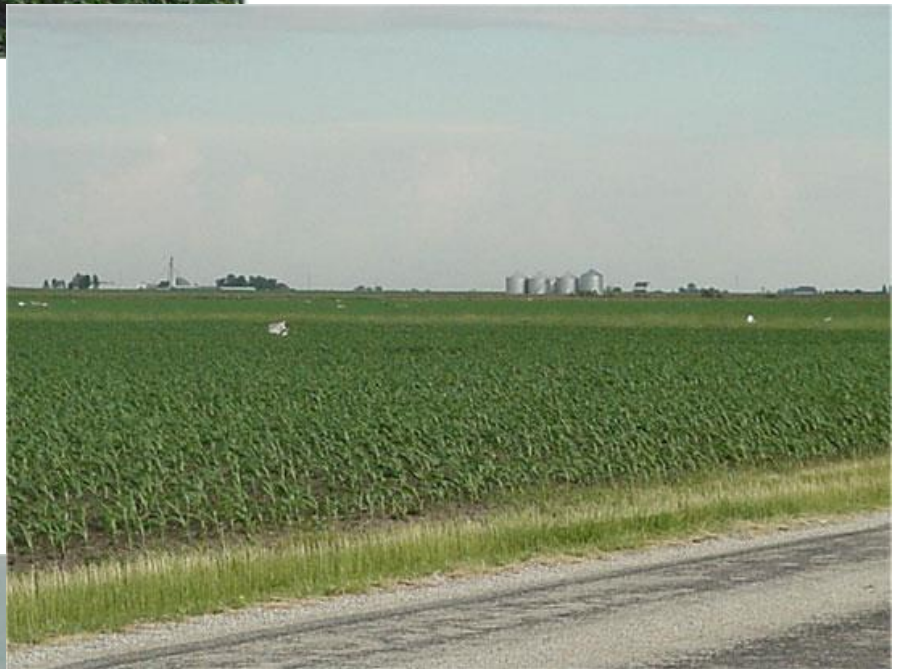
Debris from the machine shed scattered over an open corn field. Viewing southeast.

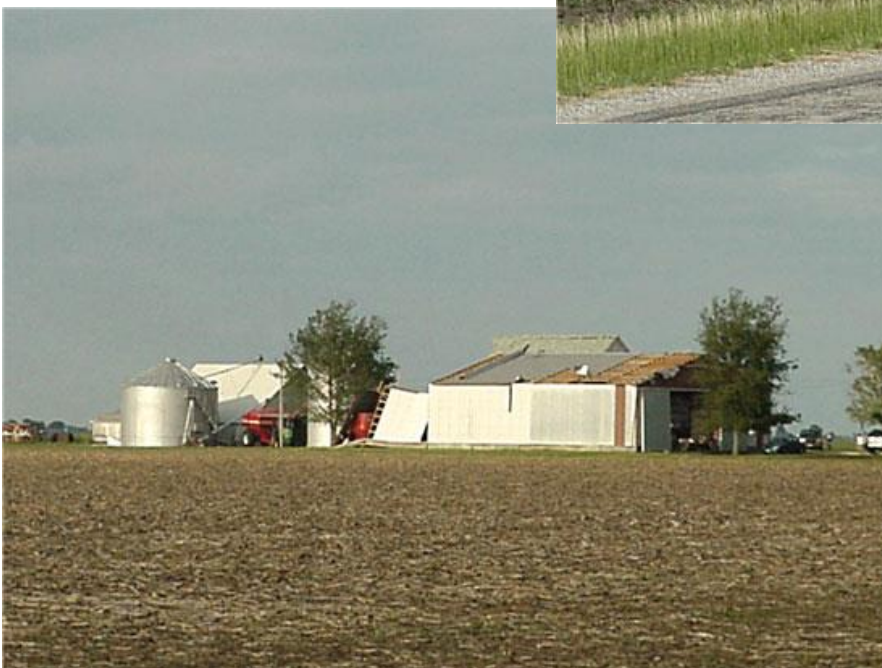
Second machine shed damaged by the tornado. The nearby farm home also sustained roof and window damage. Viewing northeast.

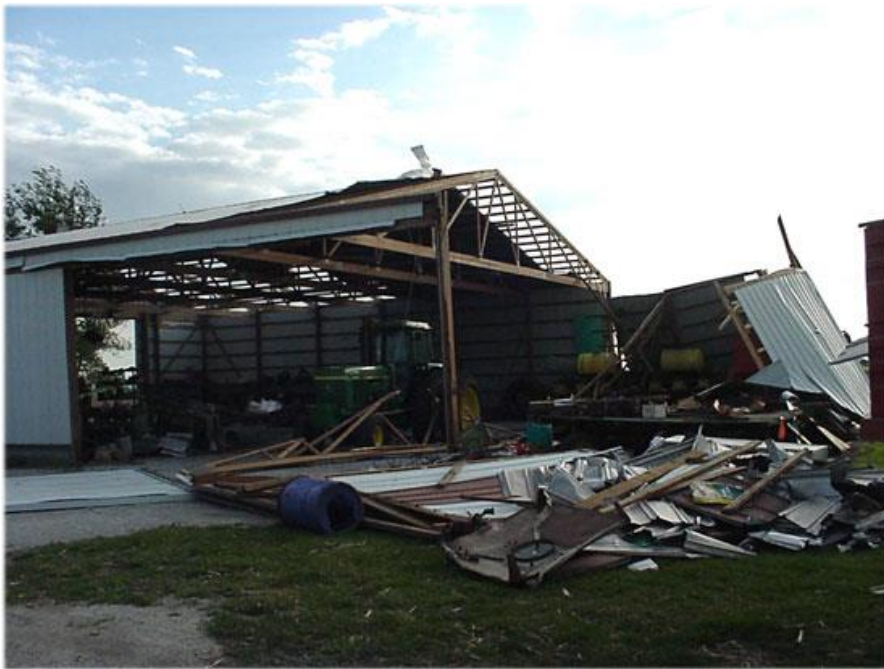
Northern part of the machine shed. Debris from the machine shed was tossed several hundred feet to the southeast. Viewing southwest.

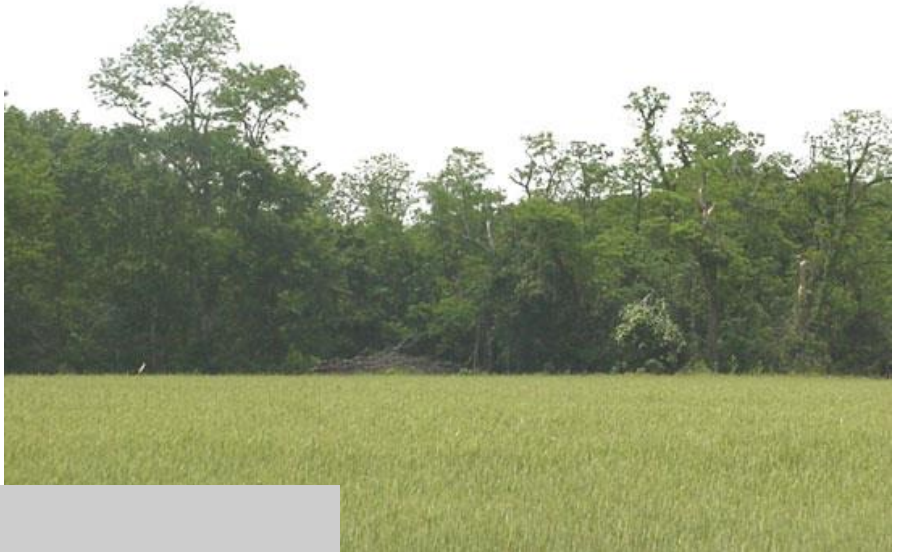
Several medium to large trees were snapped about half way up a third of a mile south of the intersection of Red Ball Trail and Hastings Cemetery Road in northern Bond County Illinois, viewing west.

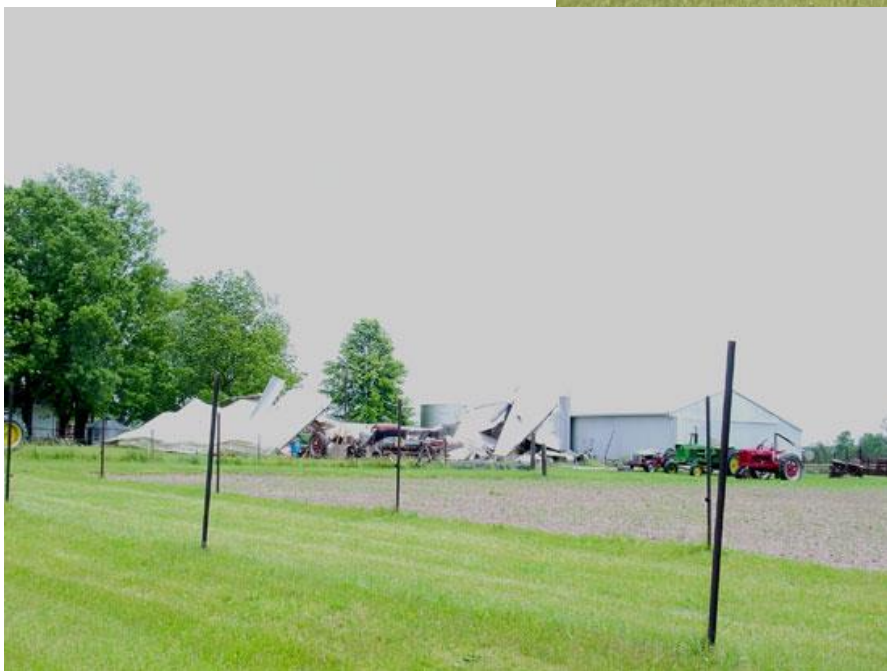
A machine shed on Hastings Cemetery Road was destroyed on this farm by the first tornado. Debris from the machine shed was tossed to the east-southeast. Viewing east-southeast. Much of the damage associated with the three weak tornadoes was tree damage.

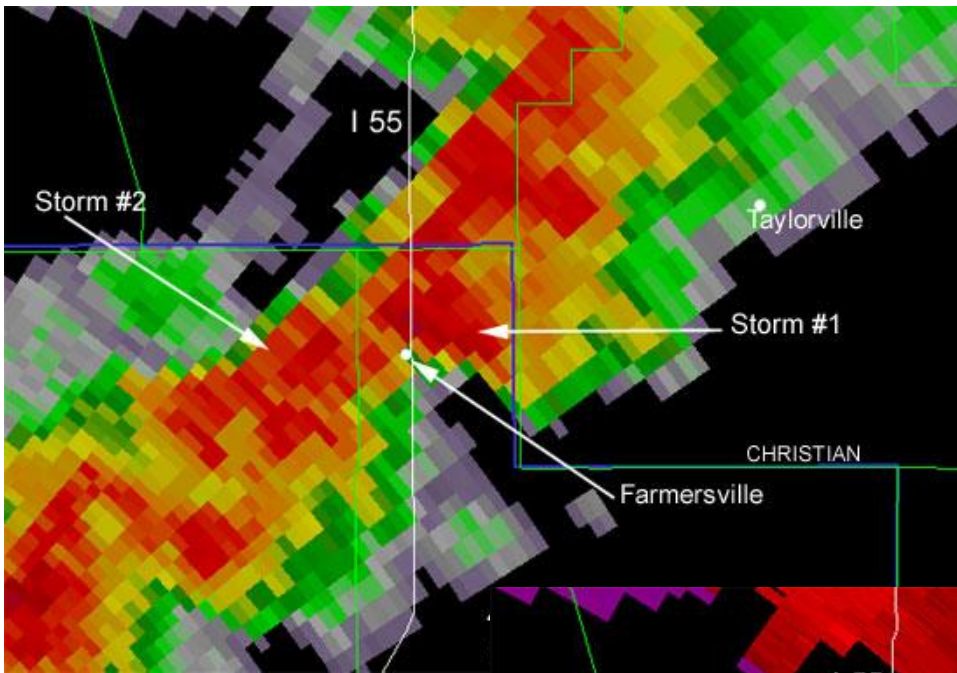
Reflectivity image from WSR-88D (St. Louis - KLSX) at 0.5 degree elevation slice at 4:01 PM CDT. Storm 2 accelerates eastward and eventually merges along the western side of a small supercell (Storm 1) over northern Macoupin County.

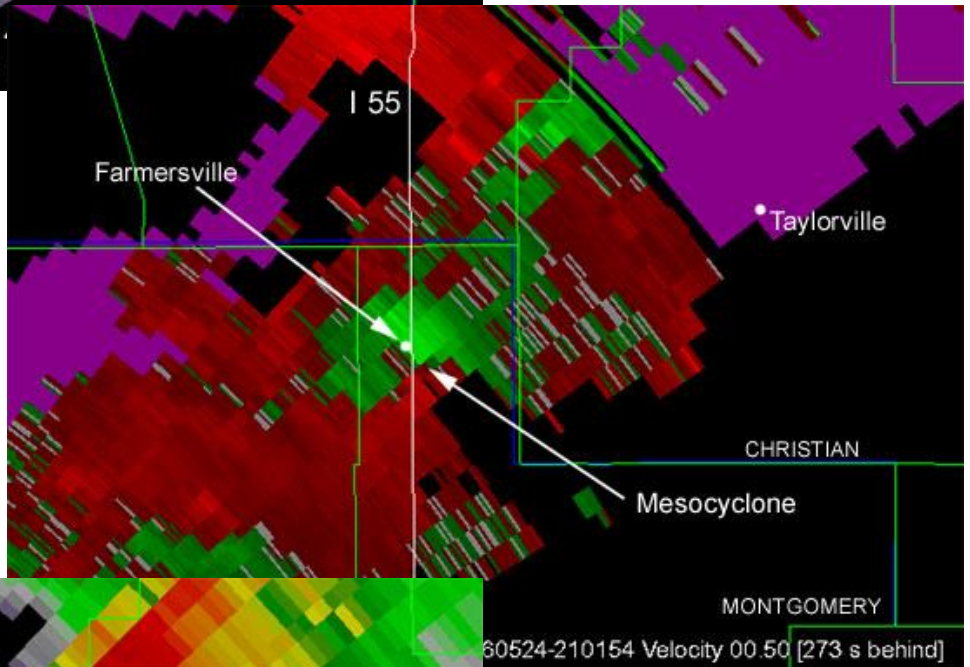
Storm-relative velocity image from KLSX at the same time (4:01 PM CDT). A moderate intensity mesocyclone is associated with the small supercell.

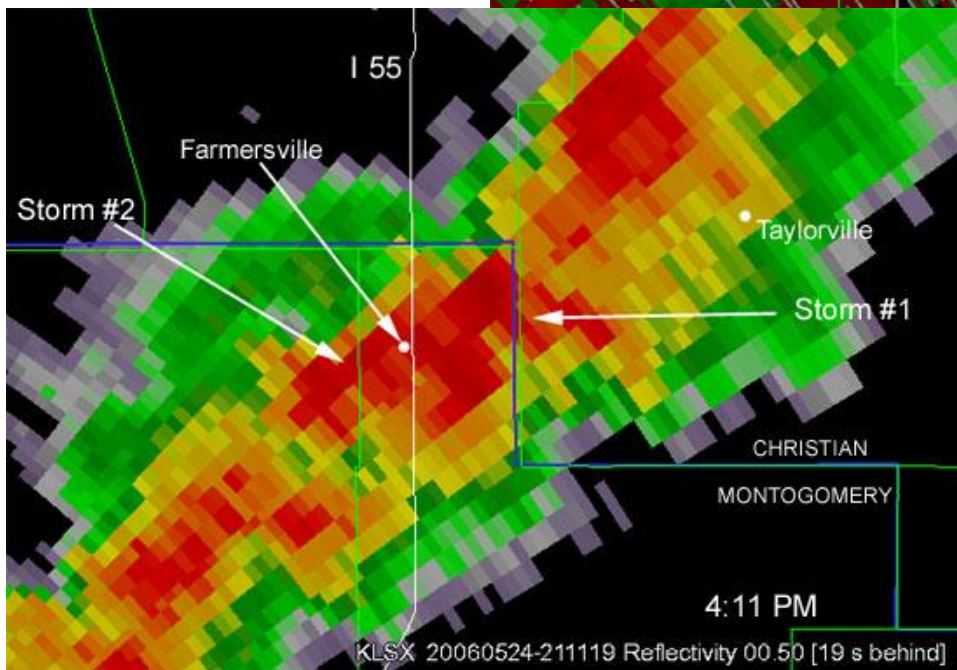
Reflectivity image from KLSX at 0.5 degree elevation slice at 4:11 PM (ten minutes later). Merger is nearly complete between the small supercell and the eastward accelerated storm within the line.

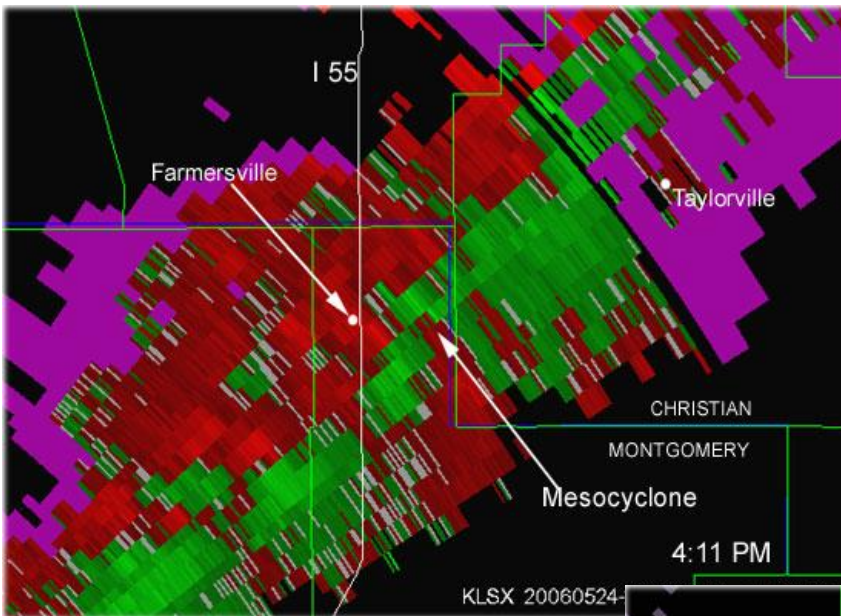
Storm-relative velocity image from KLSX at the same time (4:11 PM CDT). The mesocyclone weakens at this time. The tornado initially touched down at approximately 4:05 PM CDT.

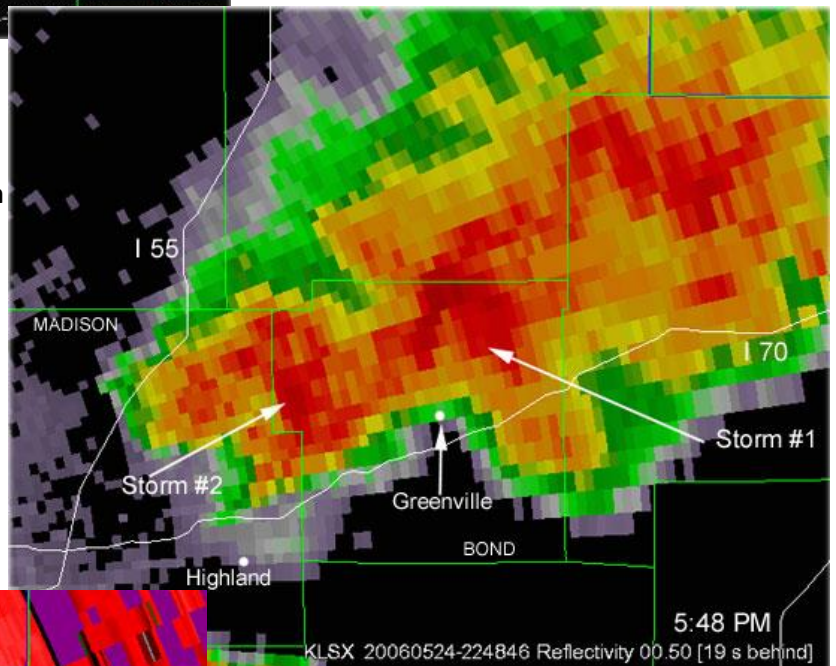
Reflectivity image from KLSX (0.5 degree) at 5:48 PM CDT showing a High-Precipitation supercell (Storm 1) and a strong thunderstorm (Storm 2) upshear of the HP storm. Between 5:40 and 5:50 PM storm 2 accelerated eastward and merged on the western flank of the HP storm.

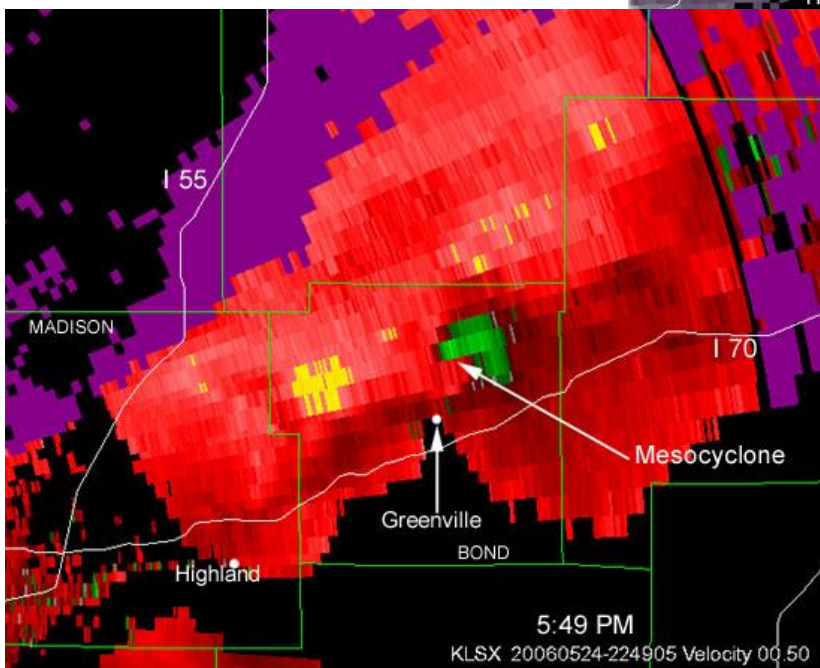
Storm-relative velocity data showing a strong mesocyclone associated with the HP storm. The three tornadoes occurred from 5:51 through 5:54 PM CDT.
