# Flash Flooding in St. Charles County

May 25<sup>th</sup>- 26<sup>th</sup>, 2008

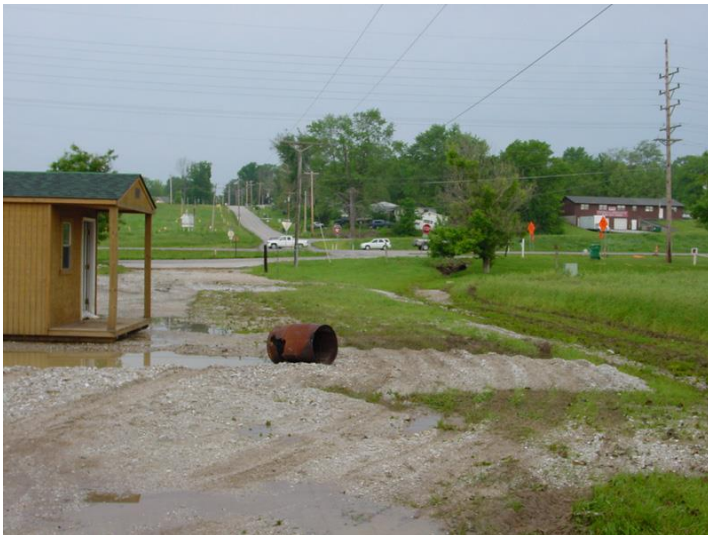
During the height of the flash flood, water poured down Peine Road (center) and over Highway 61 (left to right road), flowing into a ditch on the other side of the highway. The large shed in the foreground of the picture was picked up and moved several hundred feet down stream or in this case, down field.

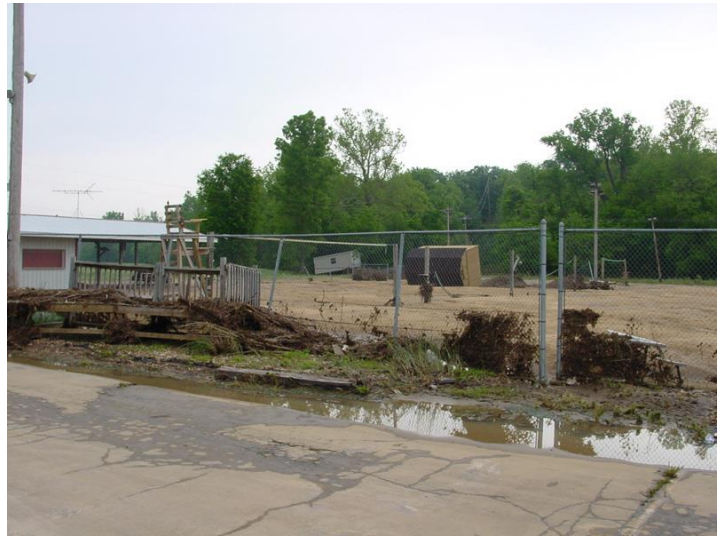
A sand volleyball court complex was severely damaged by flood waters. It is evident by the debris on the fence and sheds that are flipped over the power of the flash flood.

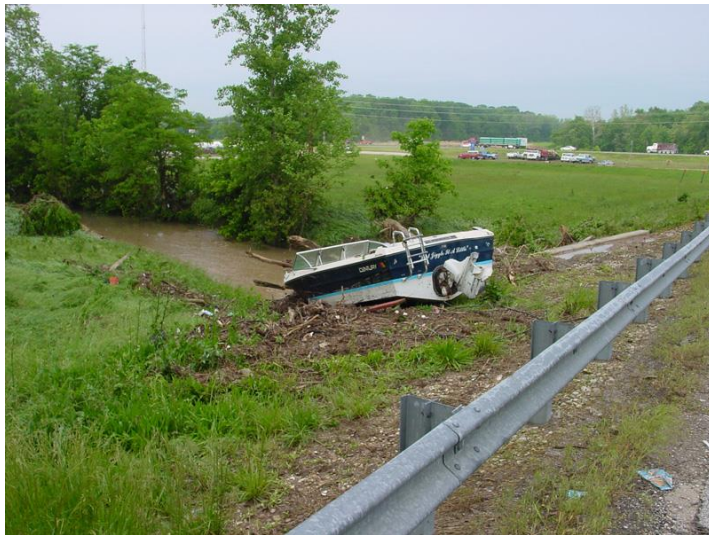
A boat that was picked up by the flood waters washed downstream and ended up alongside Highway P just east of US Highway 61.

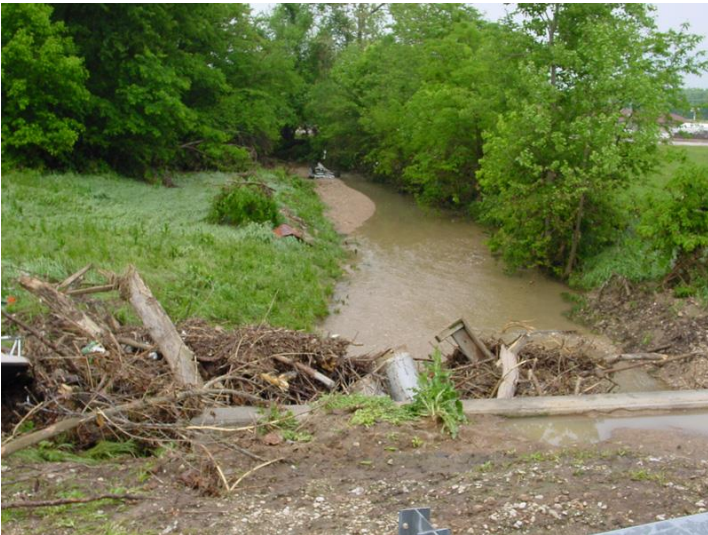
Often times debris, such as trees will clog up sewer pipes that go under roadways, resulting in pictures like this. This picture was taken from Highway P looking south or upstream. The trailer of the boat from picture #3 is located upstream within the creek bed.

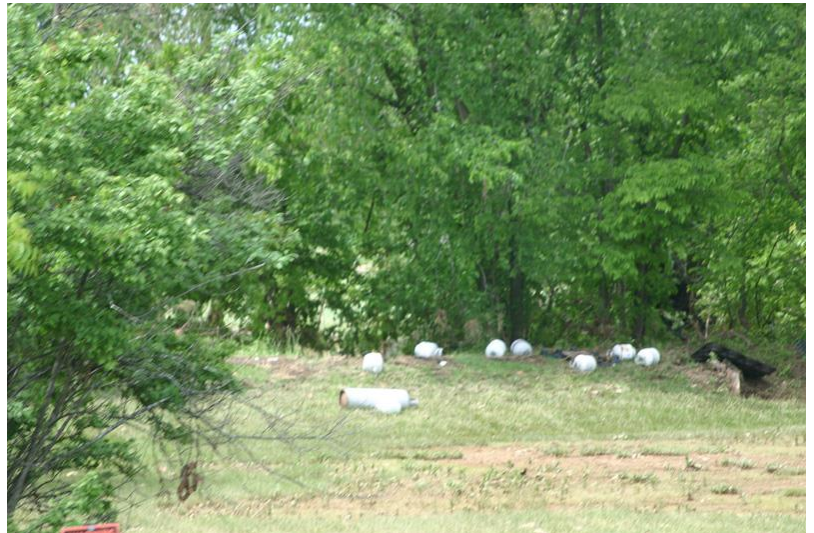
Small propane tanks from Amerigas were scattered throughout the creek bed up to a mile downstream.

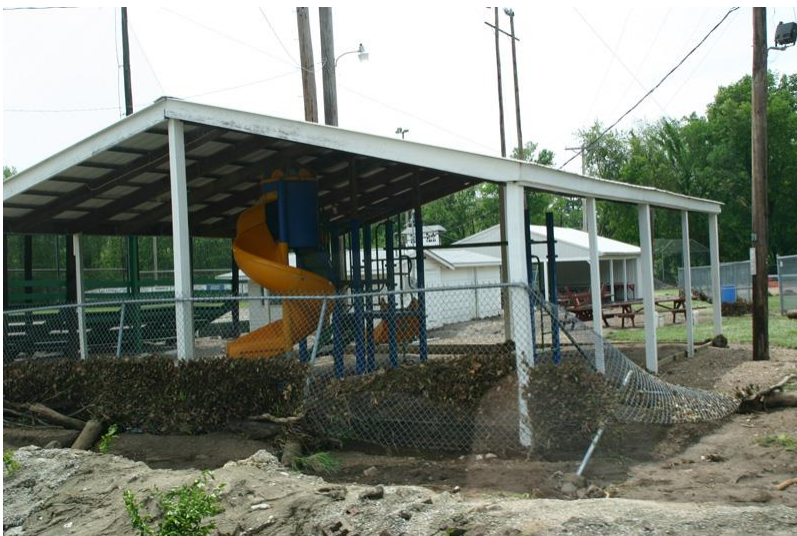
The Flint Hill baseball fields were heavily damaged by flood waters. The fast moving flood water at this location had to be nearly 3 feet deep, as evidence by the debris that was caught in the fence.

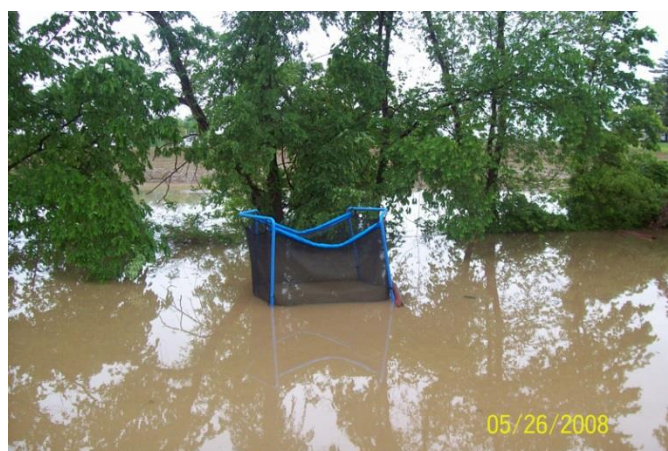
Peruque Creek, which flows from Lake St. Louis, flooded much of the area near the intersections of County Highway P, County Highway M, and US Highway 79.

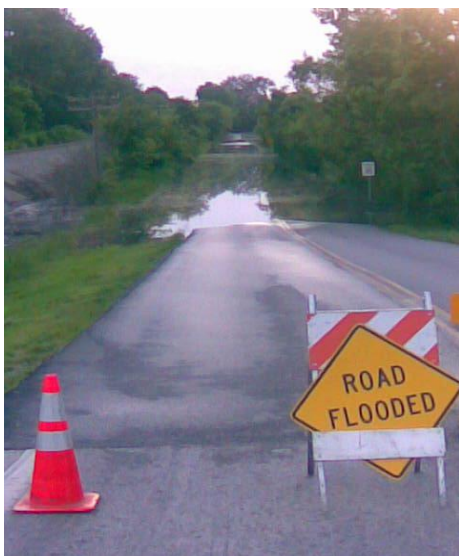
Dardenne Creek flooded low lying areas north of St. Peters, near County Highway C.

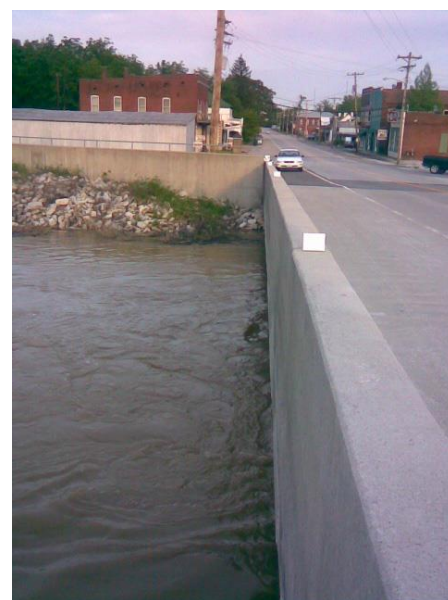
Dardenne Creek came within a few inches of the bottom of the bridge in "old downtown" St. Peters.
