Hydrologic Summary: IT'S BEEN A YEAR

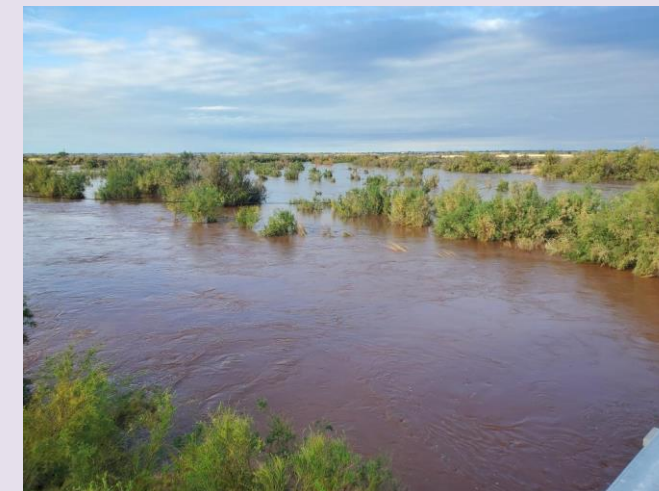
Deadly Flash Flooding

Composite Radar at 1pm MDT on 7/21/2022– at the height of the storm that resulted in 3 fatalities from a flash flood

On 7/21, heavy monsoon rains fell on the SW side of the Hermit's Peak/Calf Canyon Burn Scar. The Blue Haven Youth Camp and its associated properties were located near the headwaters of Tecolote Creek. The storm occurred under normal monsoon conditions for NM and would most likely have produced a flash flood with out any burn scar present. However, the hydrophobicity of the soils in the burn area drove a much stronger response to the rains producing catastrophic flash flooding and debris flow. ***This event claimed three lives.***

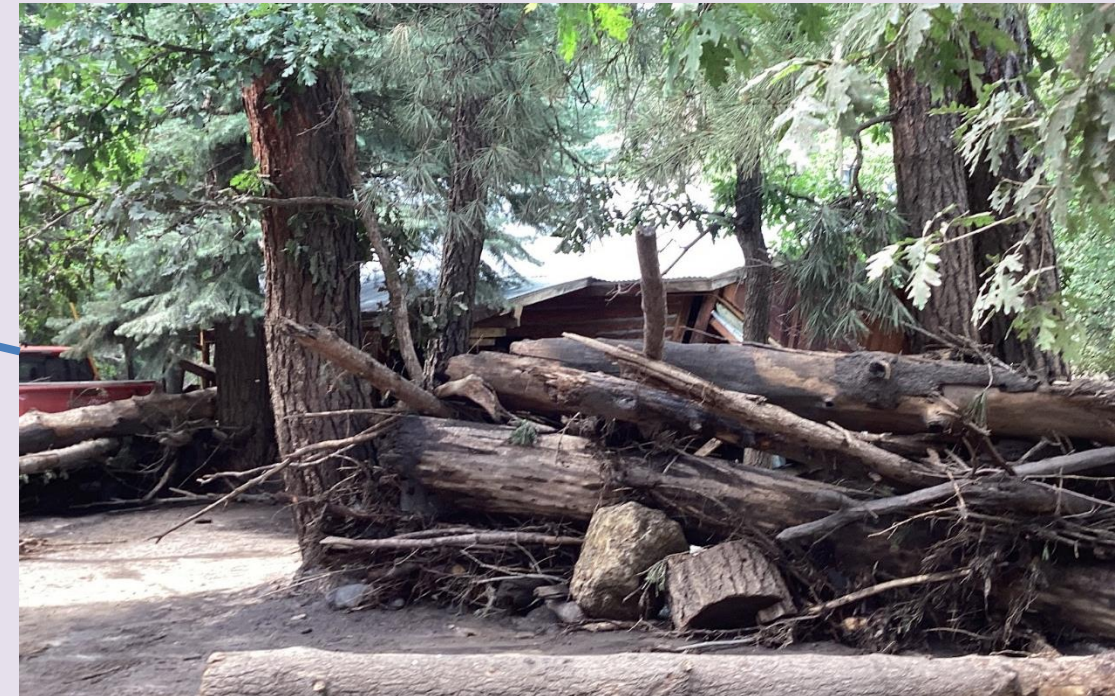
Damage surveys carried out two days after the storm showed the extent of destruction

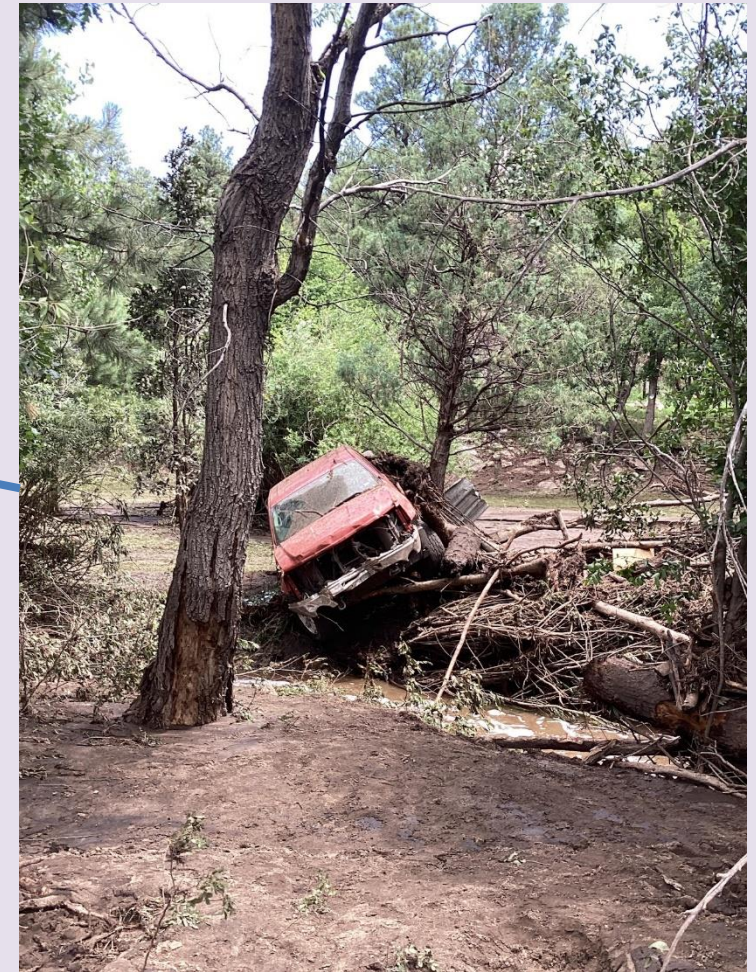
- Several cabins leased from the Blue Haven Youth Camp are located just upstream of the camp itself. These are seasonally occupied and were occupied at the time of the flood event.
- 1 cabin was completely destroyed, 2-3 others sustained some degree of damage.
- The cabin was leased by one of the women killed in the flooding event, though it is unclear if she and the other two fatalities, who were related to her, were in the cabin at the time of the flood.

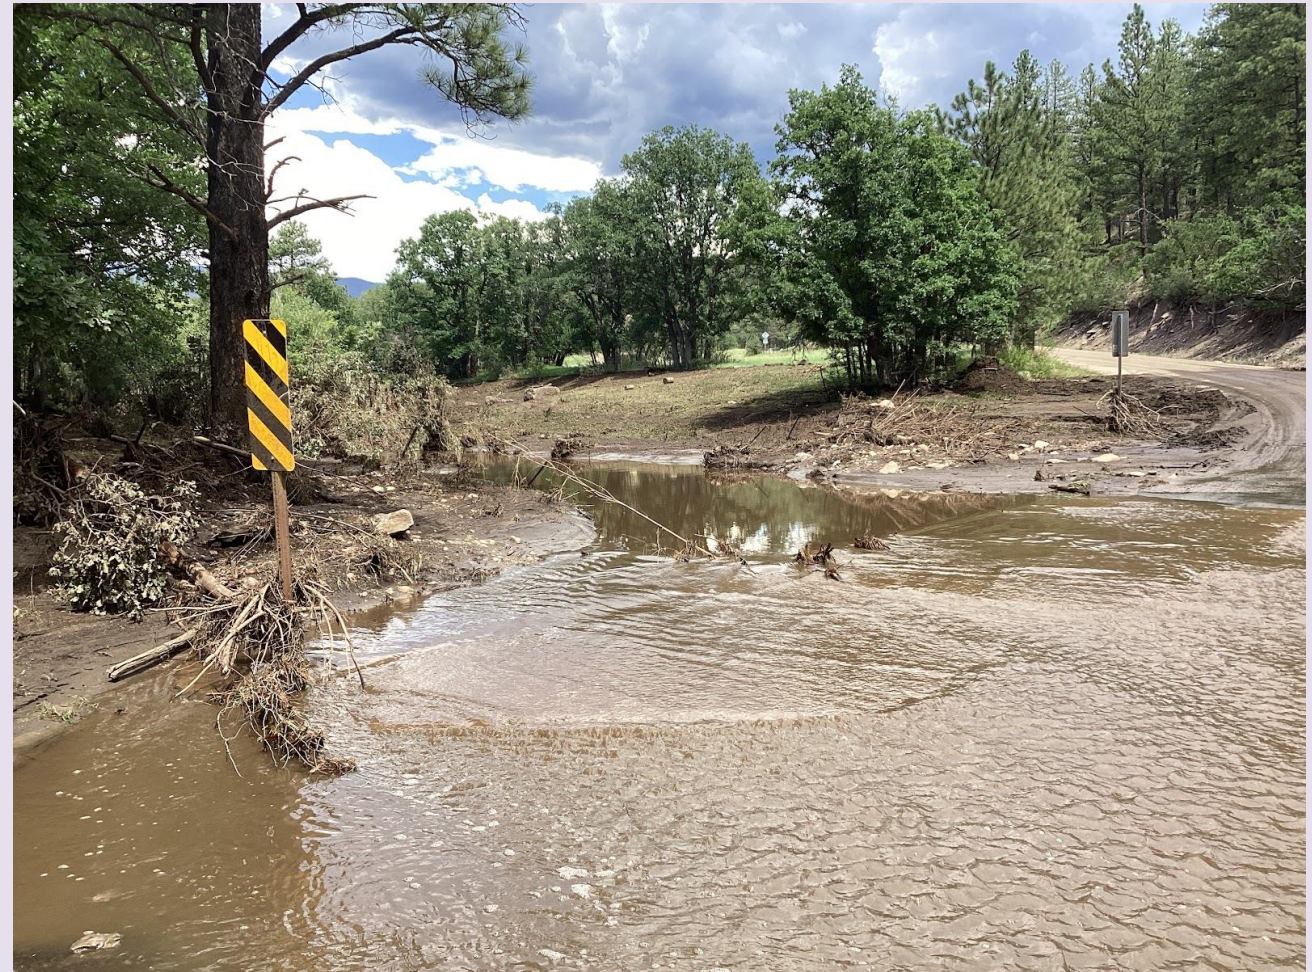
- At least two vehicles were washed away. One theory is that the three people killed were in one of these vehicles when the debris flow hit.

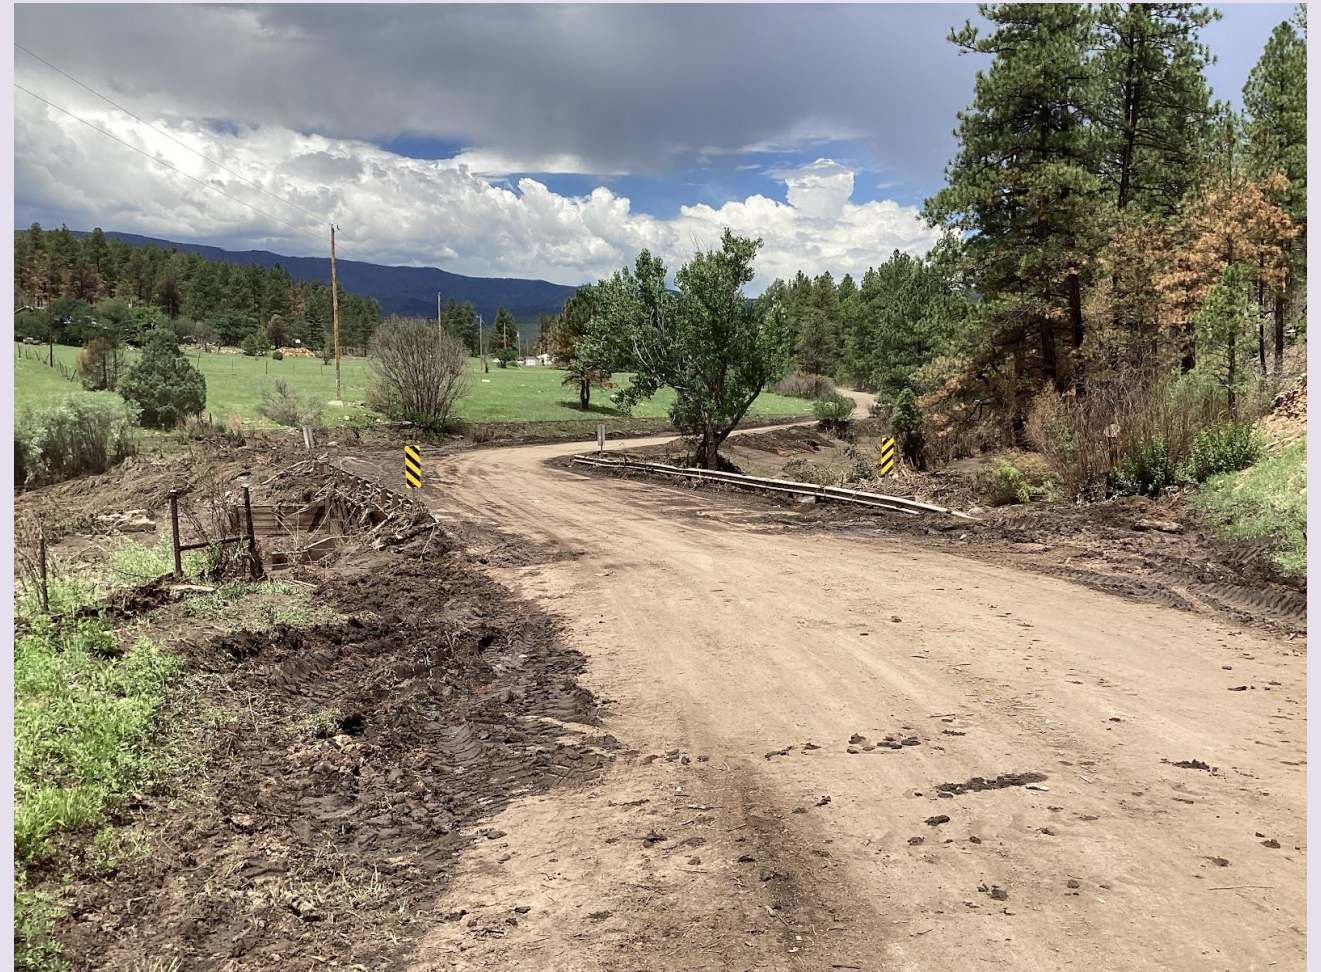
- Multiple low water crossings along roads A16C and 283 were damaged by the floodwaters

- Estimates taken by examining high water marks suggest the floodwaters were more than 6' over bridges and low water crossings and the debris flow extended as much as 5 miles down stream, stretching out to nearly $\frac{1}{4}$ mile wide as they spread out into the valley downstream

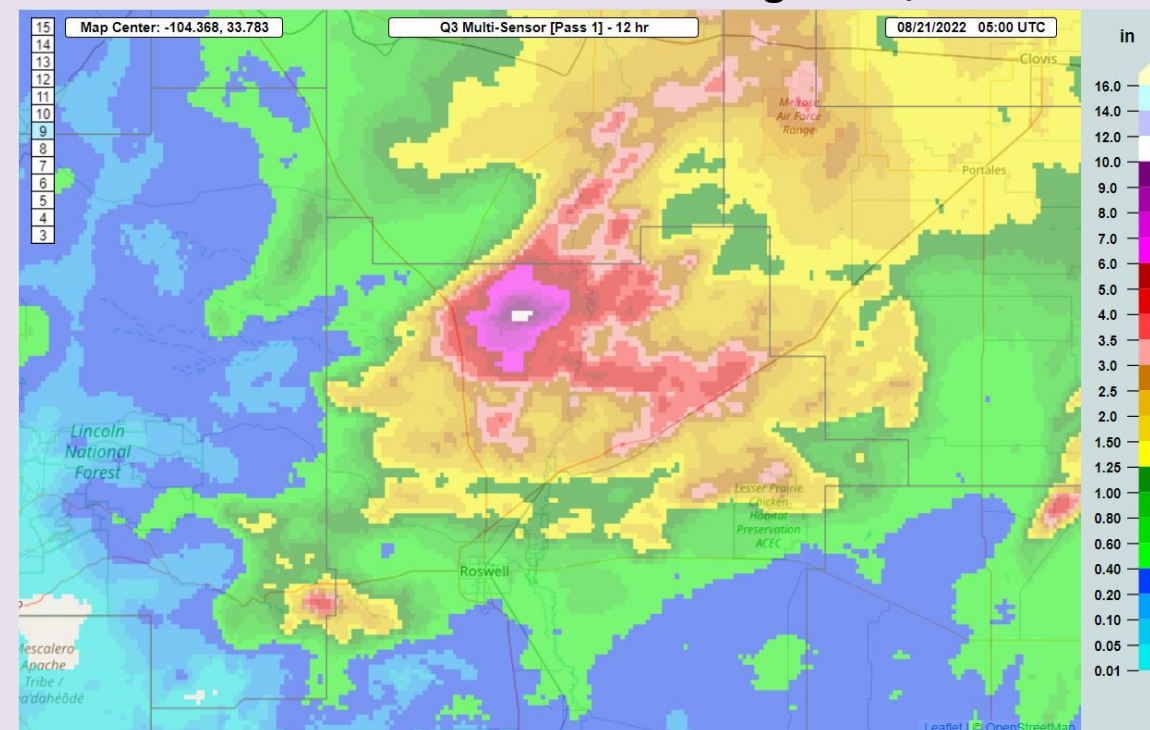
12 hour QPE from MRMS Dataset August 20, 2022

- Between 8/19 and 8/21 a stalled cold front combined with Pacific moisture and the remnants of a tropical system from the Gulf of Mexico to produce heavy rains across southern new Mexico.
- CoCoRAHs networks recorded 2-4" of rainfall in some areas, agreeing well with MRMS estimates.
- In northern Chaves County, MRMS suggested 8-10" of rainfall in an area with no rain gage reports, between 285 and the Pecos River.
- The west to east storm track fed tributaries of the Pecos River, including the Rio Hondo and Salt Creek before dumping the worst of the rain directly on the Pecos north of Roswell.

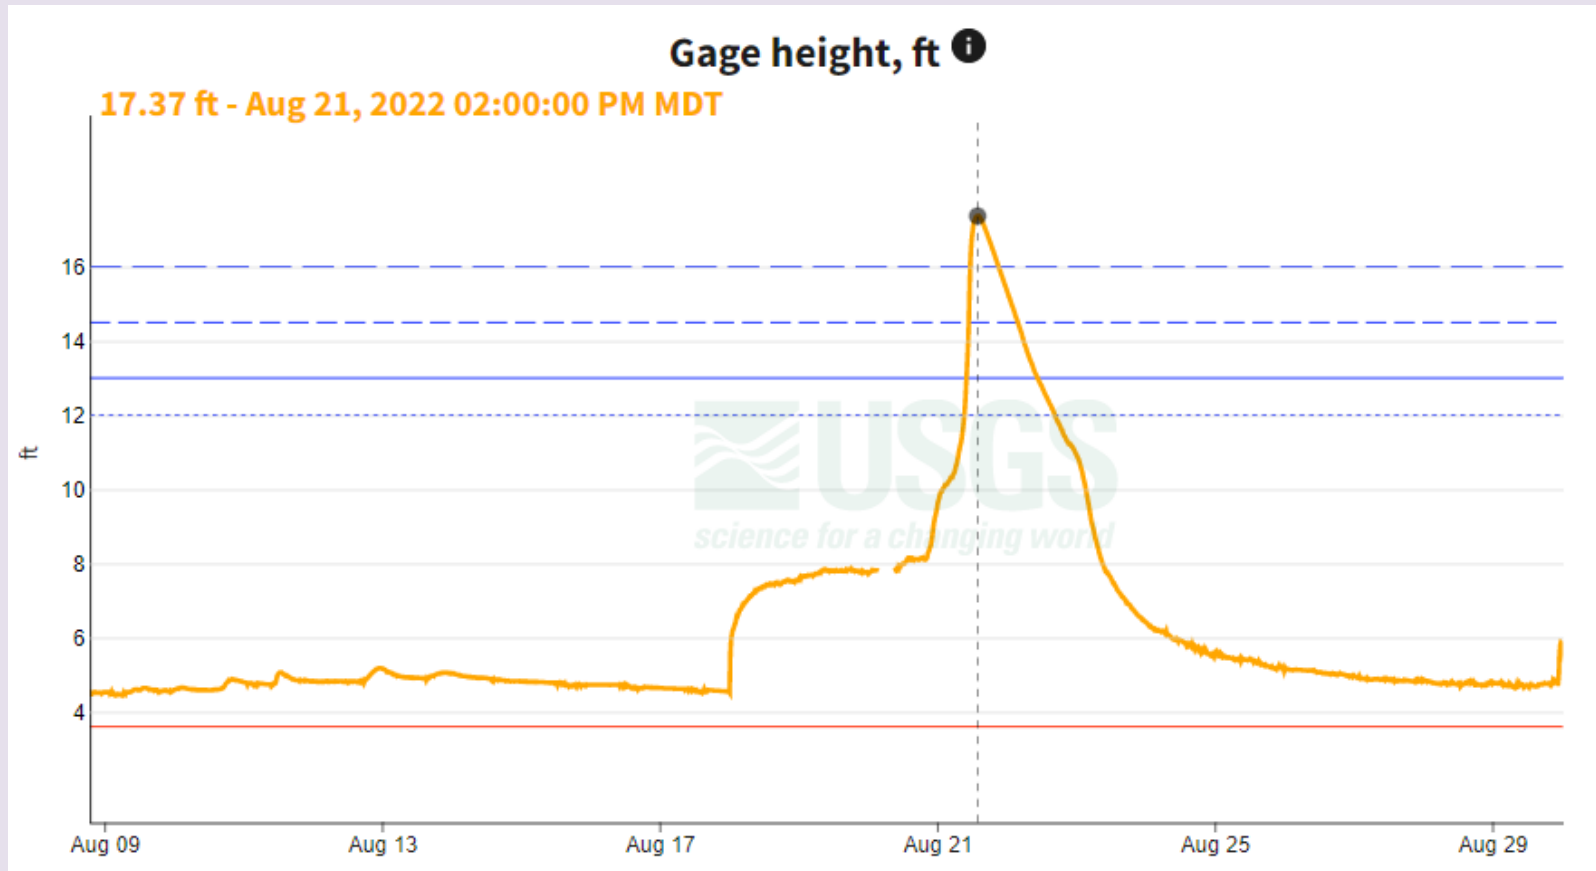
Heavy rains on August 20 drove record flooding on the Pecos River near Roswell, NM

- After an initial rise of nearly three feet from rains to the west, the pulse of water coming in from Salt Creek and the mainstem Pecos River drove a rapid rise to 17.37'
- The previous record at this gage was 14.89' in 1947, so this flood was nearly 2.5" above the previous record.
- Forecasting the flooding downstream of Acme was complicated by the fact that this flood drastically exceeded the rating curve used by the WGRFC, driving an enormous amount of uncertainty around the amount of water headed down stream

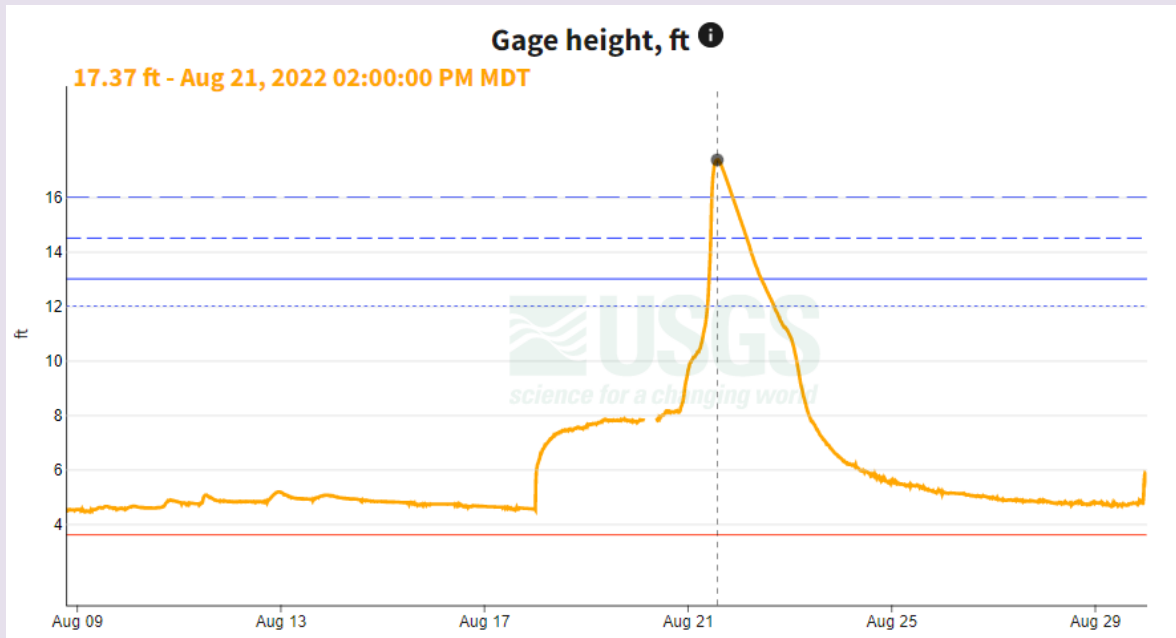
Pecos River at Acme

- The low relief of the Pecos River channel in this area drove floodwaters to spread out and work their way slowly downstream.
- As previously mentioned forecasting crest height at the downstream point of Lake Arthur was complicated by the exceedance of the rating curve used in the forecasting models.
- Forecasting the timing was also an issue as the RFC had never seen this much water move through the channel before.
- It took 5 days for the crest observed at Acme to arrive in Lake Arthur, some 30 miles south.

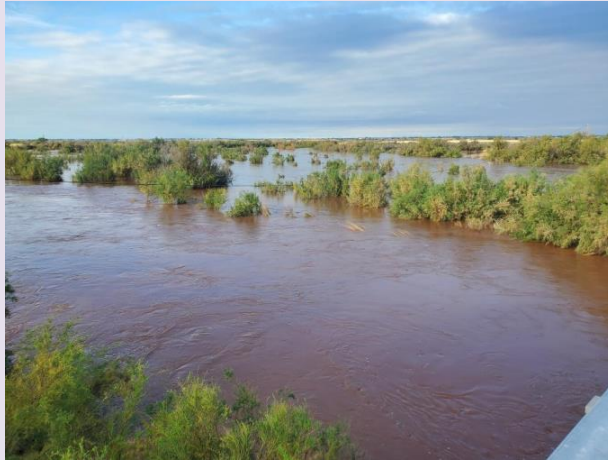
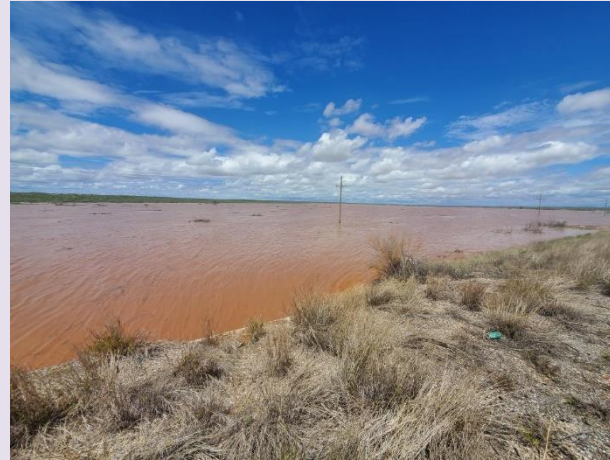
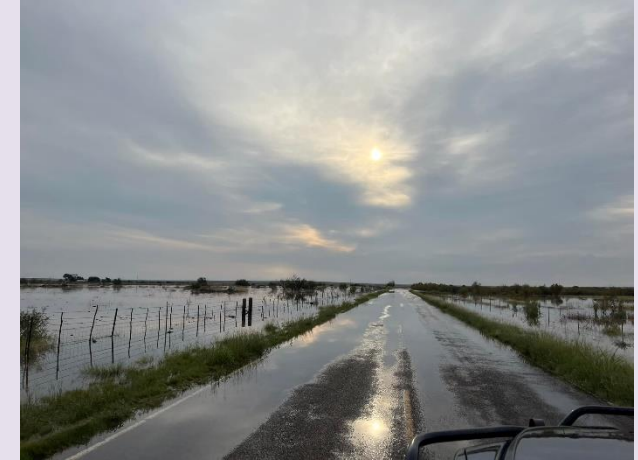
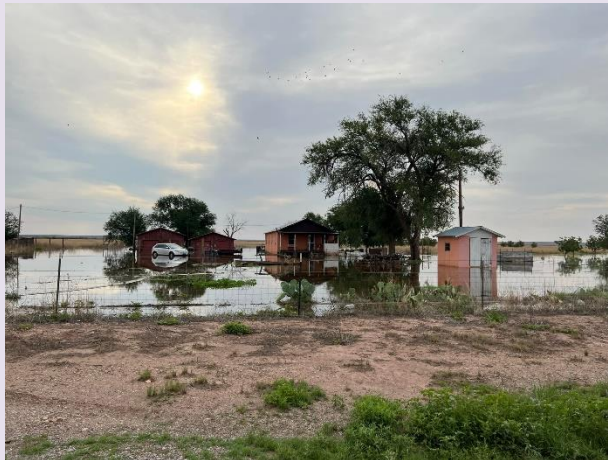
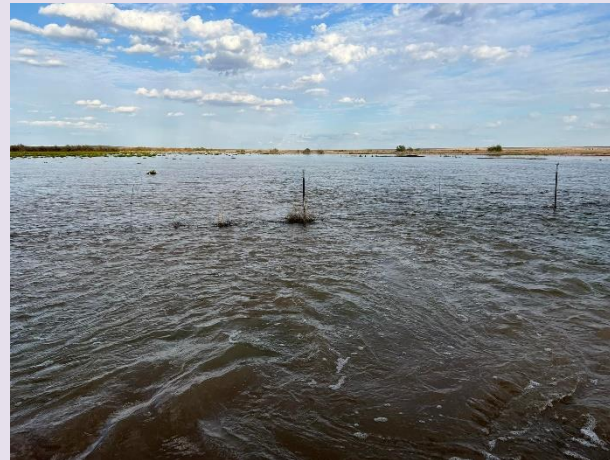
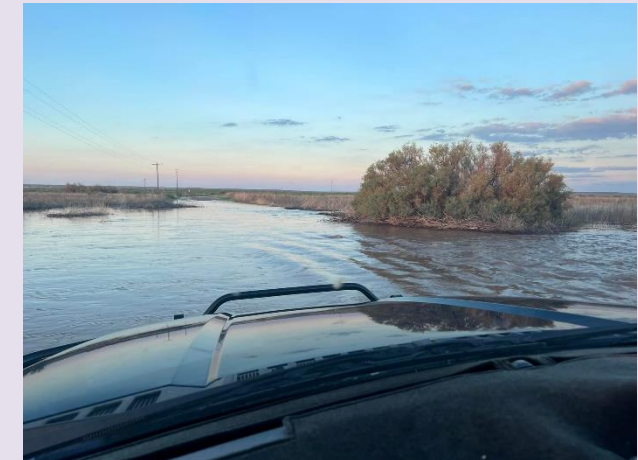
- Fortunately no lives were lost. However a reluctance to evacuate the homes near the river resulted in numerous water rescues by local emergency services. Some by foot but eventually some by boat.

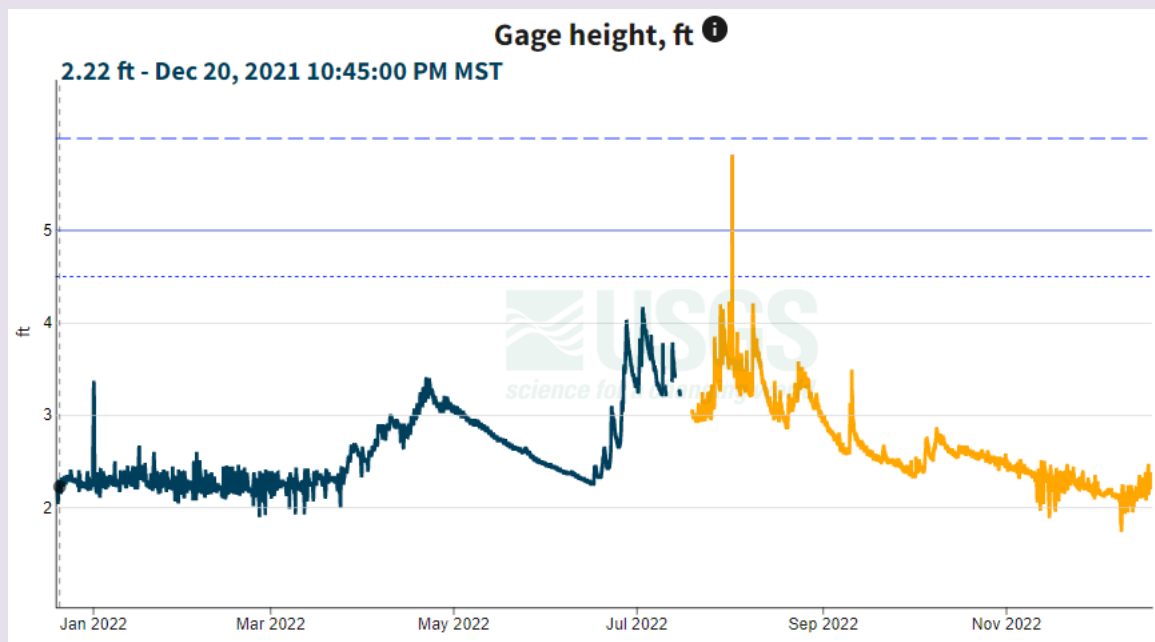
PCON5 – Pecos River Near Pecos

5.82' August 1: Minor

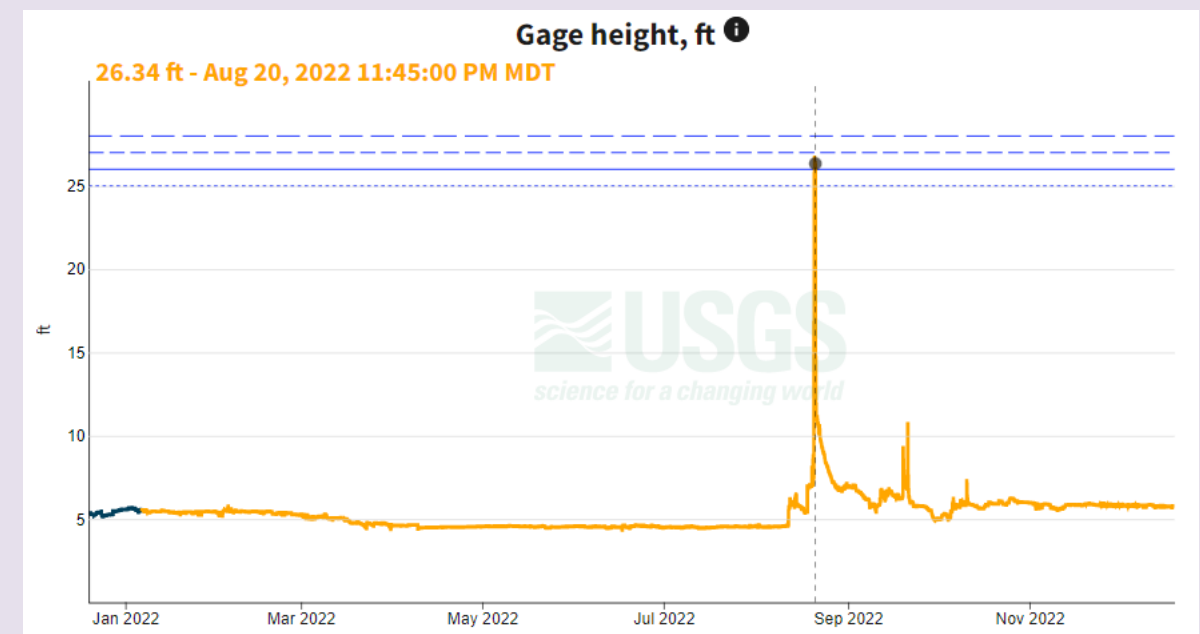
DARN5 - Rio Hondo above Roswell

26.8' August 20th: Minor

No Levee break this year but this was driven by the storm that led to record flooding in Roswell.

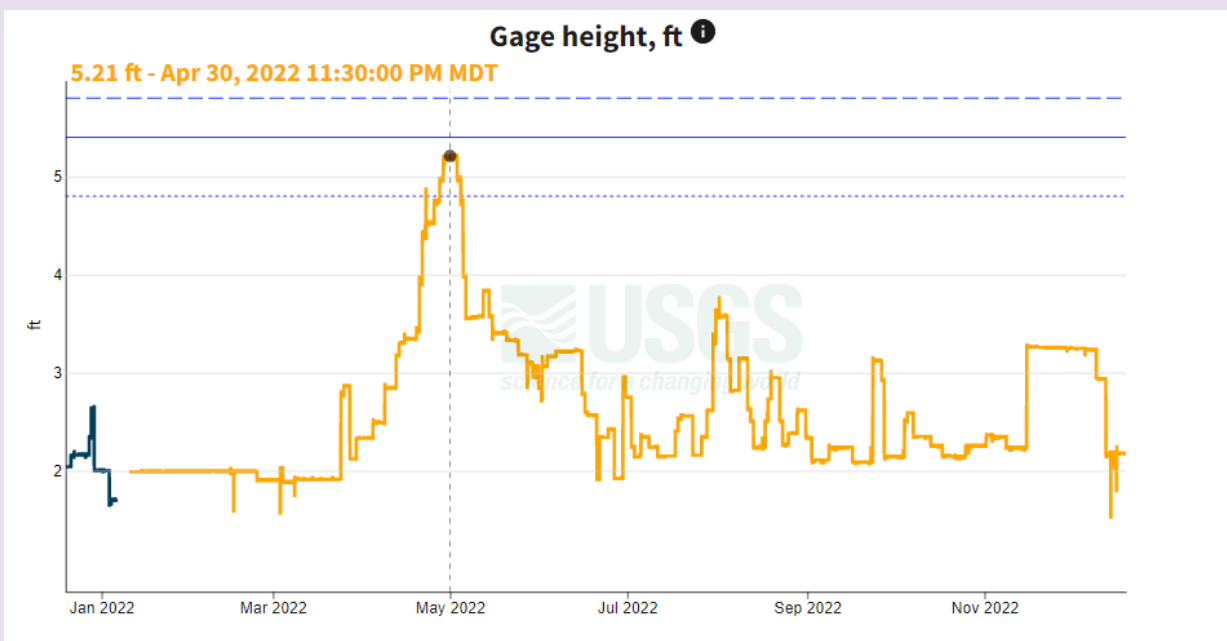
AICN5 – Rio Chama below Abiquiu

5.2' April 30th: Action

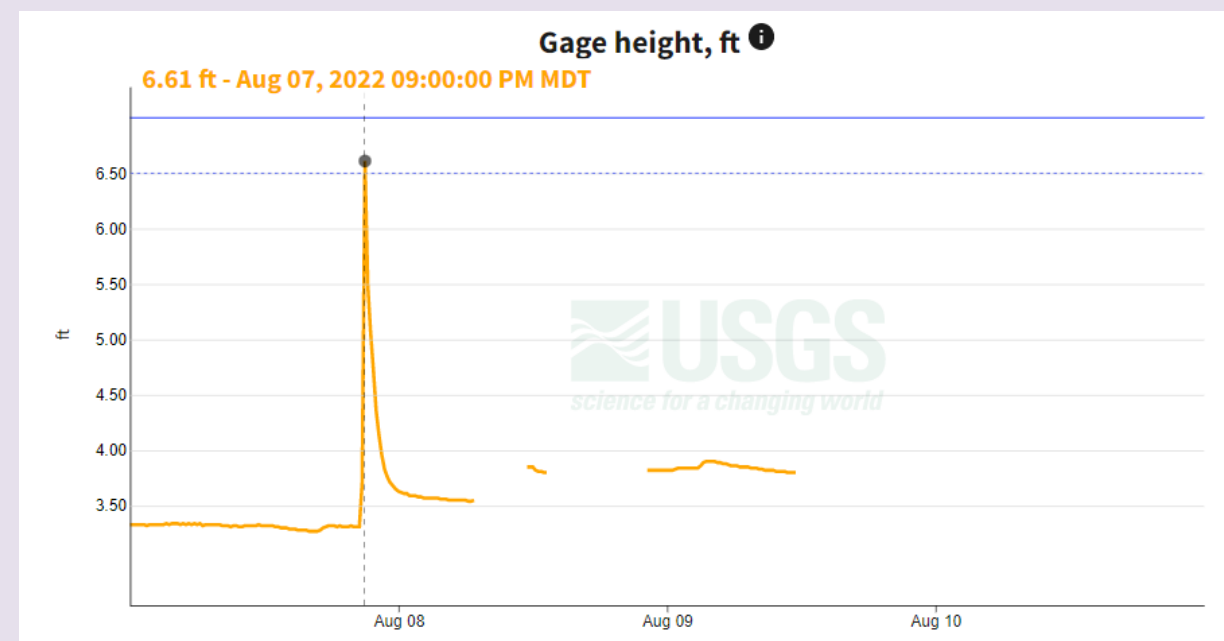
LMDN5- Rio Ojo Caliente below La Madera

6.61' August 7th: Action

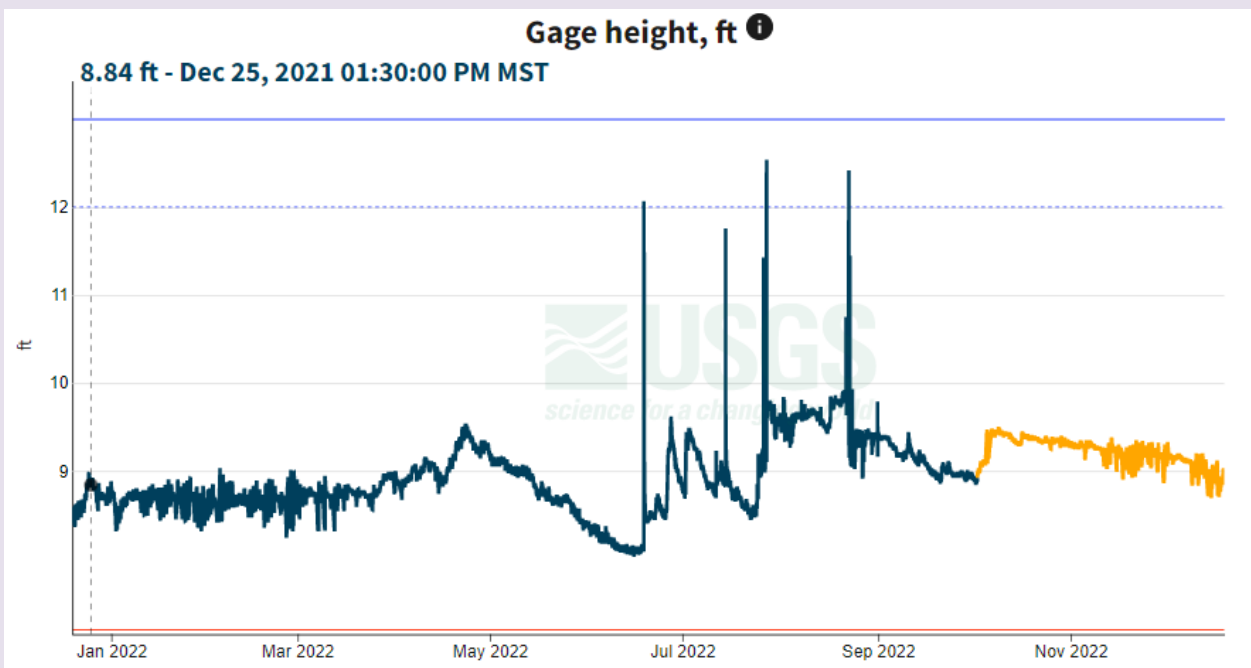
DIXN5 – Embudo Creek below Dixon

Several Action Rises

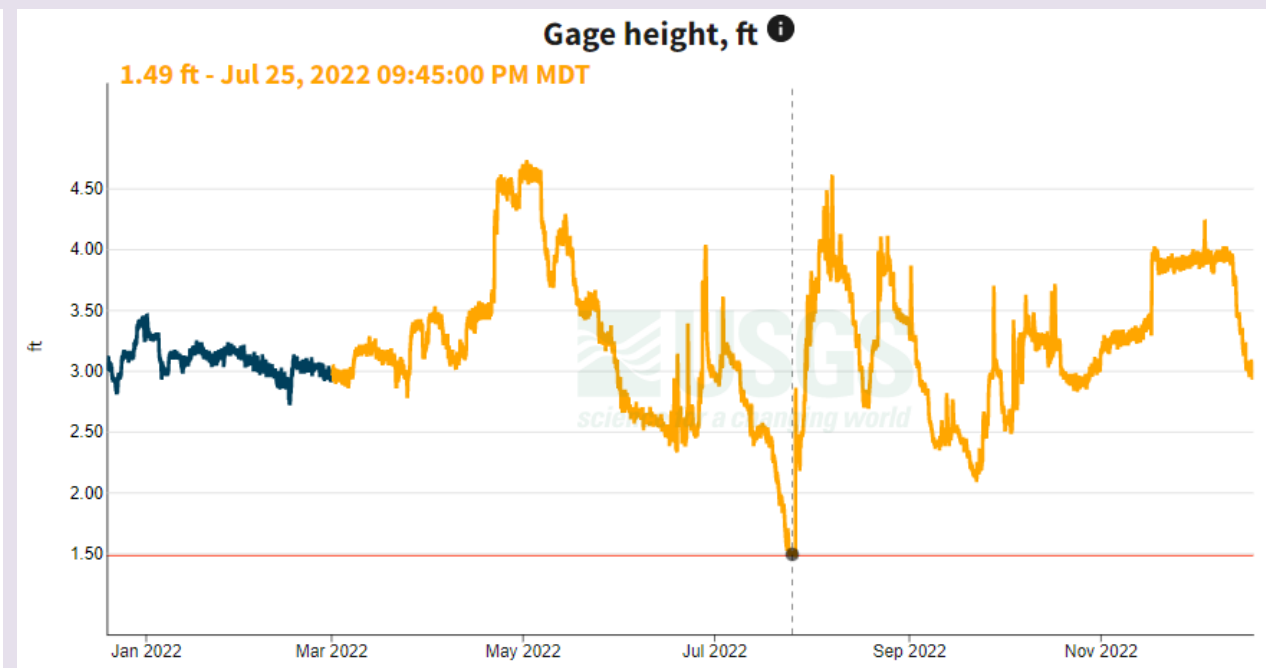
ABQN5 – Rio Grande at Albuquerque

Rio Grande at Albuquerque went dry in July.
First time since the 80's.

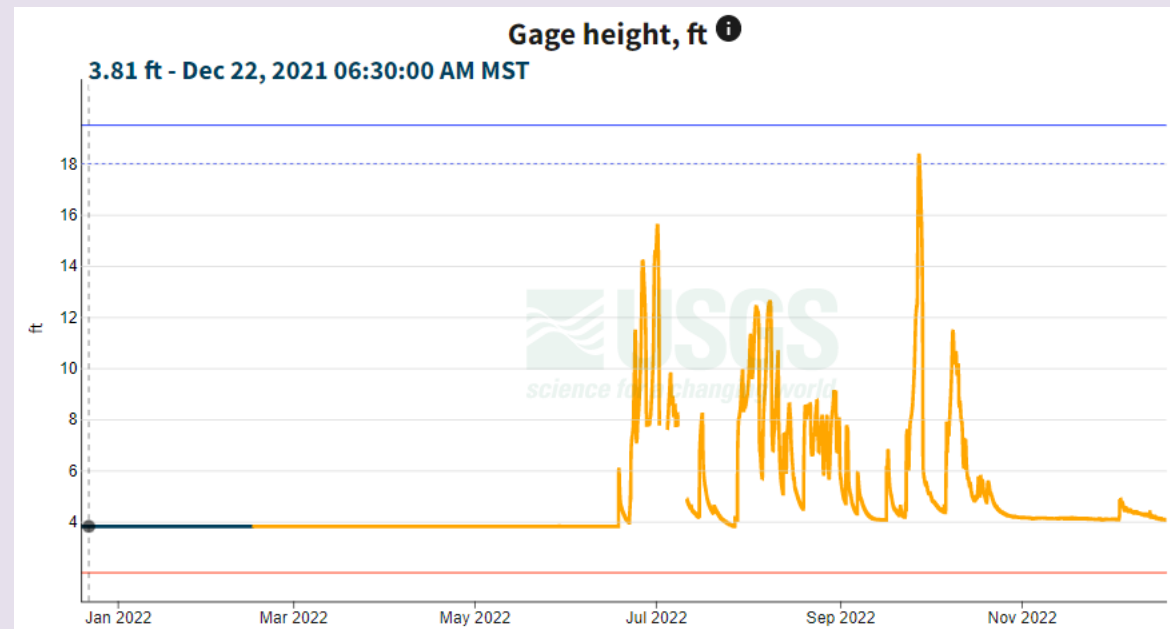
BNDN5 – Rio Puerco Near Bernardo

18.27' September 27: Action

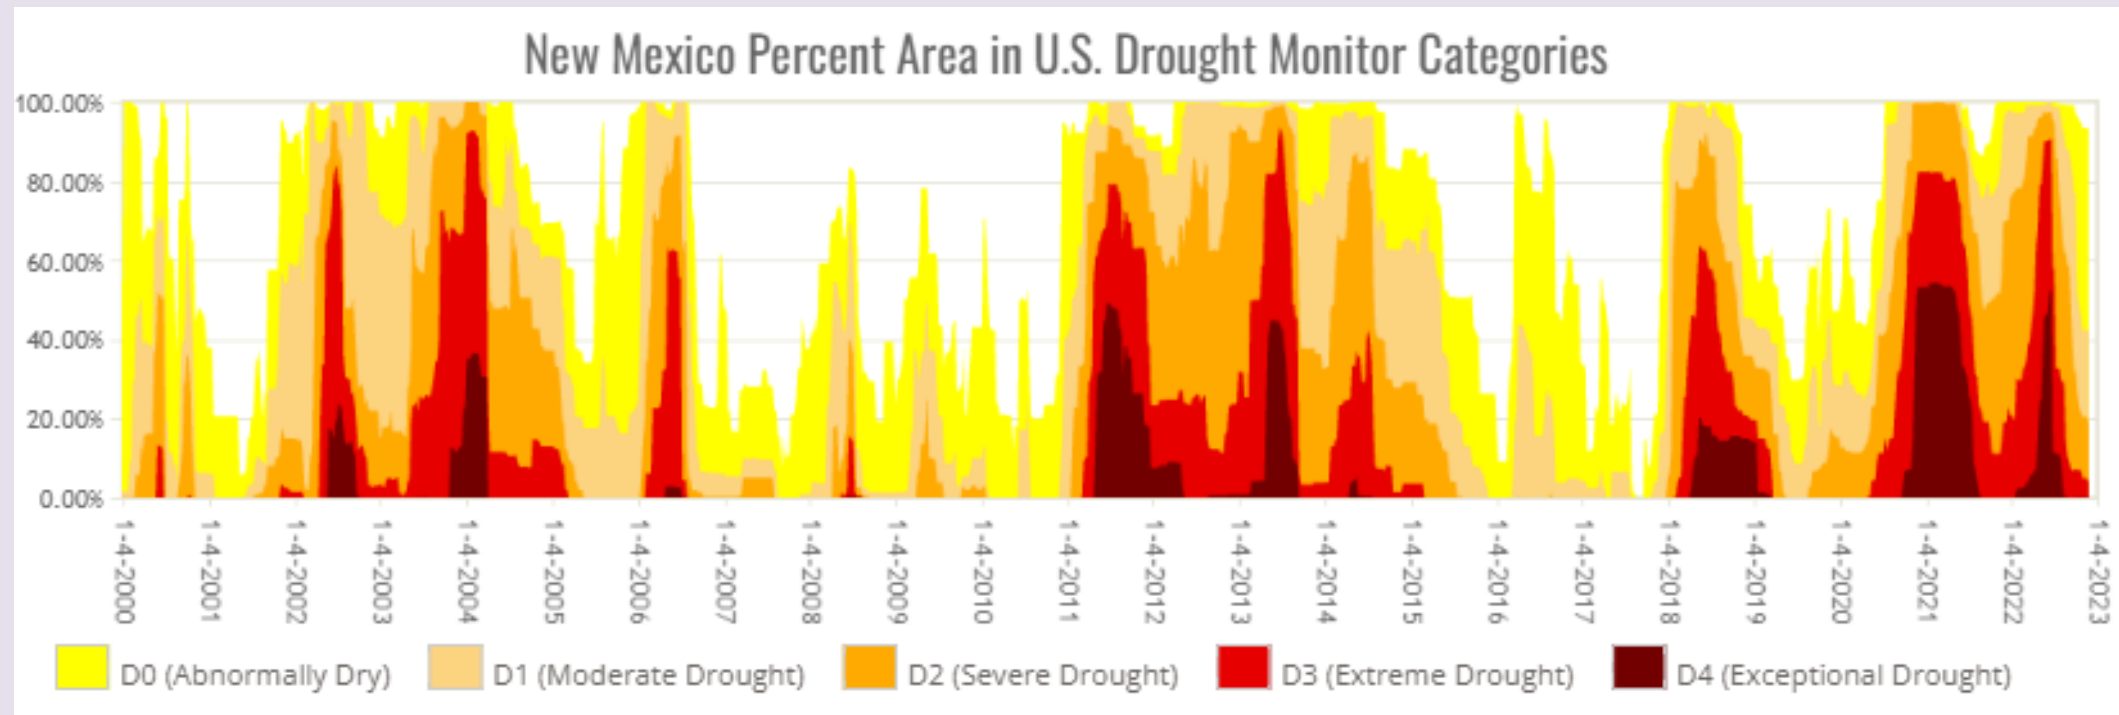
The chart below illustrates the progression of drought within New Mexico dating back to 2000. The coverage of exceptional drought conditions was greatest in 2011-2012 and during 2020-2022. Over the course of 2022 the coverage of exceptional drought approached these previous highs, with the coverage of extreme to exceptional drought rivalling any time in the past 22 years. However, the robust monsoon season of 2022 brought rapid improvement throughout NM.

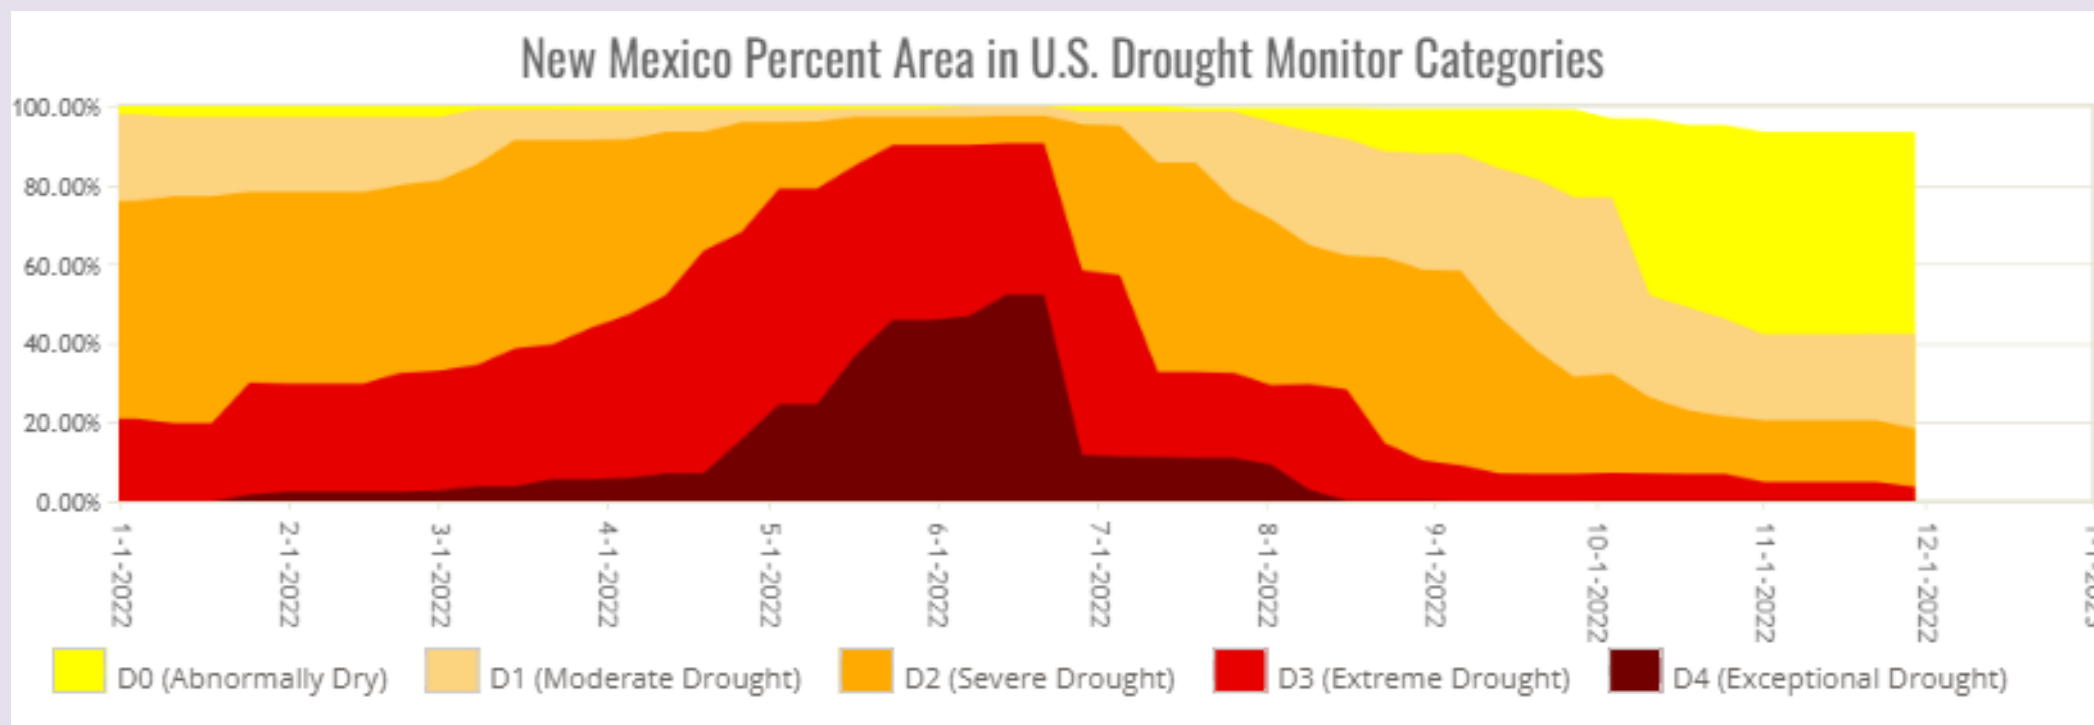
The chart below illustrates the progression of drought within NM during 2022 for the 5 drought categories. Greater than 50% of the state was in the worst category, exceptional drought, by mid June, with 90% of the state in extreme to exceptional drought. The rapid improvement seen in late June is directly attributable to the onset of the monsoon.

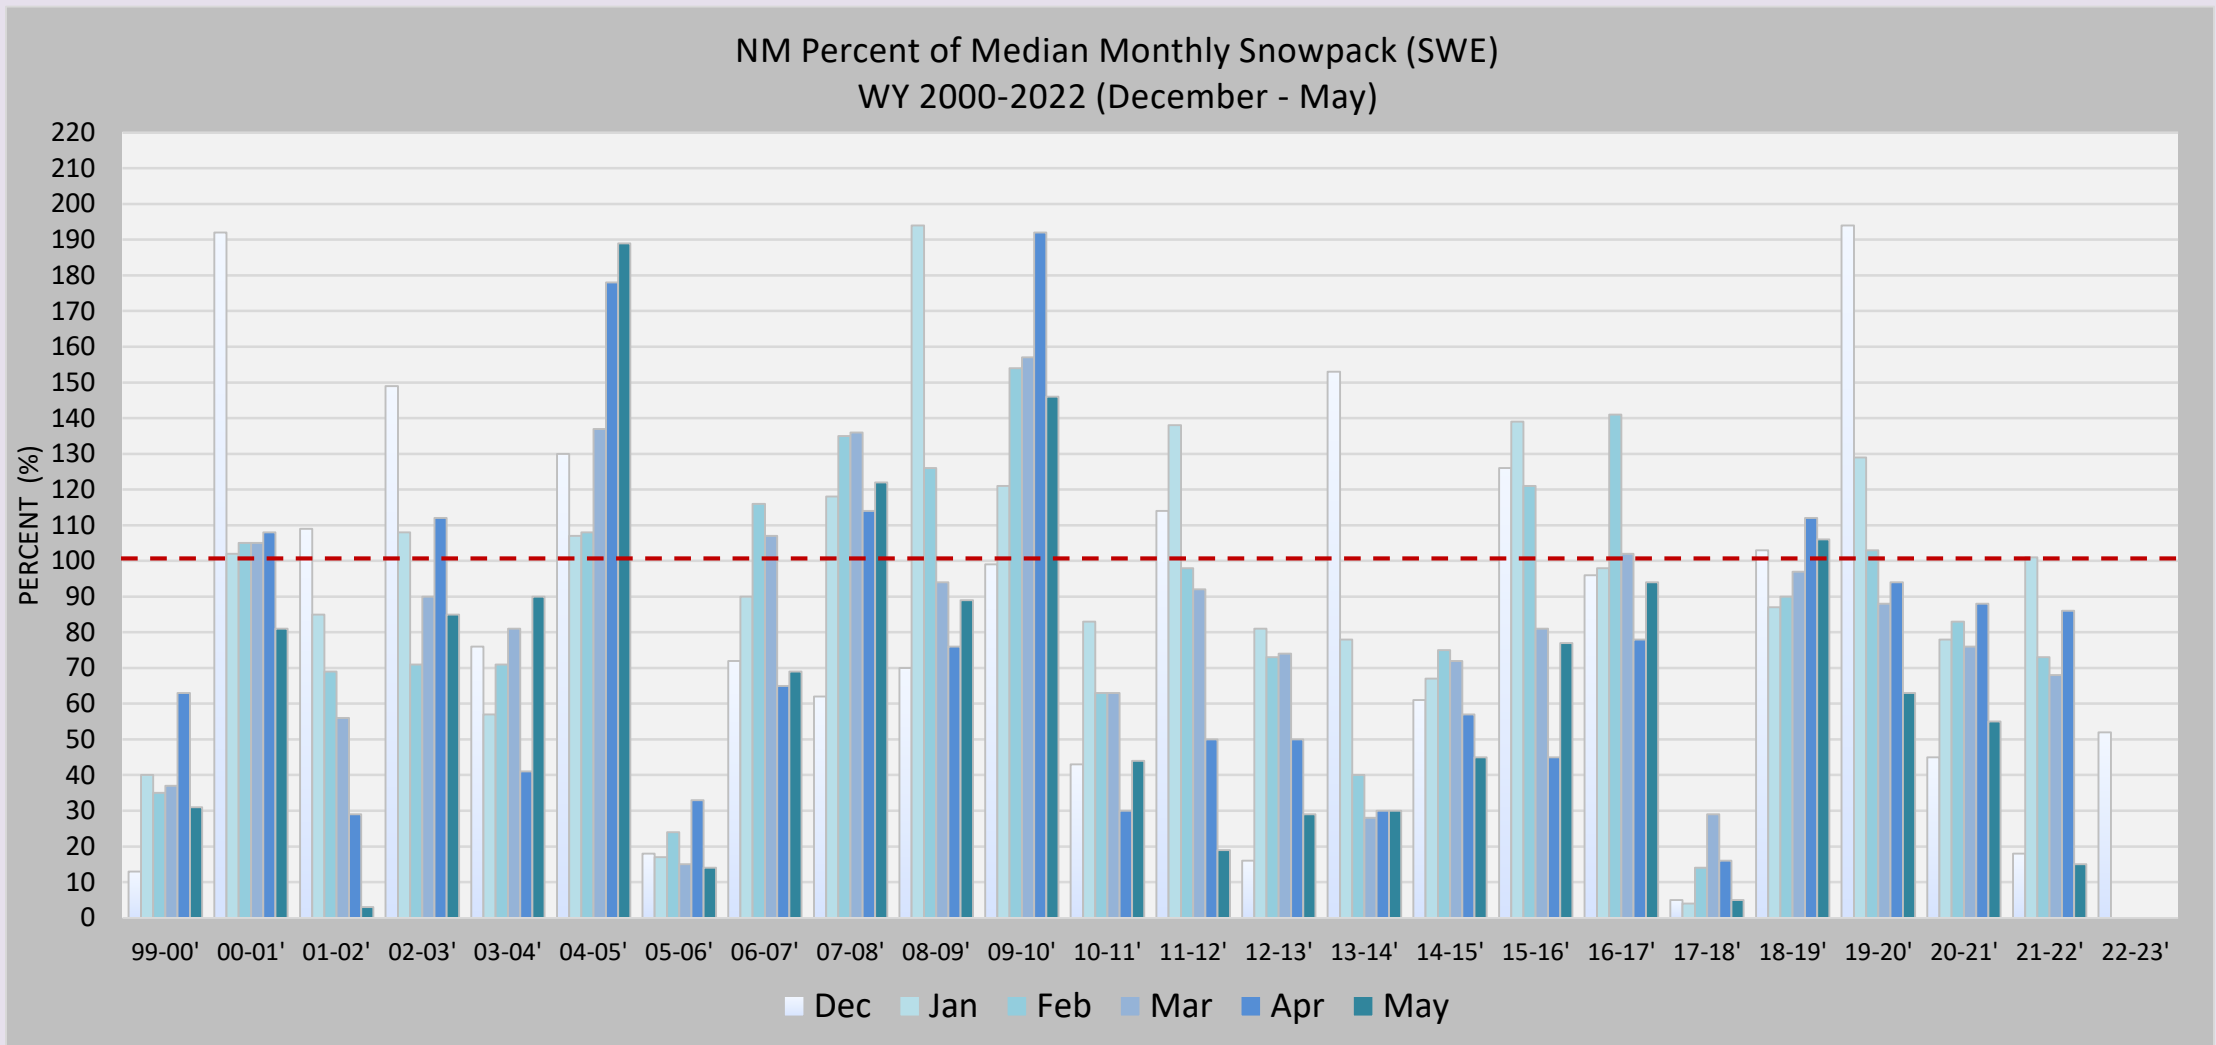
The chart above shows the percent of median monthly snow water equivalent (SWE) since 2000 for NM (1981-2010 climatology). The past 23 winter seasons have seen considerable variability with overall below median snowpack most years. Of the 138 months illustrated above, only 31% have seen above median SWE. This expansive snow drought has resulted in significant drawdown of New Mexico reservoirs. Several back-to-back heavy snow years will be needed for a notable recovery.
